CCR SURFACE IMPOUNDMENT ANNUAL INSPECTION REPORT

Big Cajun II Power Plant

Project Number TXR3568

January 2020

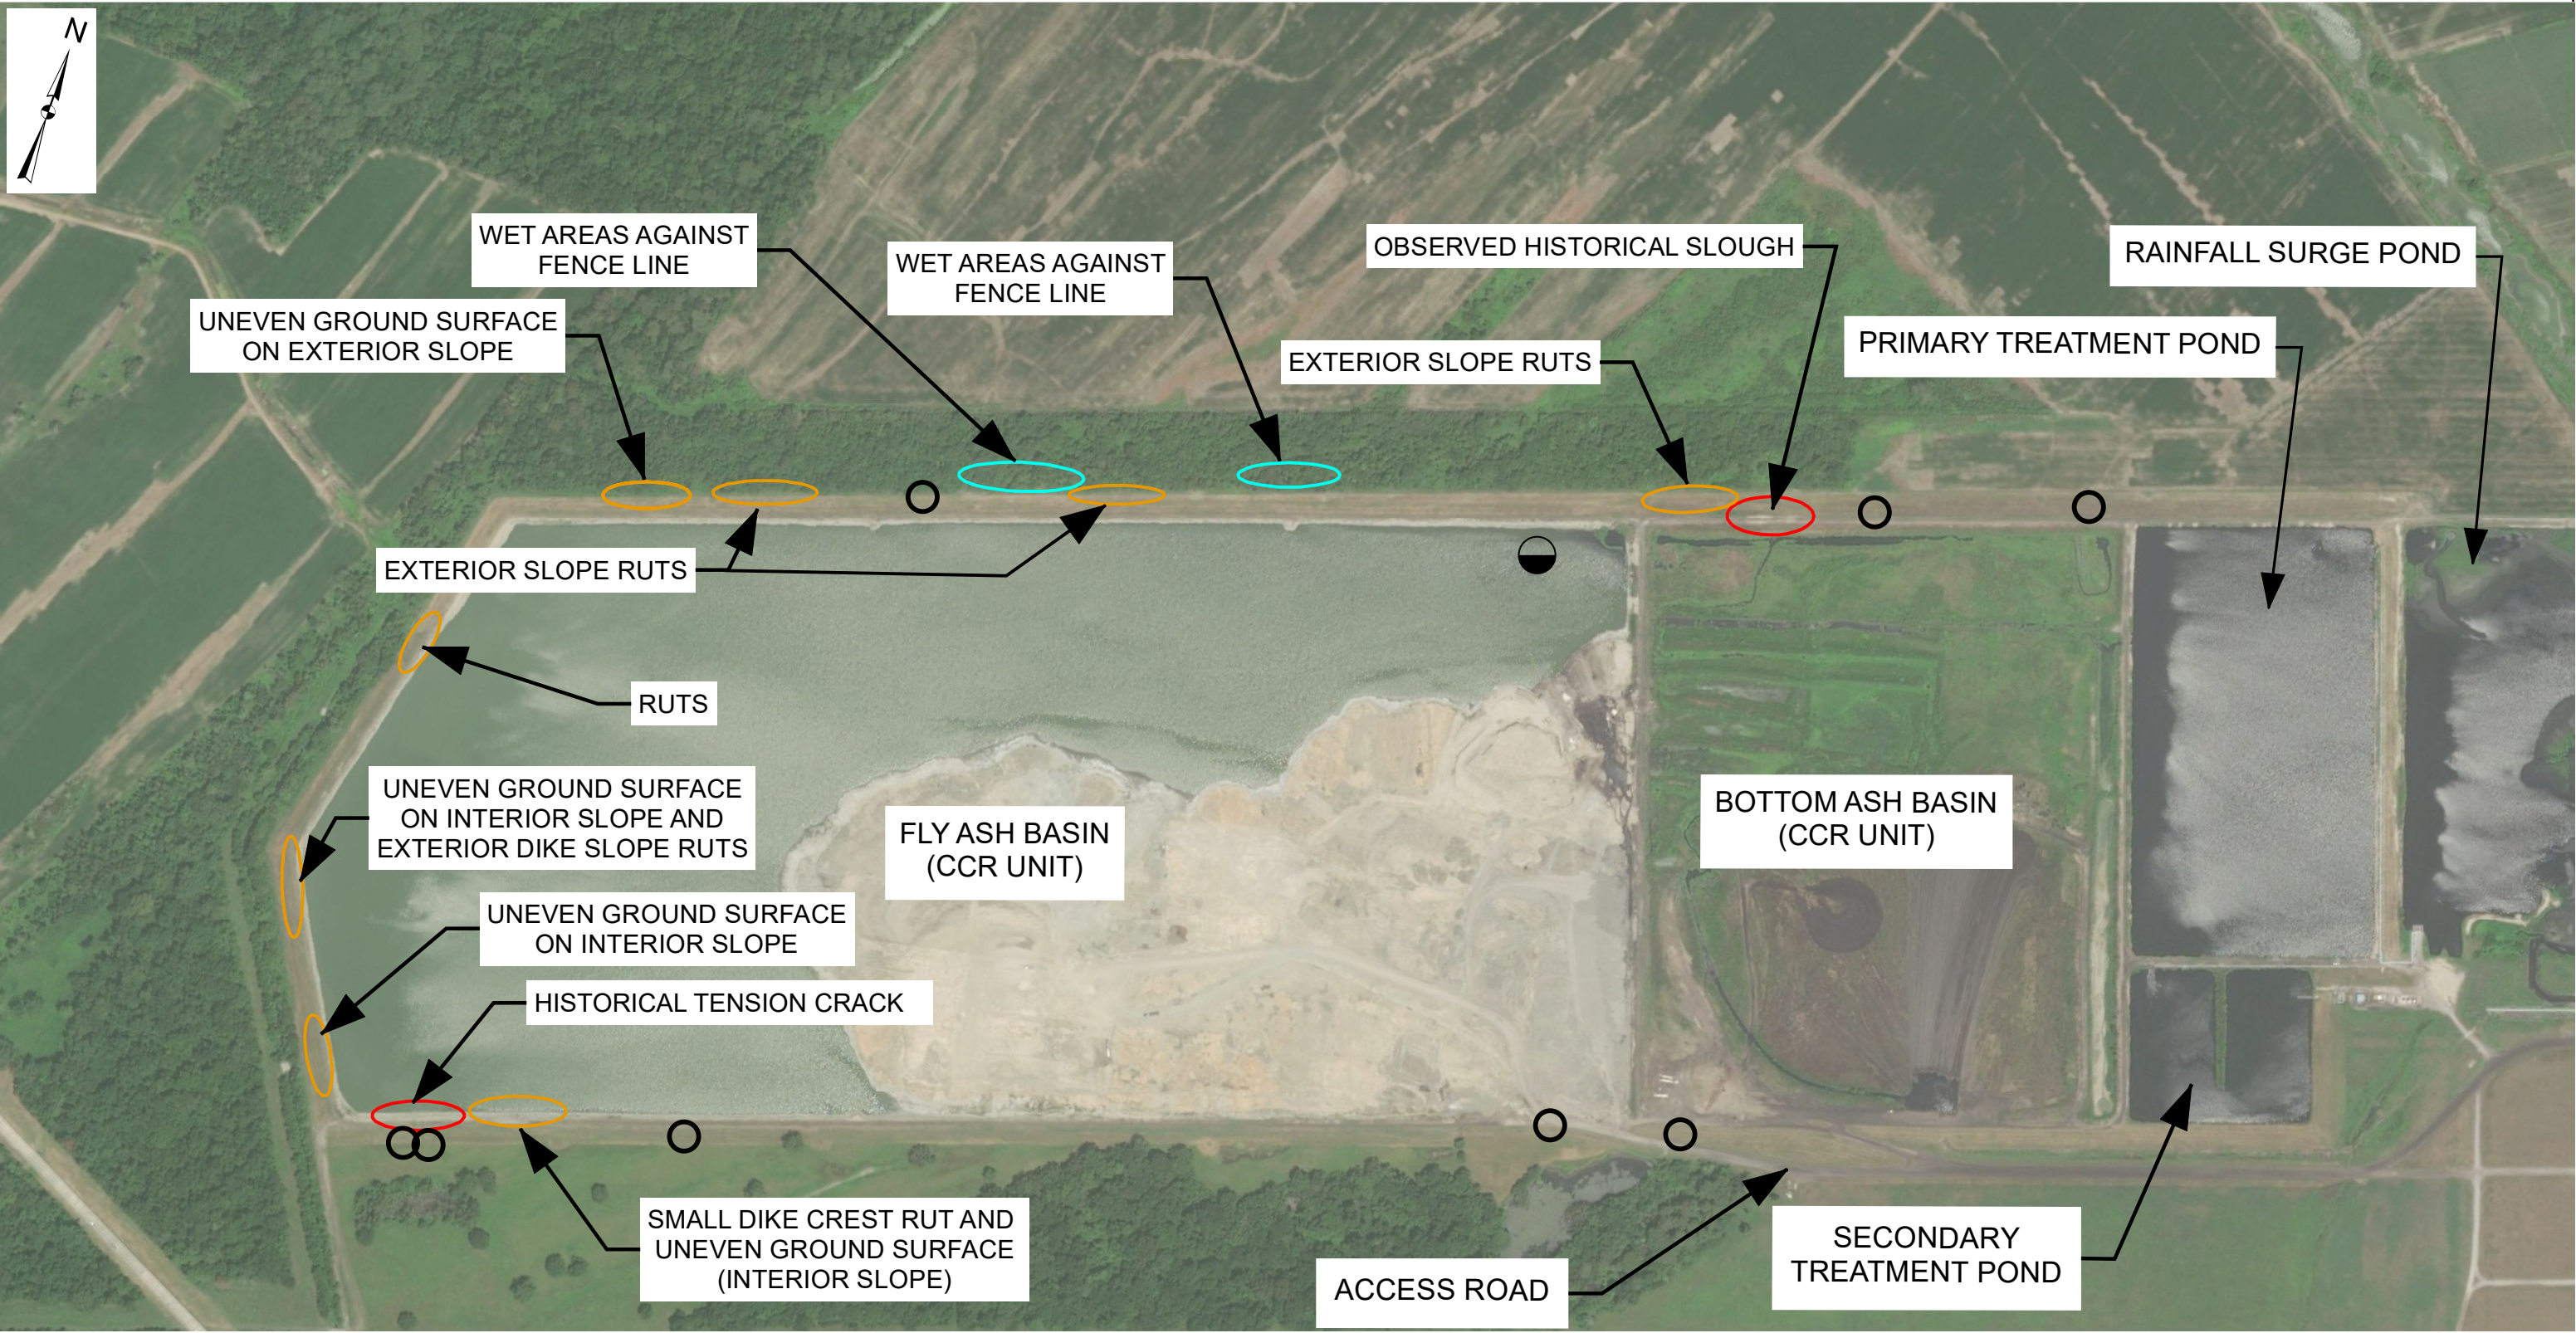
Figure 2: 10/29/2019 Inspection Map

Mr. James D. McNash, P.E., of Geosyntec visited the Facility on 29 October 2019 to visually inspect the Fly Ash Basin and Bottom Ash Basin and to interview the Facility's environmental coordinator. During this inspection, Geosyntec traversed the entire length of the Fly Ash Basin and Bottom Ash Basin perimeter dikes and the divider dike between the two CCR units. Geosyntec visually inspected and recorded observations with regards to the condition of the dike crest, upstream and downstream slopes, dike toe, and the discharge/stormwater conveyance structures to identify conditions or features that may potentially indicate distress or instability. A site map which depicts notable observations is presented on Figure 2.

- A location of localized slope instability (a localized slough) was observed on the north-facing exterior dike slope of the Bottom Ash Basin, about 400 feet east from the northwestern corner. The observed area is approximately 70-ft to 90-ft long and exhibits a roughly 12-inch escarpment at the crest that is slightly eroded with some vegetation growth. During the inspection, tractor mower tracks were observed which indicated that equipment avoided the affected area. The affected area was previously identified during past annual inspections (CB&I, 2017; Geosyntec, 2018; Geosyntec, 2019) and was repaired prior to 2015 after an inspection. The instability does not appear to have displaced further and weekly inspection records indicate that the slough is monitored routinely. The toe area was slightly bulged, but signs of seepage (i.e., softer soils) were not observed when traversed. At the time of the inspection, CCR material or significant volume of standing water were not impounded on the interior perimeter dike slope

adjacent to this area. As such, the affected area appears to be a localized observation for which a repair is recommended, but not considered an issue that impairs the operation or safety of the CCR unit. During the inspection, the Facility environmental coordinator identified that the area was scheduled for repair in 2019. In January 2020, the facility notified Geosyntec that the repair was completed in December 2019.

- The perimeter road on top of the dike was generally in good condition with no observed signs of problematic desiccation cracking or deformations.
- Three animal burrows with approximate diameters between 4 and 8 inches, were observed.

- Wet areas identified in the *2018 Annual Inspection Report* held in October 2017 (Geosyntec, 2018) on the Fly Ash Basin perimeter south dike toe about 1,300 feet and 2,000 feet west from the southeastern corner were not observed to contain standing water. The natural topography indicates that these are low-lying areas where water tends to naturally accumulate, and seepage of the perimeter dike structure or any signs of distress or malfunction were not identified.
- Limited areas of ponded water were observed on the north side of the Fly Ash Basin against an existing fence line. Topography north and outside of the fence line is slightly higher and prevents surface water runoff. The adjacent downstream

dike slope was observed to be dry; as such, the retained water does not appear to be the result of seepage through the containment structures.

- A minor rut, approximately 6 inches in depth, was identified in the dike crest in the south Fly Ash Basin perimeter dike.
- Surficial material on the interior slopes in several areas of the southwestern, western and northwestern dikes appear to be uneven that result in localized steeper slopes near the crest. In some cases, rills extend near to the interior dike crest edge.

- An area of uneven ground surface or a tension crack along the exterior about 250 feet east of the southwestern corner was observed in prior annual inspections. The southwest corner of the Fly Ash Basin was also previously identified as having potential sloughs/slope instability and was subsequently repaired. During this inspection, evidence movement or instability (i.e., seepage, wet areas, and additional slumping) was not observed. The area merits continued annual inspection and observation weekly for geometric changes or other signs of movement/weakness.

- Uneven ground surface and/or equipment rutting was observed on the downstream perimeter dike crest near the Fly Ash Basin's southwest corner. The area exhibited relatively significant equipment rutting which appears to be the predominant contributor to the uneven ground condition. During Geosyntec's inspection, evidence of movement or instability, as previously defined, was not observed. Further observation to identify changes or other signs of movement/weakness and/or regrading activities to smooth the slope for future inspections is recommended.

- In the northwest corner, a few minor ruts within the dike crest were observed. The perimeter road along the perimeter dike crest was generally observed to be in good condition with no observed signs of problematic desiccation or tension cracking and/or other deformations. Continued routine maintenance is recommended to permit access and facilitate routine inspection of the CCR unit.

- Occasional animal burrows between four to eight inches in diameter were observed on the southern and northern-facing exterior dike slopes. Limited bare areas were observed on the exterior dike slopes with desiccation cracks. Extensive desiccation cracks or signs of seepage were not observed in these areas.

- For the Fly Ash Basin, Geosyntec noted one area of potential structural weakness: a tension crack or uneven ground surface within the exterior slope in the southwest corner. However, the tension crack did not appear to have displaced recently, and the environmental coordinator indicated that the area would be maintained or repaired in early 2020.
- For the Bottom Ash Basin, Geosyntec noted one area of potential structural weakness: an area of slope instability located on the northern-facing exterior slope of the perimeter dike, near the northwest corner of the basin. The identified area was further described in Section 3.1.2, and scheduled for a repair that was completed in December 2019.

1. **Corrective Measure – Repair.** The area of localized slope instability (area of sloughing) on the northern-facing exterior slope of the perimeter dike (near the northwest corner of the Bottom Ash Basin) should be repaired to rehabilitate a potential structural weakness to the impoundment. Geosyntec understands that the Facility, scheduled and completed the repair of this area in December 2019.

2. **Heightened Awareness During Routine Inspections.** This Report identifies a few areas that warrant close observation on a routine basis (e.g., weekly inspections) for signs of changes or progressive worsening of conditions. These areas were locations where wet/soft or uneven ground was observed. While there was no evidence of slope instability or movement, such conditions may be precursors. Geosyntec understands that the southwest corner of the Fly Ash Basin may be repaired in January 2020 during routine maintenance activities.

3. **Ongoing Maintenance and Repairs as Needed.** Perform maintenance/repairs to the dikes and other appurtenant impoundment features on a routine and ongoing programmatic basis as well as on an as needed basis if warranted by problems or concerns (e.g., as identified during periodic inspections by a qualified person, or as otherwise identified). Ruts should be regraded and bare areas should be re-seeded to establish vegetation and the existing vegetation maintained in a condition to facilitate inspections. Observed ruts and erosion rills should be repaired before the feature worsens.
