ANNUAL CCR SURFACE IMPOUNDMENT INSPECTION:			
Facility Name:		Cleco Dolet Hills Power Station	
Address:		963 Power Plant Rd. Mansfield, LA	
Surface Impoundment Name :	Ash Basin No. 2	Owner:	Cleco Power LLC
Surface Impoundment ID:	P-0037	Operator:	Cleco Power LLC
Nearest City:	Mansfield	Parish:	DeSoto
Inspector:		James C. Van Hoof, P.E.	
Company:		Providence Engineering & Environmental Group LLC	
Date of Inspection:		12/18/2020	
Weather at Time of Inspection:		Sunny, cool	
DESCRIPTION OF THE OPERATION OF THE SURFACE IMPOUNDMENTS:			
<p>The bottom ash and economizer ash are mixed with water and sluiced in a slurry form to either of the two Ash Basins. Ash slurry pipelines within each basin enable the discharge of the slurry at multiple points within each basin. The discharge into each respective basin begins at the end of the pipeline network at the point furthest from the weir box, and proceeds toward the front of the pond. As a basin fills with ash, sections of the discharge pipe are removed as needed so that ash can be uniformly deposited and the storage capacity of each basin fully utilized. The ash-laden water is retained in the Ash Basins for a period of time sufficient to sett

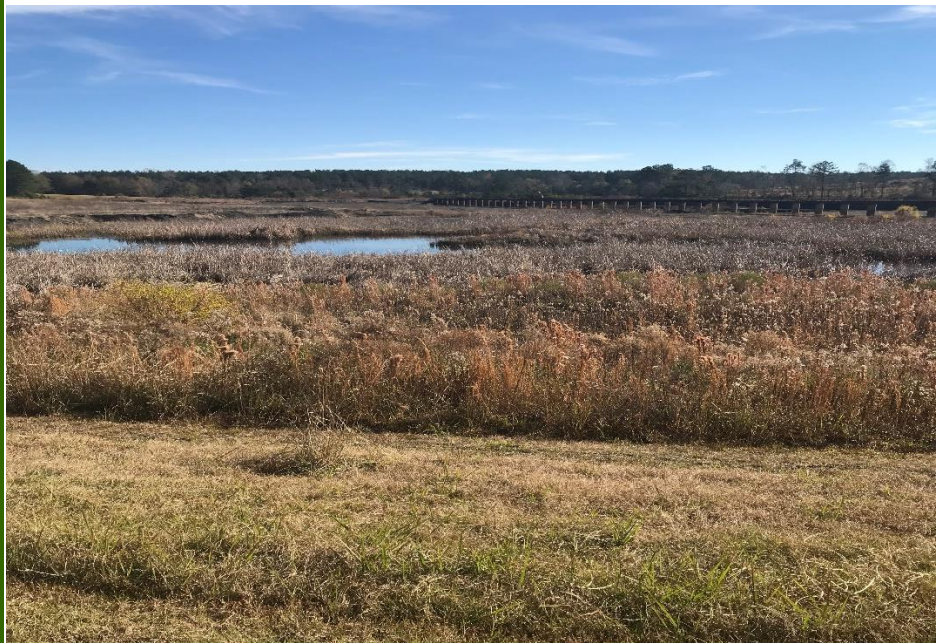
Ash Basin looking at sluice structure.

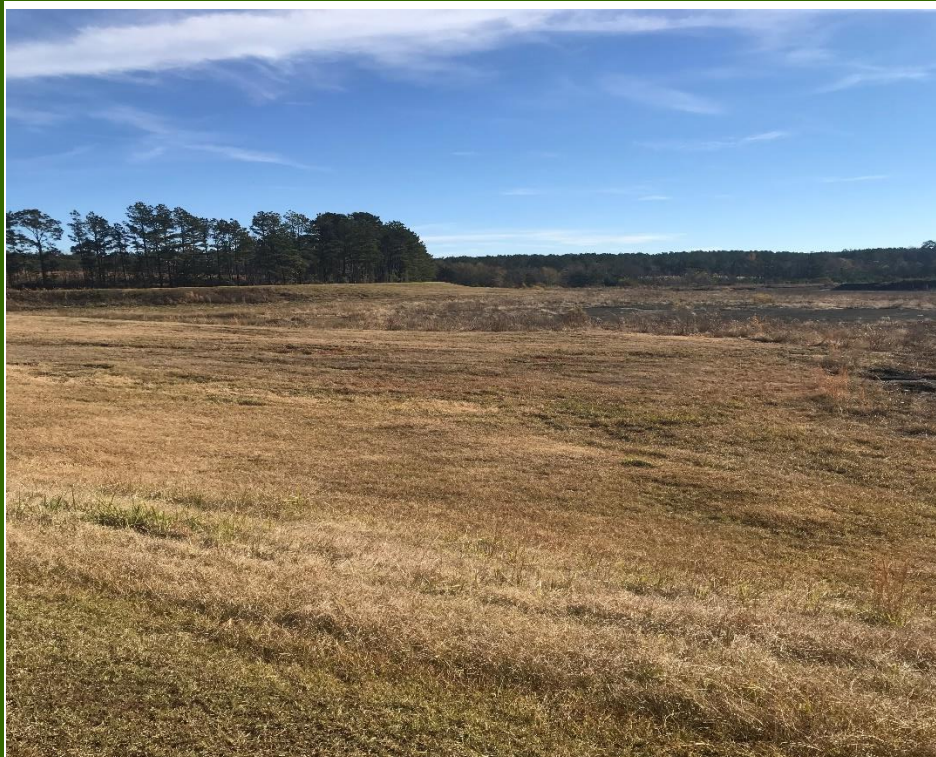
Northern side of Ash Basin.

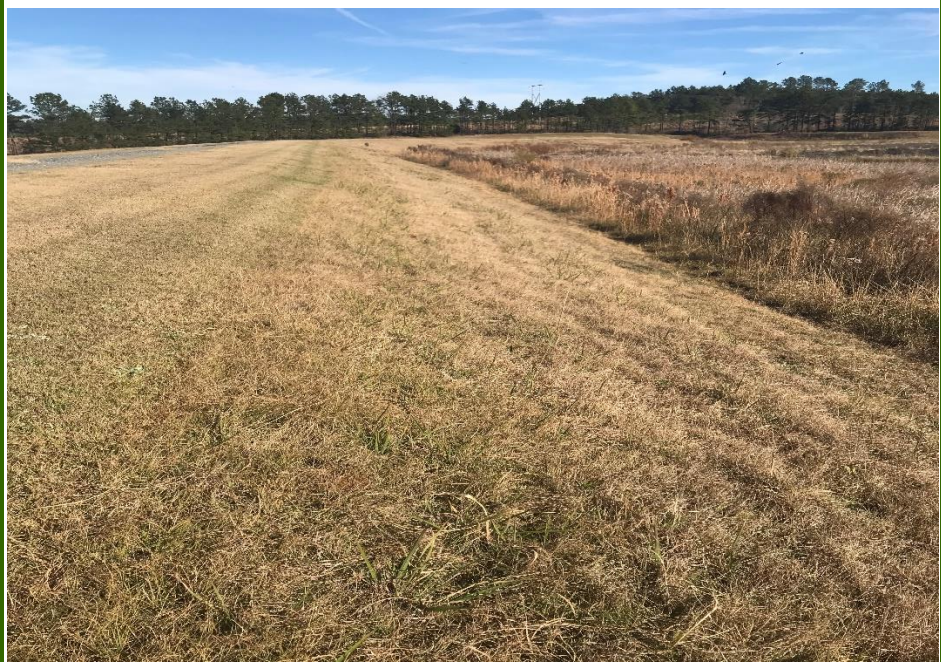
Internal slope of western levee.

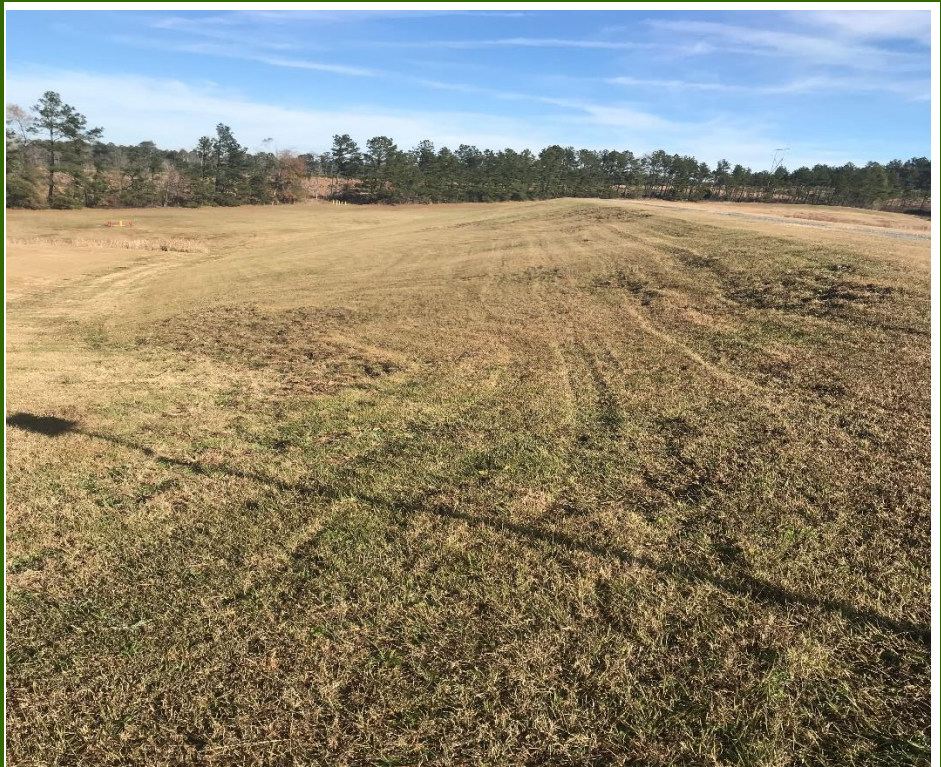
External slope of western levee.

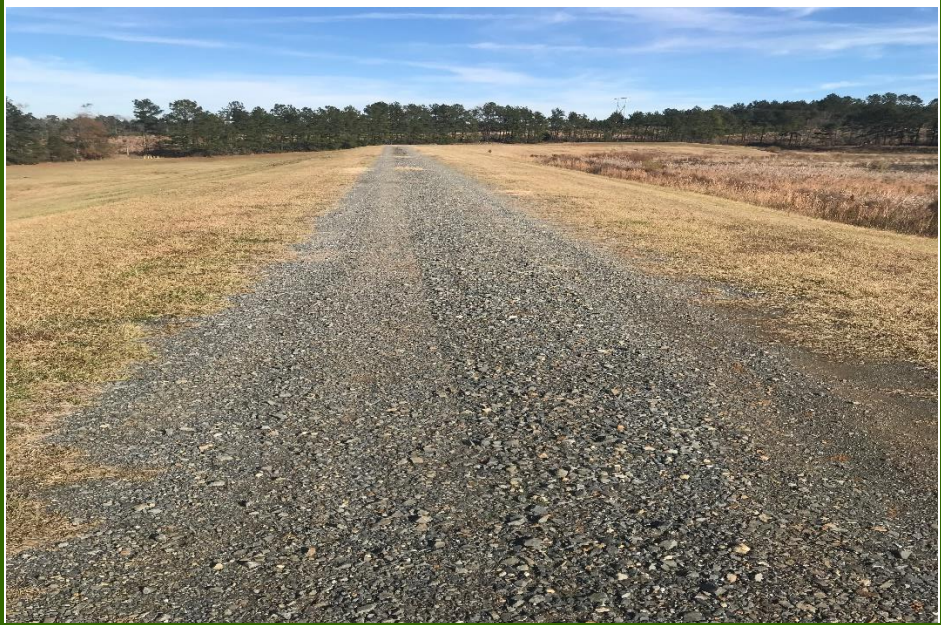
Access road on western levee.

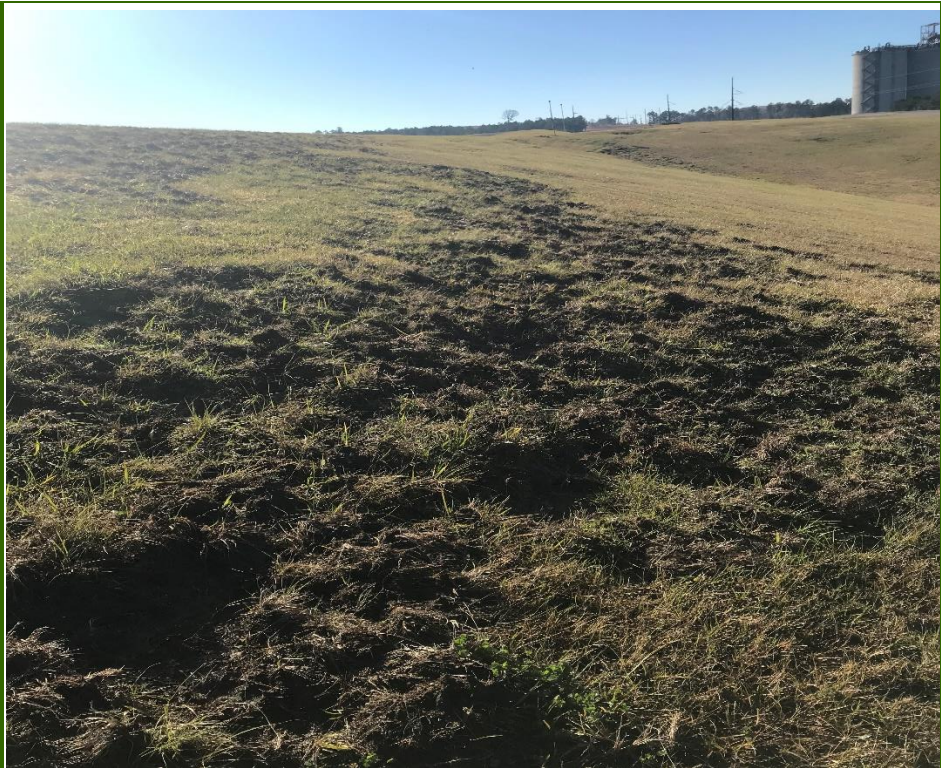
Area along the exterior levee showing where the feral hogs have recently rooted the topsoil.

Are there any trees on the slopes?	<input type="checkbox"/> Yes <input checked="" type="checkbox"/> No
If yes, describe (type of vegetation, size, location, etc.)	
Findings:	The exterior slope was inspected and appeared to be in satisfactory condition. Only minor corrective actions are required at this time based on other observations below.
Other observations on the exterior slopes:	Feral hogs have rooted an approximate 1,500 square foot topsoil area on the exterior slope of Ash Basin No. 2. The area needs to be smoothed, then seeded and fertilized to prevent erosion.

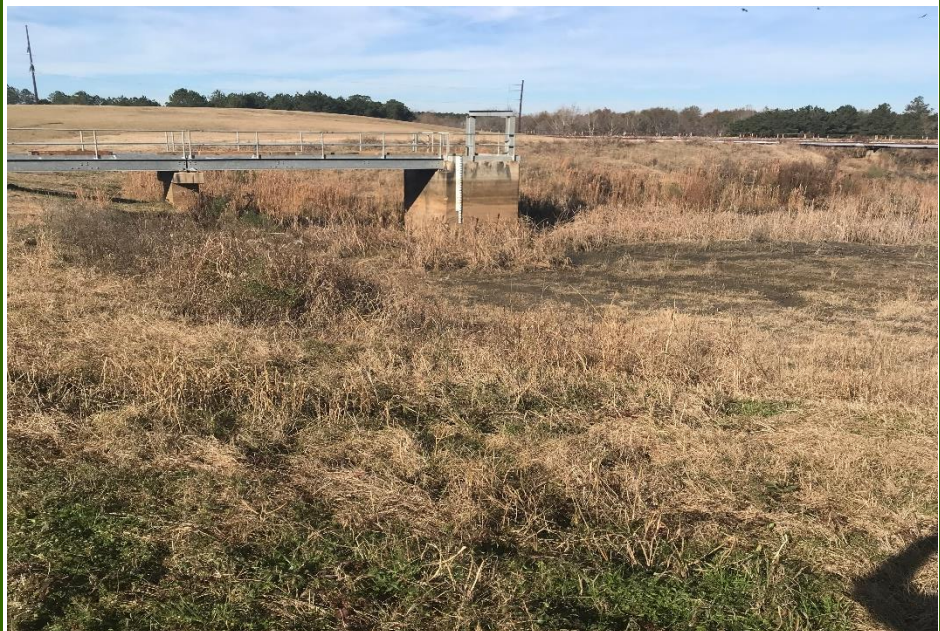
Overflow weir structure with level gauge.

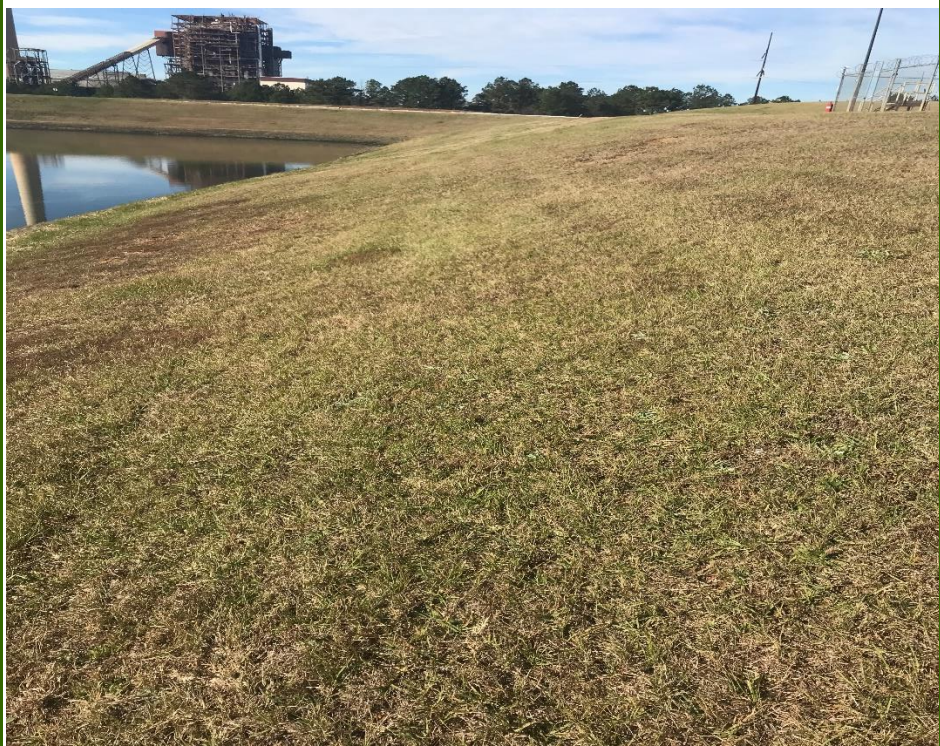
Exterior slope of southern levee.
