ANNUAL CCR LANDFILL INSPECTION:			
Facility Name:		Cleco Dolet Hills Power Station	
Address:		963 Power Plant Rd. Mansfield, LA	
Landfill Name :	Dolet Hills Landfill	Owner:	Cleco Power LLC
Surface Impoundment ID:	P-0064R1	Operator:	Cleco Power LLC
Nearest City:	Mansfield	Parish:	DeSoto
Inspector:		James C. Van Hoof, P.E.	
Company:		Providence Engineering & Environmental Group LLC	
Date of Inspection:		12/18/2020	
Weather at Time of Inspection:		Sunny, Cool	
DESCRIPTION OF THE OPERATION OF THE LANDFILL:			
<p>Cleco Dolet Hills Power Station (Dolet Hills) operates a Fly Ash/Scrubber Sludge Landfill used for the disposal of noncombustible by-product of lignite combustion from the Dolet Hills Power Station.</p> <p>Dolet Hills operates a landfill for the disposal of nonhazardous on-site generated waste only. None of the wastes disposed is characterized as hazardous or is listed hazardous waste as defined by LAC 33:V.Subpart I or by federal regulations. The non-hazardous nature of each waste stream is confirmed by process knowledge. The primary waste that is disposed in the landfill is fly ash and flue gas desulfurization (FGD) or scrubber sludge. The fly ash is a fine particulate compos

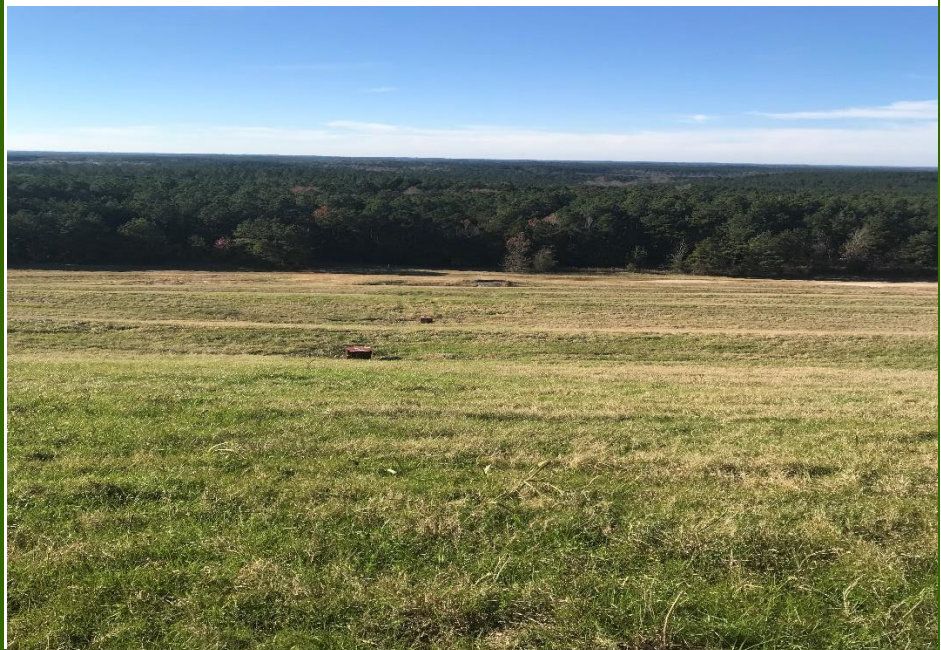
Western slope showing terraces.

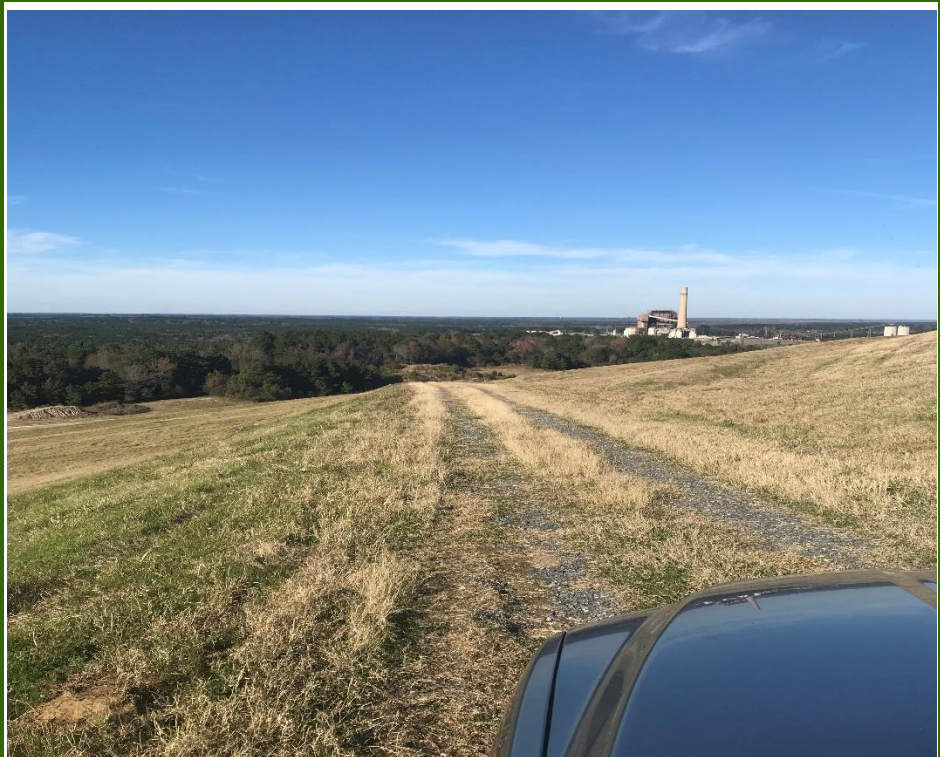
Access ramp.

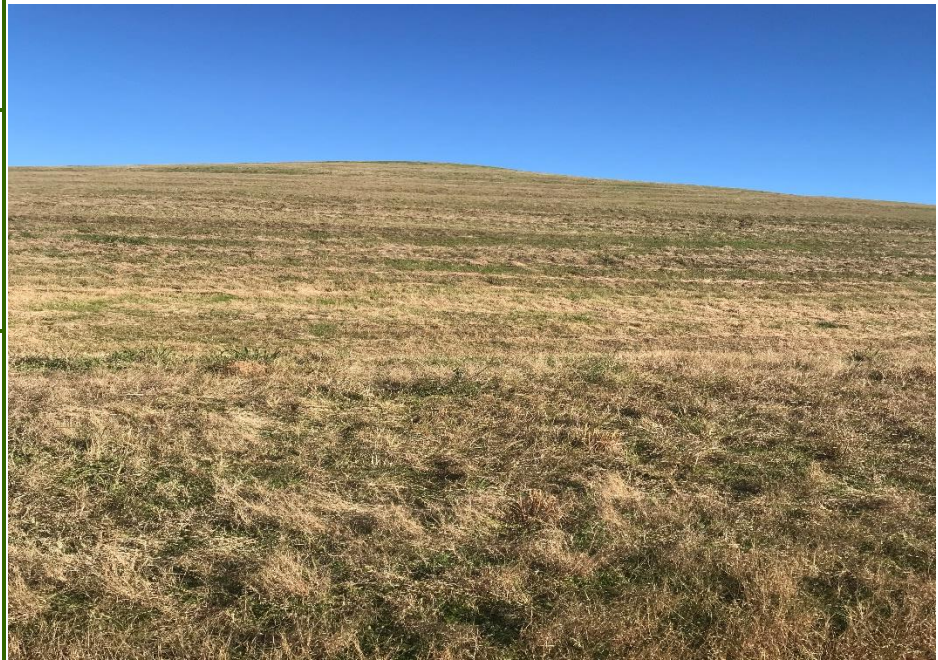
Southern slope showing terraces.

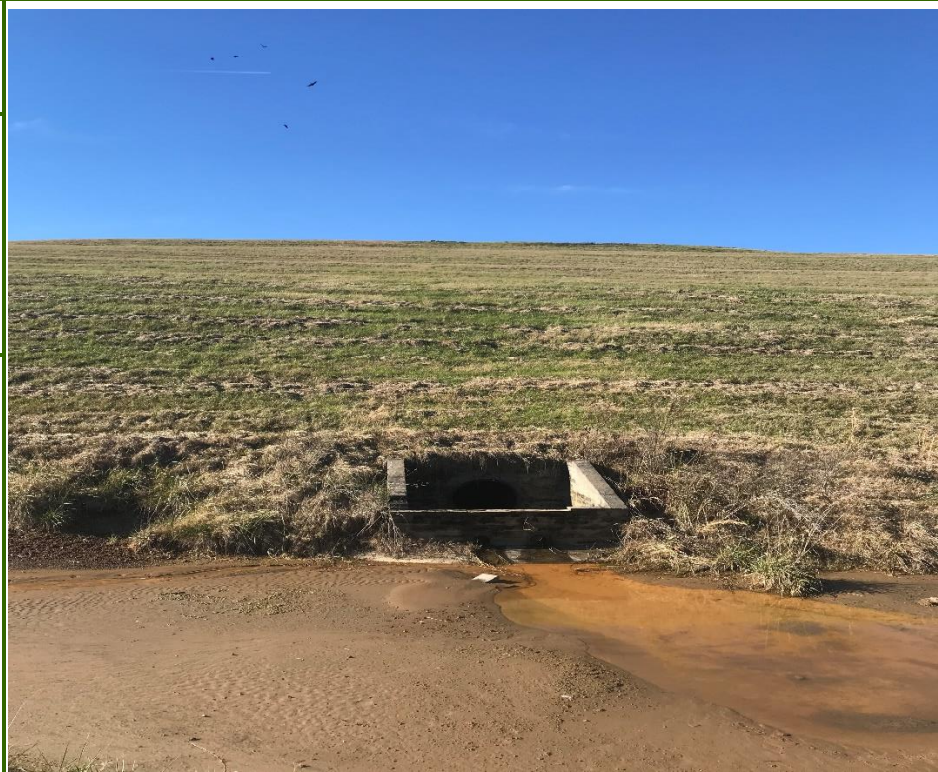
Eastern exterior slope showing discharge opening for upper elevation inlet piping.

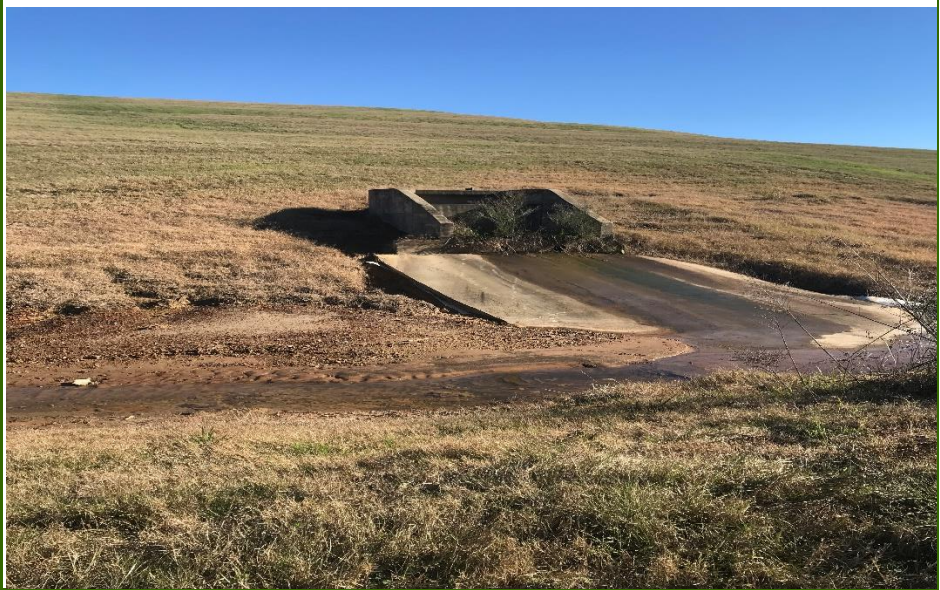
If yes, describe (size, location, etc.)	
Is the stormwater infrastructure in good condition?	<input checked="" type="checkbox"/> Yes <input type="checkbox"/> No
Findings:	The exterior slopes were inspected and appeared to be in fair condition. Rutting caused by feral hogs needs to be corrected on western slope. Erosion on slope needs to be corrected.
Other observations on the exterior slopes:	None

Western exterior slope. Discharge opening for upper elevation inlet piping. Erosion needs to be corrected.

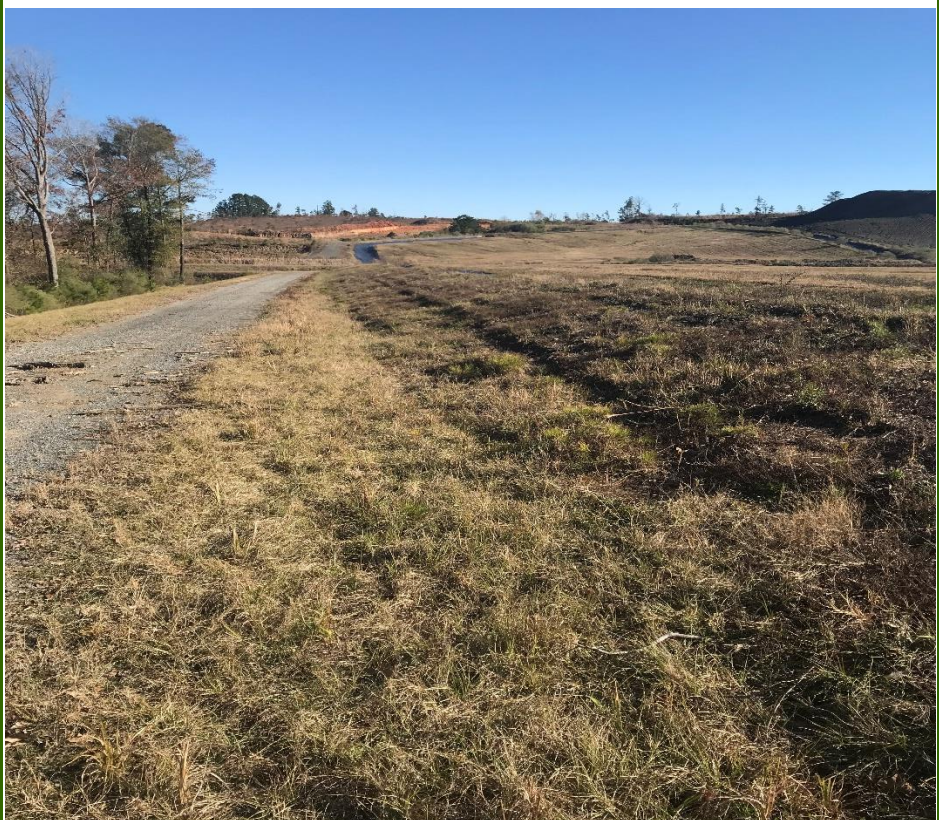
Access road along north side of Cell 11.

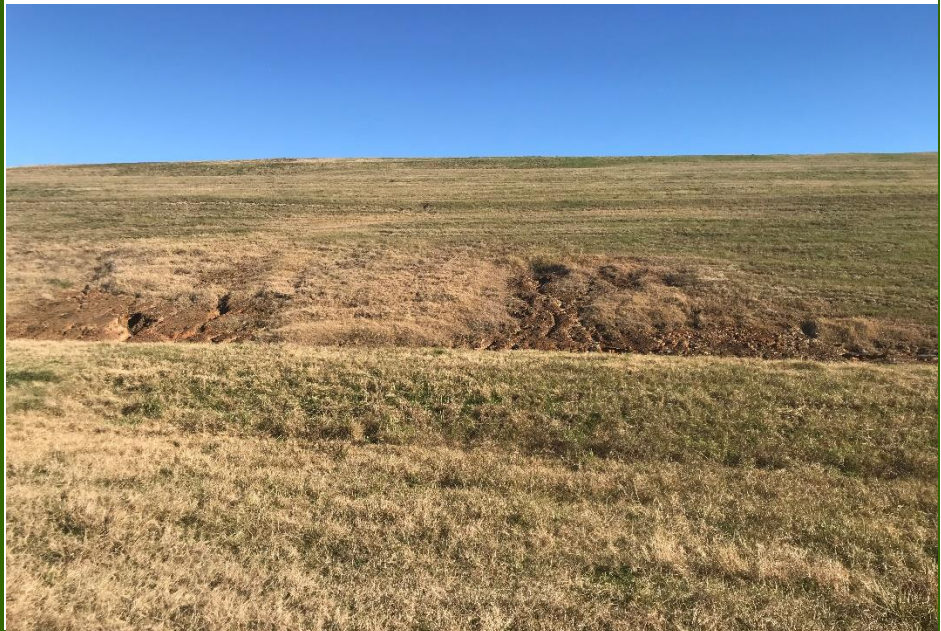
Erosion on western slope needs to be corrected.

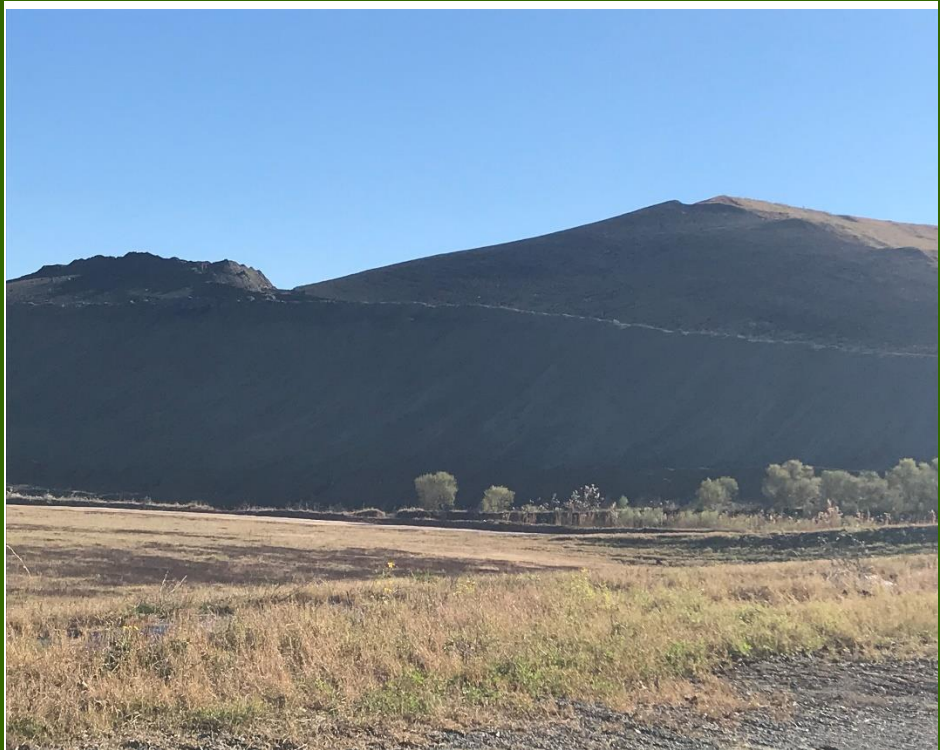
Working face of the landfill.

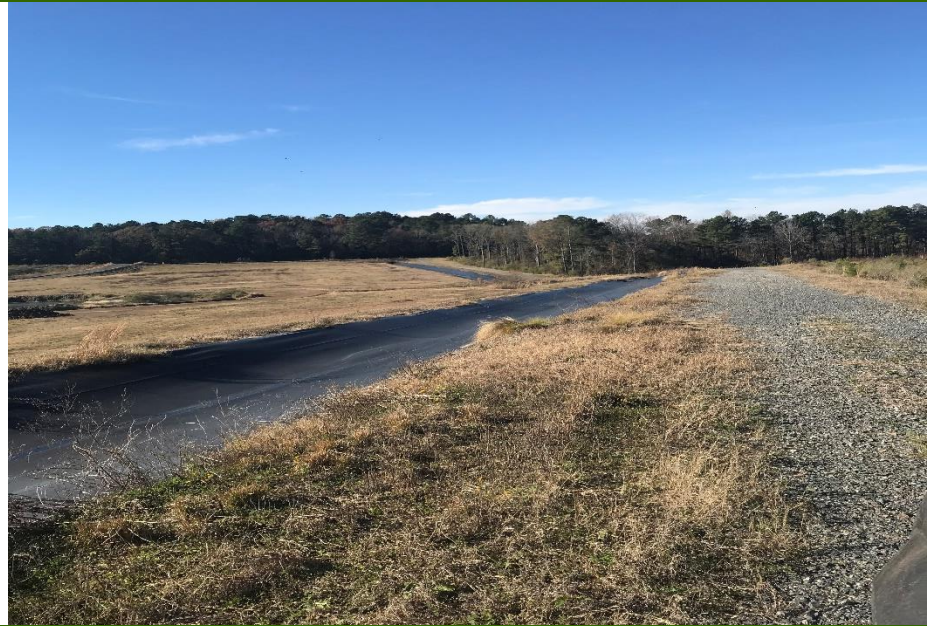
Storm water drainage ditch north side of cell 11 of landfill that drains to the landfill runoff pond.

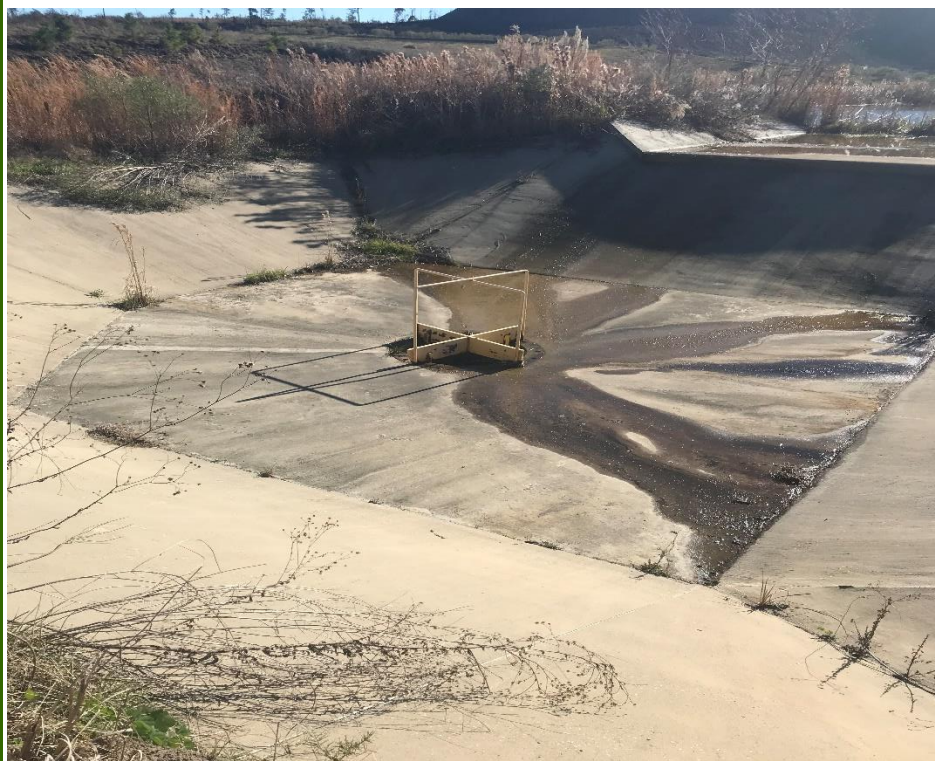
Storm water overflow inlet that drains to the landfill runoff pond.

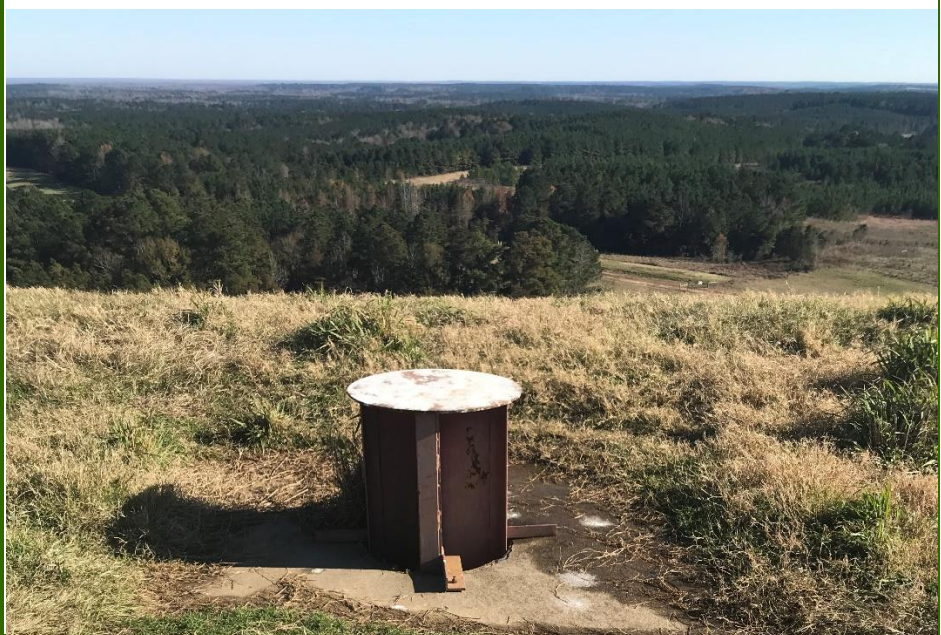
Drop inlet structure on crown of landfill cap.

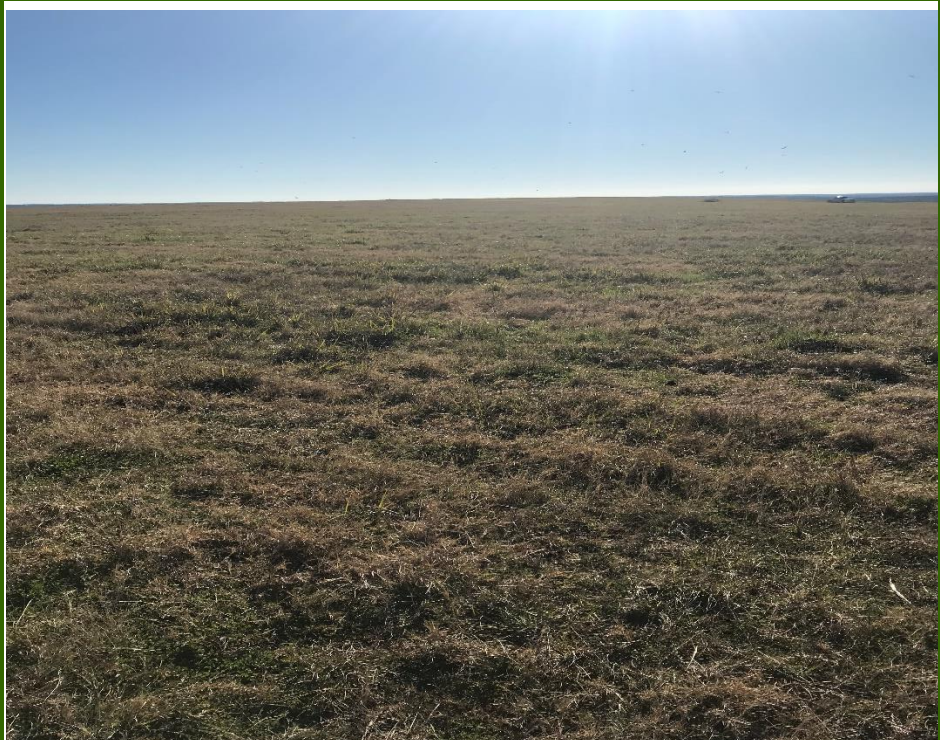
Upper elevation flat crown area.

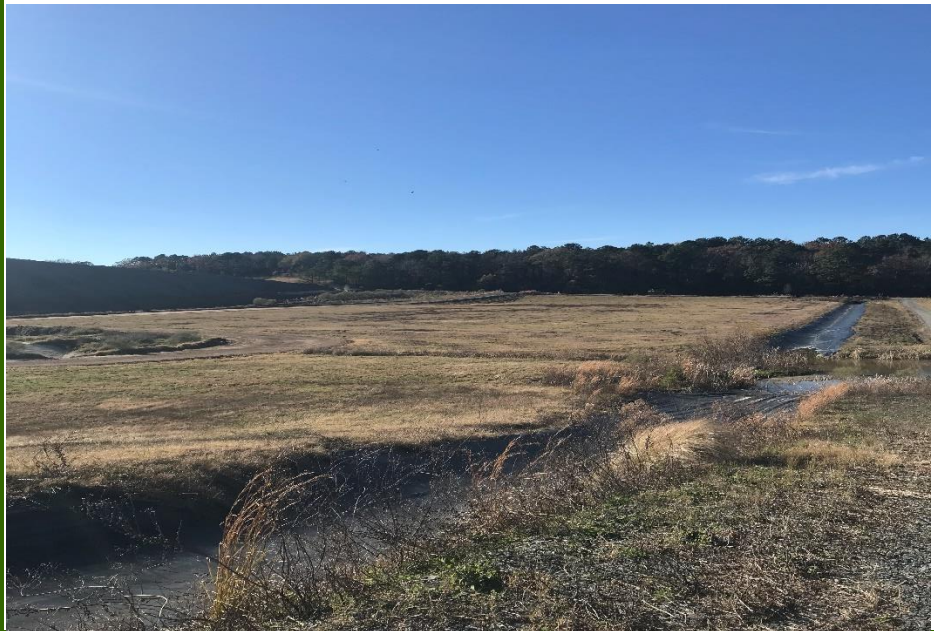
Cell 11 area.

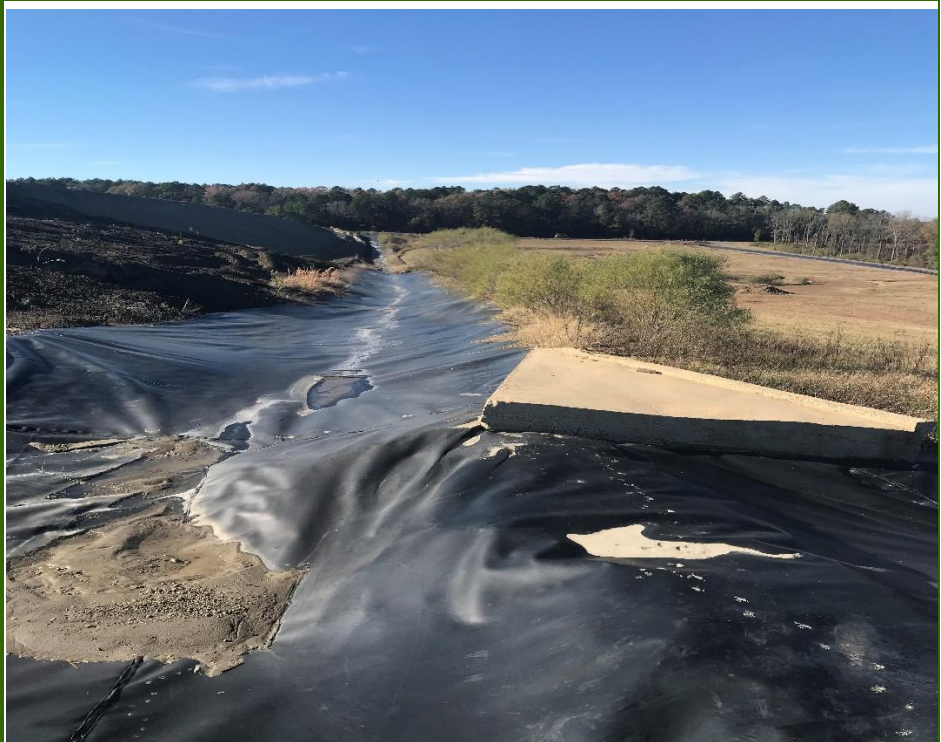
Small brush needs to be removed between Cell 11 and the working face on east and west sides.
