CLECO POWER LLC

DOLET HILLS POWER STATION

CCR ANNUAL INSPECTION

ASH BASIN NO. 1

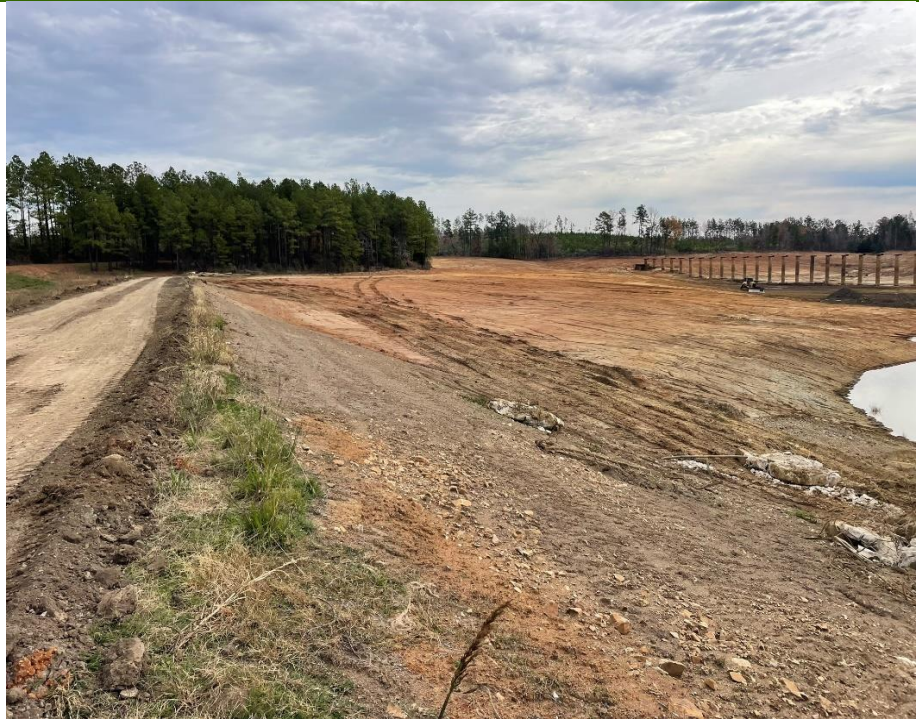
Northern portion of Ash Basin No. 1

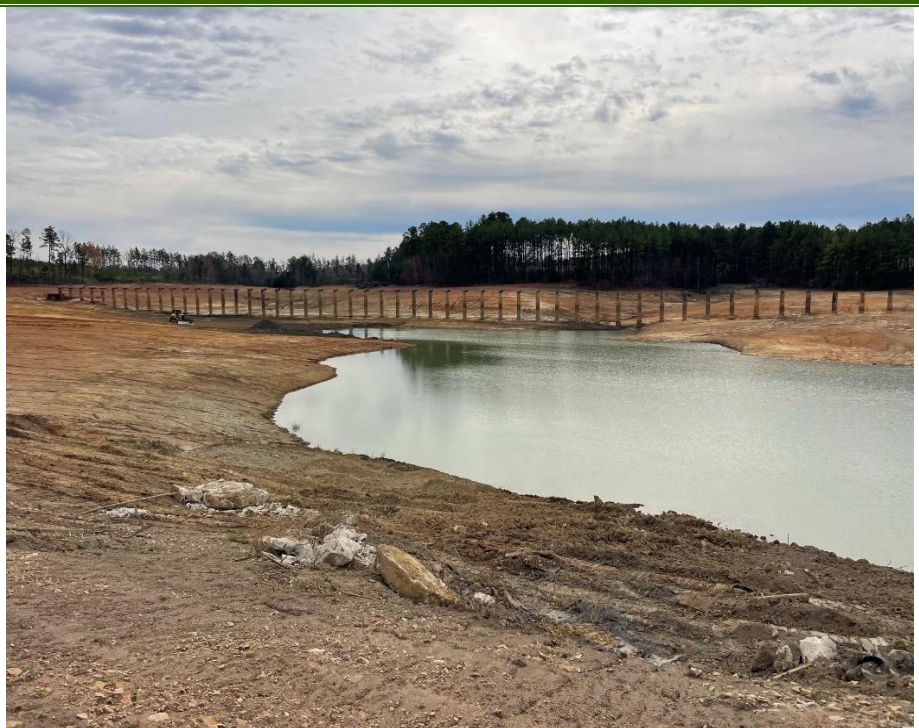
Ash Basin No. 1

Shallow water accumulation. Former sluice structure in background.

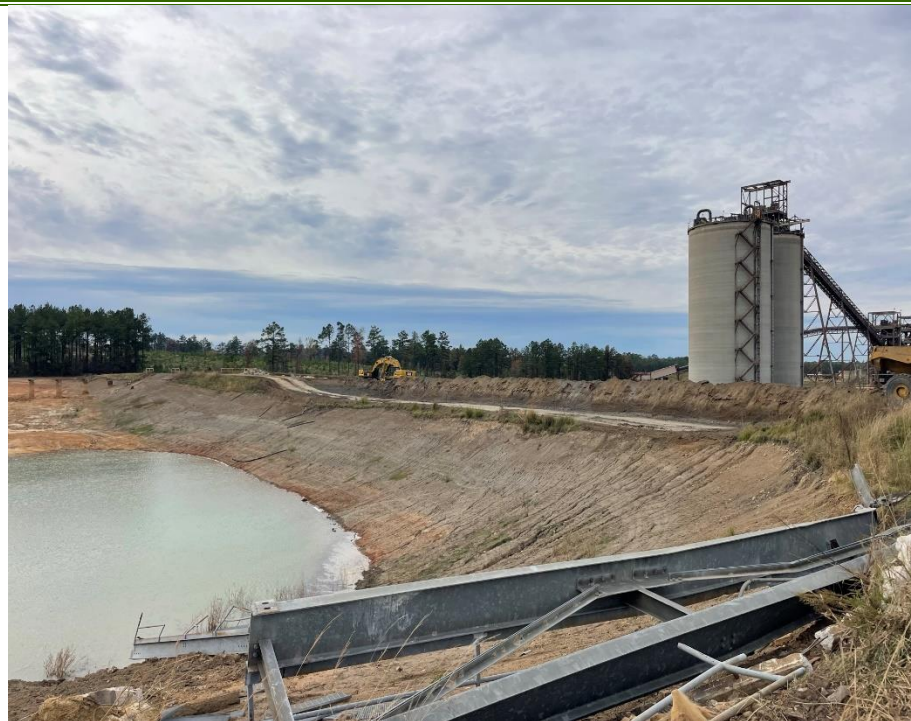
If yes, describe (size of area, location, severity, etc.)	
Are there any trees on the slopes?	<input type="checkbox"/> Yes <input checked="" type="checkbox"/> No
If yes, describe (type of vegetation, size, location, etc.)	
Findings:	Ash Basin No. 1 is undergoing final regulatory closure. Western levee degrading has been initiated.
Other observations on the exterior slopes:	Ash Basin No. 1 is undergoing final regulatory closure.

Degradation of western levee of Ash Basin No. 1.
