<b>ANNUAL CCR SURFACE IMPOUNDMENT INSPECTION:</b>			
<b>Facility Name:</b>		Cleco Dolet Hills Power Station	
<b>Address:</b>		963 Power Plant Rd. Mansfield, LA	
<b>Surface Impoundment Name :</b>	Ash Basin No. 2	<b>Owner:</b>	Cleco Power LLC
<b>Surface Impoundment ID:</b>	P-0037	<b>Operator:</b>	Cleco Power LLC
<b>Nearest City:</b>	Mansfield	<b>Parish:</b>	DeSoto
<b>Inspector:</b>		James C. Van Hoof, P.E.	
<b>Company:</b>		Providence Engineering & Environmental Group LLC	
<b>Date of Inspection:</b>		12/14/2016	
<b>Weather at Time of Inspection:</b>		Cloudy, cool	
<b>DESCRIPTION OF THE OPERATION OF THE SURFACE IMPOUNDMENTS:</b>			
<p>The bottom ash and economizer ash are mixed with water and sluiced in a slurry form to either of the two Ash Basins. Ash slurry pipelines within each basin enable the discharge of the slurry at multiple points within each basin. The discharge into each respective basin begins at the end of the pipeline network at the point furthest from the weir box, and proceeds toward the front of the pond. As a basin fills with ash, sections of the discharge pipe are removed as needed so that ash can be uniformly deposited and the storage capacity of each basin fully

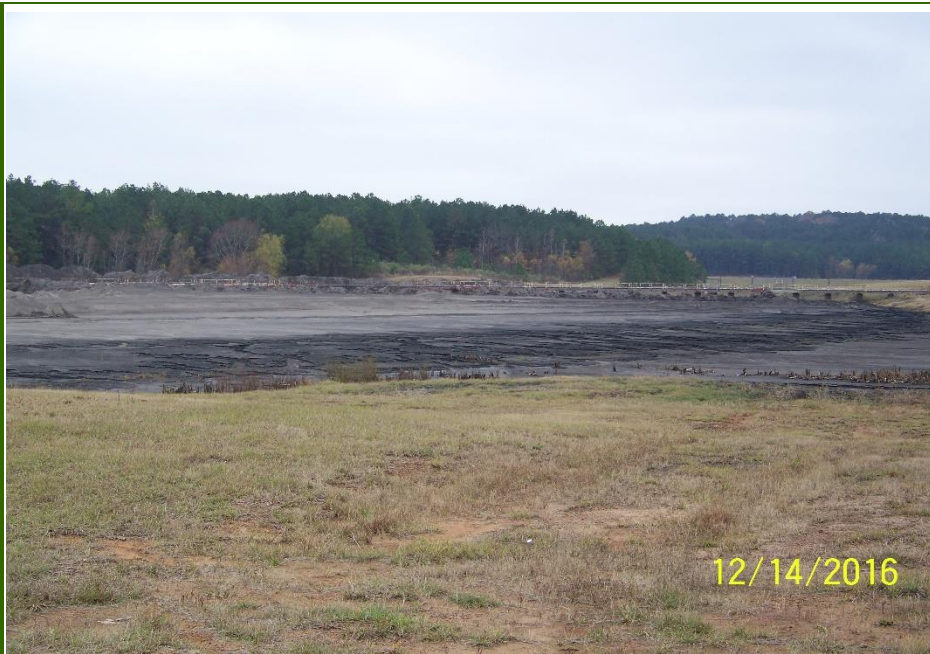
Southerly

Ash Basin looking at sluice structure.

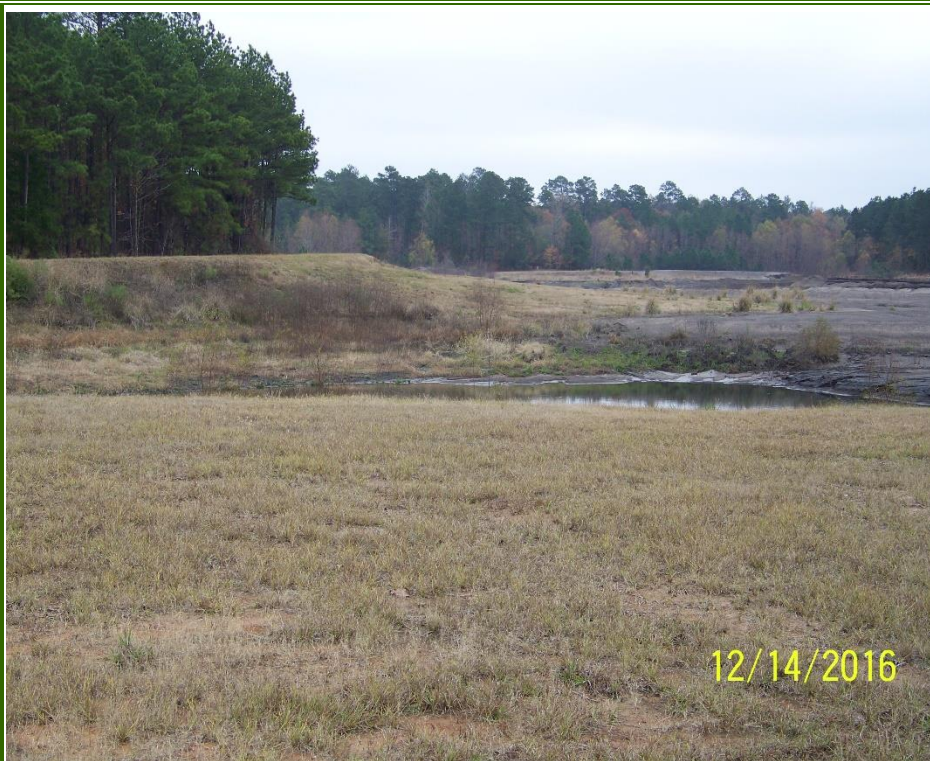
Easterly

Ash Basin

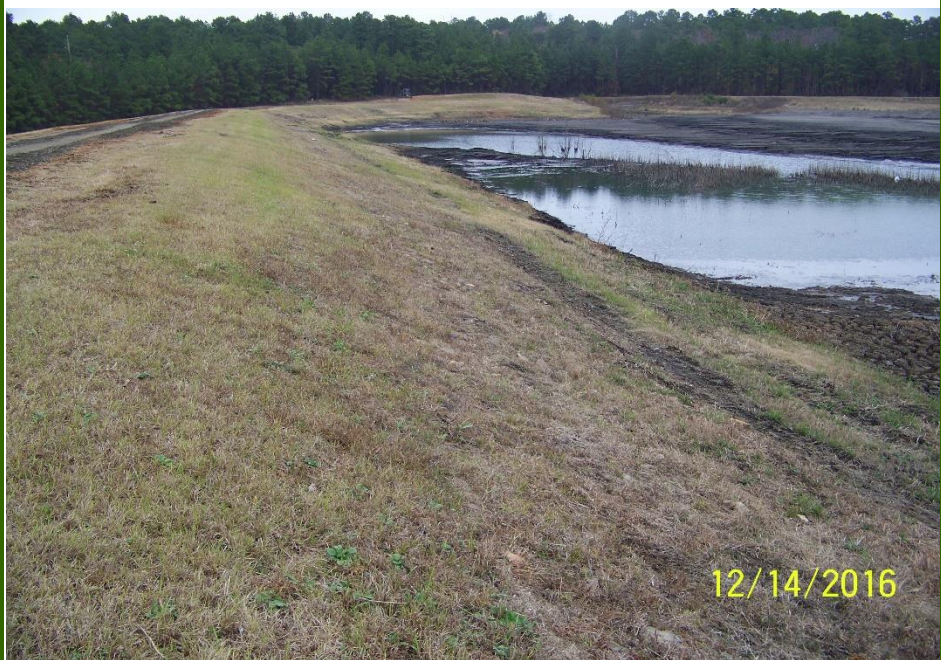
Northerly

If yes, describe (size of area, location, severity, etc.)	
<b>Findings:</b>	The interior slope was inspected and appeared to be in satisfactory condition. No corrective actions are required at this time.
<b>Other observations on the interior slopes:</b>	None

Internal slope of western levee

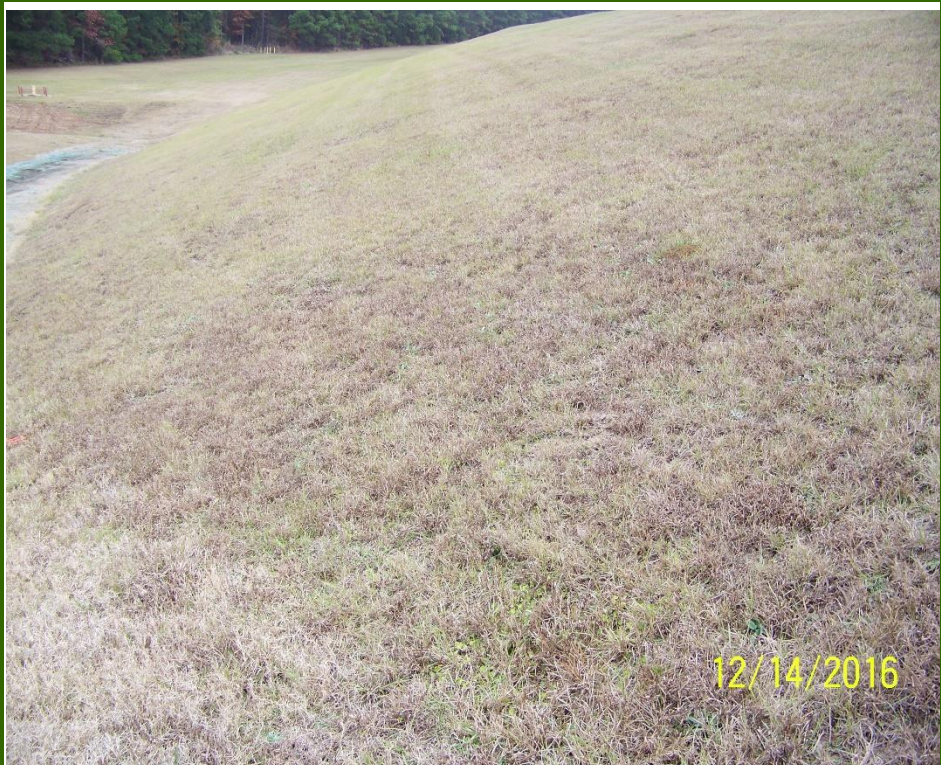
Northerly

If yes, describe (size of area, location, severity, etc.)	
<b>Are there any trees on the slopes?</b>	<input type="checkbox"/> Yes <input checked="" type="checkbox"/> No
If yes, describe (type of vegetation, size, location, etc.)	
<b>Findings:</b>	The exterior slope was inspected and appeared to be in satisfactory condition. No corrective actions are required at this time.
<b>Other observations on the exterior slopes:</b>	None

External slope of western levee.

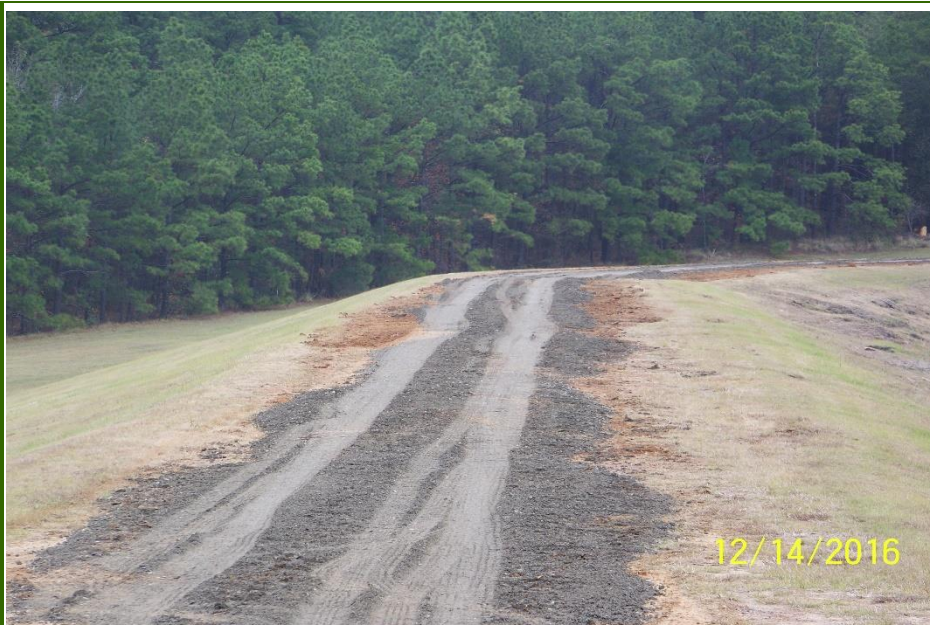
Northerly

<b>DOCUMENTATION REVIEW:</b>	
<b>Weekly Inspections Reviewed:</b>	<input checked="" type="checkbox"/> Yes <input type="checkbox"/> No
<b>Findings:</b> Corrected ruts in roadway of western levee	
<b>Monthly Instrument Inspections Reviewed:</b>	<input checked="" type="checkbox"/> Yes <input type="checkbox"/> No
<b>Findings:</b> No issues	
<b>Groundwater Monitoring:</b>	Monitoring wells are in-place.
<b>Drawings Reviewed:</b>	<input checked="" type="checkbox"/> Yes <input type="checkbox"/> No
<b>Are there any changes in the geometry of the surface impoundment structure since the previous inspection?</b>	<input type="checkbox"/> Yes <input checked="" type="checkbox"/> No <input type="checkbox"/> NA
If yes, describe (size, location, etc.)	
<b>Other observations:</b>	None

Access road on western levee.

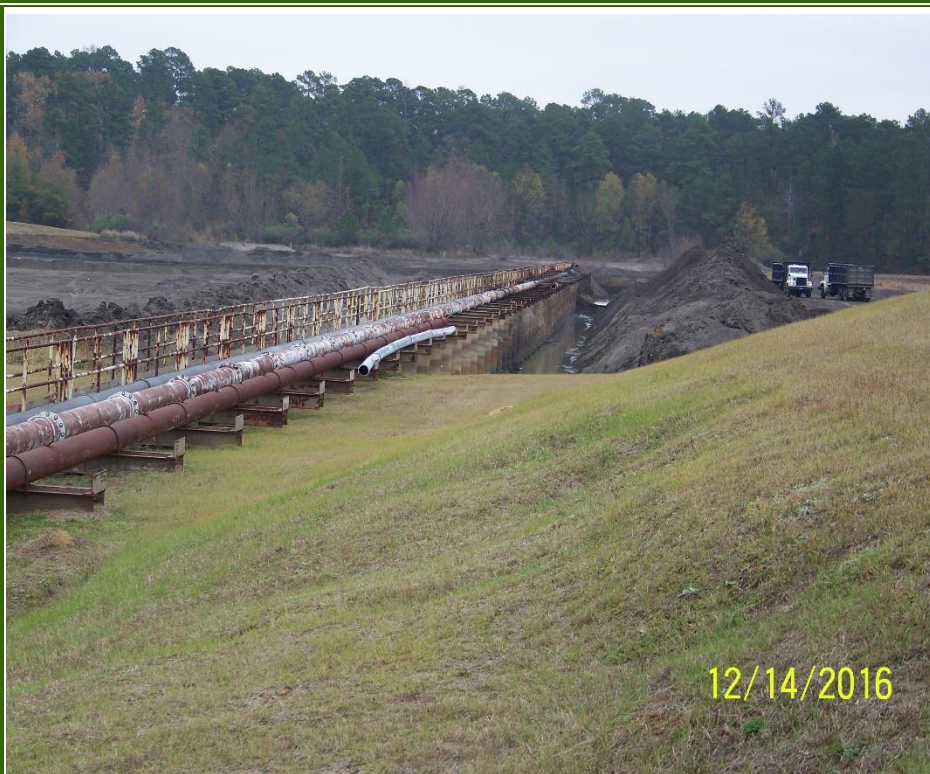
Easterly

Bottom ash being removed from around sluice structure.

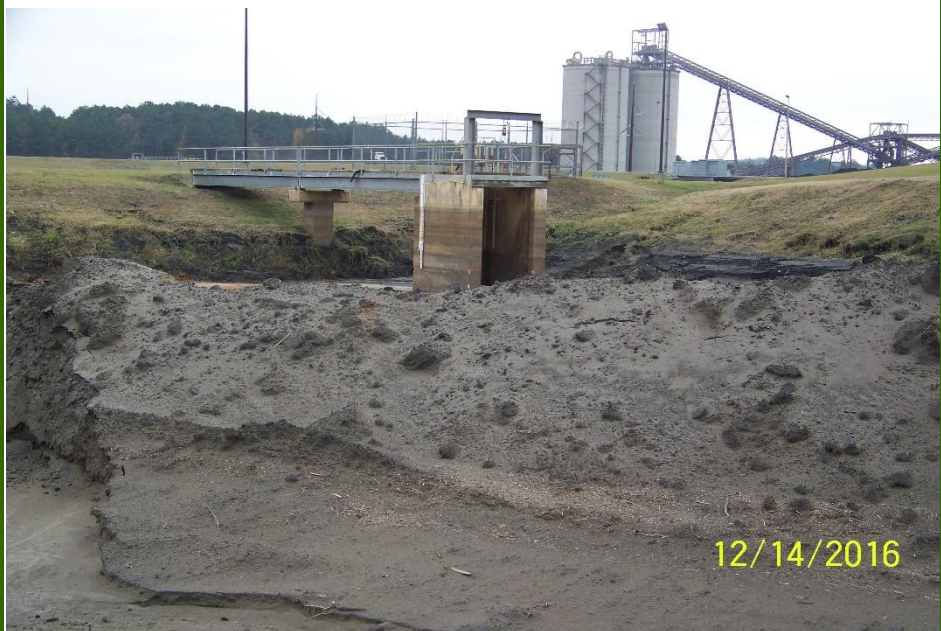
Easterly

Overflow weir structure with level gauge.

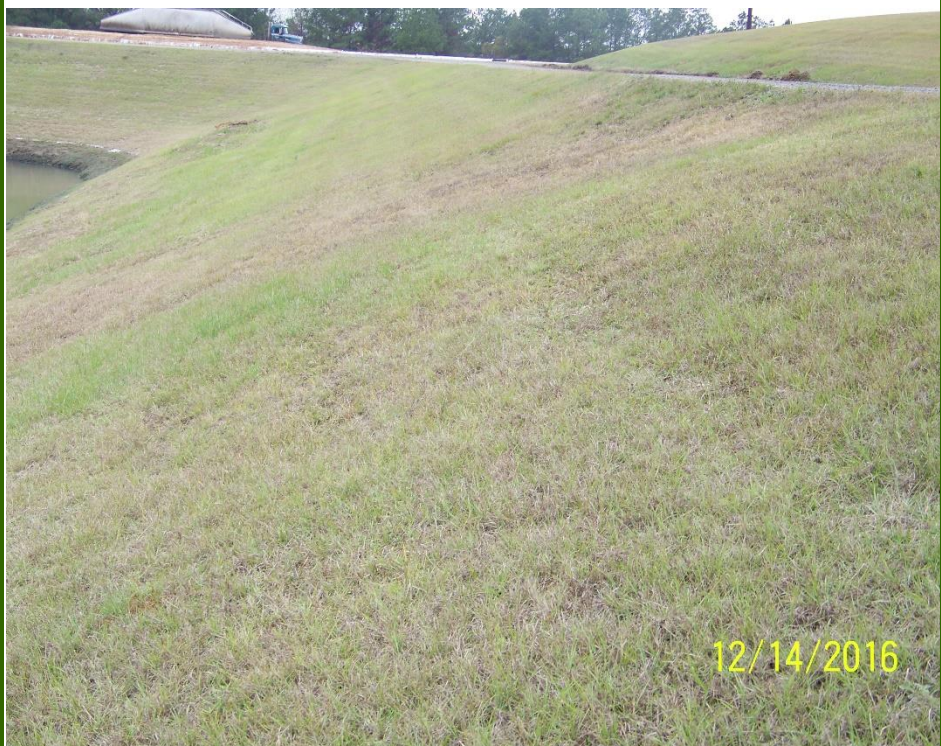
Westerly

Exterior slope of southern levee.
