<b>ANNUAL CCR SURFACE IMPOUNDMENT INSPECTION:</b>			
<b>Facility Name:</b>		Cleco Dolet Hills Power Station	
<b>Address:</b>		963 Power Plant Rd. Mansfield, LA	
<b>Surface Impoundment Name :</b>	Ash Basin No. 2	<b>Owner:</b>	Cleco Power LLC
<b>Surface Impoundment ID:</b>	P-0037	<b>Operator:</b>	Cleco Power LLC
<b>Nearest City:</b>	Mansfield	<b>Parish:</b>	DeSoto
<b>Inspector:</b>		James C. Van Hoof, P.E.	
<b>Company:</b>		Providence Engineering & Environmental Group LLC	
<b>Date of Inspection:</b>		1/13/2016	
<b>Weather at Time of Inspection:</b>		Sunny	
<b>DESCRIPTION OF THE OPERATION OF THE SURFACE IMPOUNDMENTS:</b>			
<p>The bottom ash and economizer ash are mixed with water and sluiced in a slurry form to either of the two Ash Basins. Ash slurry pipelines within each basin enable the discharge of the slurry at multiple points within each basin. The discharge into each respective basin begins at the end of the pipeline network at the point furthest from the weir box, and proceeds toward the front of the pond. As a basin fills with ash, sections of the discharge pipe are removed as needed so that ash can be uniformly deposited and the storage capacity of each basin fully utilized

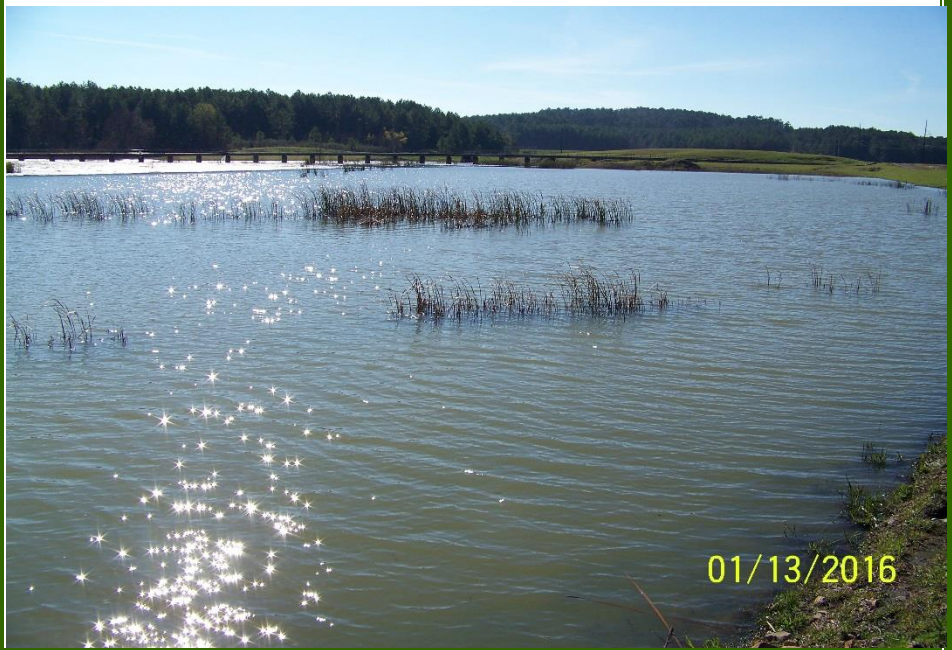
Ash Basin looking at sluice structure.

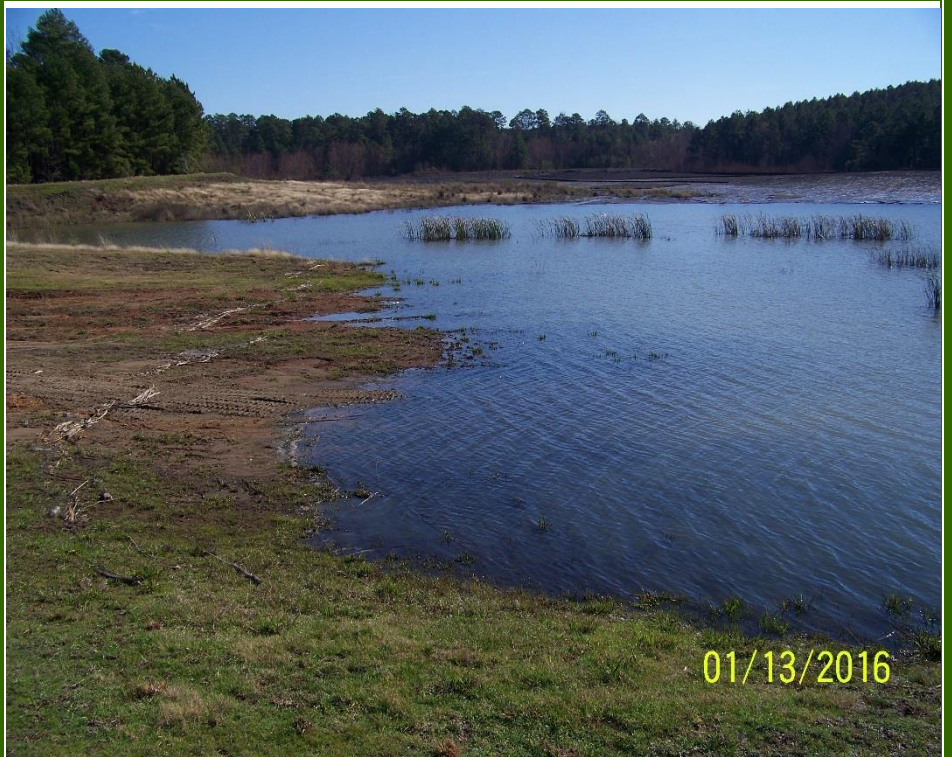
Ash Basin

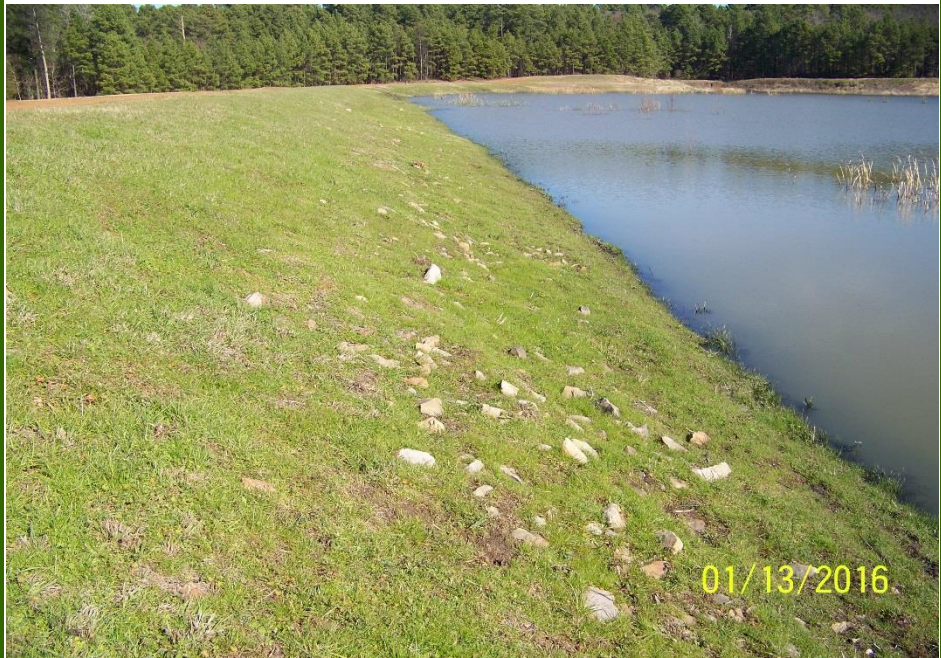
<b>Are there any Sinkholes Observed?</b>	<input type="checkbox"/> Yes <input checked="" type="checkbox"/> No
If yes, describe (size of area, location, severity, etc.)	
<b>Findings:</b>	The interior slope was inspected and appeared to be in satisfactory condition. No corrective actions are required at this time.
<b>Other observations on the interior slopes:</b>	None

Internal slope of western levee

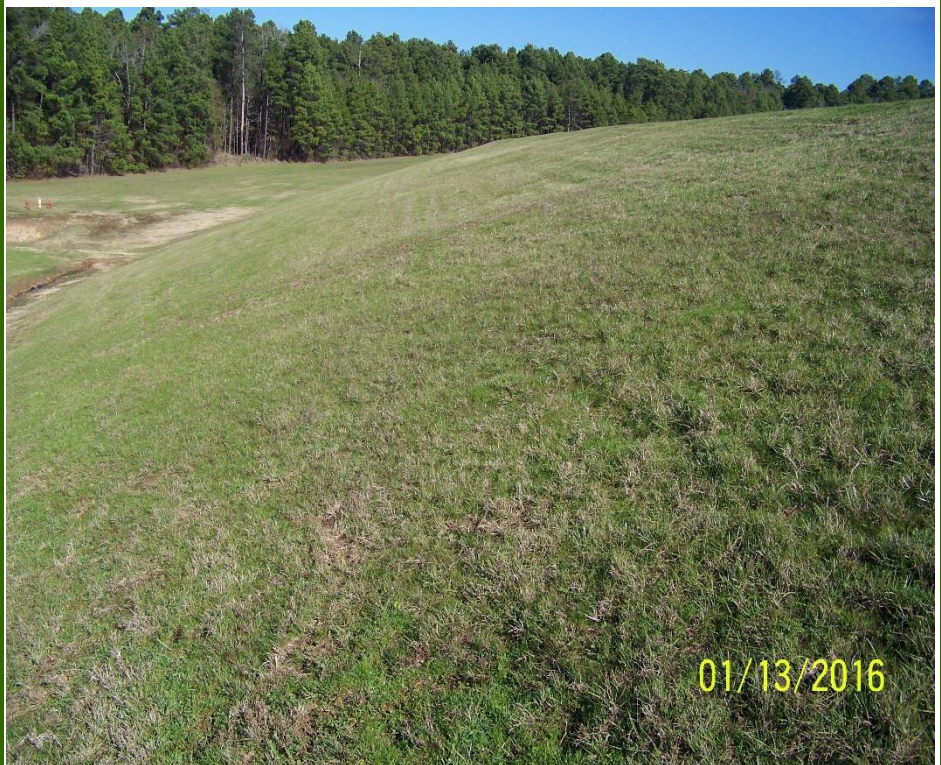
If yes, describe (size of area, location, severity, etc.)	
<b>Are there any trees on the slopes?</b>	<input type="checkbox"/> Yes <input checked="" type="checkbox"/> No
If yes, describe (type of vegetation, size, location, etc.)	
<b>Findings:</b>	The exterior slope was inspected and appeared to be in satisfactory condition. No corrective actions are required at this time.
<b>Other observations on the exterior slopes:</b>	None

External slope of western levee.

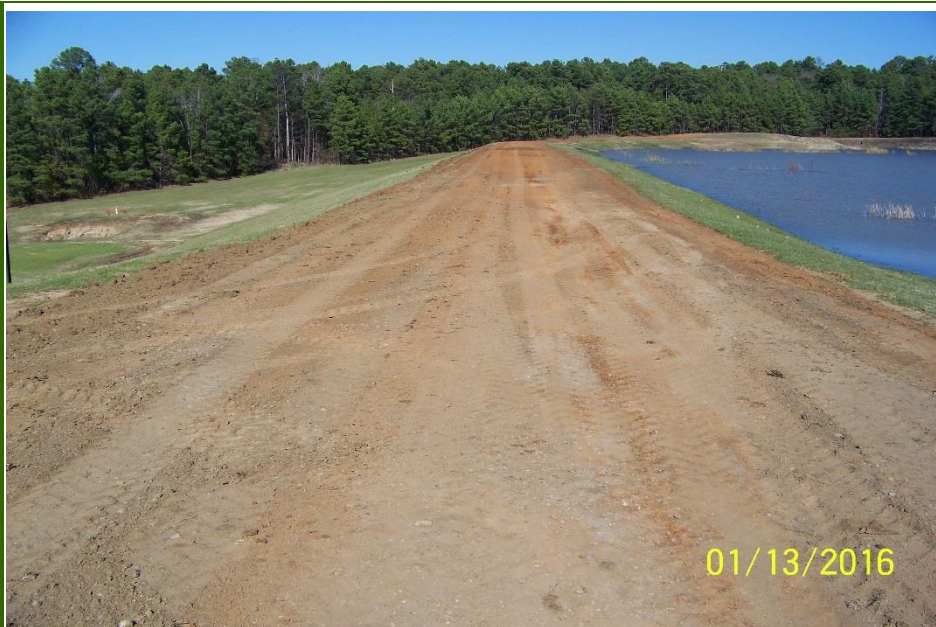
If yes, describe (size, location, etc.)	
<b>Are there any sinkholes?</b>	<input type="checkbox"/> Yes <input checked="" type="checkbox"/> No
If yes, describe (size, location, etc.)	
<b>Findings:</b>	The crest was inspected and appeared to be in satisfactory condition. No corrective actions are required at this time.
<b>Other observations on the crest:</b>	None

Access road on western levee.

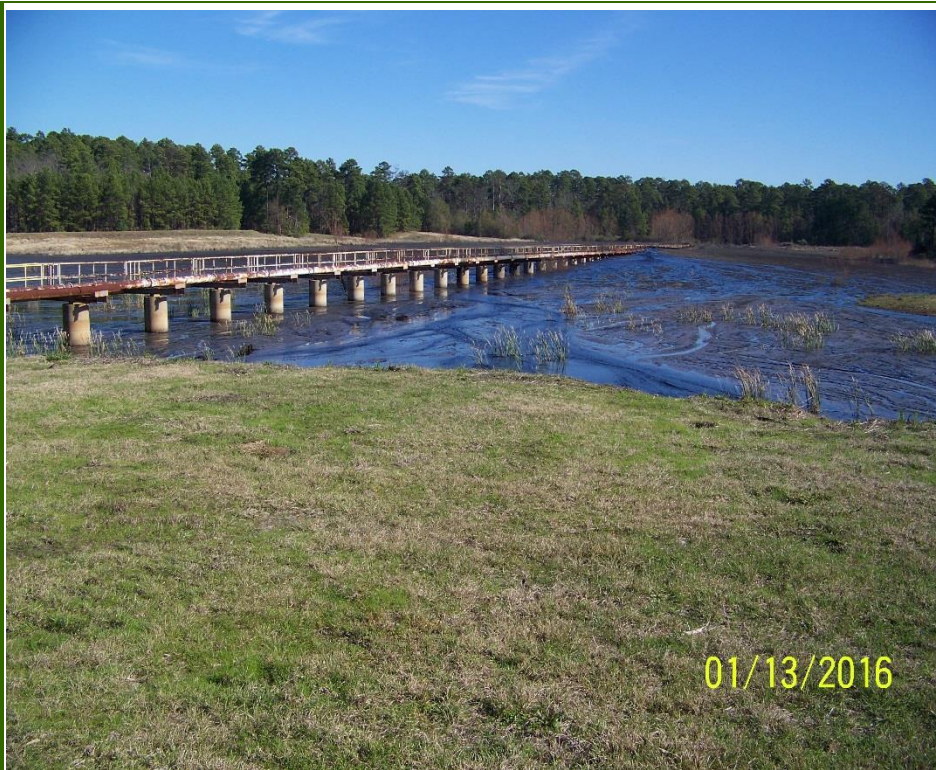
If no, describe (type of debris, reason for obstruction, etc.)	
<b>Describe the quality of discharge from hydraulic structure (turbidity, depth, etc.)</b>	The inflowing water contains bottom ash which is sluiced out of solution.
<b>Findings:</b>	The intake works were inspected and appeared to be in satisfactory condition. No corrective actions are required at this time.
<b>Other observations on the intake works:</b>	None

Sluice structure.

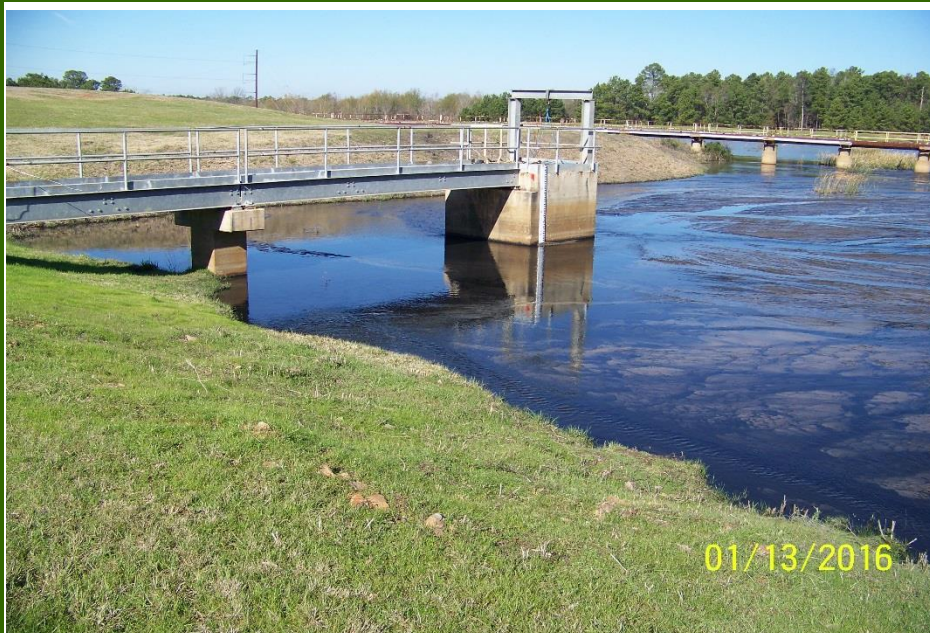
<b>PHYSICAL DAM FEATURES – SPILLWAY/OVERFLOW STRUCTURE:</b>	
<b>Type (1):</b>	Internal Concrete Structure with Adjustable Overflow Weir
<b>Slope Protection:</b>	Encased in concrete
<b>Approach:</b>	Concrete structure surrounded by ash
<b>Erosion:</b>	None observed
<b>Vegetation:</b>	Concrete structure surrounded by ash.
<b>Findings:</b>	The overflow structure was inspected and appeared to be in satisfactory condition. No corrective actions are required at this time.
<b>Other observations on overflow structure:</b>	None
<b>Type (2):</b>	Auxiliary Spillway
<b>Slope Protection:</b>	6" rip rap up to elevation 246.0 NAVD 88.
<b>Approach:</b>	6" rip rap up to elevation 246.0 NAVD 88.
<b>Erosion:</b>	None observed
<b>Vegetation:</b>	Grass vegetation on top of the rip rap as it enters the Secondary Pond.
<b>Findings:</b>	The spillway was inspected and appeared to be in satisfactory condition. No corrective actions are required at this time.

Overflow weir structure with level gauge.

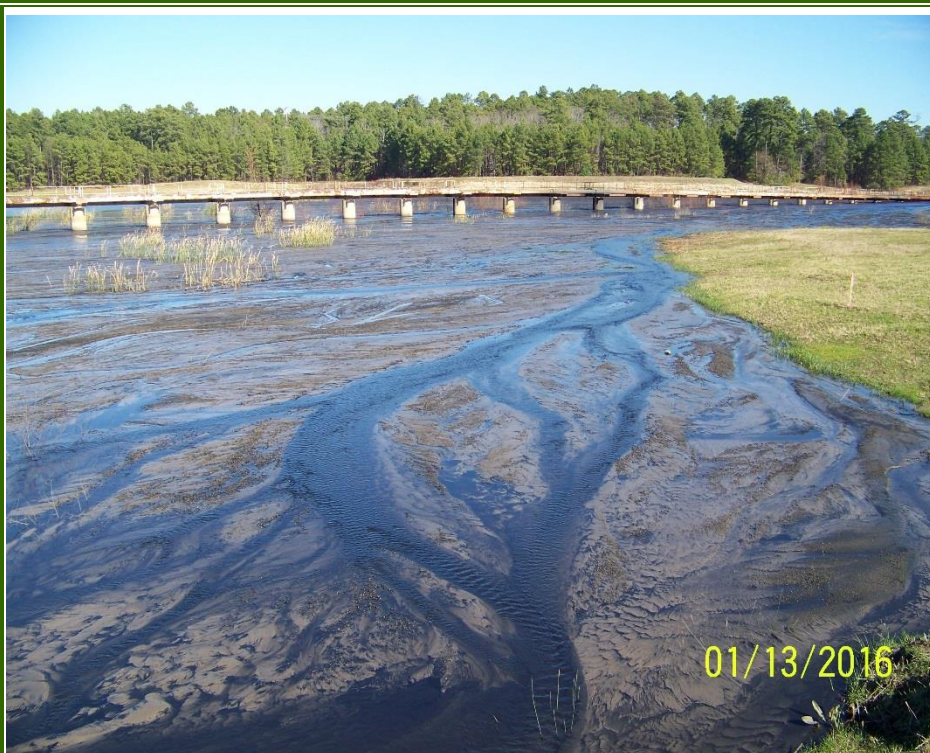
Ash Basin with sluice structure in background.
