ANNUAL CCR SURFACE IMPOUNDMENT INSPECTION:			
Facility Name:		Cleco Dolet Hills Power Station	
Address:		963 Power Plant Rd. Mansfield, LA	
Surface Impoundment Name :	Ash Basin No. 1	Owner:	Cleco Power LLC
Surface Impoundment ID:	P-0037	Operator:	Cleco Power LLC
Nearest City:	Mansfield	Parish:	DeSoto
Inspector:		James C. Van Hoof, P.E.	
Company:		Providence Engineering & Environmental Group LLC	
Date of Inspection:		12/11/2018	
Weather at Time of Inspection:		Sunny, Cool	
DESCRIPTION OF THE OPERATION OF THE SURFACE IMPOUNDMENTS:			
<p>The bottom ash and economizer ash are mixed with water and sluiced in a slurry form to either of the two Ash Basins. Ash slurry pipelines within each basin enable the discharge of the slurry at multiple points within each basin. The discharge into each respective basin begins at the end of the pipeline network at the point furthest from the weir box, and proceeds toward the front of the pond. As a basin fills with ash, sections of the discharge pipe are removed as needed so that ash can be uniformly deposited and the storage capacity of each basin fully utilized. The ash-laden water is retained in the Ash Basins for a period of time sufficient to sett

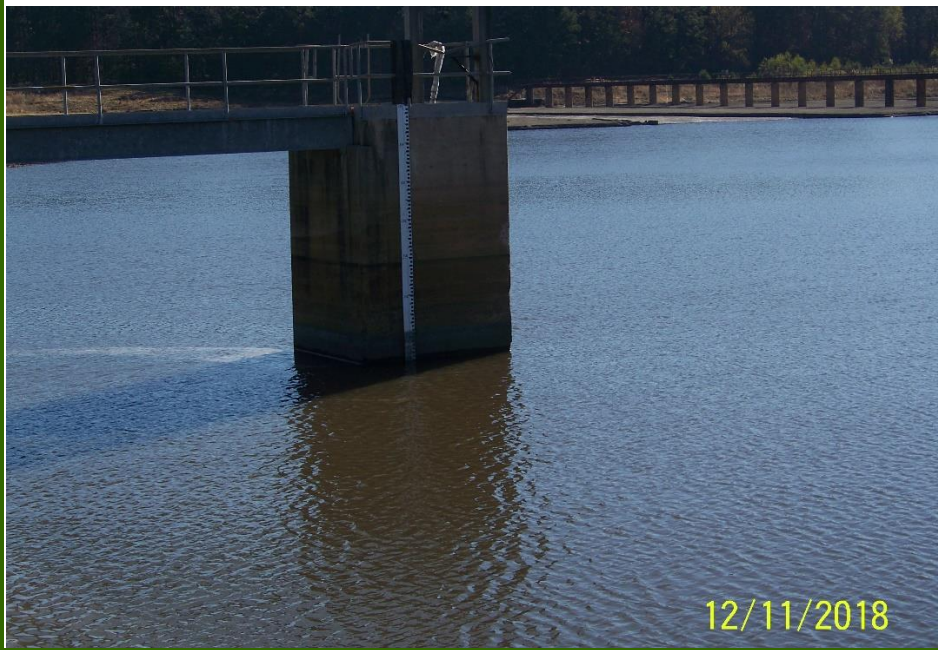
Overflow weir structure with concrete stoplogs. Level gauge attached to structure.

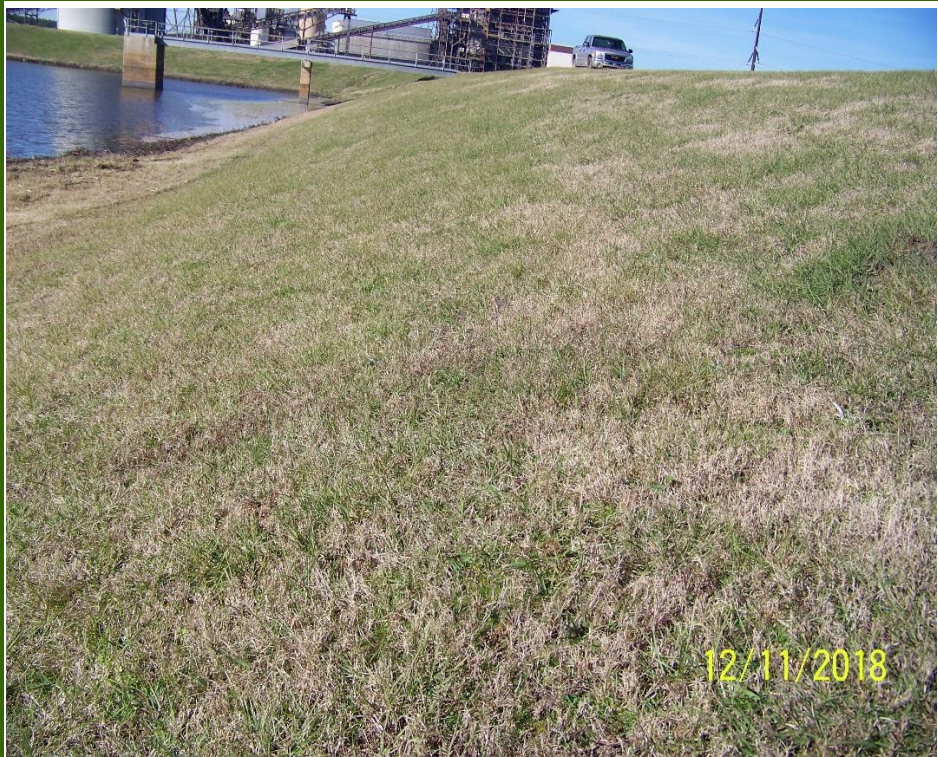
Internal slope of northern levee.

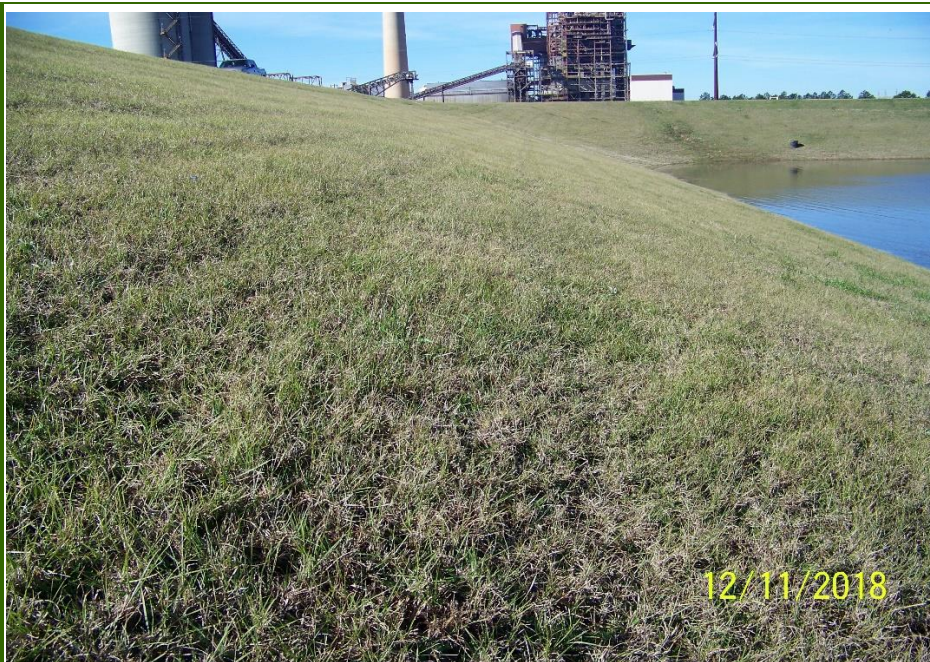
External slope of northern levee.

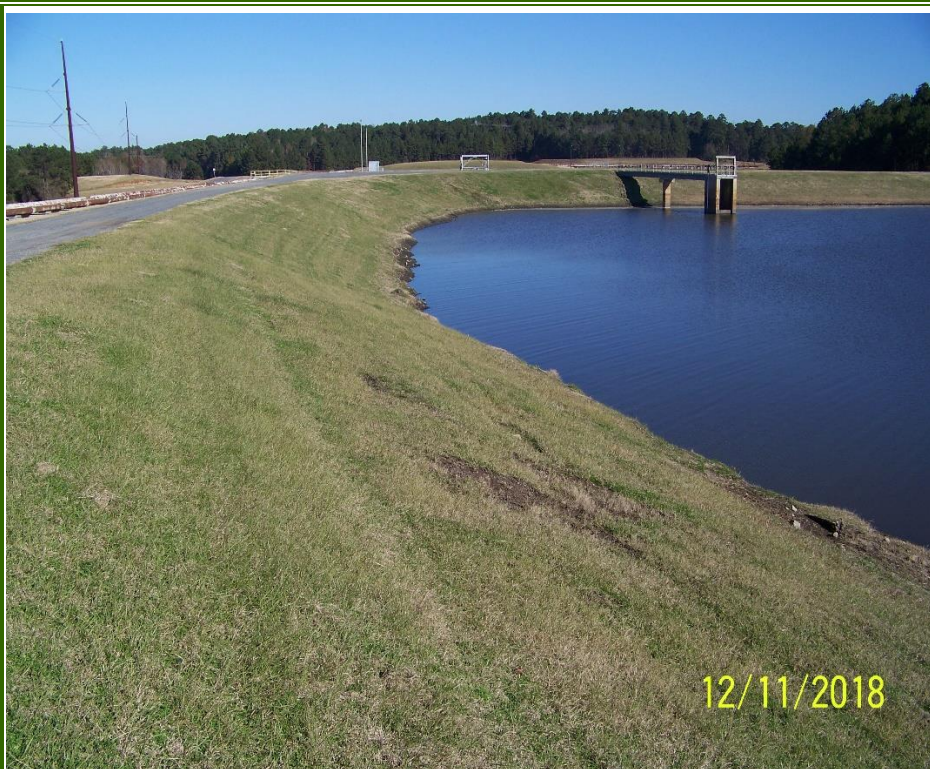
Internal slope of western levee.

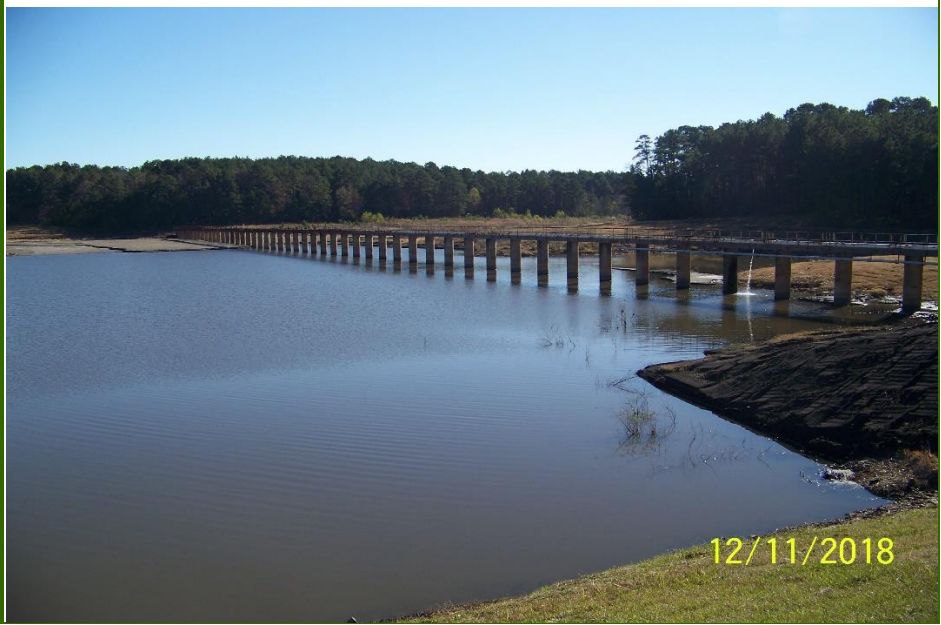
Bottom ash sluicing structure in surface impoundment.

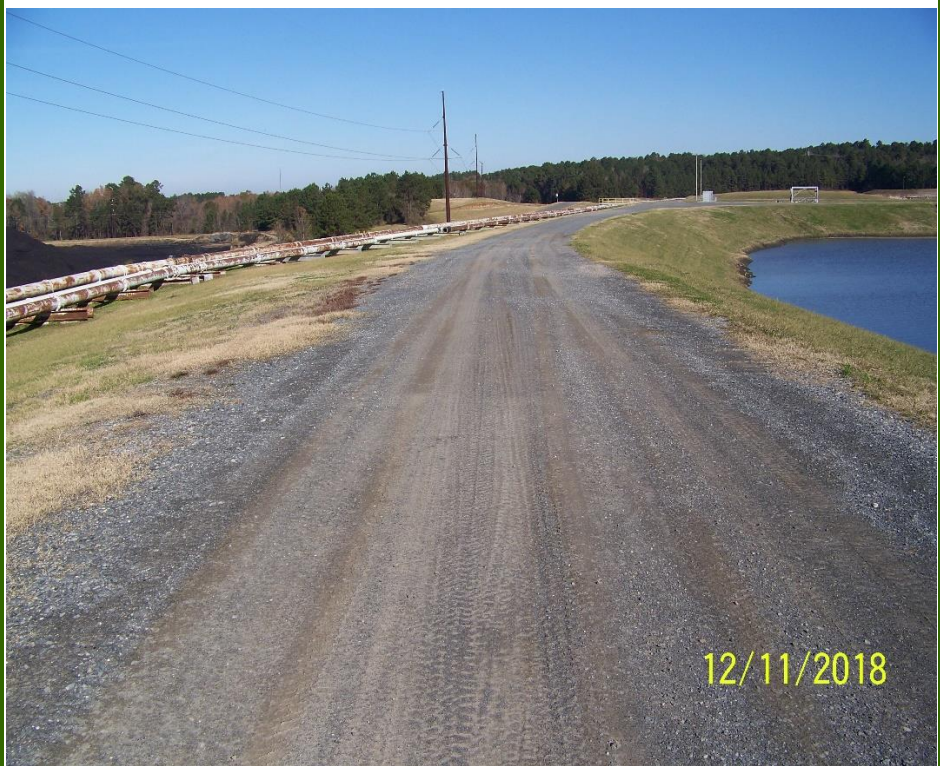
Access road on western levee.

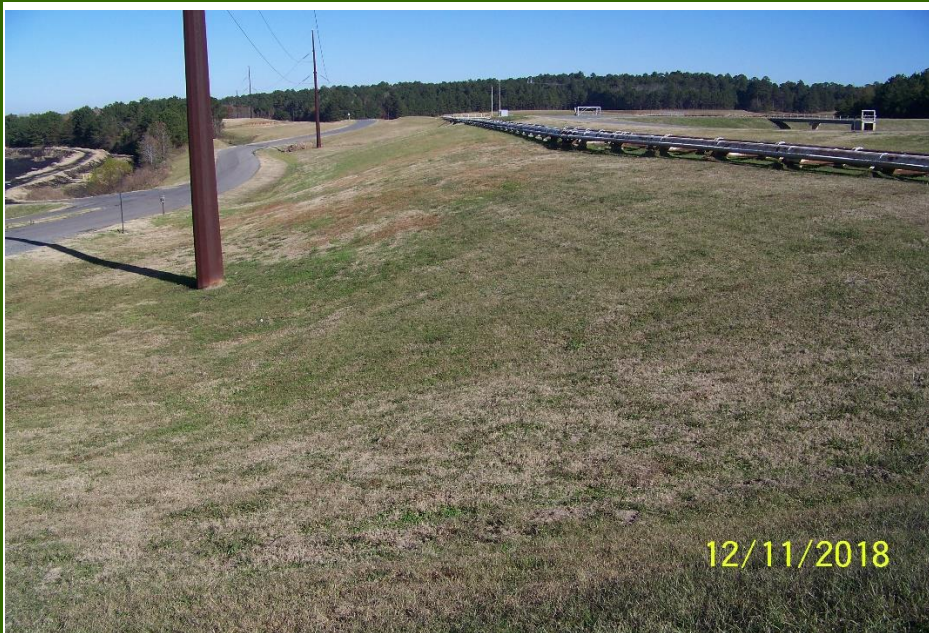
Western exterior
levee slope.

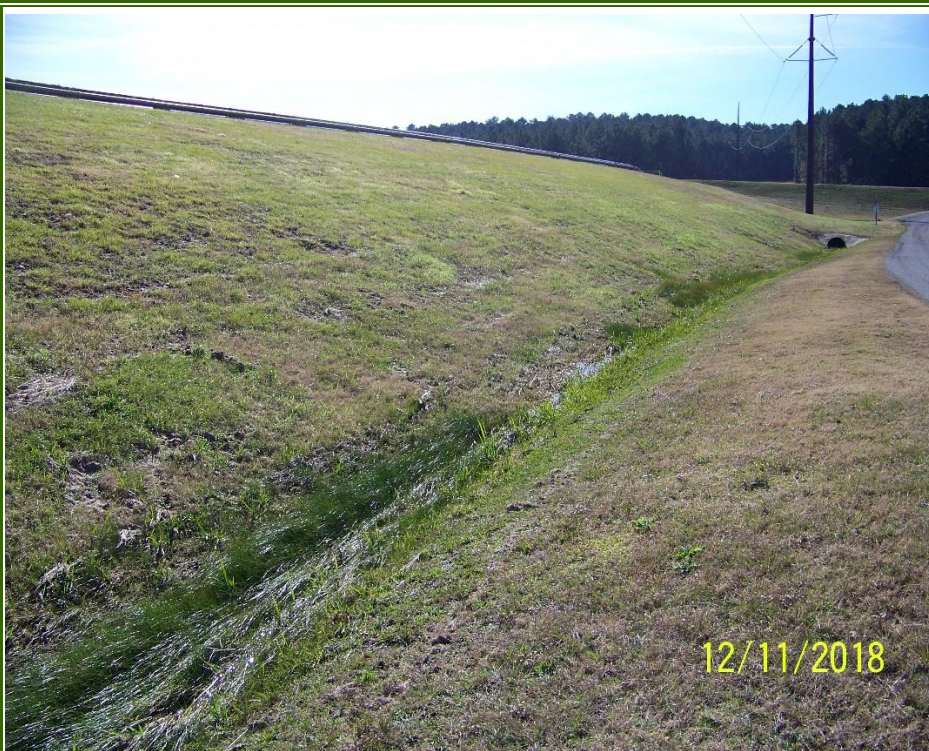
Western exterior
levee slope.
