ANNUAL CCR SURFACE IMPOUNDMENT INSPECTION:			
Facility Name:		Cleco Dolet Hills Power Station	
Address:		963 Power Plant Rd. Mansfield, LA	
Surface Impoundment Name :	Ash Basin No. 2	Owner:	Cleco Power LLC
Surface Impoundment ID:	P-0037	Operator:	Cleco Power LLC
Nearest City:	Mansfield	Parish:	DeSoto
Inspector:		James C. Van Hoof, P.E.	
Company:		Providence Engineering & Environmental Group LLC	
Date of Inspection:		12/11/2018	
Weather at Time of Inspection:		Sunny, cool	
DESCRIPTION OF THE OPERATION OF THE SURFACE IMPOUNDMENTS:			
<p>The bottom ash and economizer ash are mixed with water and sluiced in a slurry form to either of the two Ash Basins. Ash slurry pipelines within each basin enable the discharge of the slurry at multiple points within each basin. The discharge into each respective basin begins at the end of the pipeline network at the point furthest from the weir box, and proceeds toward the front of the pond. As a basin fills with ash, sections of the discharge pipe are removed as needed so that ash can be uniformly deposited and the storage capacity of each basin fully utilized. The ash-laden water is retained in the Ash Basins for a period of time sufficient to sett

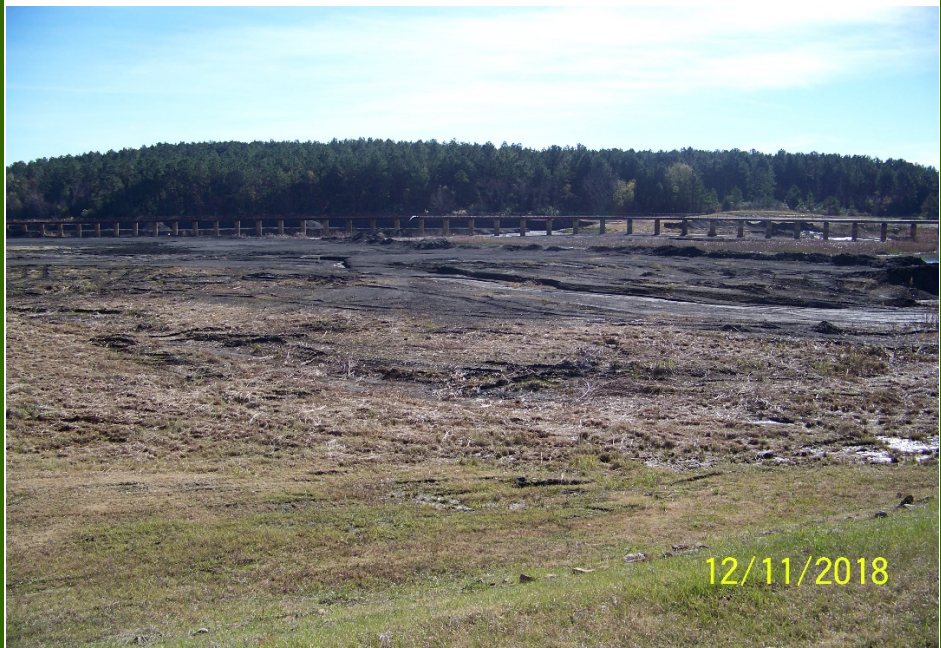
Ash Basin No. 2

Ash Basin looking at sluice structure.

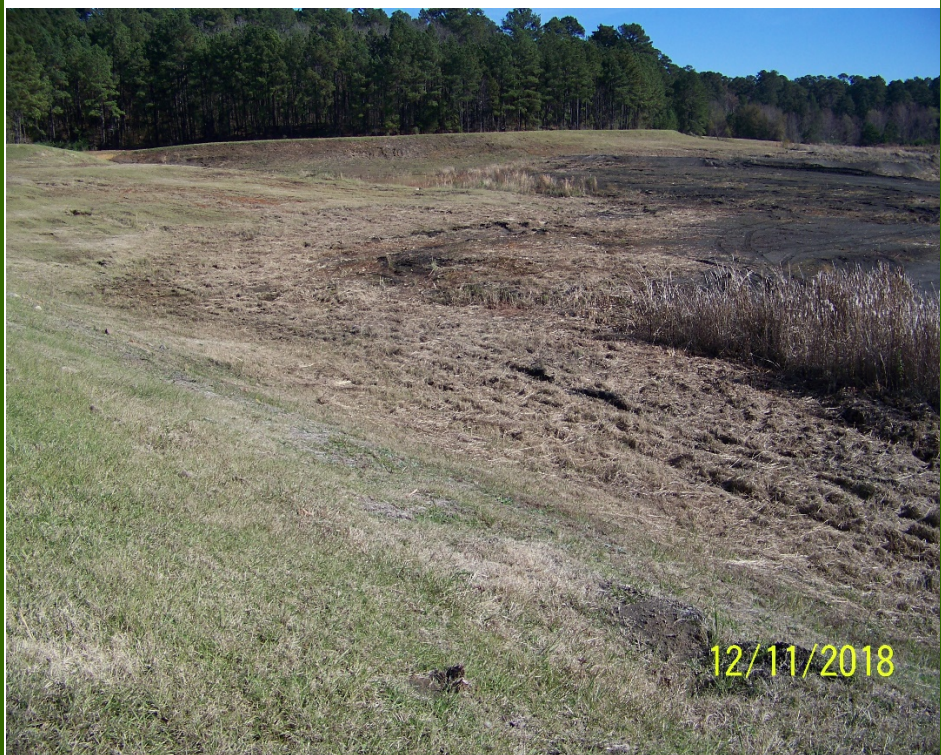
Ash Basin No. 2

Northern side of Ash Basin.

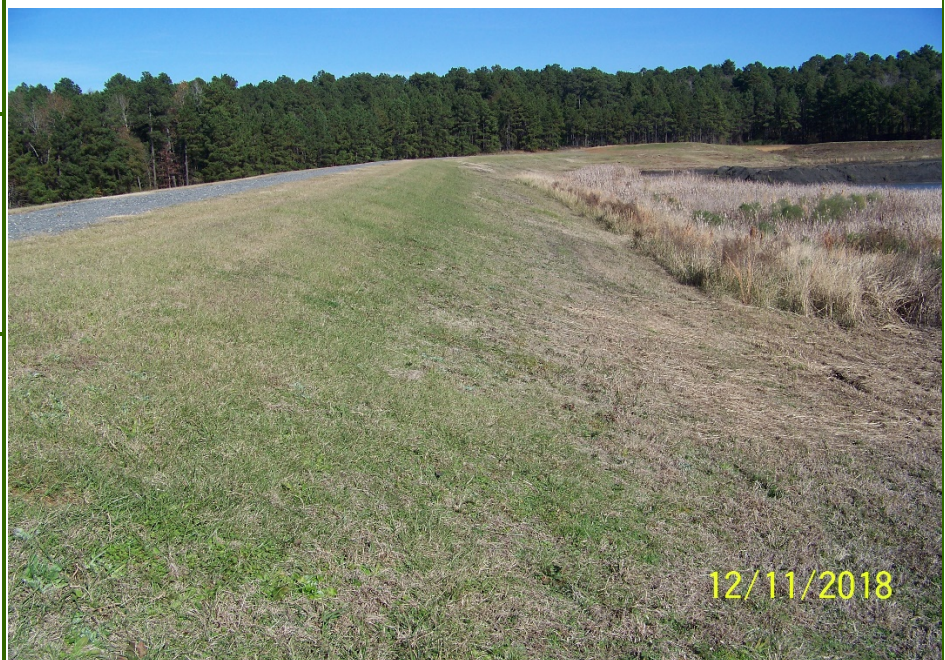
Ash Basin No. 2

If yes, describe (size of area, location, severity, etc.)	
Findings:	The interior slope was inspected and appeared to be in satisfactory condition. No corrective actions are required at this time.
Other observations on the interior slopes:	None

Internal slope of western levee.

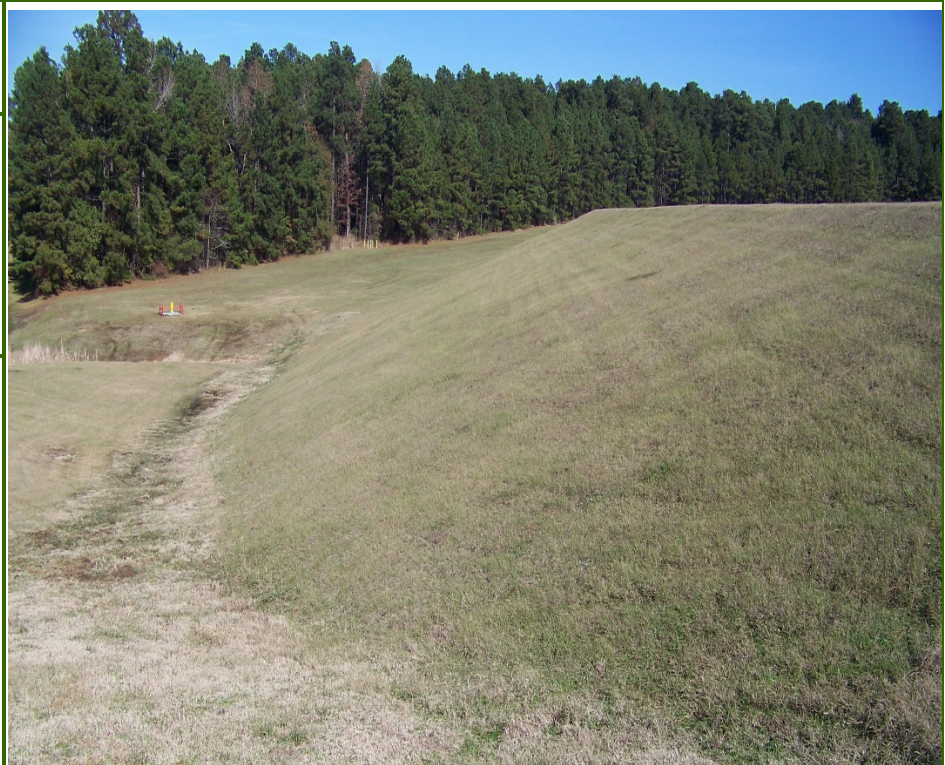
Ash Basin No. 2

Are there any trees on the slopes?	<input type="checkbox"/> Yes <input checked="" type="checkbox"/> No
If yes, describe (type of vegetation, size, location, etc.)	
Findings:	The exterior slope was inspected and appeared to be in satisfactory condition. No corrective actions are required at this time.
Other observations on the exterior slopes:	None

External slope of western levee.

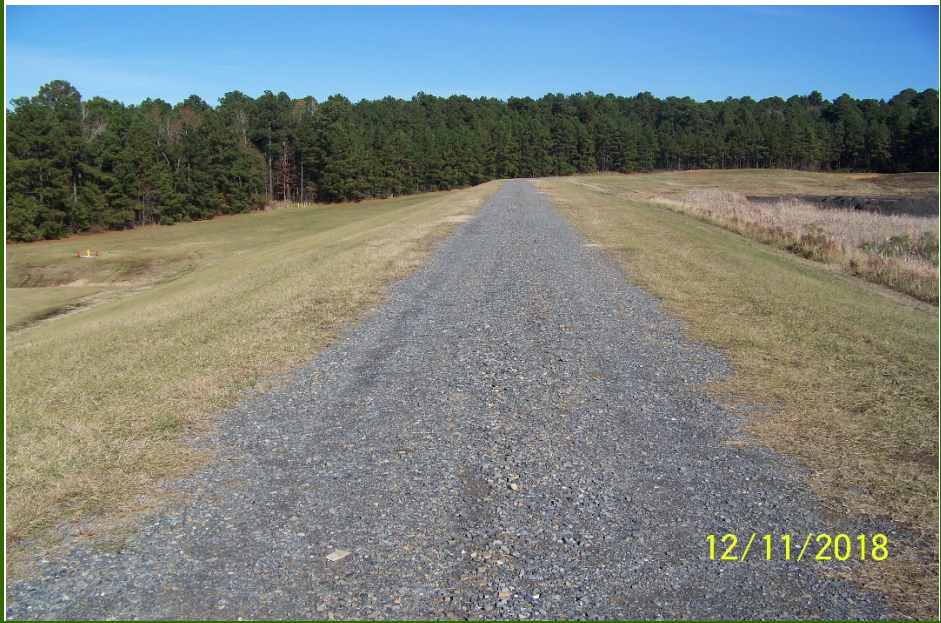
Ash Basin No. 2

If yes, describe (size, location, etc.)	
Are there any sinkholes?	<input type="checkbox"/> Yes <input checked="" type="checkbox"/> No
If yes, describe (size, location, etc.)	
Findings:	The crest was inspected and appeared to be in satisfactory condition. No corrective actions are required at this time.
Other observations on the crest:	None

Access road on western levee.

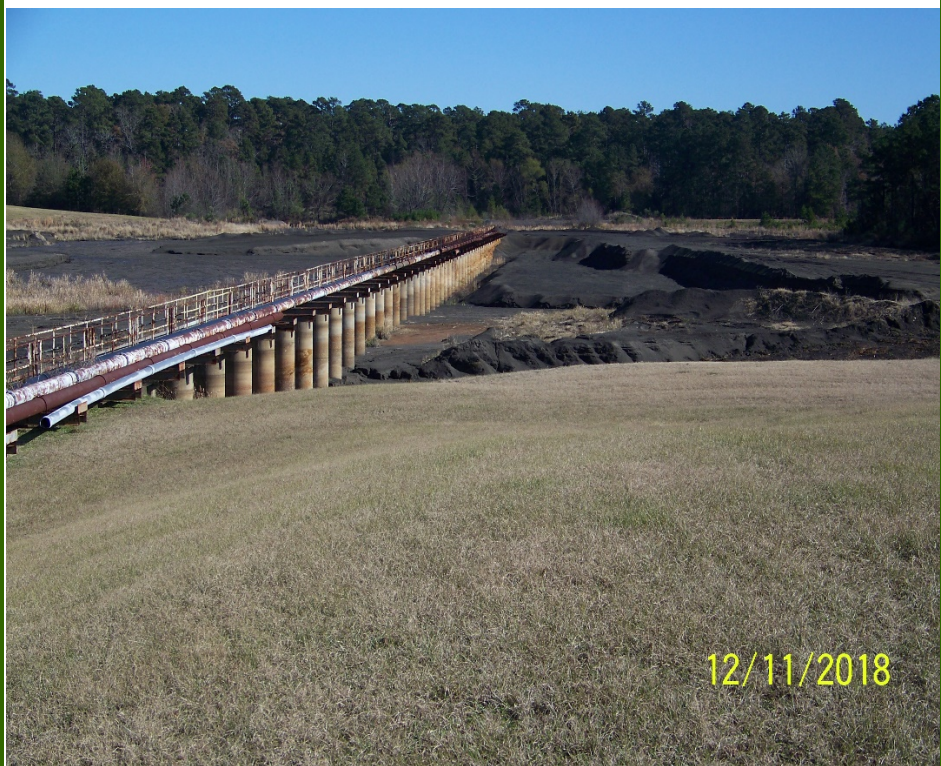
Ash Basin No. 2

Findings:	The intake works were inspected and appeared to be in satisfactory condition. No corrective actions are required at this time.
Other observations on the intake works:	None

Bottom ash sluice structure.

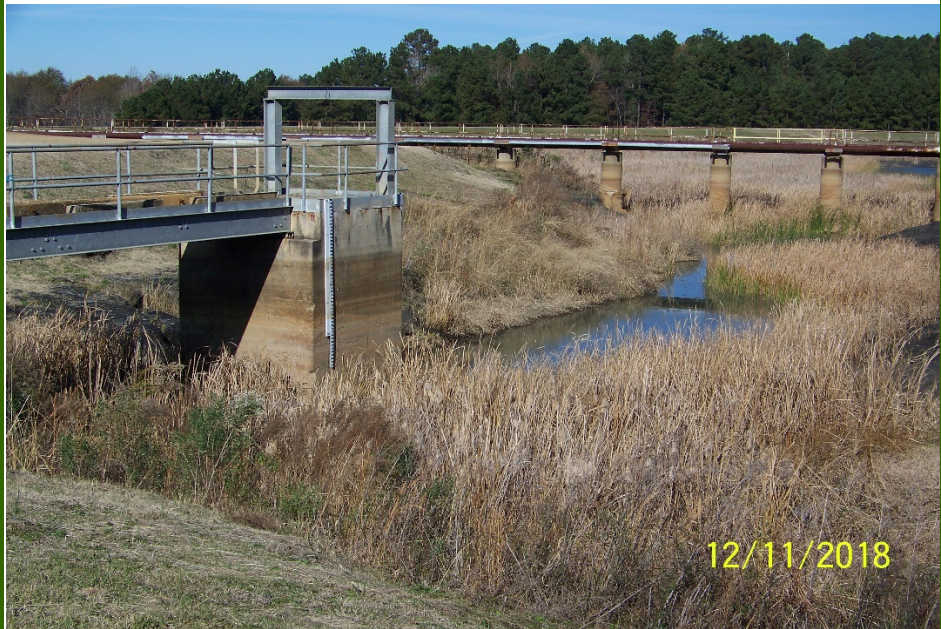
Ash Basin No. 2

PHYSICAL DAM FEATURES – SPILLWAY/OVERFLOW STRUCTURE:	
Type (1):	Internal Concrete Structure with Adjustable Overflow Weir
Slope Protection:	Encased in concrete
Approach:	Concrete structure surrounded by ash
Erosion:	None observed
Vegetation:	Concrete structure surrounded by ash.
Findings:	The overflow structure was inspected and appeared to be in satisfactory condition. No corrective actions are required at this time.
Other observations on overflow structure:	None
Type (2):	Auxiliary Spillway
Slope Protection:	6" rip rap up to elevation 246.0 NAVD 88.
Approach:	6" rip rap up to elevation 246.0 NAVD 88.
Erosion:	None observed
Vegetation:	Grass vegetation on top of the rip rap as it enters the Secondary Pond.
Findings:	The spillway was inspected and appeared to be in satisfactory condition. No corrective actions are required at this time.
Other observations on the spillway:	None

Overflow weir structure with level gauge.

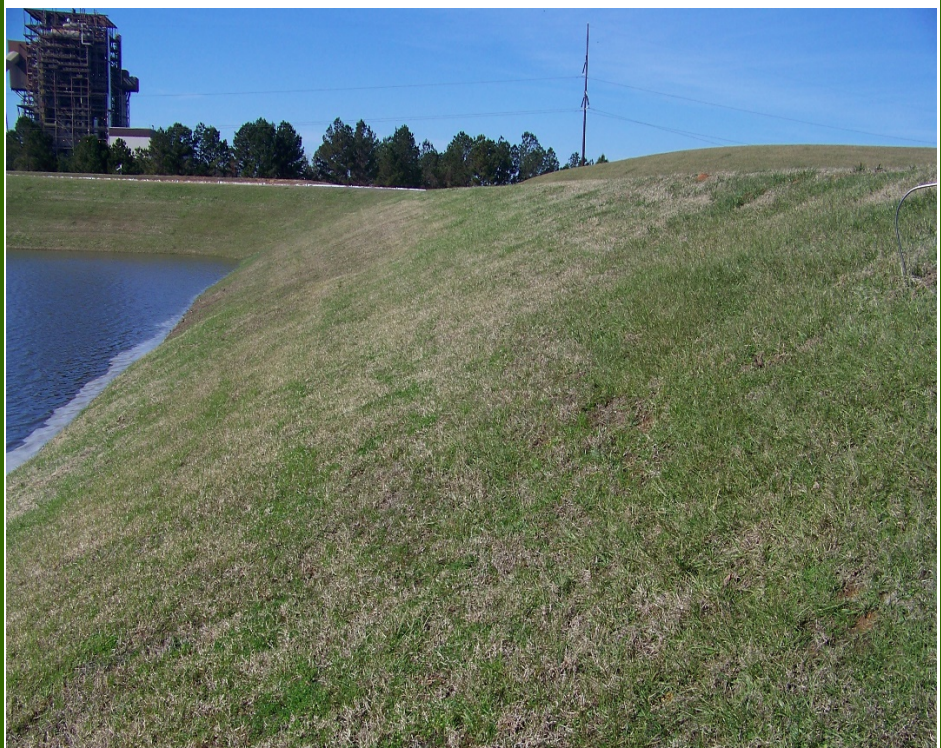
Ash Basin No. 2

Exterior slope of southern levee.
