ANNUAL CCR LANDFILL INSPECTION:			
Facility Name:		Cleco Dolet Hills Power Station	
Address:		963 Power Plant Rd. Mansfield, LA	
Landfill Name :	Dolet Hills Landfill	Owner:	Cleco Power LLC
Surface Impoundment ID:	P-0064	Operator:	Cleco Power LLC
Nearest City:	Mansfield	Parish:	DeSoto
Inspector:		James C. Van Hoof, P.E.	
Company:		Providence Engineering & Environmental Group LLC	
Date of Inspection:		12/11/2018	
Weather at Time of Inspection:		Sunny, Cool	
DESCRIPTION OF THE OPERATION OF THE LANDFILL:			
<p>Cleco Dolet Hills Power Station (Dolet Hills) operates a Fly Ash/Scrubber Sludge Landfill used for the disposal of noncombustible by-product of lignite combustion from the Dolet Hills Power Station.</p> <p>Dolet Hills operates a landfill for the disposal of nonhazardous on-site generated waste only. None of the wastes disposed is characterized as hazardous or is listed hazardous waste as defined by LAC 33:V.Subpart I or by federal regulations. The non-hazardous nature of each waste stream is confirmed by process knowledge. The primary waste that is disposed in the landfill is fly ash and flue gas desulfurization (FGD or scrubber) sludge. The fly ash is a fine particulate composed

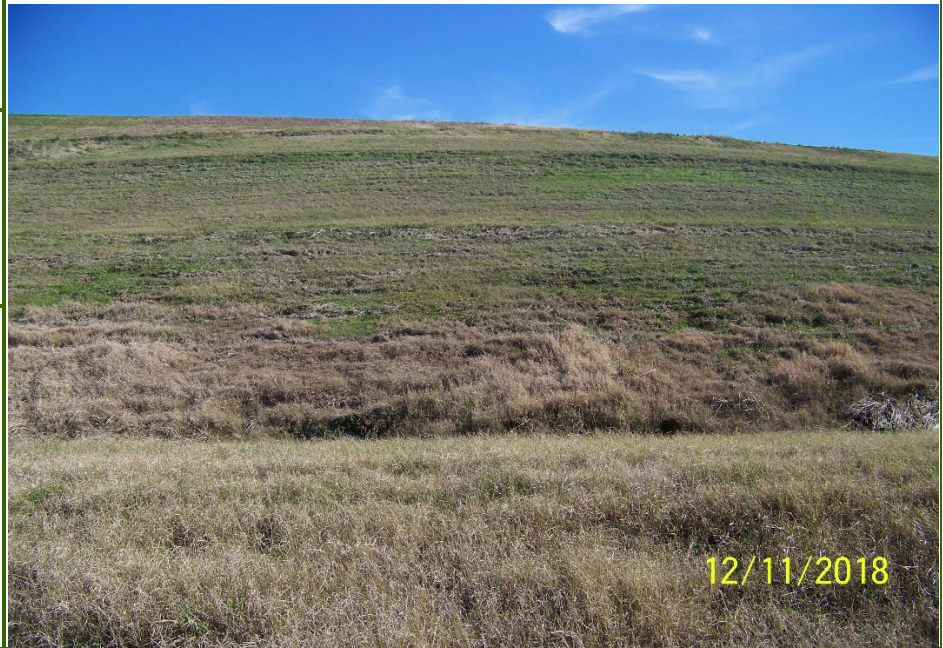
Western side slope.

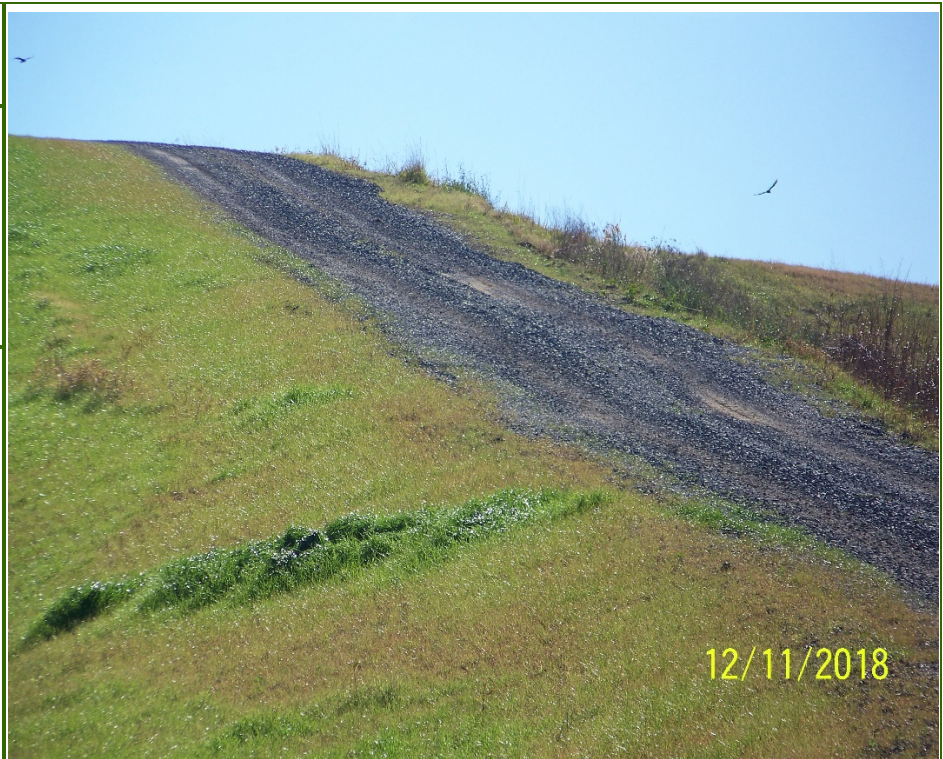
Access ramp.

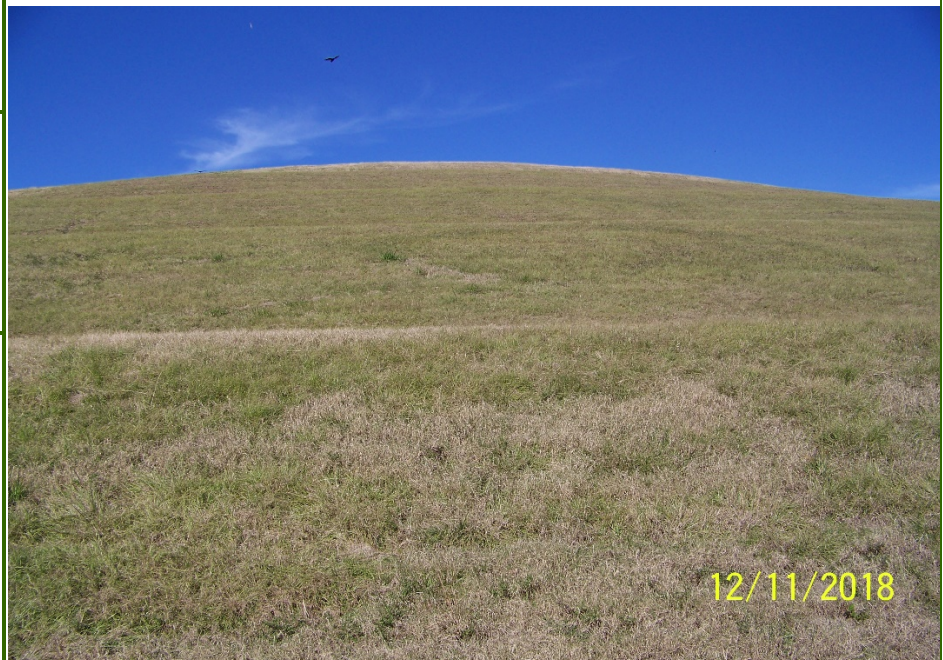
Southern slope showing terraces.

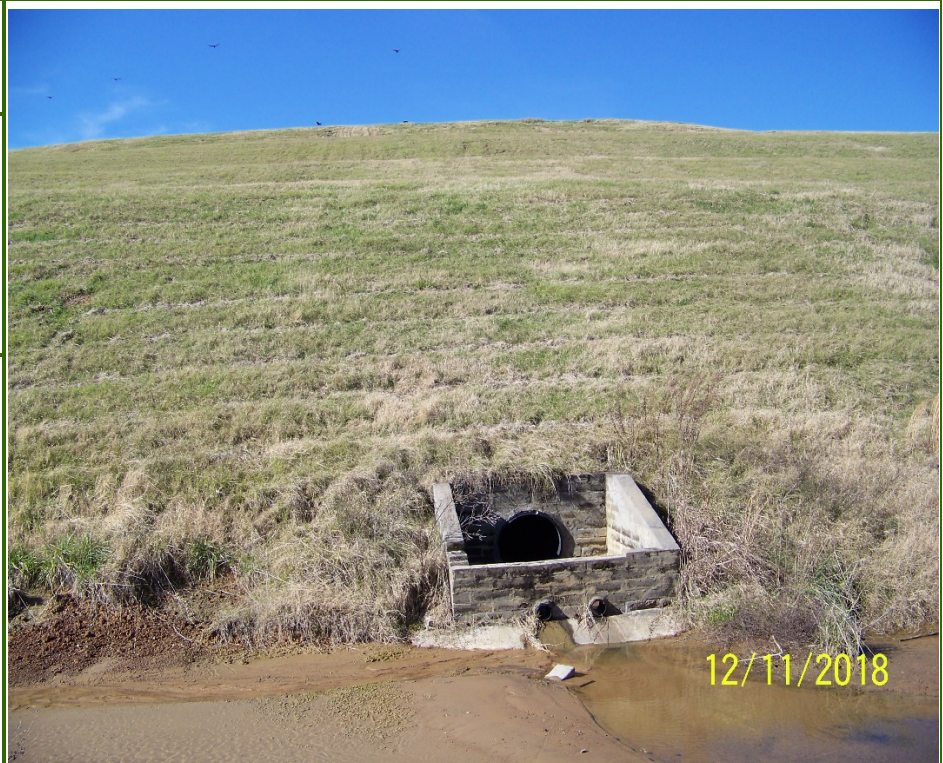
Eastern exterior slope showing discharge opening for upper elevation inlet piping.

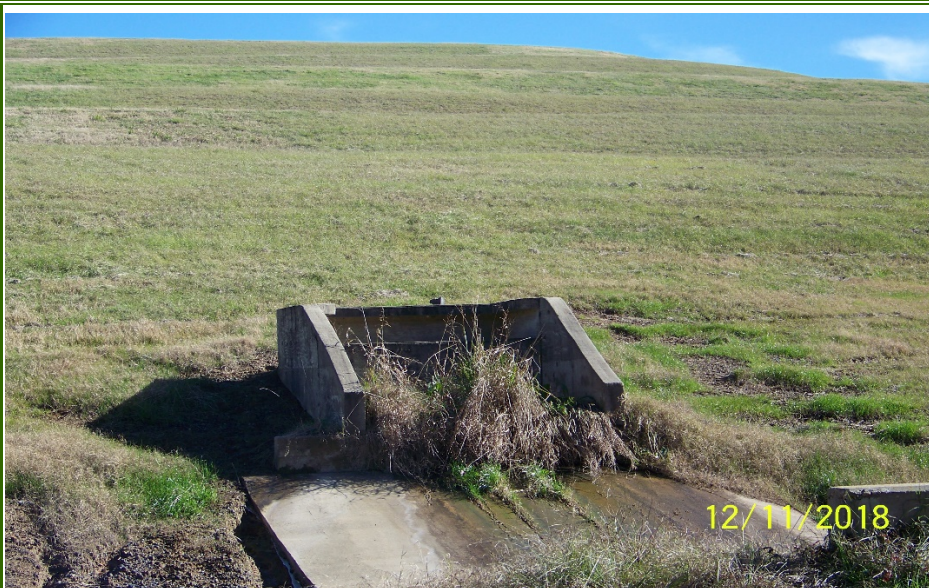
If yes, describe (size, location, etc.)	
Is the stormwater infrastructure in good condition?	<input checked="" type="checkbox"/> Yes <input type="checkbox"/> No
Findings:	The exterior slopes were inspected and appeared to be in fair condition. Sloughing caused by feral hogs needs to be corrected on western slope. Erosion near discharge structure on western slope needs to be corrected.
Other observations on the exterior slopes:	None

Western exterior slope - discharge opening for upper elevation inlet piping. Erosion needs to be corrected.

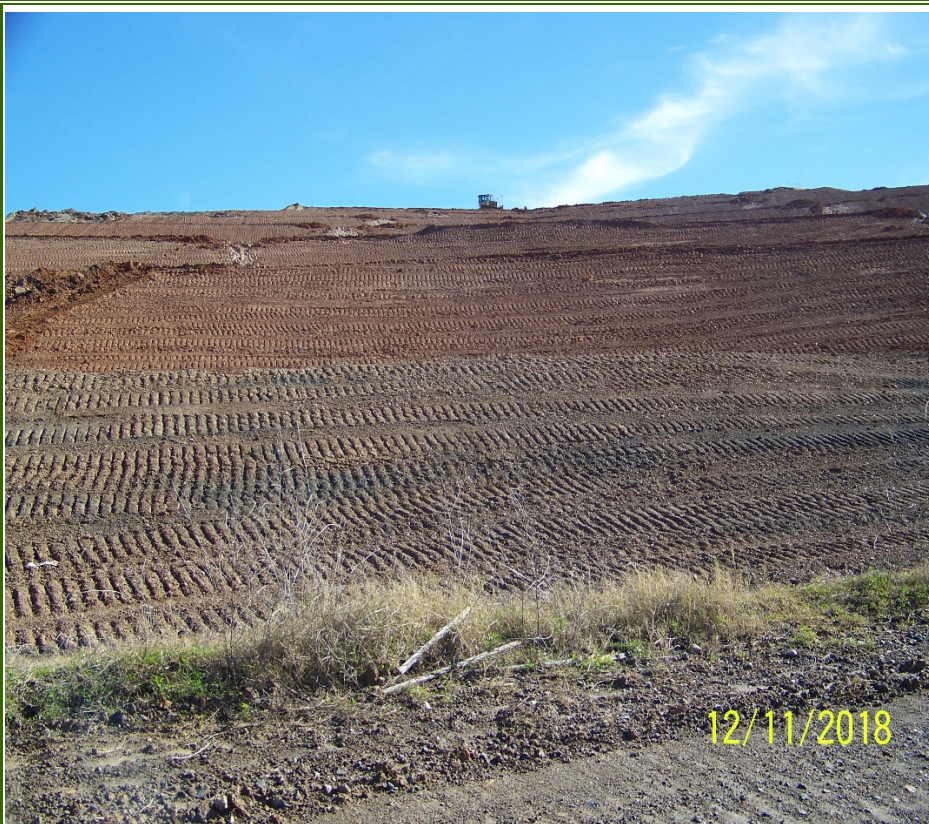
DOCUMENTATION REVIEW:	
Weekly Inspections Reviewed:	<input checked="" type="checkbox"/> Yes <input type="checkbox"/> No
Findings:	Vegetation maintenance, general erosion issues
Groundwater Monitoring:	Monitoring wells are in-place.
Drawings Reviewed:	<input checked="" type="checkbox"/> Yes <input type="checkbox"/> No
Any other change(s) which may have affected the stability or operation of the landfill since the previous annual inspection?	<input type="checkbox"/> Yes <input checked="" type="checkbox"/> No <input type="checkbox"/> NA
Are there any changes in the geometry of the landfill since the previous inspection?	<input checked="" type="checkbox"/> Yes <input type="checkbox"/> No <input type="checkbox"/> NA
If yes, describe (size, location, etc.)	In process of capping 5.4 acres on western slope.
Other observations:	None

5.4-acre capping project on western slope in progress.

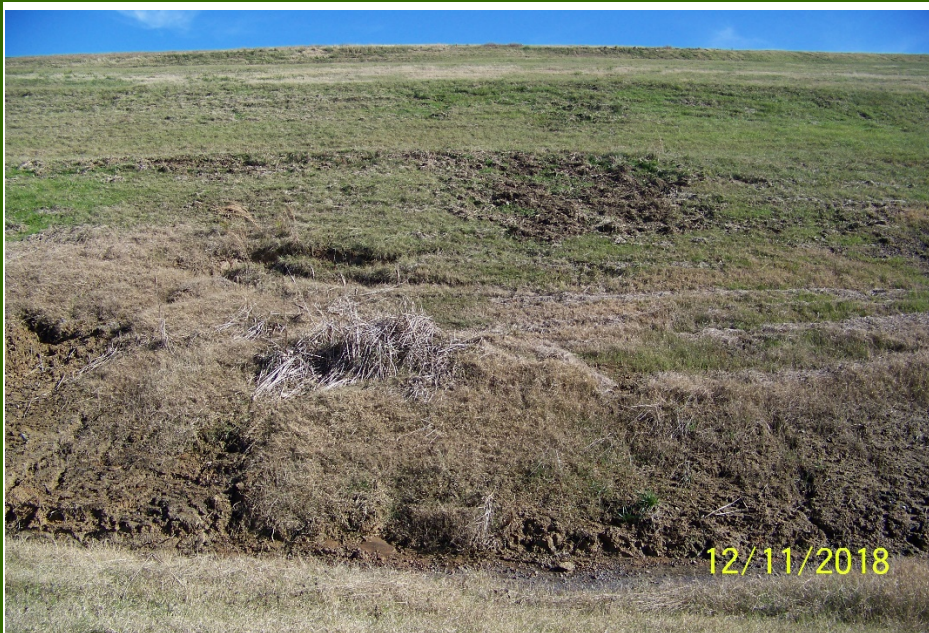
Ferral hogs have rutted the western slope causing sloughing that needs to be corrected.

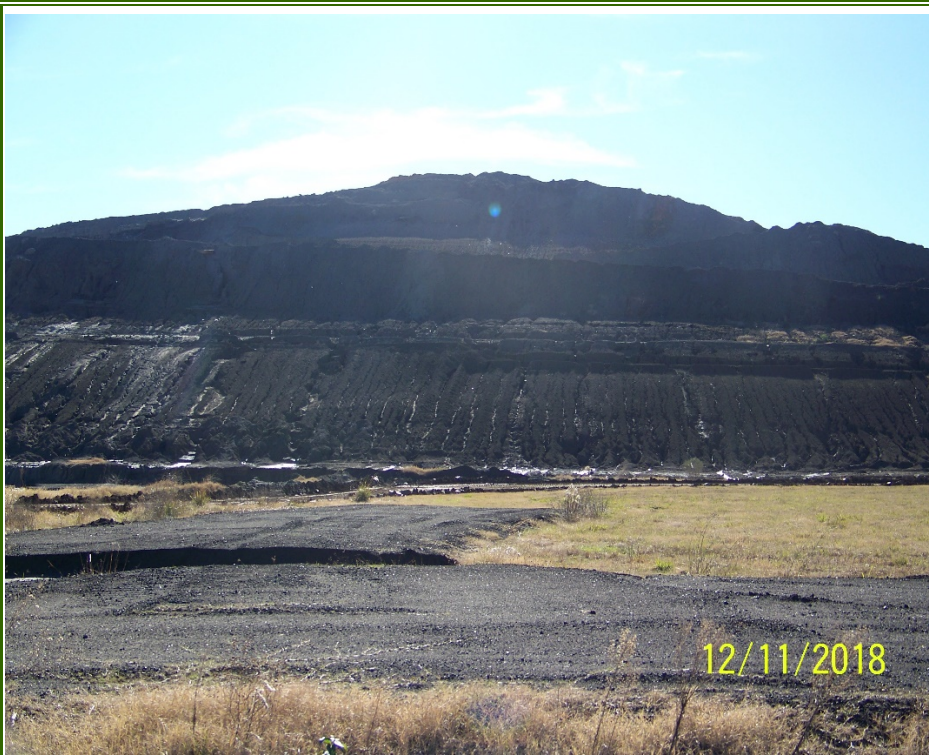
Working face of the landfill.

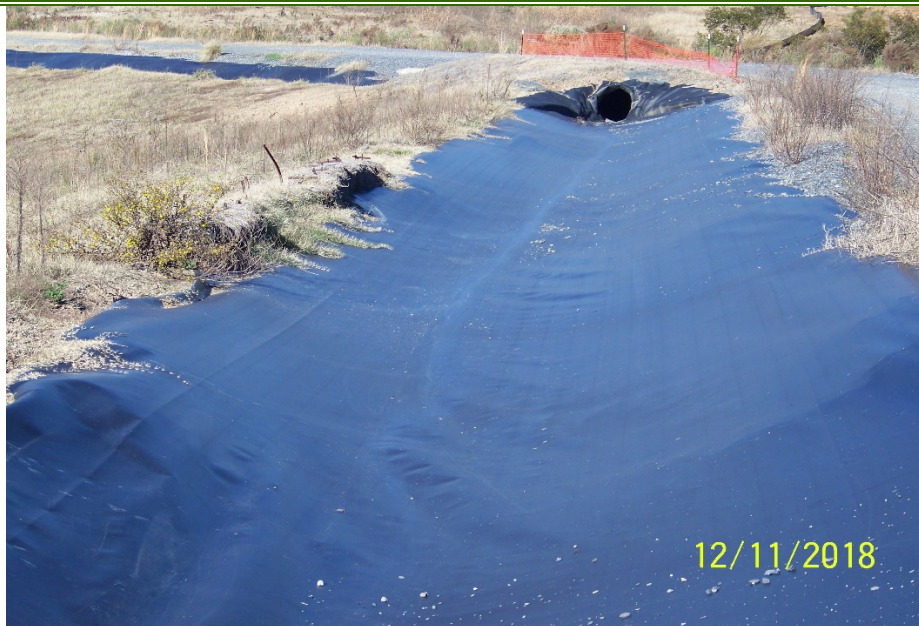
Storm water drainage ditch east side of cell 11 of landfill that drains to the landfill runoff pond.

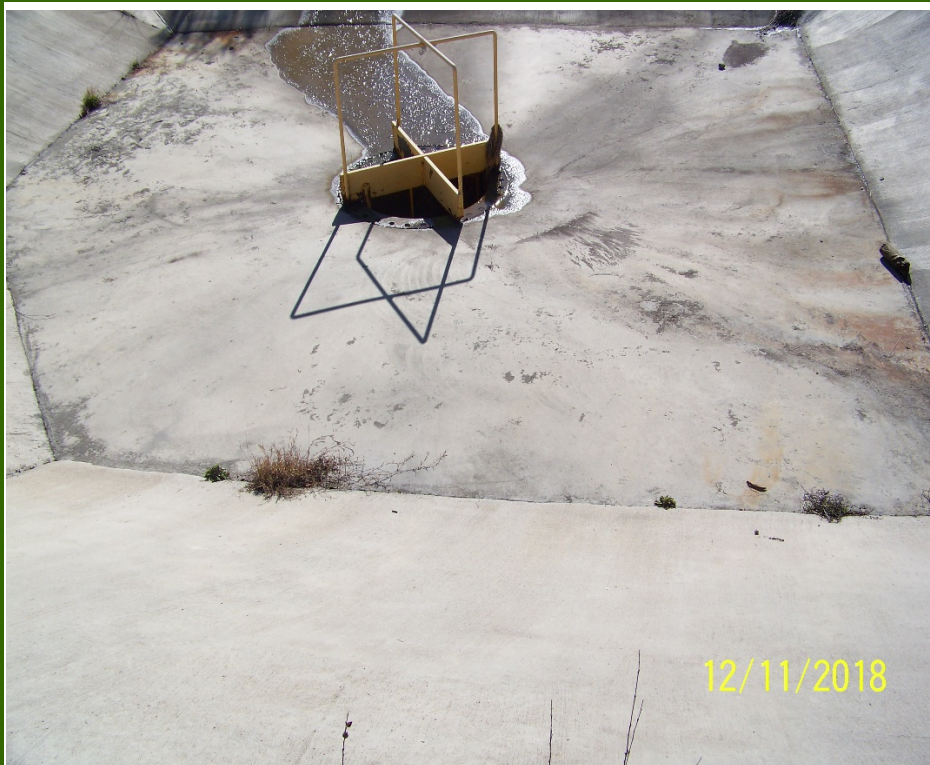
Storm water overflow inlet that drains to the landfill runoff pond.

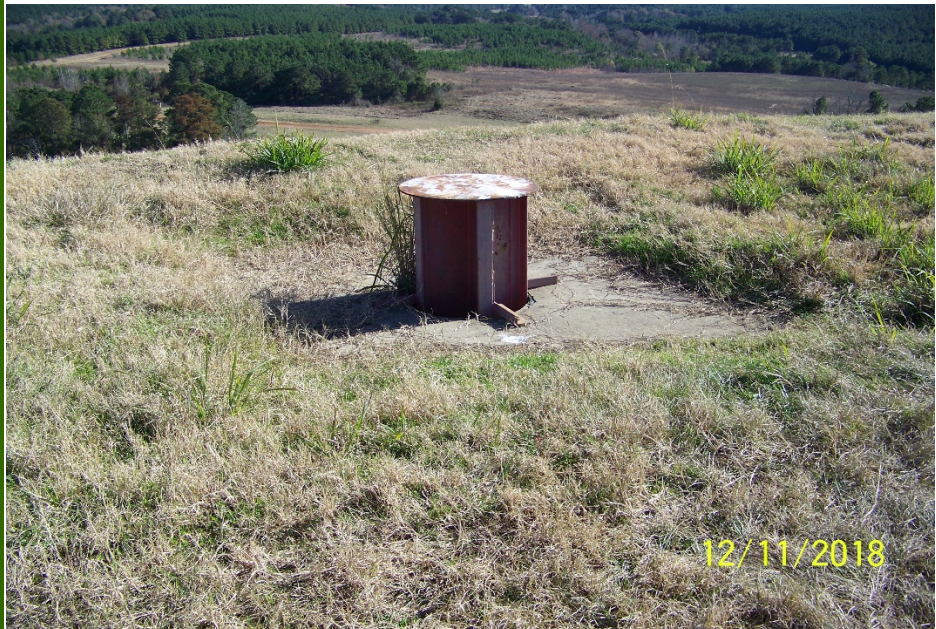
Drop inlet structure on crown of landfill cap.

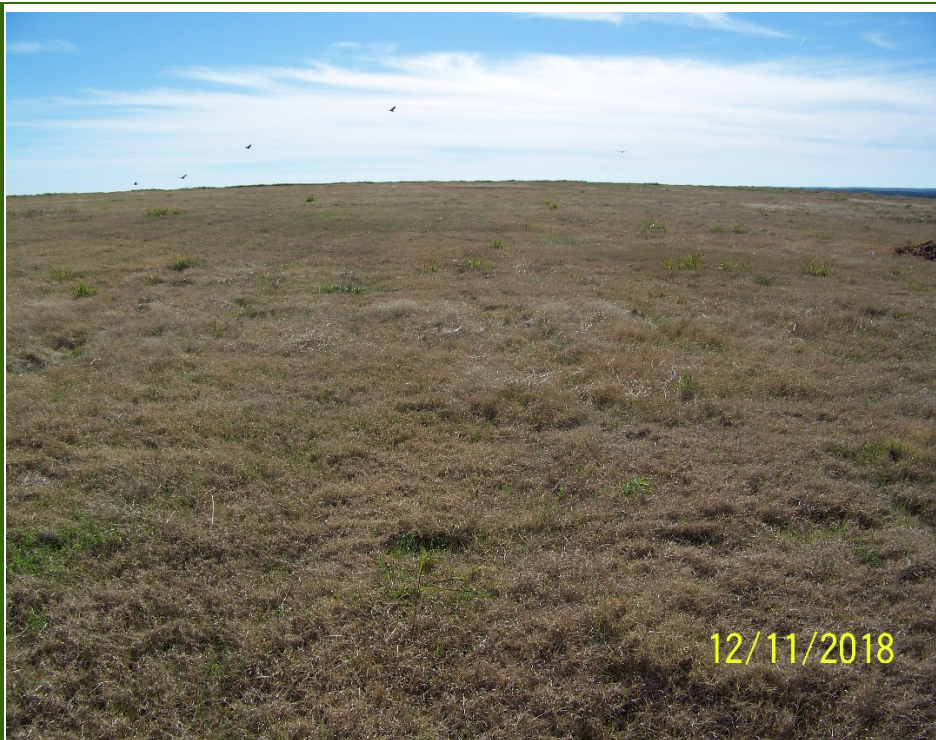
Upper elevation flat crown area.
