ANNUAL CCR LANDFILL INSPECTION:			
Facility Name:		Cleco Dolet Hills Power Station	
Address:		963 Power Plant Rd. Mansfield, LA	
Landfill Name :	Dolet Hills Landfill	Owner:	Cleco Power LLC
Surface Impoundment ID:	P-0064	Operator:	Cleco Power LLC
Nearest City:	Mansfield	Parish:	DeSoto
Inspector:		James C. Van Hoof, P.E.	
Company:		Providence Engineering & Environmental Group LLC	
Date of Inspection:		12/11/2019	
Weather at Time of Inspection:		Sunny, Cool	
DESCRIPTION OF THE OPERATION OF THE LANDFILL:			
<p>Cleco Dolet Hills Power Station (Dolet Hills) operates a Fly Ash/Scrubber Sludge Landfill used for the disposal of noncombustible by-product of lignite combustion from the Dolet Hills Power Station.</p> <p>Dolet Hills operates a landfill for the disposal of nonhazardous on-site generated waste only. None of the wastes disposed is characterized as hazardous or is listed hazardous waste as defined by LAC 33:V.Subpart I or by federal regulations. The non-hazardous nature of each waste stream is confirmed by process knowledge. The primary waste that is disposed in the landfill is fly ash and flue gas desulfurization (FGD) or scrubber sludge. The fly ash is a fine particulate composed

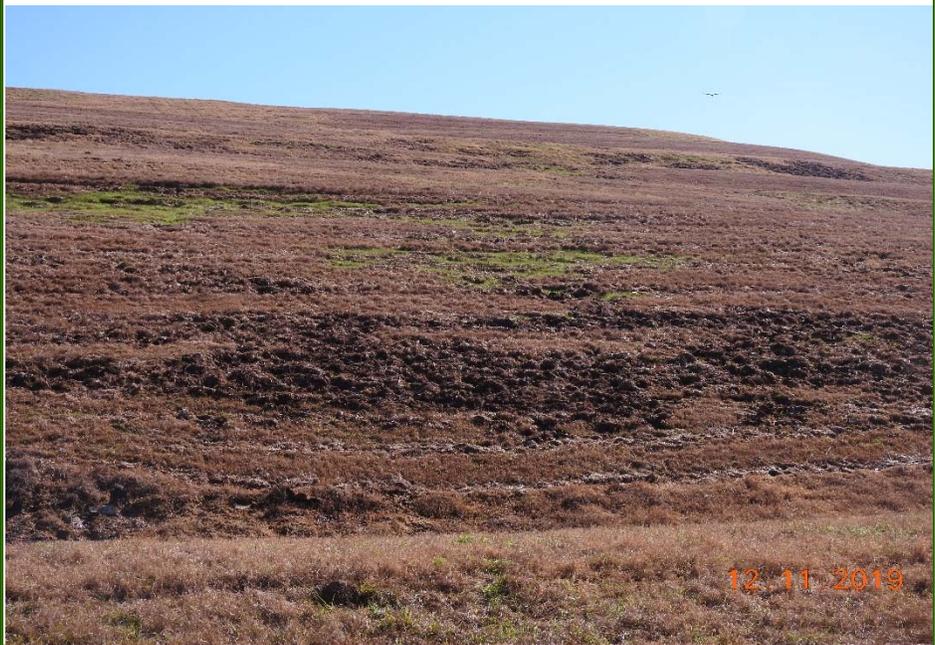
If yes, describe (size, location, etc.)	
Is the stormwater infrastructure in good condition?	<input checked="" type="checkbox"/> Yes <input type="checkbox"/> No
Findings:	The exterior slopes were inspected and appeared to be in fair condition. Rutting caused by feral hogs needs to be corrected on western slope. Erosion on slope needs to be corrected. Erosion near discharge structure on western slope needs to be corrected.
Other observations on the exterior slopes:	None

Ferral hogs have rutted the western slope that needs to be corrected to prevent further erosion.

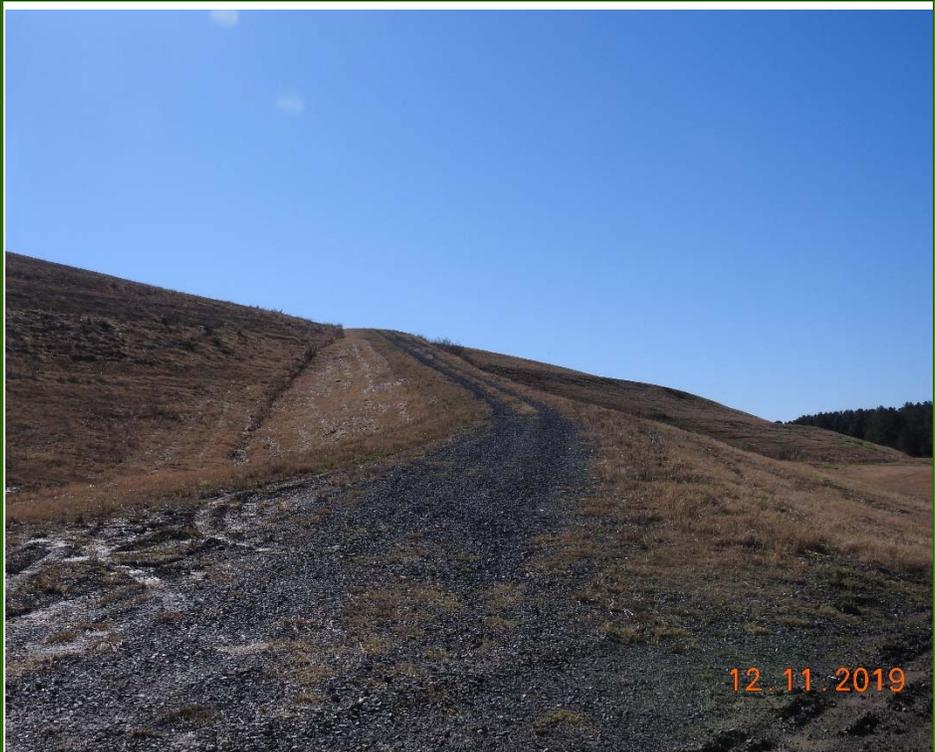
Access ramp.

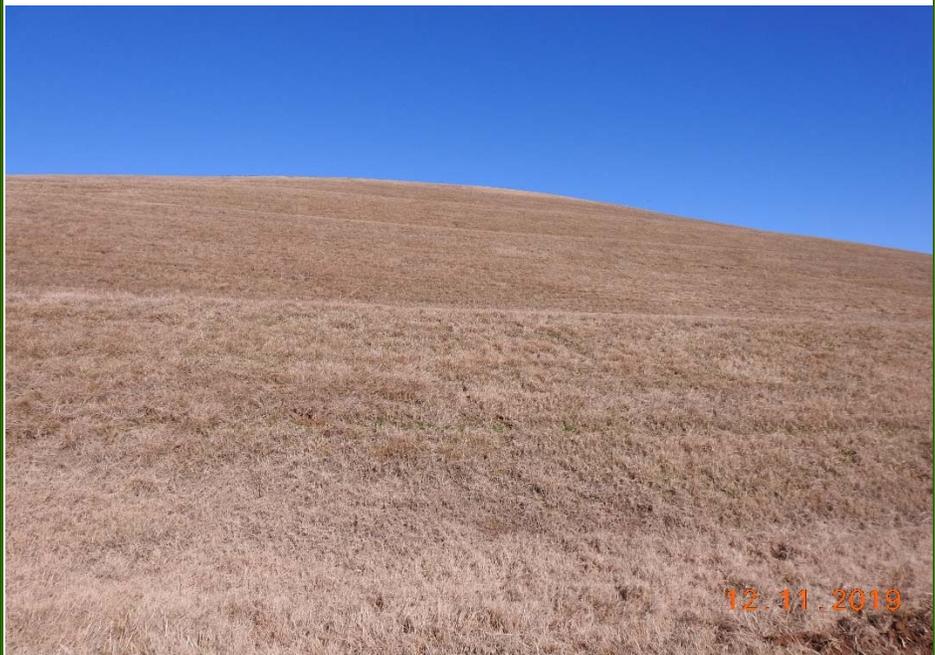
Southern slope showing terraces.

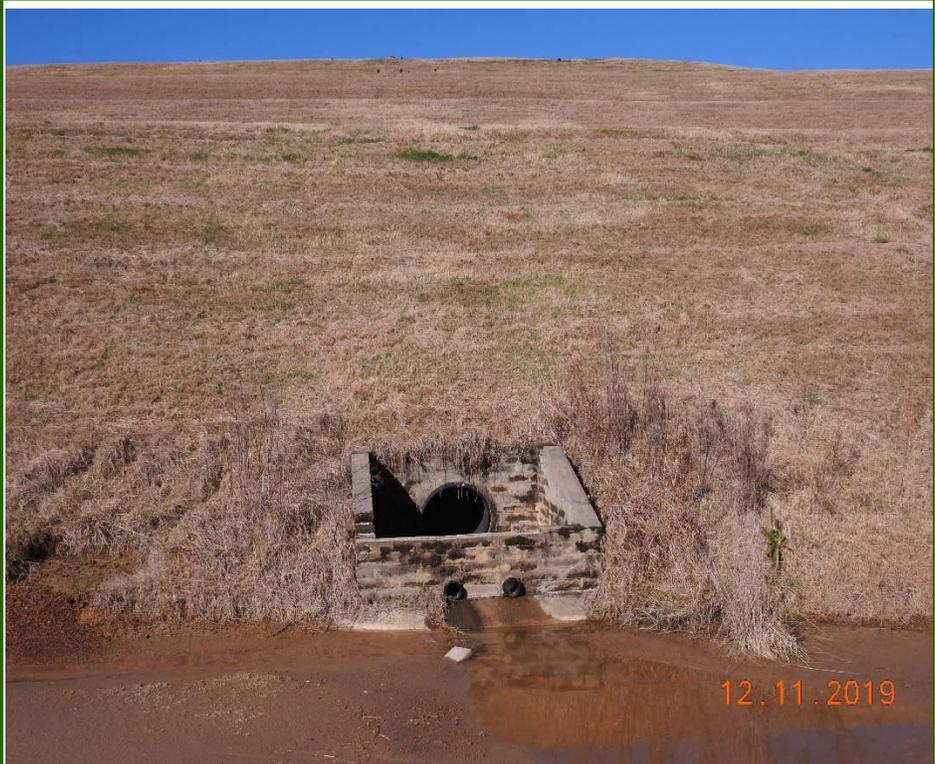
Eastern exterior slope showing discharge opening for upper elevation inlet piping.

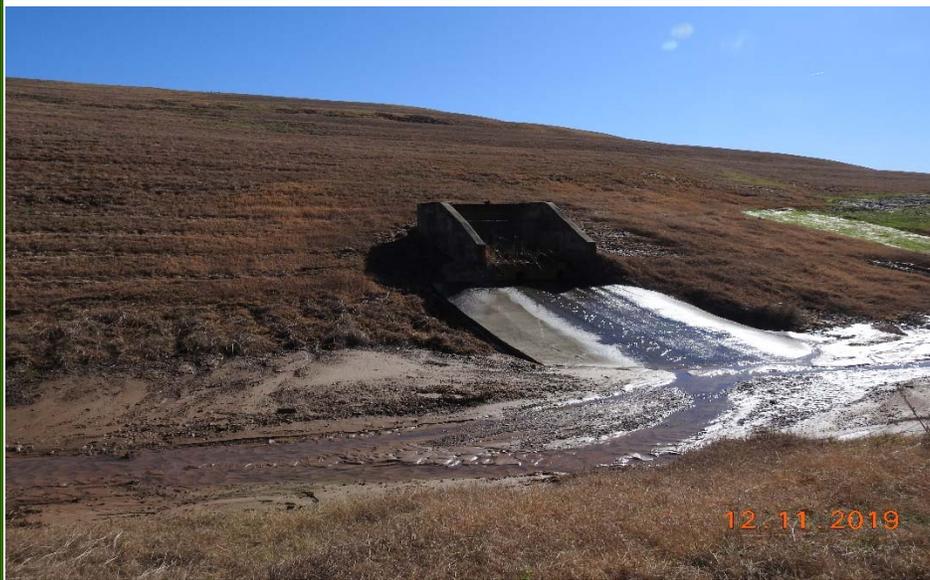
Western exterior slope. Discharge opening for upper elevation inlet piping. Erosion needs to be corrected.

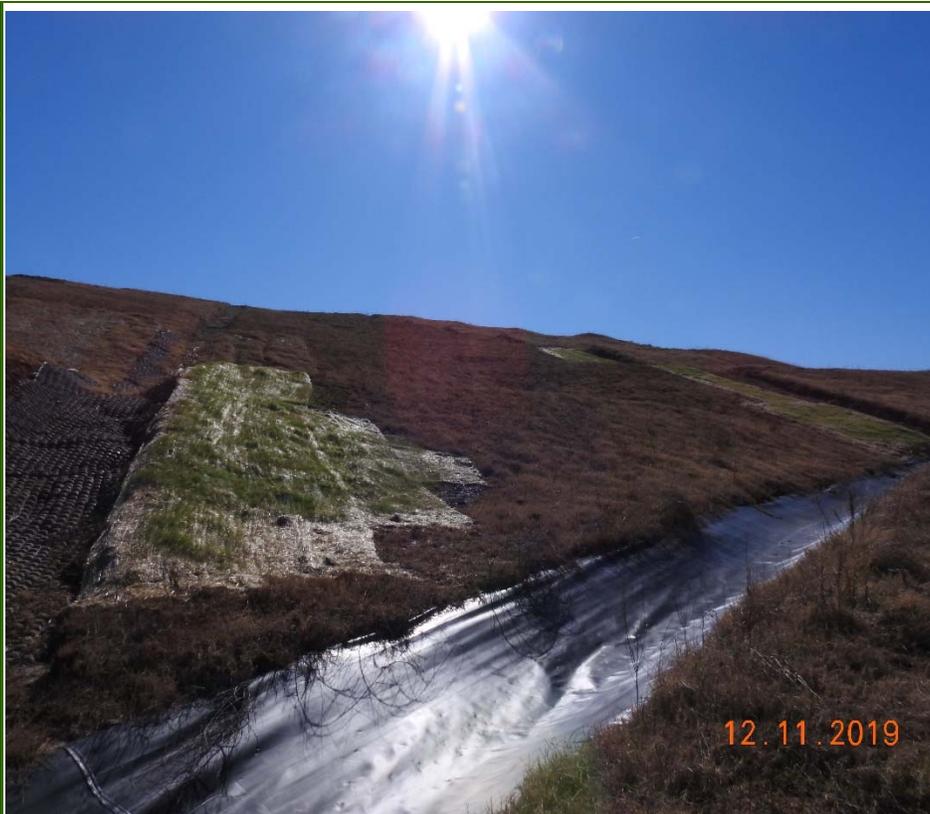
5.4-acre capping project on western slope completed.

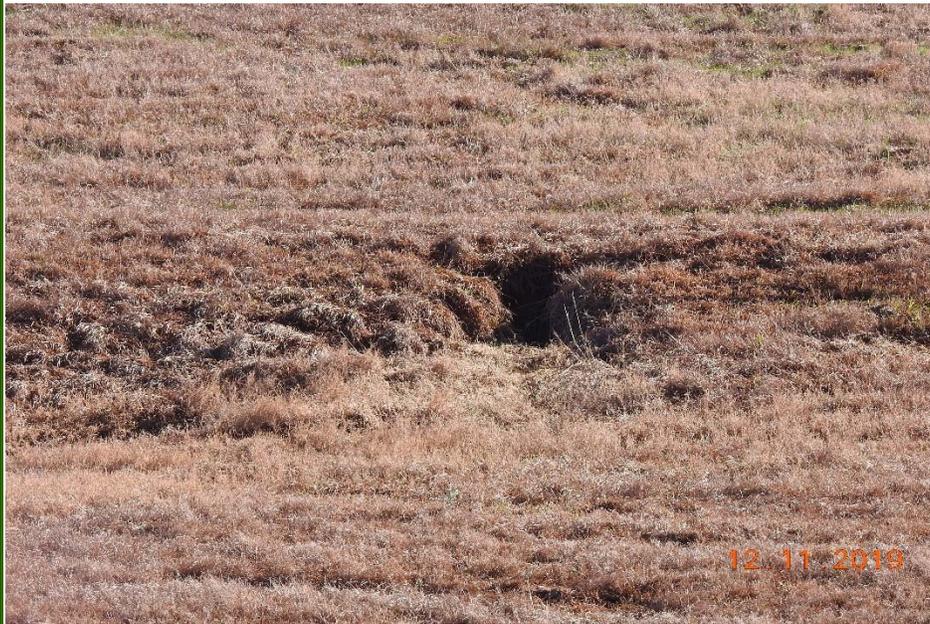
Erosion on western slope needs to be corrected.

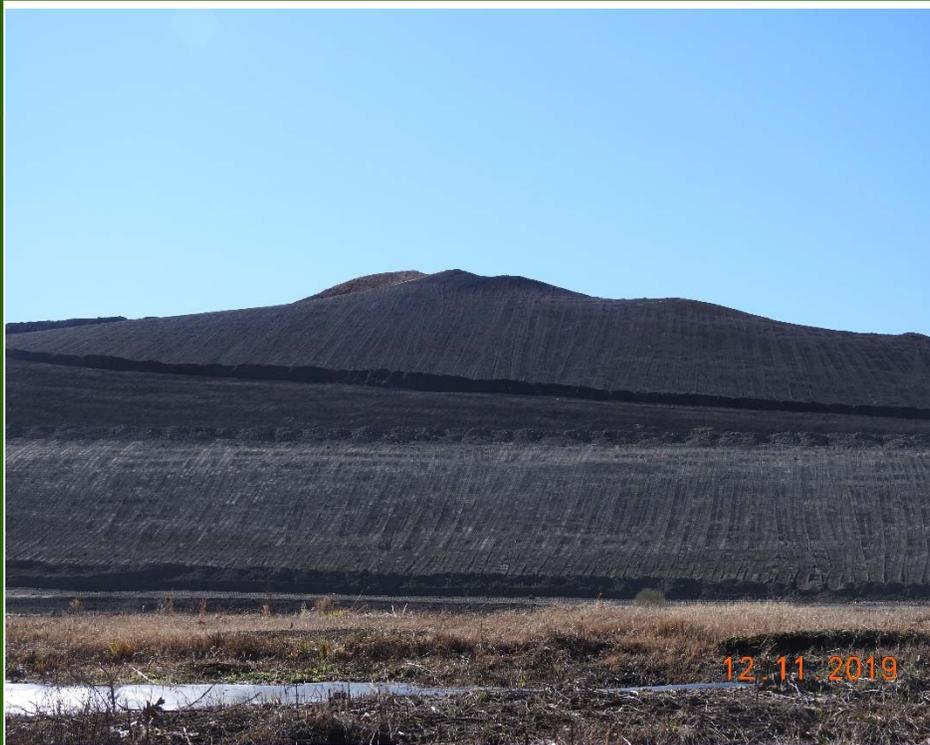
Working face of the landfill.

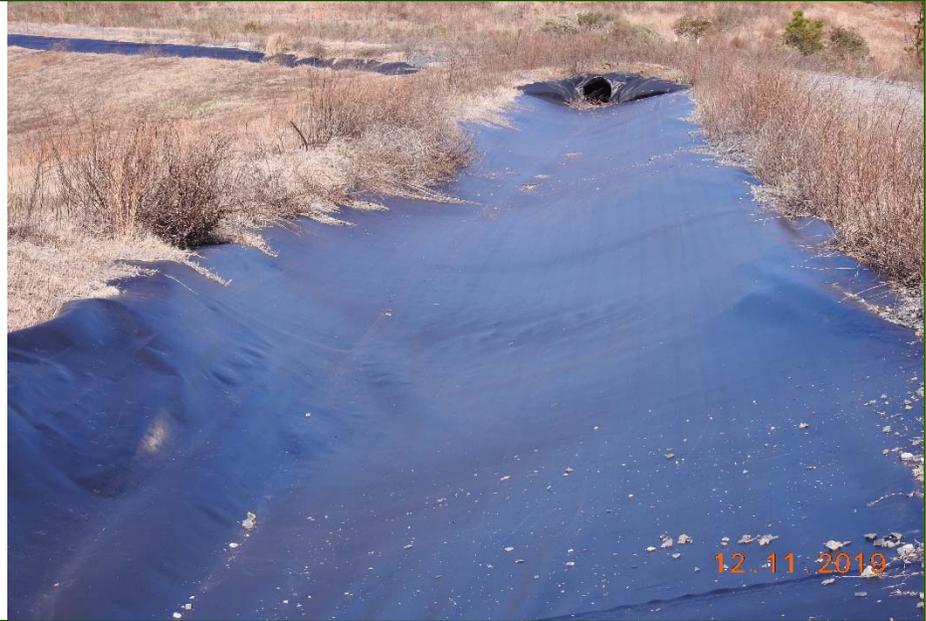
Storm water drainage ditch east side of cell 11 of landfill that drains to the landfill runoff pond.

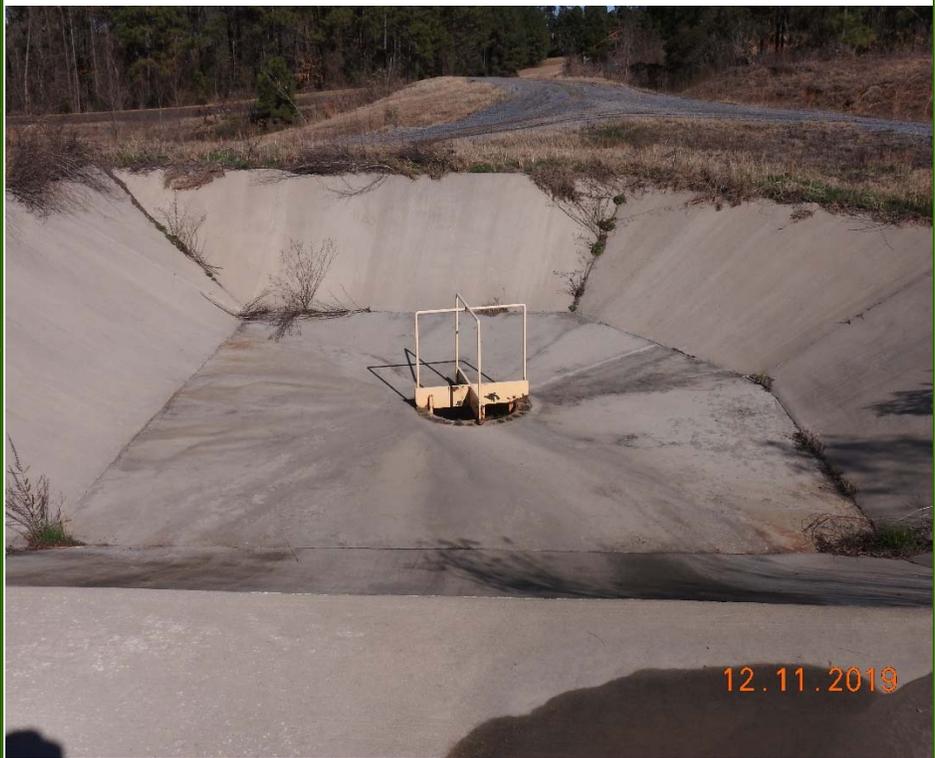
Storm water overflow inlet that drains to the landfill runoff pond.

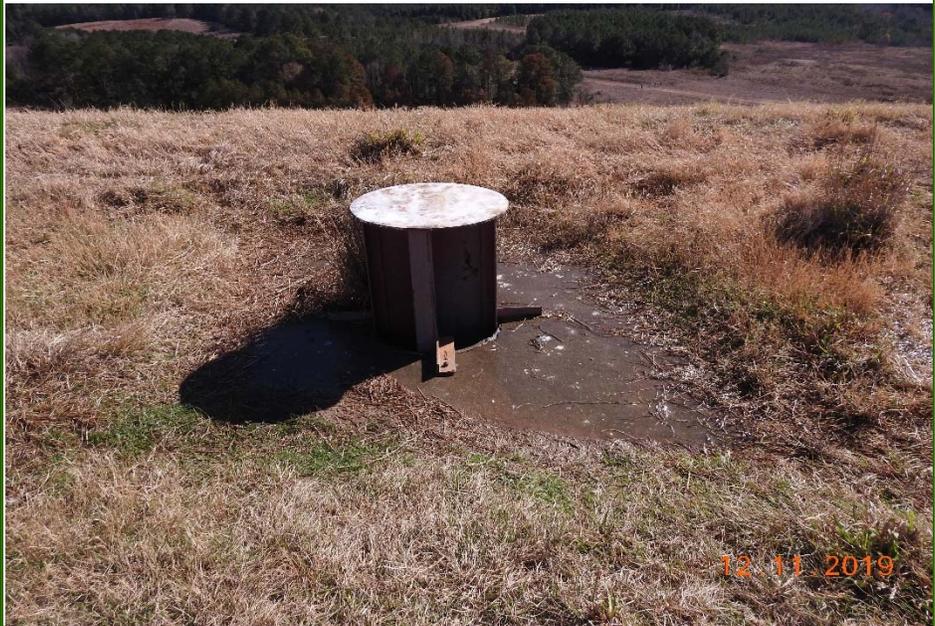
Drop inlet structure on crown of landfill cap.

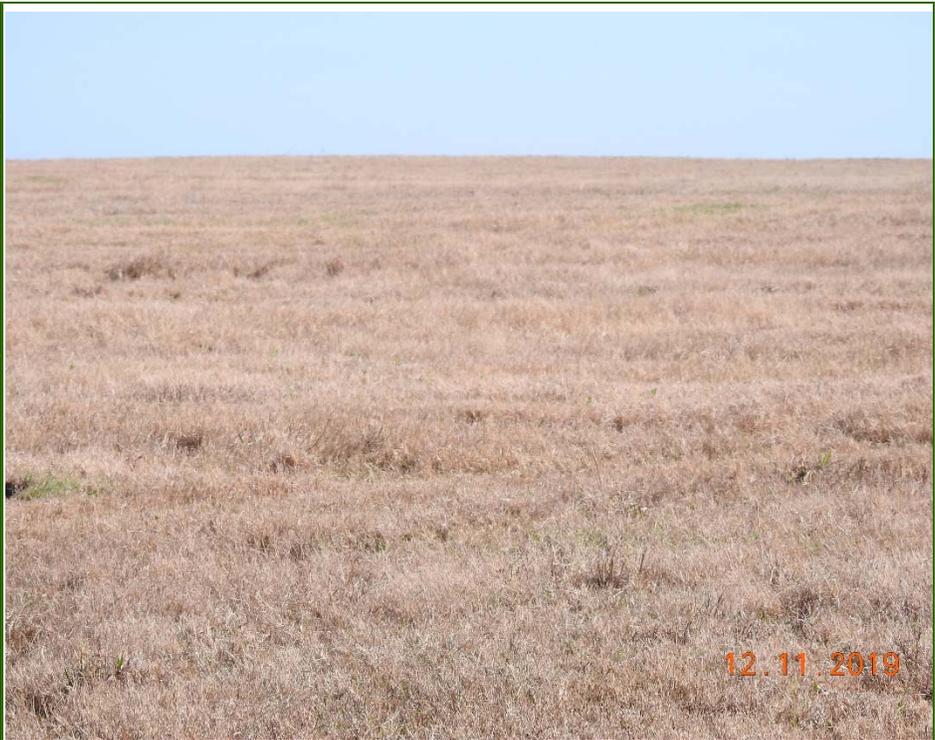
Upper elevation flat crown area.

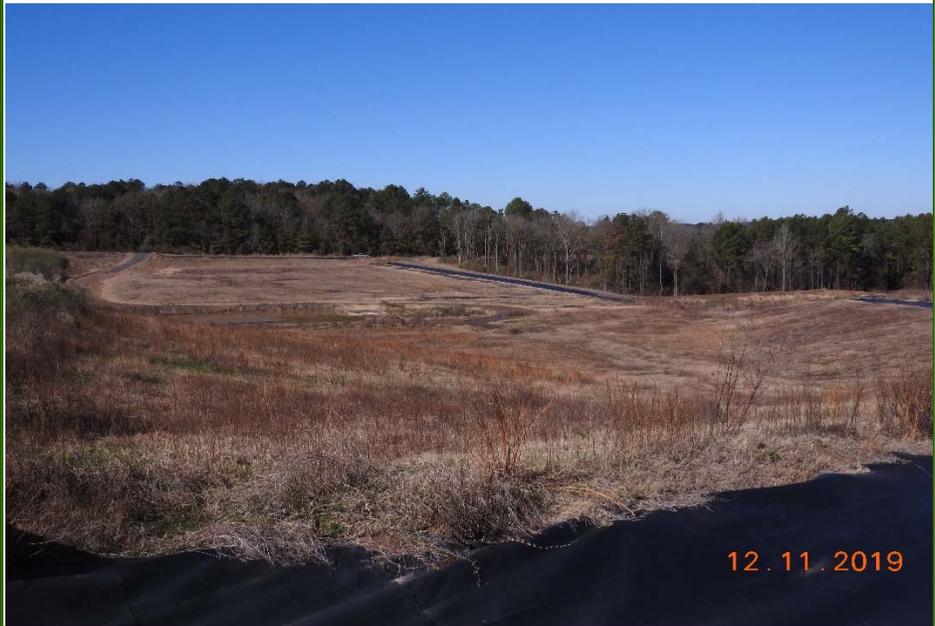
Cell 11 area.

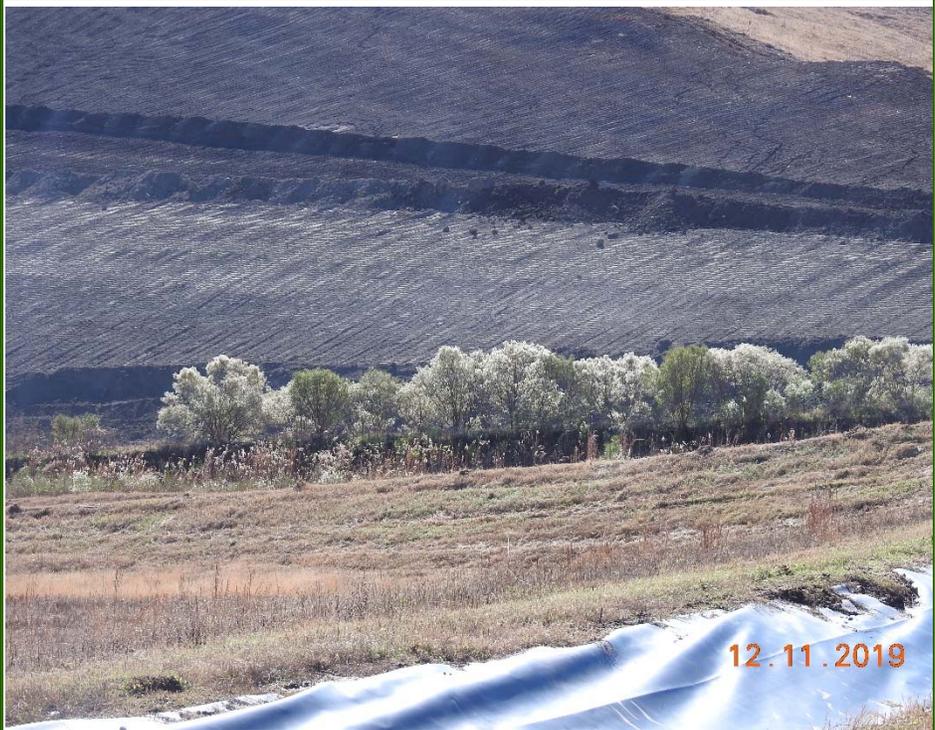
Small brush needs to be removed between Cell 11 and the working face.
