# **CLECO POWER LLC**

## **BRAME ENERGY CENTER**

### **STRUCTURAL STABILITY ASSESSMENT**

### **FLY ASH POND**

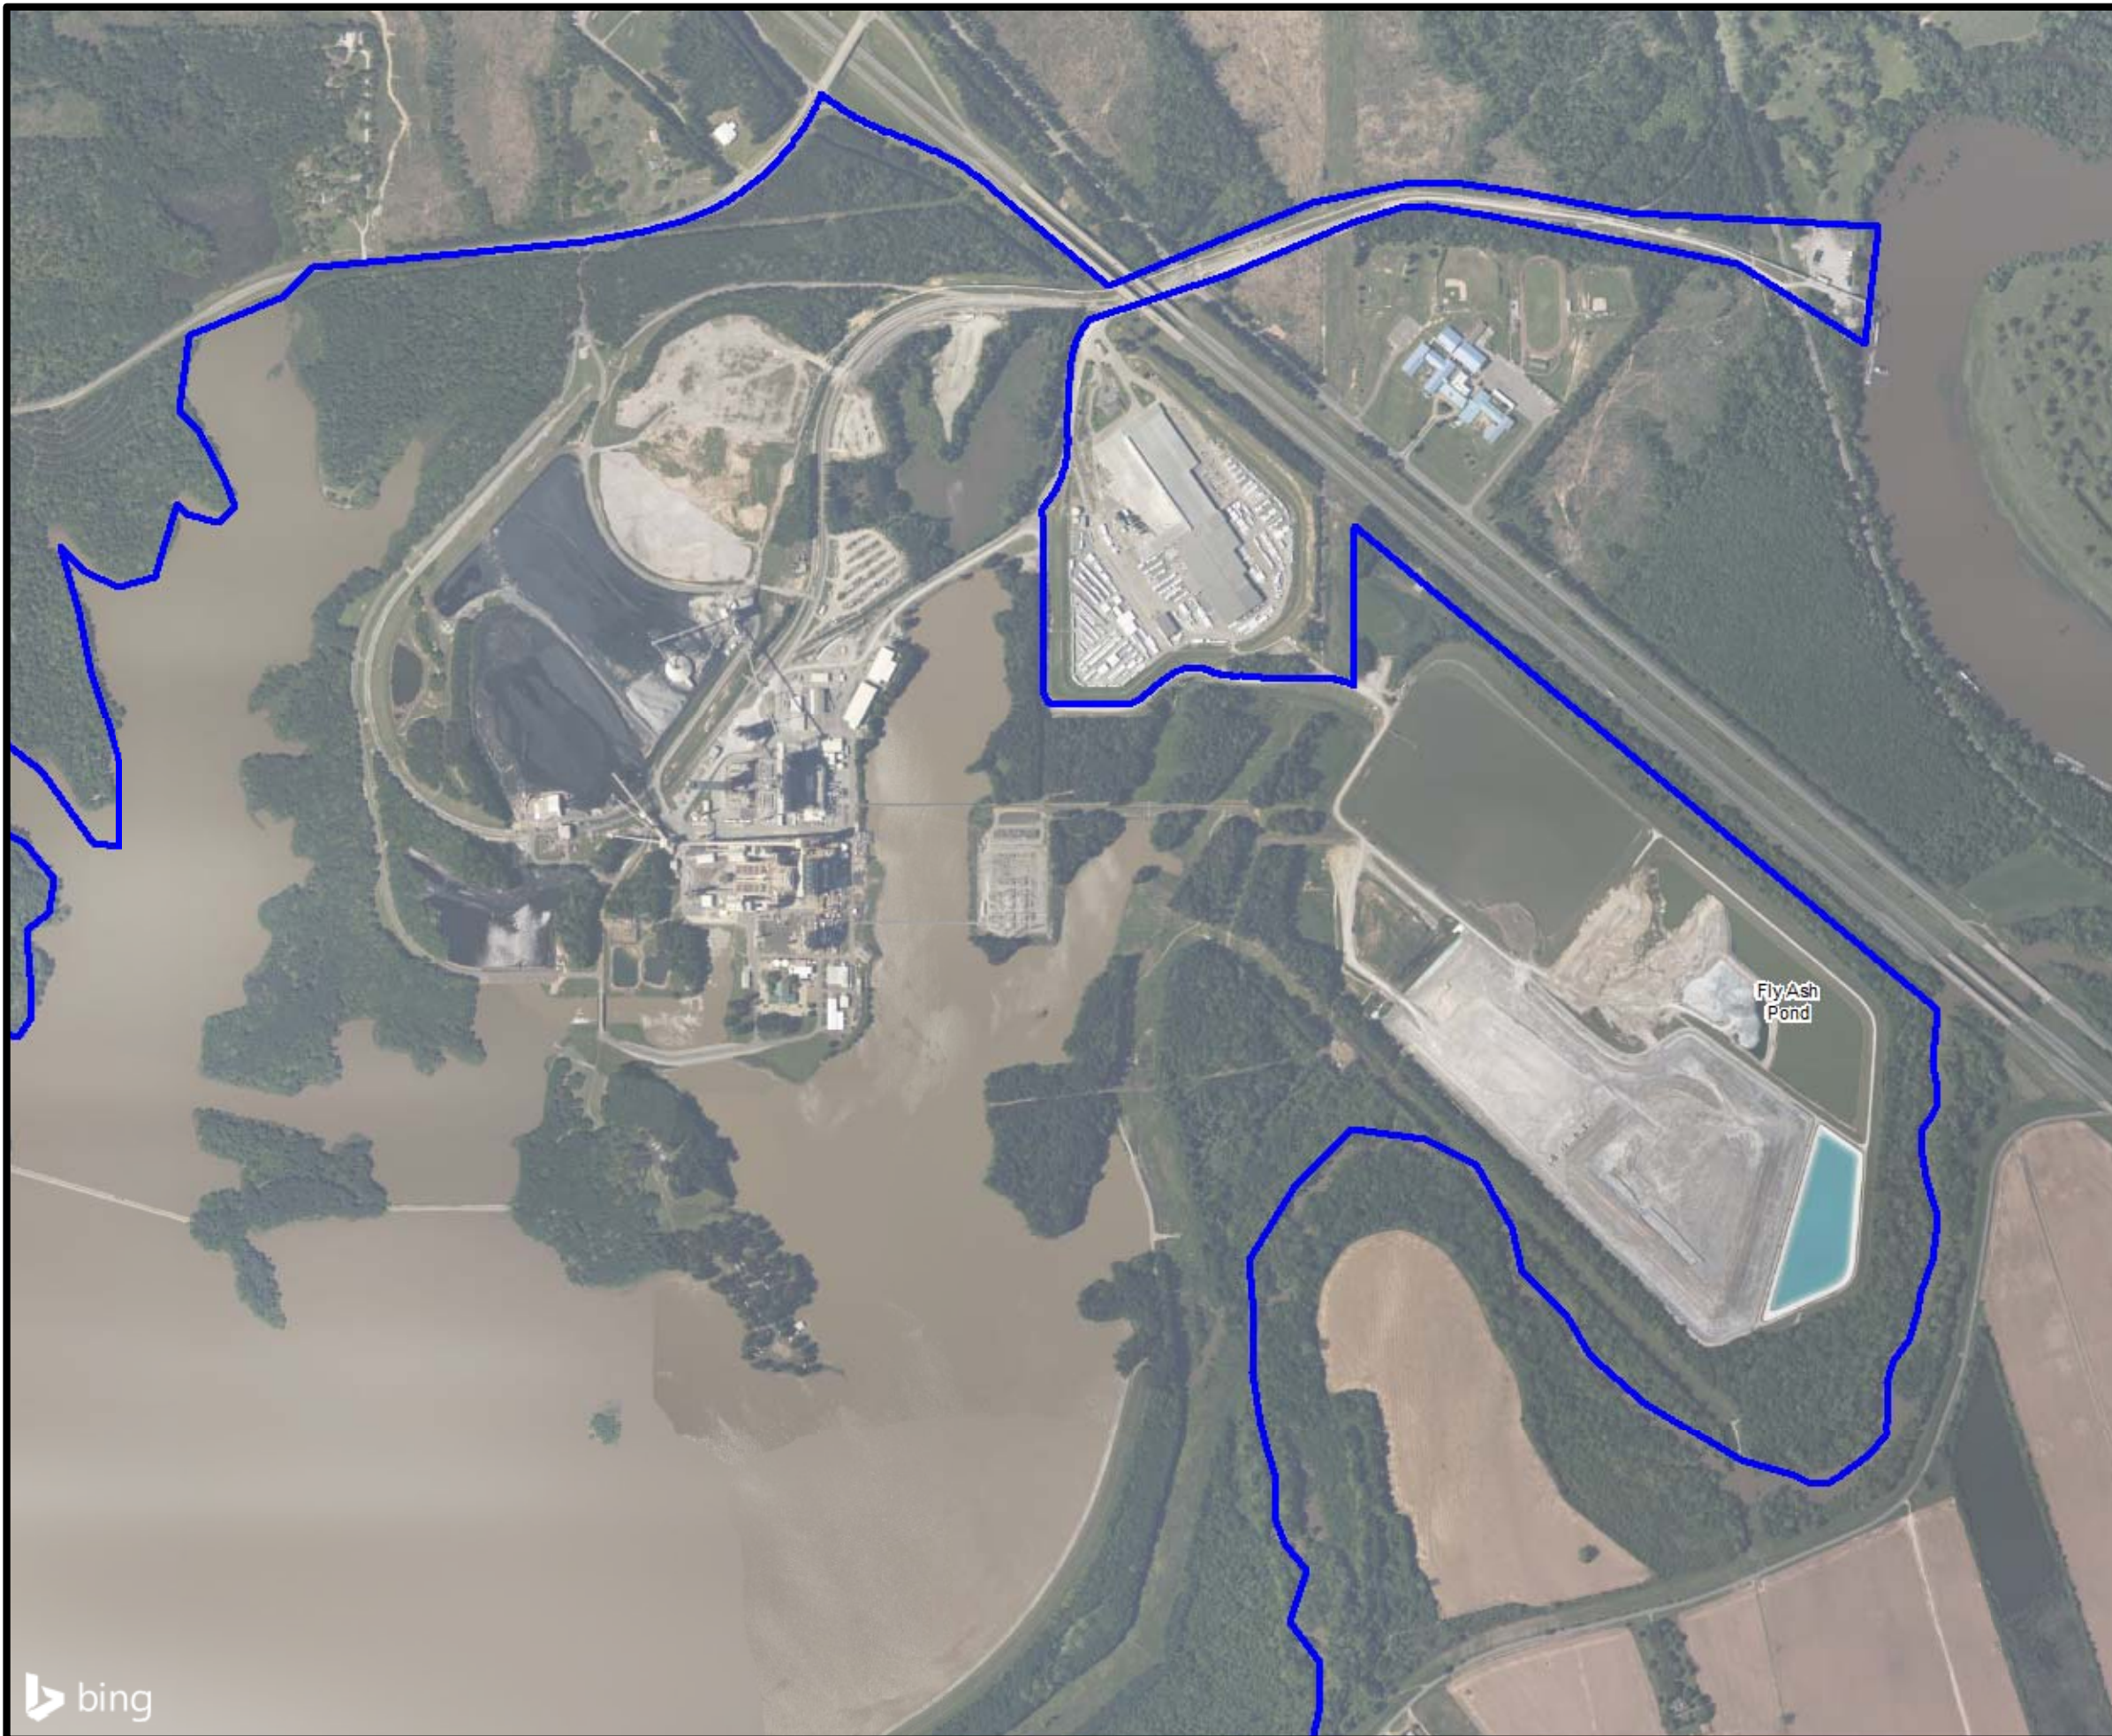
**FIGURE 2**  
**SITE MAP**

This 5-year periodic review of the structural stability assessment pertains to the Fly Ash surface impoundment (Pond) that is utilized for the Rodemacher Unit 2 coal-fired generation unit. The Brame Energy center is located approximately 6 miles southeast of Lena, Rapides Parish, Louisiana. A site location map is included as **Figure 1**. The Fly Ash Pond is shown on **Figure 2**.
