CLECO POWER LLC

BRAME ENERGY CENTER

CCR ANNUAL INSPECTION

BOTTOM ASH POND

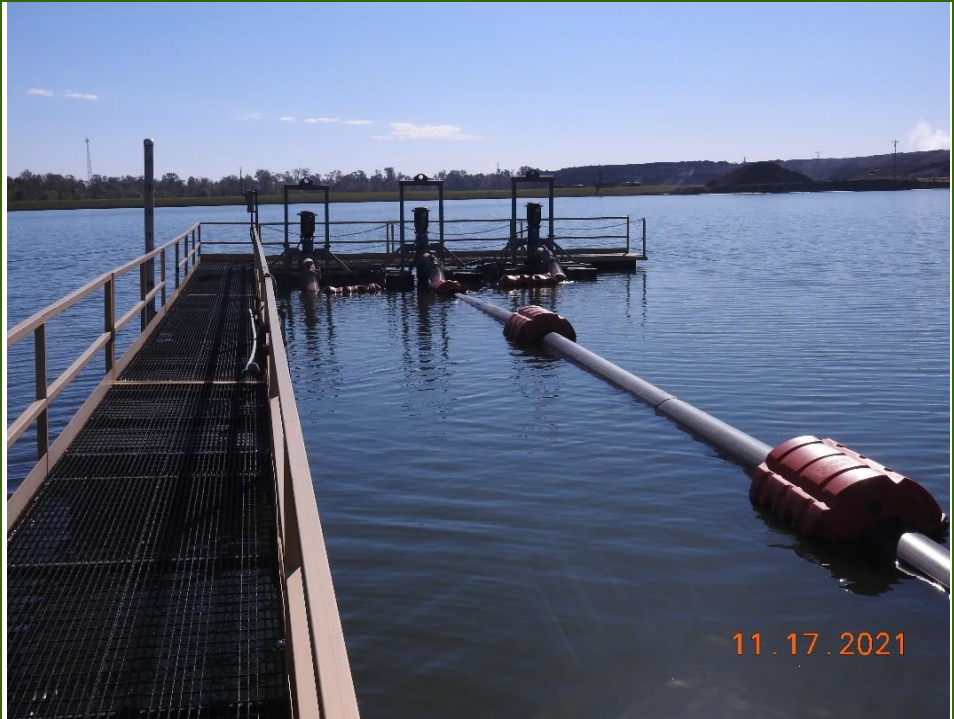
Floating pump structure in Bottom Ash Pond.

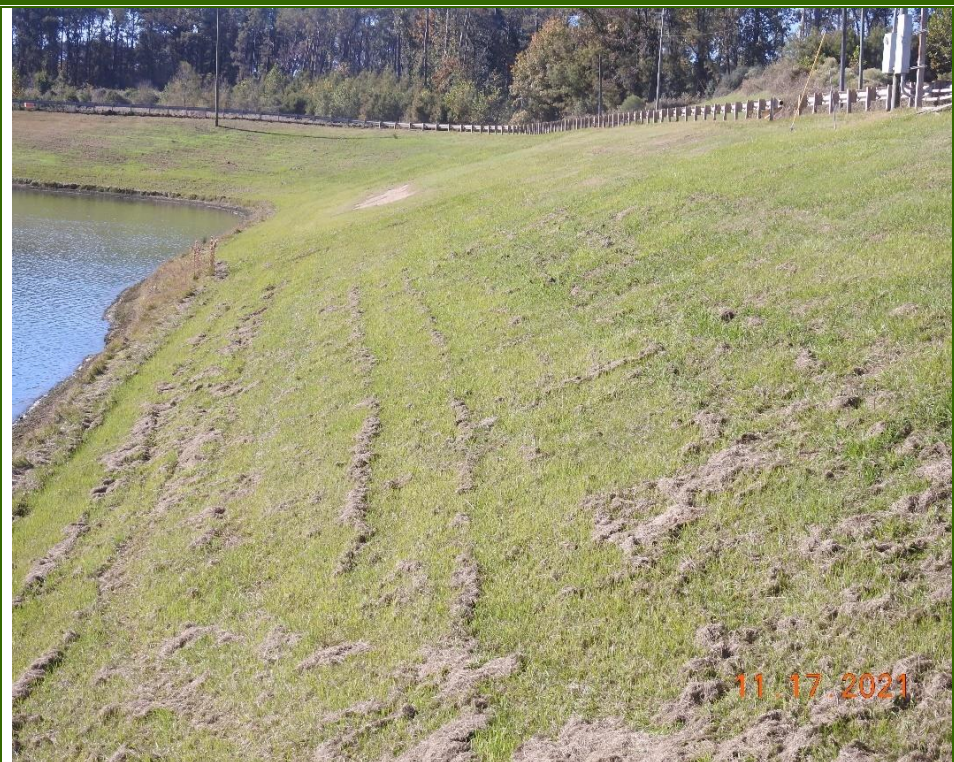
Interior slope of western levee.

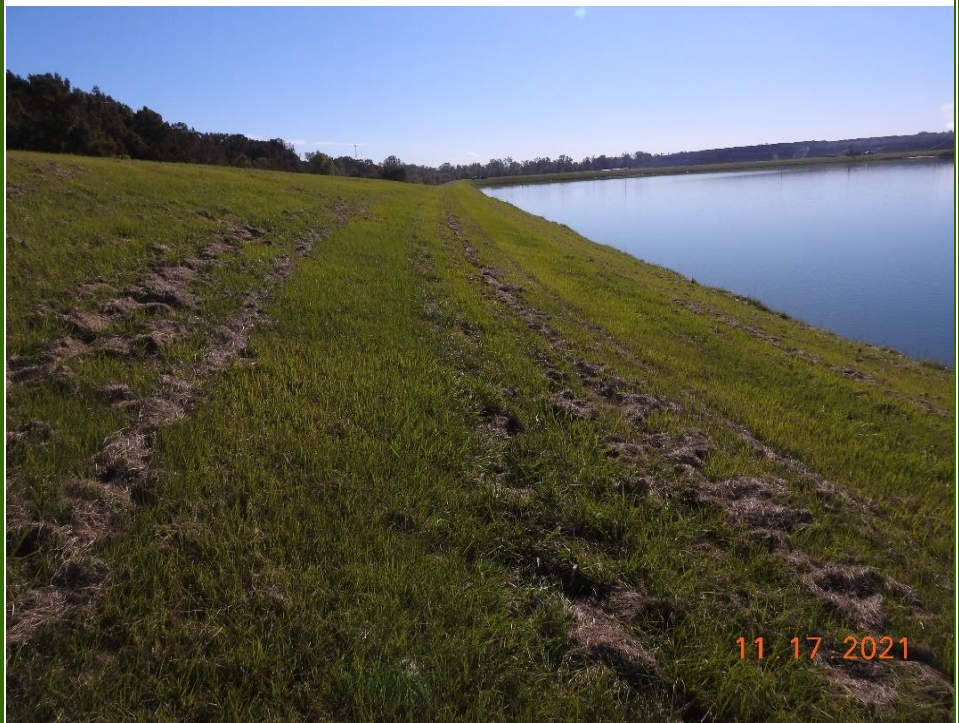
Interior slope of northern levee.

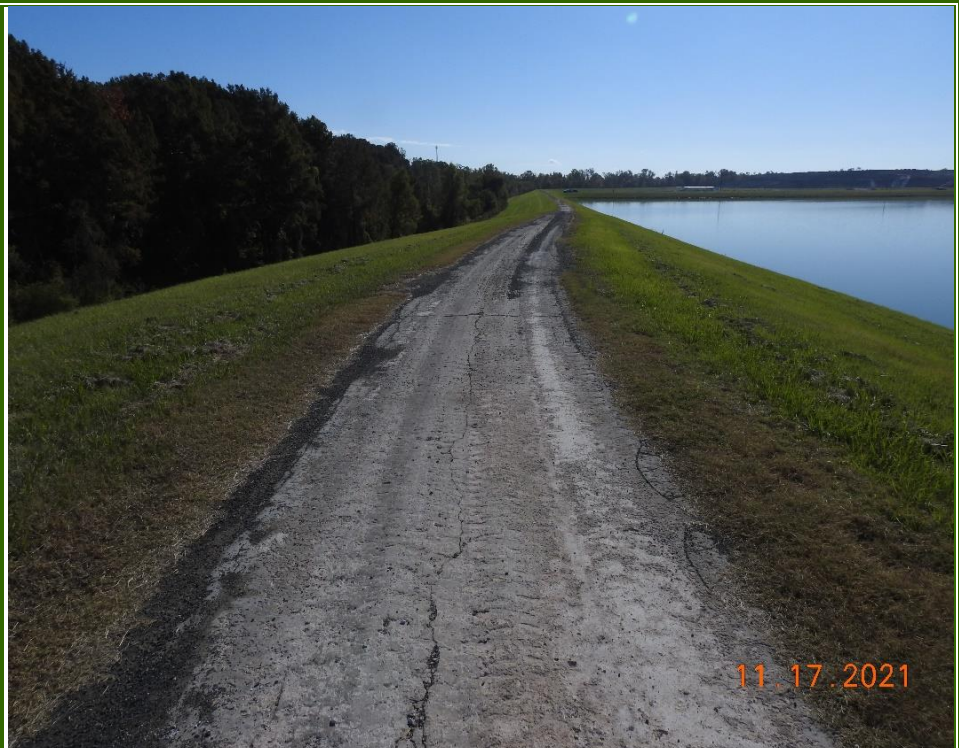
Crest of northern levee.

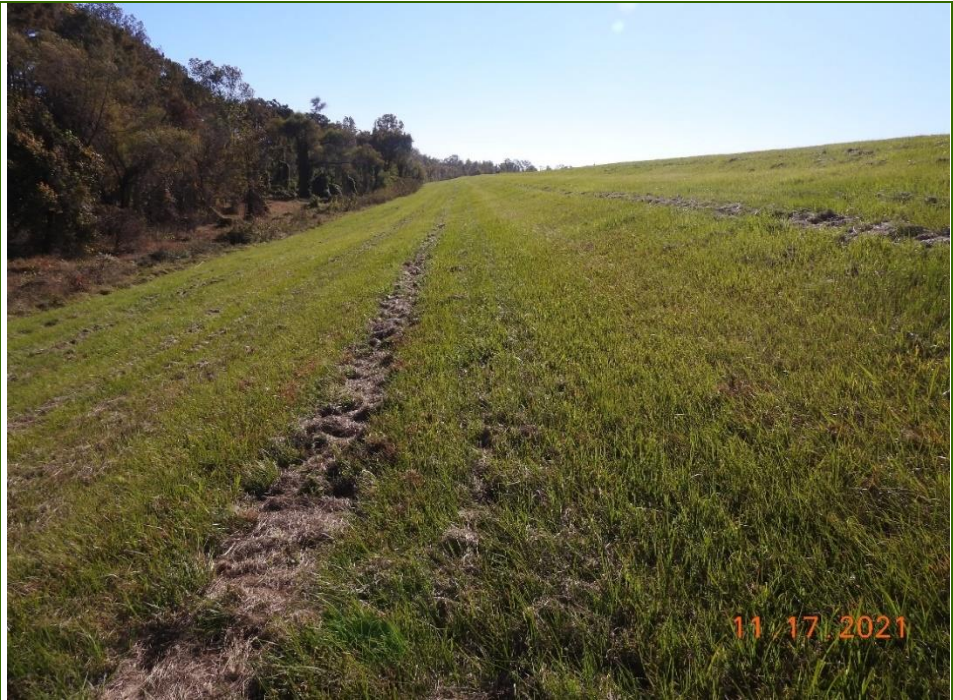
Exterior slope of northern levee.

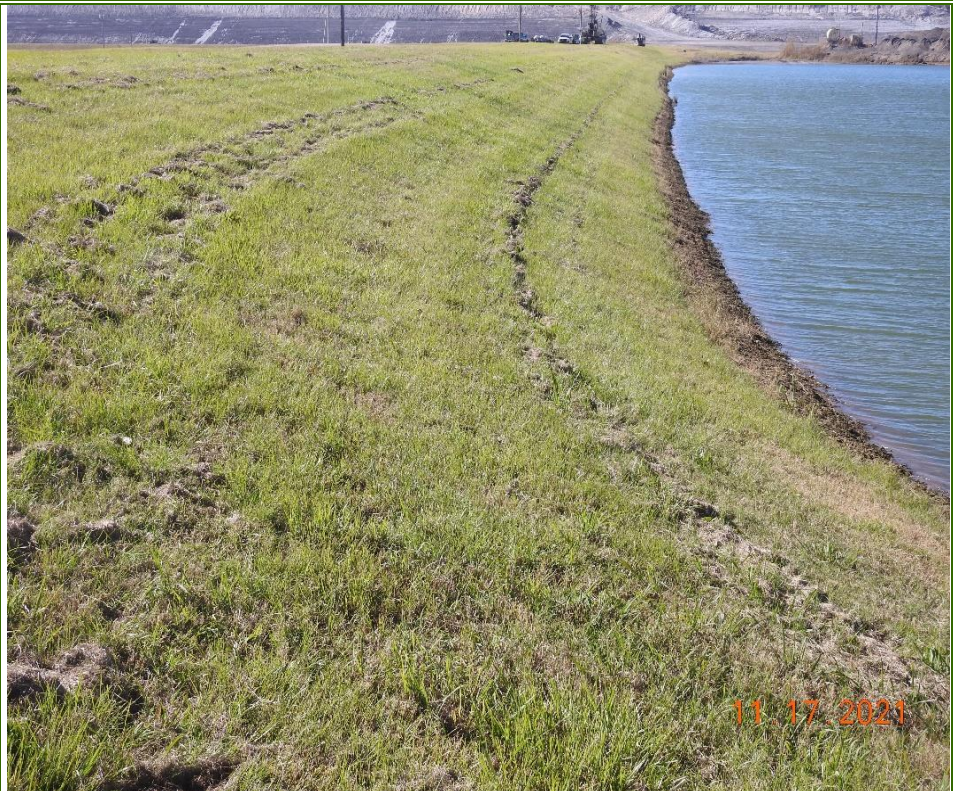
Interior slope of eastern levee.

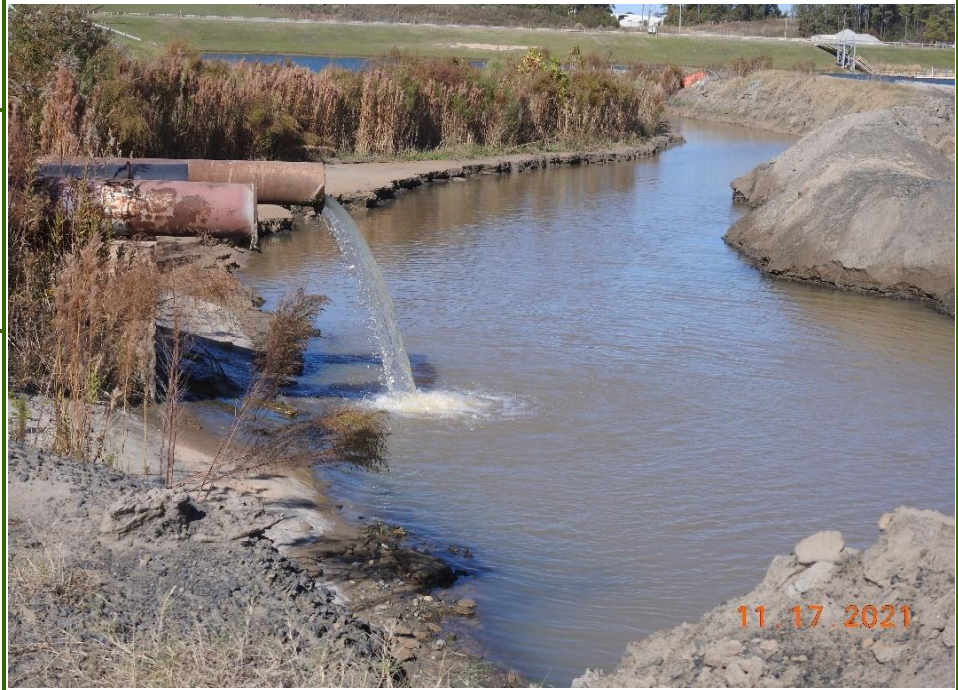
Sluice pipe discharging into the Bottom Ash Pond.

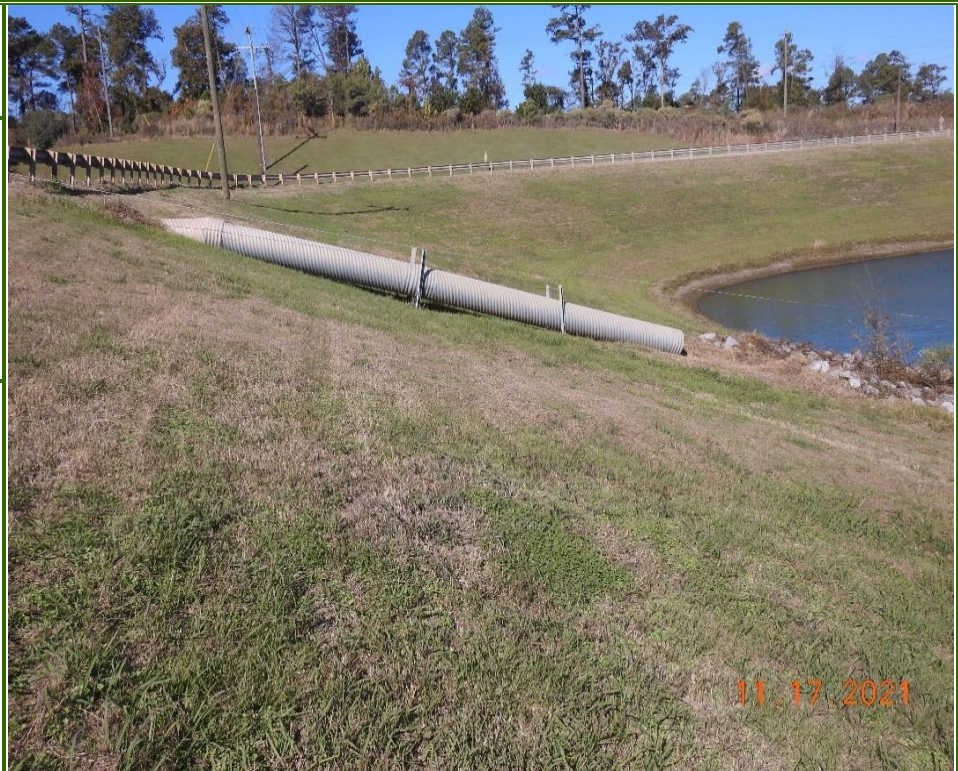
Storm water discharge pipe from sluice pipe trench.

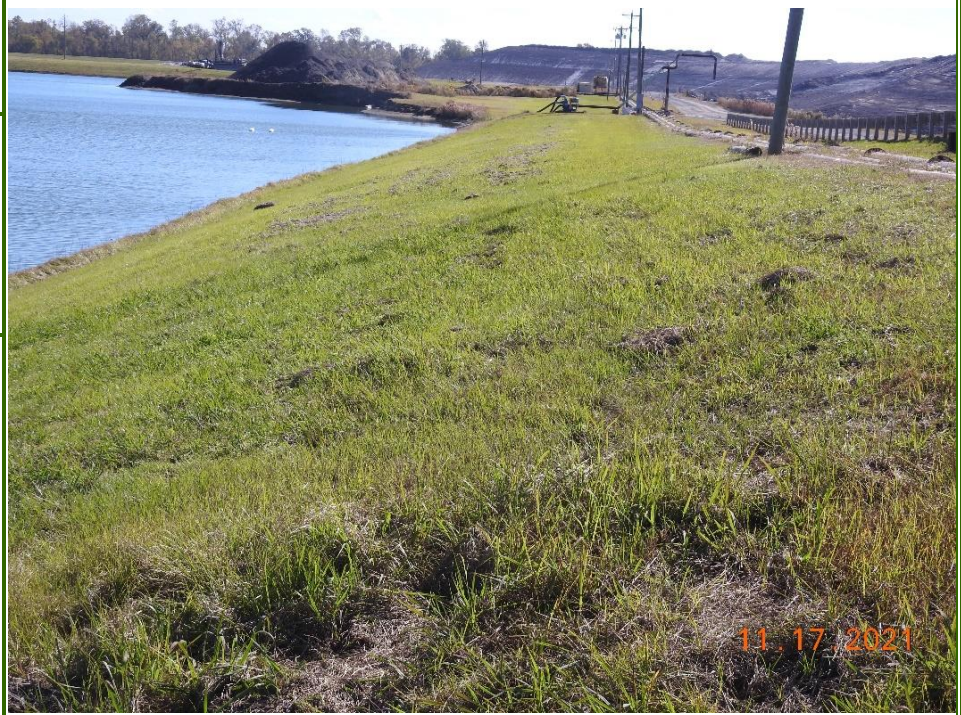
Interior slope of southern levee.

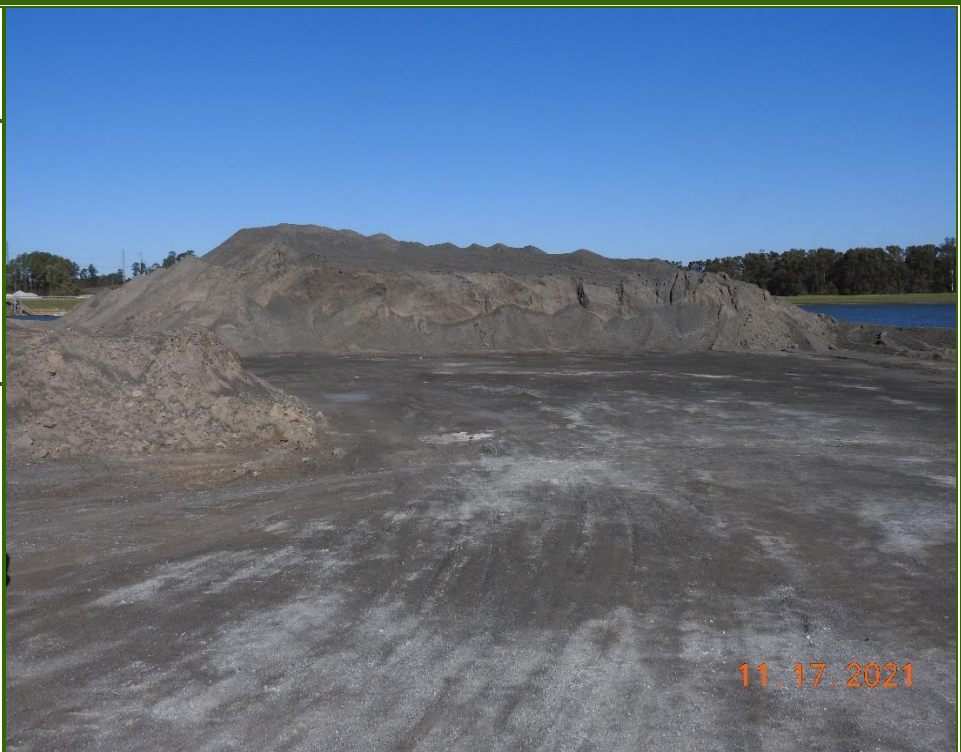
Bottom ash shown in southeast corner of Bottom Ash Pond.

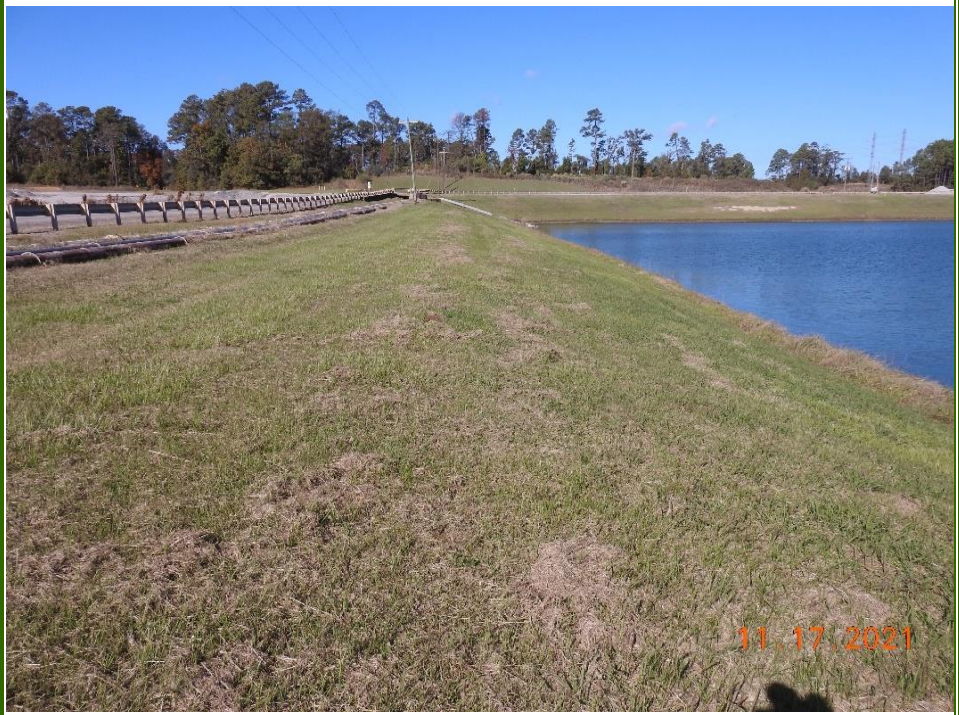
Interior slope of southern levee.

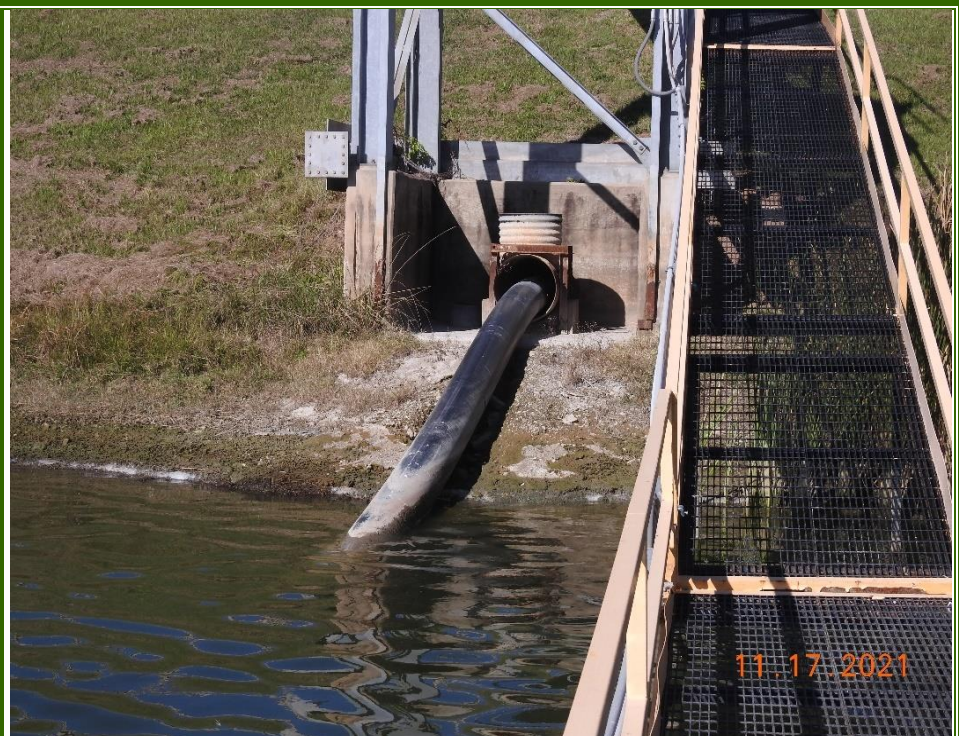
Bottom Ash discharge pipe shown on interior of the western levee.
