# **CLECO POWER LLC**

## **BRAME ENERGY CENTER**

# **CCR ANNUAL INSPECTION**

## **FLY ASH POND**

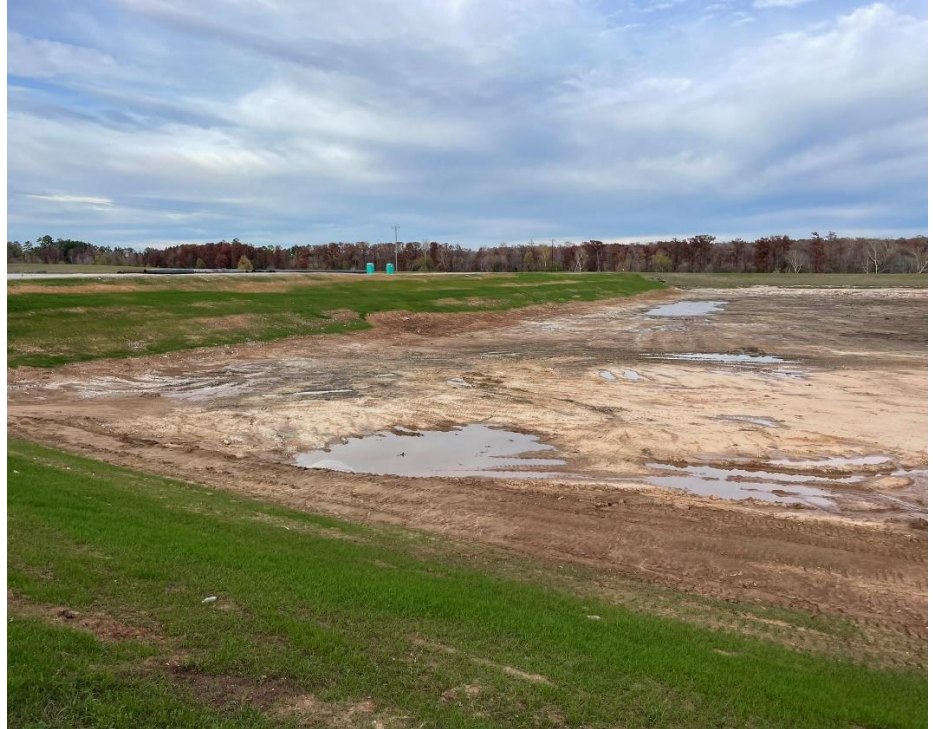
Interior slopes and bottom of Fly Ash Pond

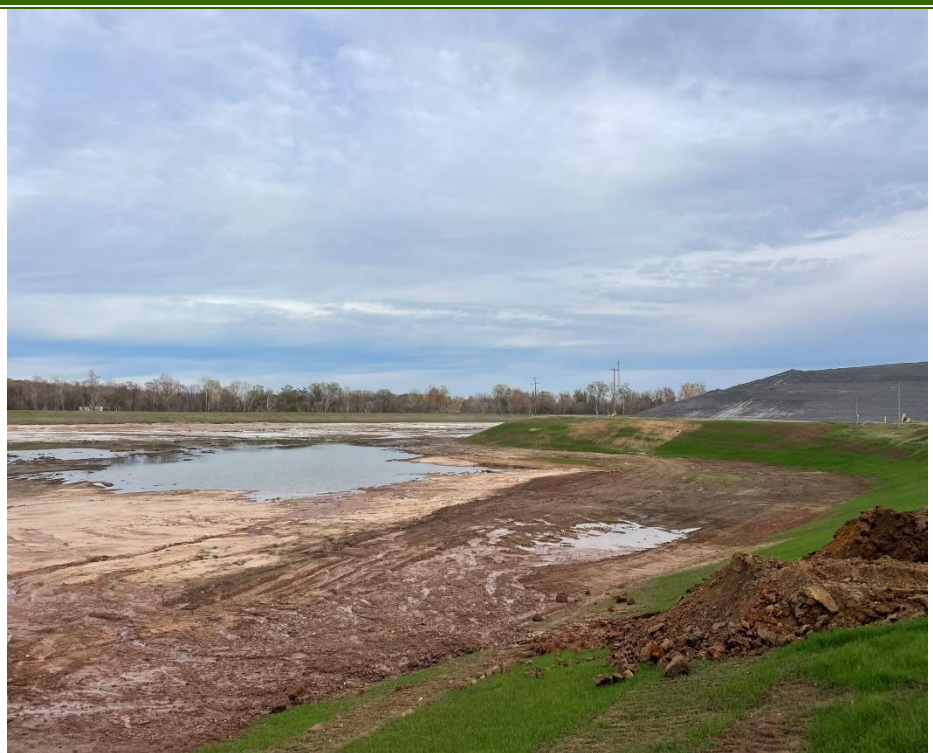
Interior slopes and bottom of Fly Ash Pond

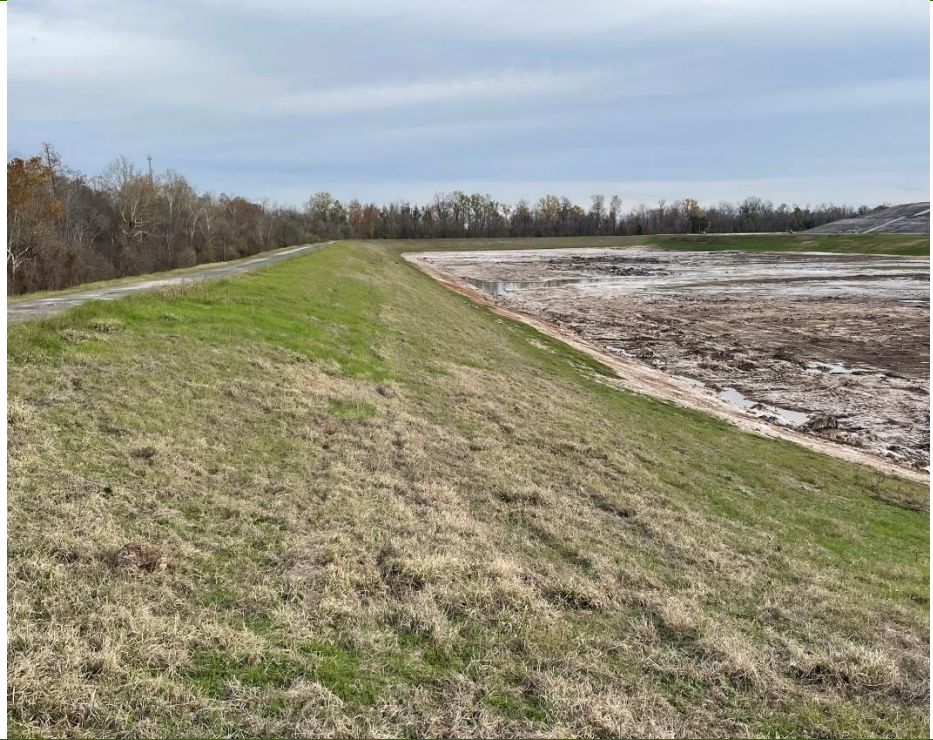
If yes, describe (size of area, location, severity, etc.)	
<b>Findings:</b>	The interior slope was inspected and appeared to be in satisfactory condition. Closure construction recently completed.
<b>Other observations on the interior slopes:</b>	None

Interior slope of eastern levee

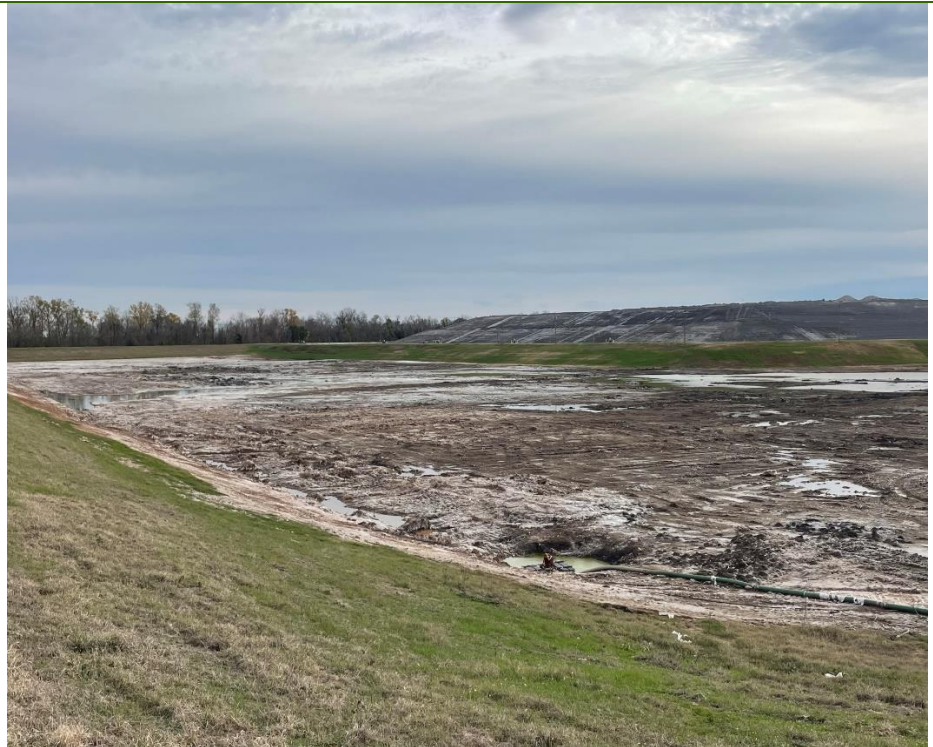
Bottom of Fly Ash Pond

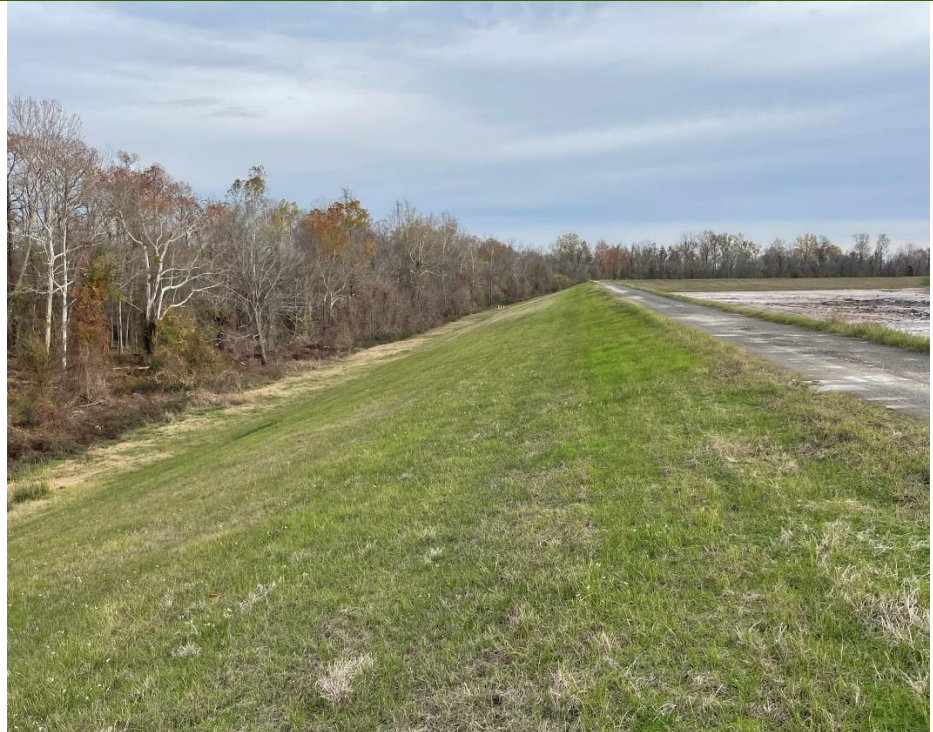
If yes, describe (size of area, location, severity, etc.)	
<b>Are there any trees on the slopes?</b>	<input type="checkbox"/> Yes <input checked="" type="checkbox"/> No
If yes, describe (type of vegetation, size, location, etc.)	
<b>Findings:</b>	The exterior slope was inspected and appeared to be in satisfactory condition.
<b>Other observations on the exterior slopes:</b>	None

Exterior levee slope on east side of Fly Ash Pond

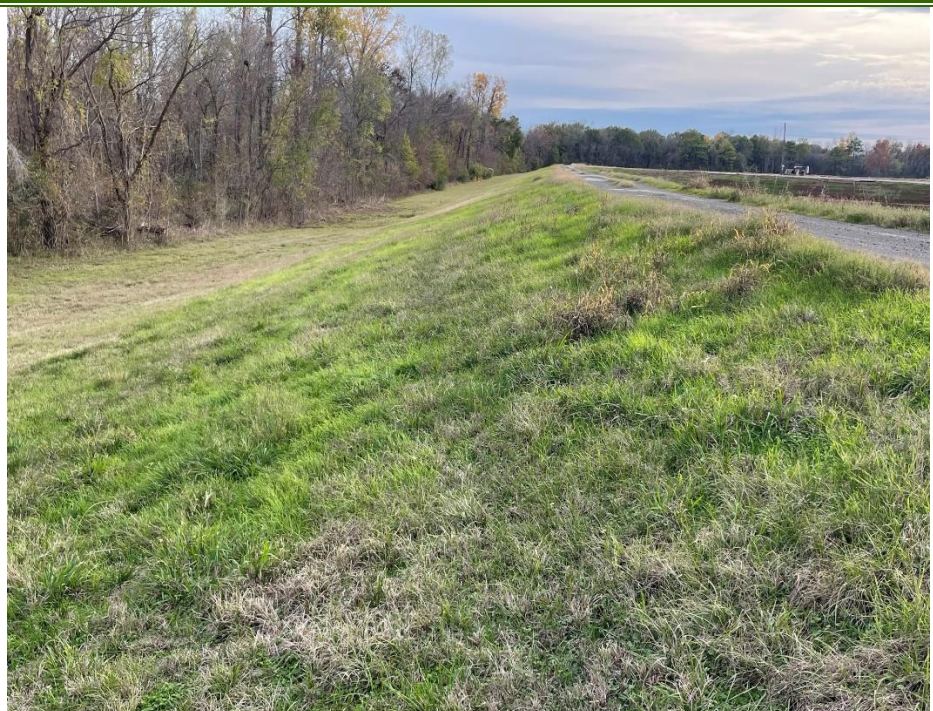
Exterior levee slope on east side of Fly Ash Pond

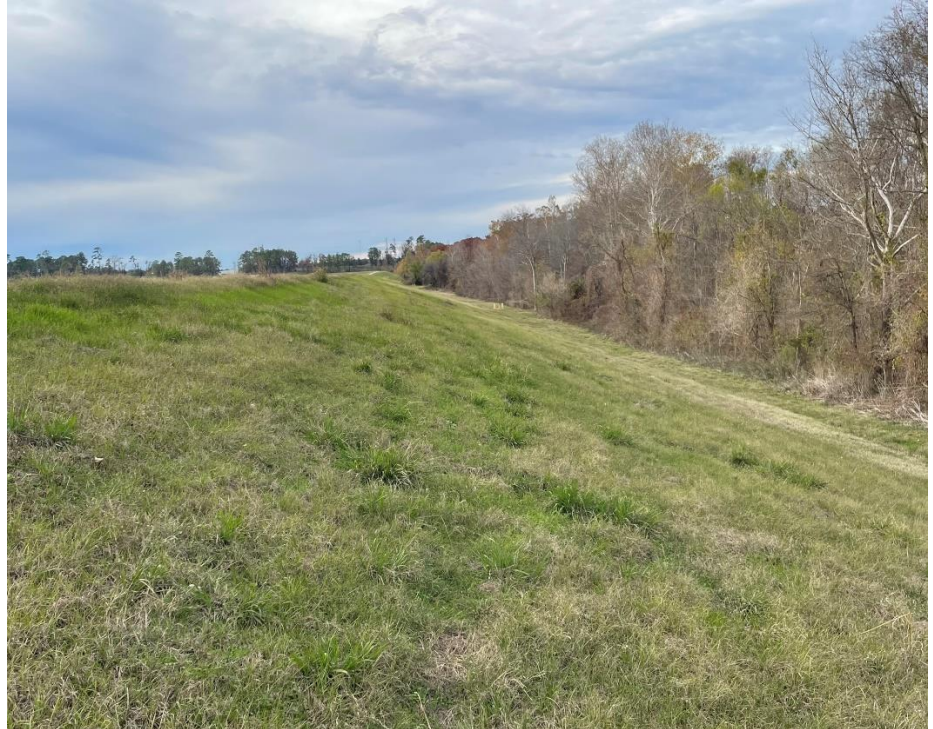
Exterior levee on east side of Fly Ash Pond

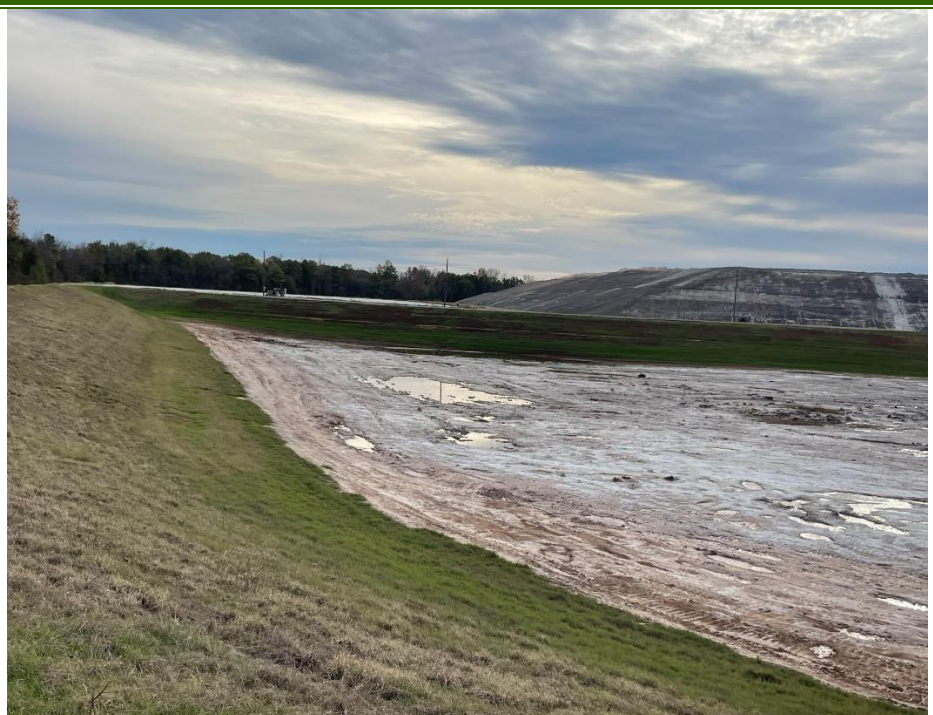
Interior slope of eastern levee of Fly Ash Pond

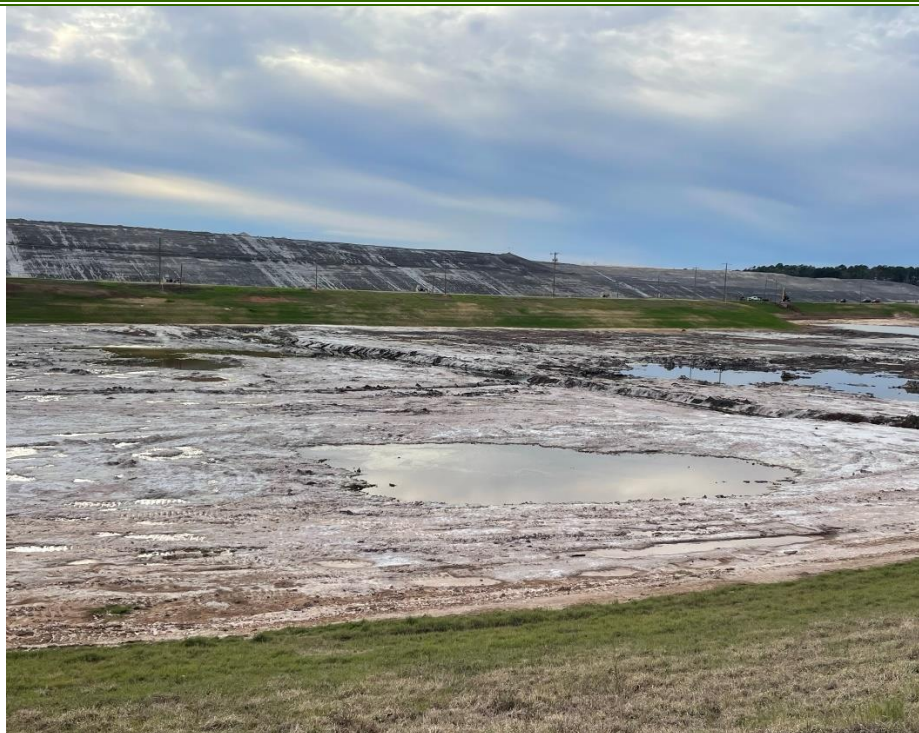
Bottom of Fly Ash Pond
