OCTOBER 2016

CLECO POWER LLC BRAME ENERGY CENTER

**STRUCTURAL
STABILITY
ASSESSMENT:**

**BOTTOM ASH
POND**

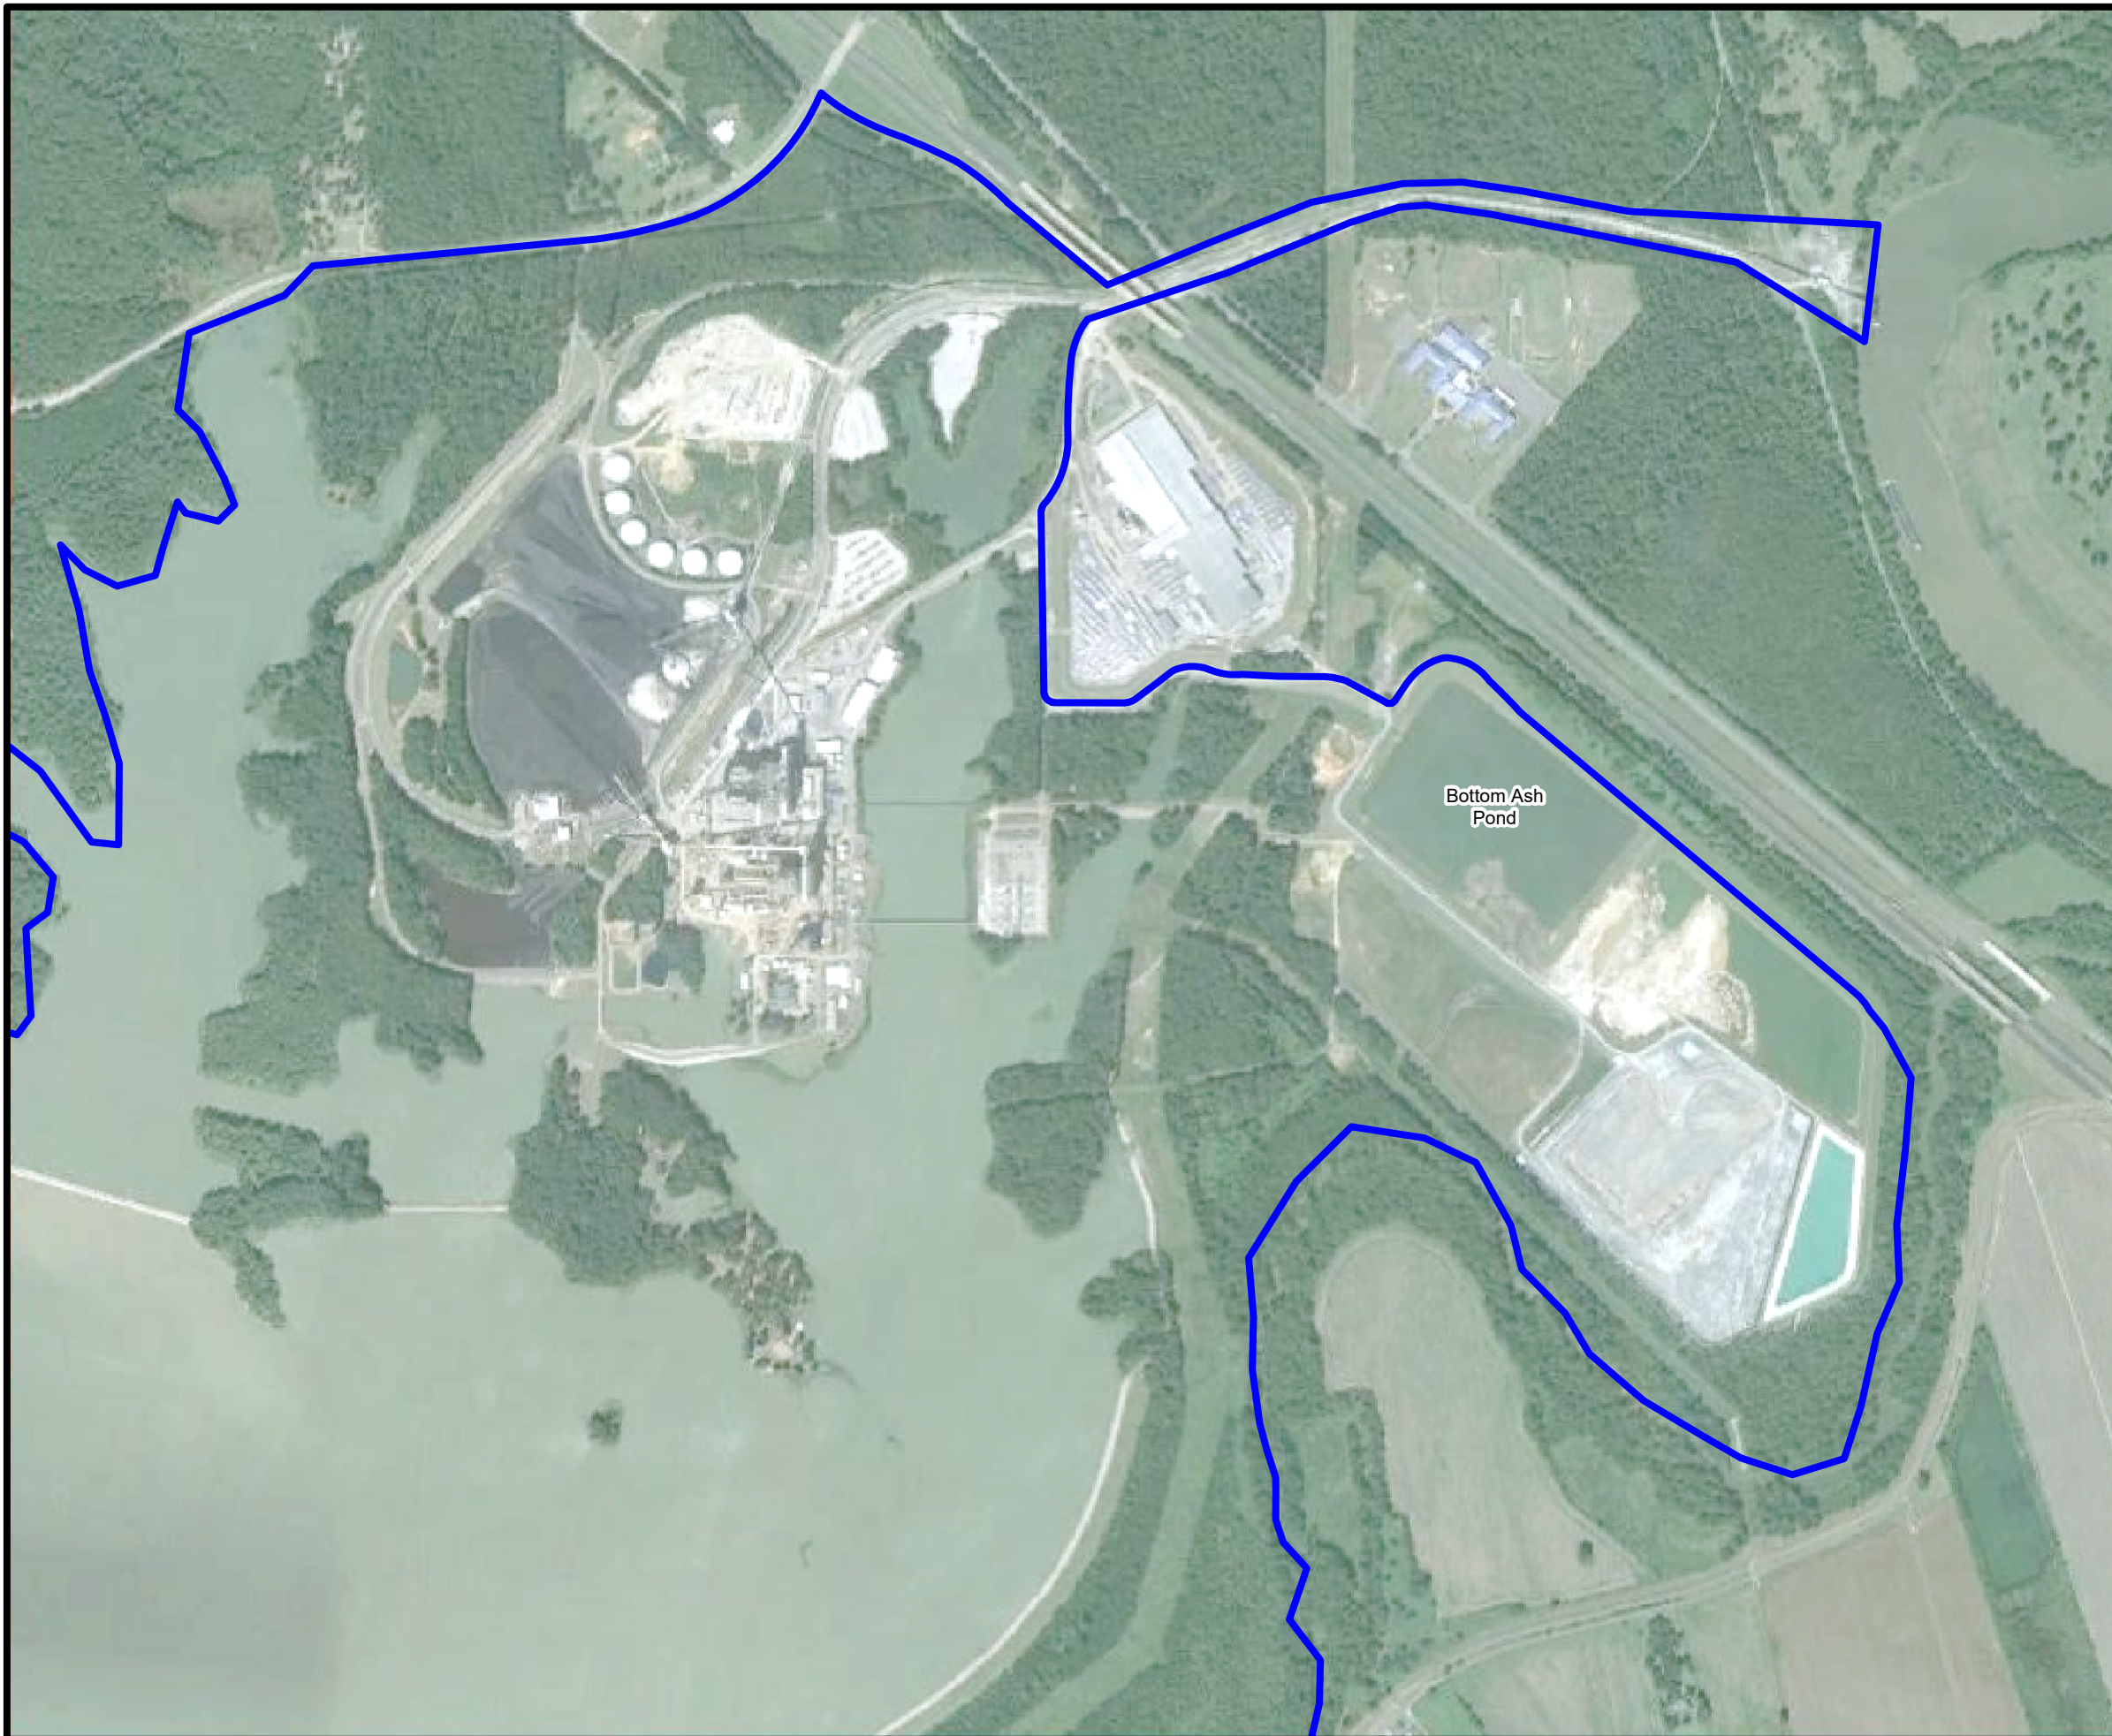
FIGURE 2
SITE MAP

The Cleco Brame Energy Center is located near Lena in Rapides Parish, Louisiana. A site location map showing the Brame Energy Center is included as **Figure 1**. This structural stability assessment pertains to the Bottom Ash surface impoundment (Pond) utilized for the Unit 2 coal-fired generation unit. A site map for the Bottom Ash Pond is included as **Figure 2**. Providence reviewed the construction drawings and operational plan, and reviewed the inspection and maintenance procedures for the Bottom Ash Pond.
