CLECO POWER LLC BRAME ENERGY CENTER

FAULT AREAS ASSESSMENT

FLY ASH POND

Project Number 002-213

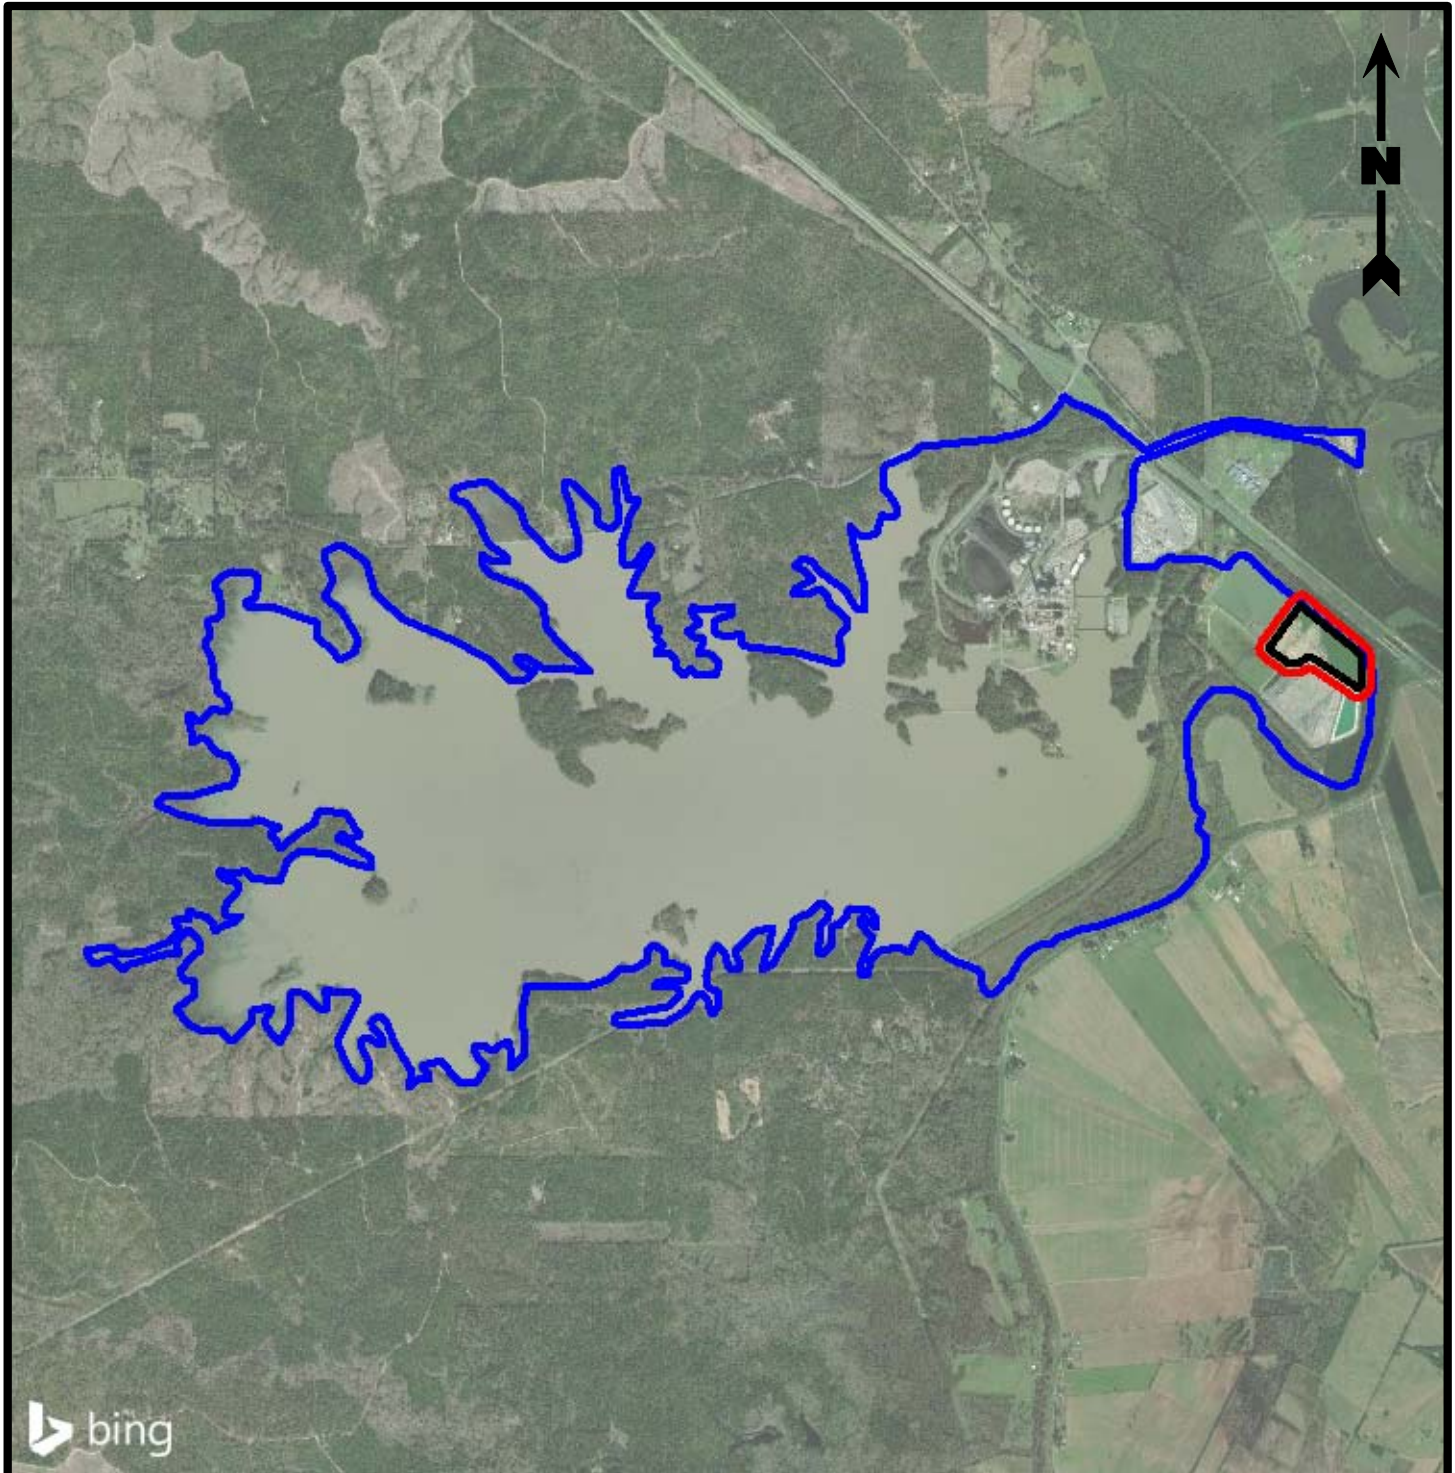
FIGURE 3
FAULT LOCATION MAP

The fault locator map created on the USGS website, Mineral Resources, Online Spatial Data, By State (<https://mrdata.usgs.gov/geology/state/state.php?state=LA>) indicates no faults located within 60 meters (200 feet). This 200-foot buffer is shown in **Figure 3**.

There are no faults located within a 200' buffer of the Fly Ash Pond.
