# CCR SURFACE IMPOUNDMENT ANNUAL INSPECTION REPORT

## Big Cajun II Power Plant

## New Roads, Pointe Coupee Parish, Louisiana

January 2019

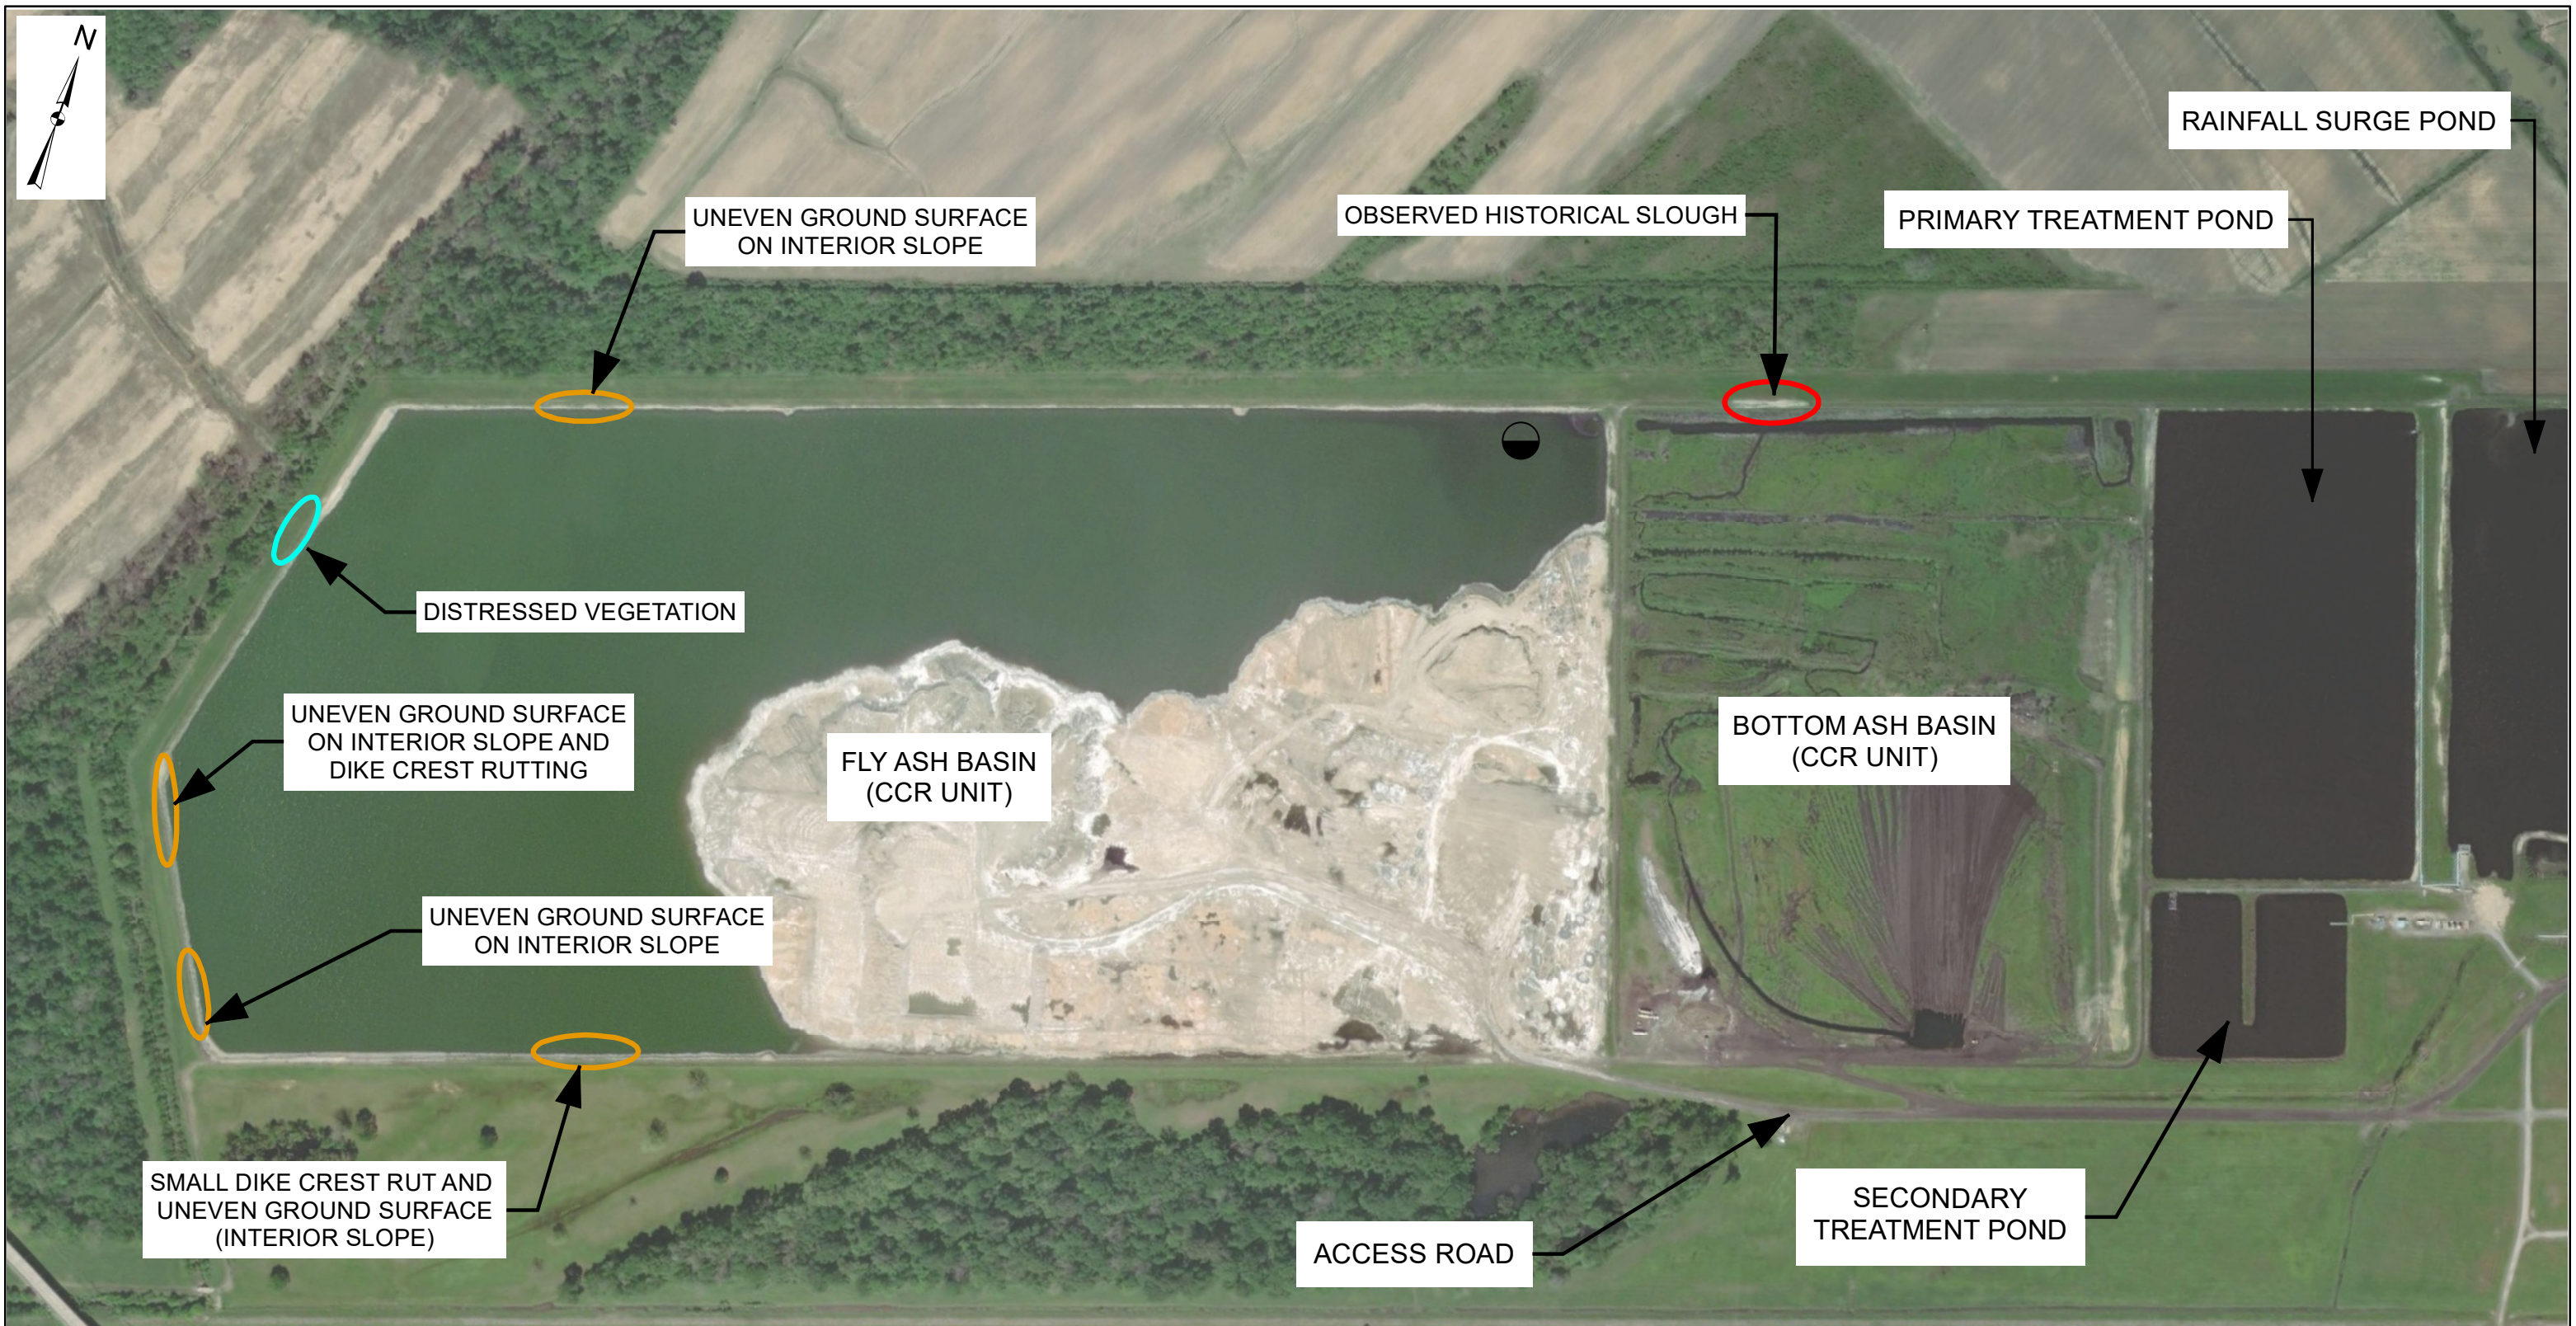
Figure 2: 10/11/2018 Inspection Map

Mr. James D. McNash, P.E., of Geosyntec visited the Facility on 11 October 2018 to visually inspect the Fly Ash Basin and Bottom Ash Basin and to interview the Facility's environmental coordinator. During this inspection, Geosyntec traversed the entire length of the Fly Ash Basin and Bottom Ash Basin perimeter dikes and the divider dike between the two units. Geosyntec visually inspected and recorded observations with regards to the condition of the dike crest, upstream and downstream slopes, dike toe, and the discharge/stormwater conveyance structures to identify conditions or features that may potentially indicate distress or instability. A site map which depicts notable observations is presented on Figure 2

- A location of localized slope instability (a localized slough) was observed on the north-facing exterior dike slope of the Bottom Ash Basin, about 400 feet east from the northwestern corner. The observed area is approximately 70 to 90-ft long and exhibits a roughly 12-inch escarpment at the crest that is slightly eroded. The affected area was previously identified during past annual inspections (CB&I, 2017; Geosyntec, 2018) and was repaired prior to 2015 after an inspection. The instability does not appear to have displaced further and weekly inspection records indicate that the slough is monitored routinely. The toe area was slightly bulged, but signs of seepage (i.e., softer soils) were not observed when traversed. At the time of the inspection, CCR material or significant volume of standing water were not impounded on the interior perimeter dike slope adjacent to this area. As such, the affected area appears to be a localized observation for which a repair is

recommended, but not considered an issue that impairs the operation or safety of the CCR unit. As the location coincides with previously-noted slope failures and repairs, slough condition and potential seepage when the CCR basin accumulates significant water volume should be carefully observed for changes and scheduled for repair.

- Uneven ground surface and/or equipment rutting was observed on the perimeter dike crest near the Fly Ash Basin's southwest corner. The area exhibited relatively significant equipment rutting which appears to be the predominant contributor to the uneven ground condition. During Geosyntec's inspection, evidence of movement or instability, as previously defined, was not observed. However, this area is identified as a relevant observation due to the uneven ground surface, which may indicate a deeper slope movement or contribute to increase erosion due to ponding of water. Further observation to identify changes or other signs of movement/weakness and/or regrading activities to smooth the dike crest for future inspections is recommended.

- Occasional animal burrows less than two inches in diameter were observed on the southern and western-facing exterior dike slopes. One larger animal burrow greater than three inches in diameter was observed on the south face of the Fly Ash Basin. However, some limited bare areas were observed on the exterior dike slopes with desiccation cracks. Extensive desiccation cracks or signs of seepage were not observed in these areas.

1. **Corrective Measure – Repair.** The area of localized slope instability (area of sloughing) on the northern-facing exterior slope of the perimeter dike (near the northwest corner of the Bottom Ash Basin) should be repaired to rehabilitate a potential structural weakness to the impoundment.

3. **Ongoing Maintenance and Repairs as Needed.** Perform maintenance/repairs to the dikes and other appurtenant impoundment features on a routine and ongoing programmatic basis as well as on an as needed basis if warranted by any problems or concerns (e.g., as identified during periodic inspections by a qualified person, or as otherwise identified). Bare areas should be re-seeded to establish vegetation and the existing vegetation maintained in a condition to facilitate inspections. Observed ruts and erosion rills should be repaired before the feature worsens.
