# 2020 CCR SURFACE IMPOUNDMENT ANNUAL INSPECTION REPORT

## Big Cajun II Power Plant Pointe Coupee Parish, Louisiana

**Cleco Cajun, LLC**  
10431 Cajun II Road, Highway 981  
New Roads, Louisiana 70760

January 2021

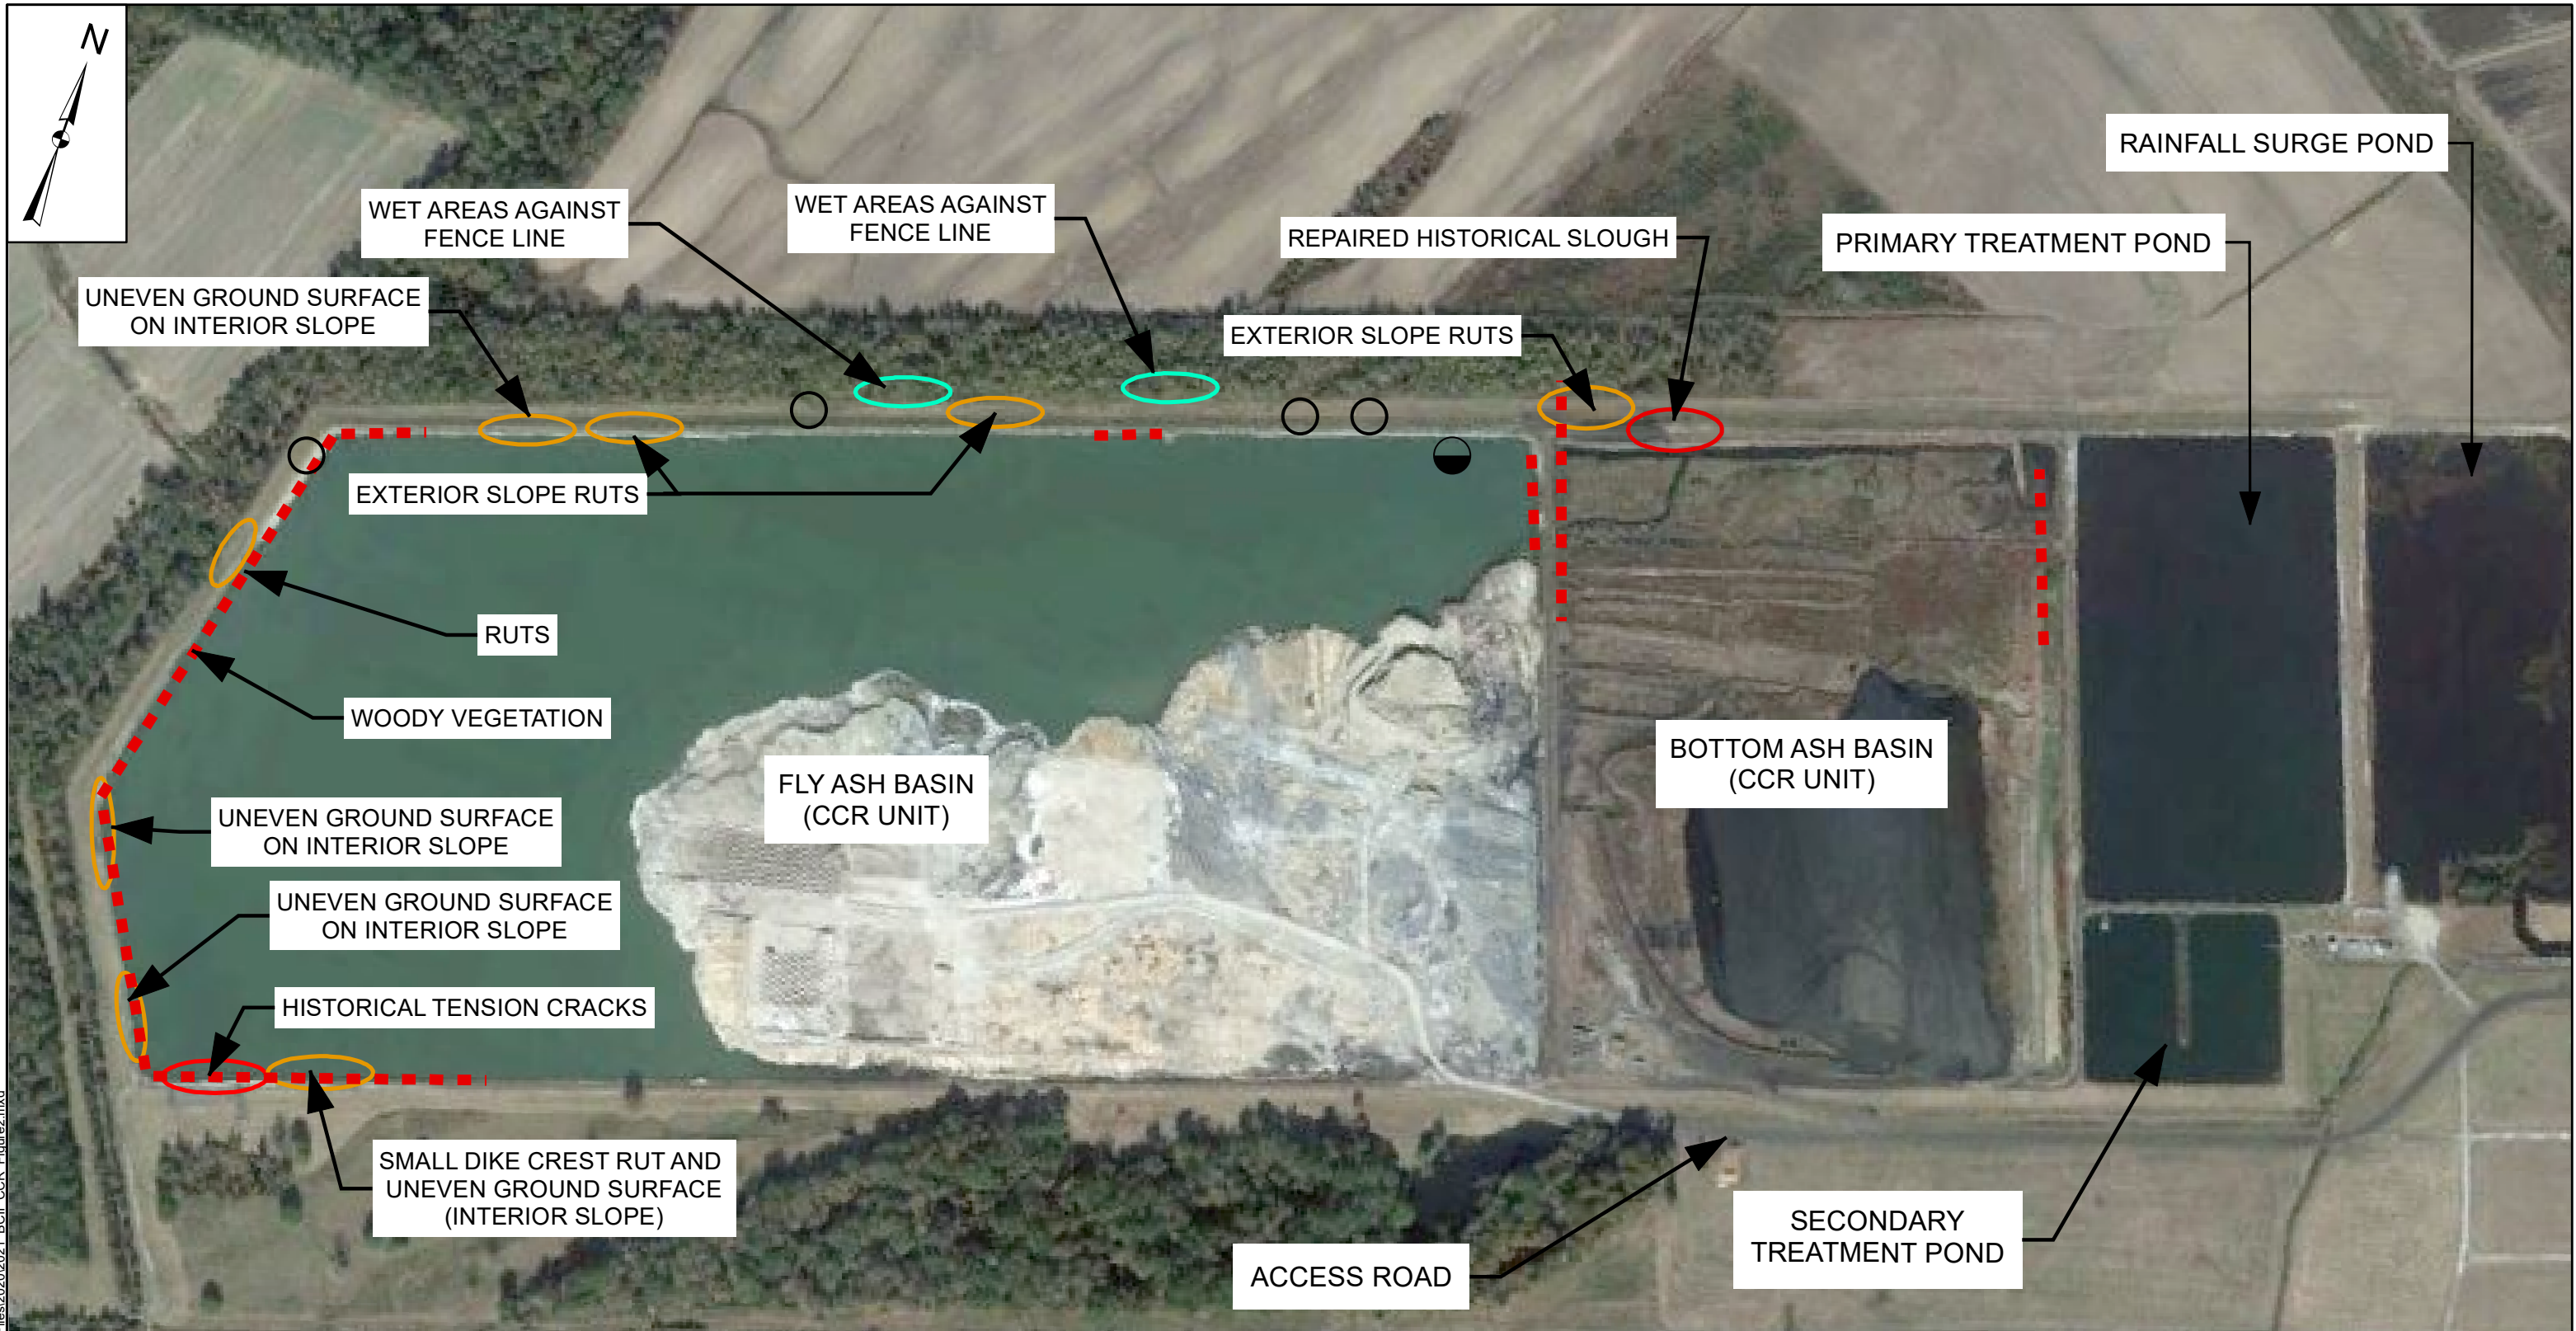
- A historical location of localized slope instability (a localized slough) on the north-facing exterior dike slope of the Bottom Ash Basin, about 400 feet east from the northwestern corner was identified during past annual inspections (CB&I, 2017; Geosyntec, 2018; Geosyntec, 2019; Geosyntec, 2020). The dimensions of the historical instability were approximately 70-ft to 90-ft long and exhibited a roughly 12-inch escarpment at the crest, that was slightly eroded with some vegetation growth. In January 2020, the Facility notified Geosyntec that a repair of this area was completed in December 2019. The repaired area does not appear to be displaced at the time of the inspection. Weekly inspection records indicate that the historical slough is monitored routinely, with no further evidence of displacement. At the time of the inspection, CCR material or a significant volume of standing water was not observed to be impounded on the interior perimeter dike slope adjacent to this area. As such, the former historical instability area appears to be a localized observation, that appears to have been adequately repaired prior to the 2020 annual inspection; and therefore, the area is not considered an issue that impairs the operation or safety of the CCR unit at this time.

- Overall, vegetation was observed to be in good condition, with no observed areas of significant distress and no signs of erosion of the exterior dike slopes or seeps exiting the slope. Adjacent to and west of the historical slough, rutting was observed in the downstream dike slope, which appeared to be associated with tractor style mowing equipment used to maintain vegetation on the slope.

- Standing water was observed and was located predominantly along drainage swales on the northern and eastern sides, where CCR placement within the Bottom Ash Basin is set-back from the perimeter dikes. During the inspection, process water was channelized towards the southeast corner of the impoundment. Temporary diesel driven pumps were present around the Bottom Ash Basin, but were not operational during the inspection. Process water was pumped into the south end of the basin. The hydraulic structure conditions are discussed subsequently within this Report.

- Woody vegetation was observed on the interior of the berm on the northwest and northeast sides of the Bottom Ash Basin. Woody vegetation has the potential to lead to pathways of infiltration through the berm, reducing the berm's structural integrity. However, at the time of the 2020 annual inspection, evidence of pond water infiltration through the berm was not observed. Therefore, woody vegetation is recommended to be removed from the interior of the berm as practicable and the localized area recompacted after vegetation has been removed.

- Wet areas were indicated in the *2018 Annual Inspection Report* (inspected in October 2017) [Geosyntec, 2018]. The wet areas were identified on the Fly Ash Basin perimeter south dike toe about 1,300 feet and 2,000 feet west from the southeastern corner and were not observed to contain standing water. The natural topography indicates that these are low-lying areas where water tends to naturally accumulate, and seepage of the perimeter dike structure or signs of distress or malfunction were not identified.

- Limited areas of ponded water were observed on the north side of the Fly Ash Basin against an existing fence line. Topography north and outside of the fence line is slightly higher and prevents surface water runoff. The adjacent downstream dike slope was observed to be dry; as such, the retained water does not appear to be the result of seepage through the containment structures.

- Surficial material on the interior slopes in several areas of the southwestern, western and northwestern dikes appear to be uneven that result in localized steeper slopes near the crest. In some cases, rills extend near to the interior dike crest edge.

- An area of uneven ground surface or a tension crack along the exterior about 250 feet east of the southwestern corner was observed in prior annual inspections. The southwest corner of the Fly Ash Basin was also previously identified as having potential sloughs/slope

instability and was subsequently repaired. During this inspection, evidence of movement or instability (e.g., seepage, wet areas, and additional slumping) was not observed. The area merits continued annual inspection and observation weekly for geometric changes or other signs of movement/instability.

- Uneven ground surface and/or equipment rutting was observed on the downstream perimeter dike crest near the Fly Ash Basin's southwest corner. The area exhibited relatively significant equipment rutting which appears to be the predominant contributor to the uneven ground condition. During Geosyntec's inspection, evidence of movement or instability, as previously defined, was not observed. Further observation to identify changes or other signs of movement/instability and/or regrading activities to smooth the slope for future inspections is recommended.

- In the northwest corner, a few minor ruts within the dike crest were observed. The perimeter road along the perimeter dike crest was generally observed to be in good condition with no observed signs of problematic desiccation or tension cracking and/or other deformations. Continued routine maintenance is recommended to permit access and facilitate routine inspection of the CCR unit.

- Occasional animal burrows between four to eight inches in diameter were observed on the southern, western, and northern-facing exterior dike slopes. Limited bare areas were observed on the exterior dike slopes with desiccation cracks. Extensive desiccation cracks or signs of seepage were not observed in these areas.

- Woody vegetation was observed on the interior of the berm on the western facing side and at the northeast corner of the Fly Ash Basin. Woody vegetation may lead to pathways of pond water infiltration through the berm, reducing the berm's structural integrity. However, at the time of the 2020 annual inspection, evidence of pond water infiltration through the berm was not observed. Therefore, woody vegetation is recommended to be removed from the interior of the berm as practicable and the localized area recompacted after vegetation has been removed.

1. **Corrective Measure Repairs.** No corrective measure repairs are recommended at this time.
2. **Heightened Awareness During Routine Inspections.** This Report identifies a few areas that warrant close observation on a routine basis (i.e., weekly inspections) for signs of changes or progressive worsening of conditions. These areas were locations where wet/soft or uneven ground was observed. While there was no evidence of slope instability or movement, such conditions may be precursors. The southwest corner of the Fly Ash Basin was repaired in January 2020 during routine maintenance activities. A continuation of weekly inspections in this area is recommended for monitoring signs of changes.

3. **Ongoing Maintenance and Repairs as Needed.** Maintenance/repairs to the dikes and other appurtenant impoundment features should be performed on a routine and ongoing programmatic basis as well as on an as needed basis if warranted by problems or concerns (i.e., as identified during periodic inspections by a qualified person, or as otherwise identified). Ruts should be regraded and bare areas should be re-seeded to establish vegetation, and the existing vegetation maintained in a condition to facilitate inspections. Observed ruts and erosion rills should be repaired before the feature worsens. Animal burrows should be filled with hydrated bentonite or equivalent material and covered with natural soil. Woody vegetation from the interior of the berms should be removed as practicable and the area recompact following vegetation removal. Continue with current practices of maintaining set-back distance between CCR material stockpiles and the dikes.
