<b>ANNUAL CCR SURFACE IMPOUNDMENT INSPECTION:</b>			
<b>Facility Name:</b>		Cleco Dolet Hills Power Station	
<b>Address:</b>		963 Power Plant Rd. Mansfield, LA	
<b>Surface Impoundment Name :</b>	Ash Basin No. 1	<b>Owner:</b>	Cleco Power LLC
<b>Surface Impoundment ID:</b>	P-0037	<b>Operator:</b>	Cleco Power LLC
<b>Nearest City:</b>	Mansfield	<b>Parish:</b>	DeSoto
<b>Inspector:</b>		James C. Van Hoof, P.E.	
<b>Company:</b>		Providence Engineering & Environmental Group LLC	
<b>Date of Inspection:</b>		12/18/2020	
<b>Weather at Time of Inspection:</b>		Sunny, Cool	
<b>DESCRIPTION OF THE OPERATION OF THE SURFACE IMPOUNDMENTS:</b>			
<p>The bottom ash and economizer ash are mixed with water and sluiced in a slurry form to either of the two Ash Basins. Ash slurry pipelines within each basin enable the discharge of the slurry at multiple points within each basin. The discharge into each respective basin begins at the end of the pipeline network at the point furthest from the weir box, and proceeds toward the front of the pond. As a basin fills with ash, sections of the discharge pipe are removed as needed so that ash can be uniformly deposited and the storage capacity of each basin fully u

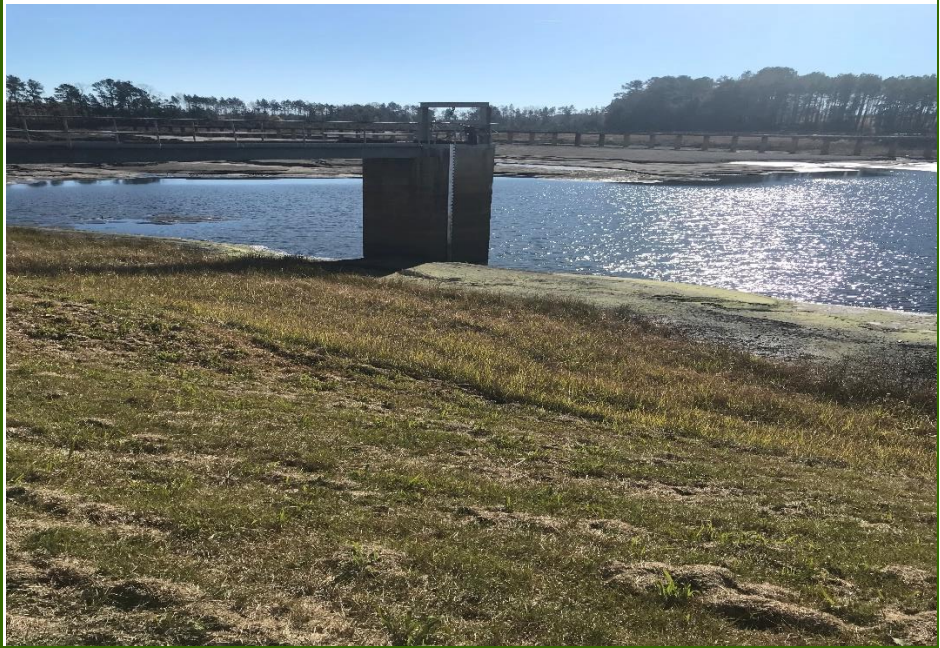
**Ash Basin No. 1**

**Comments:**  
Overflow weir structure with concrete stoplogs. Level gauge attached to structure.

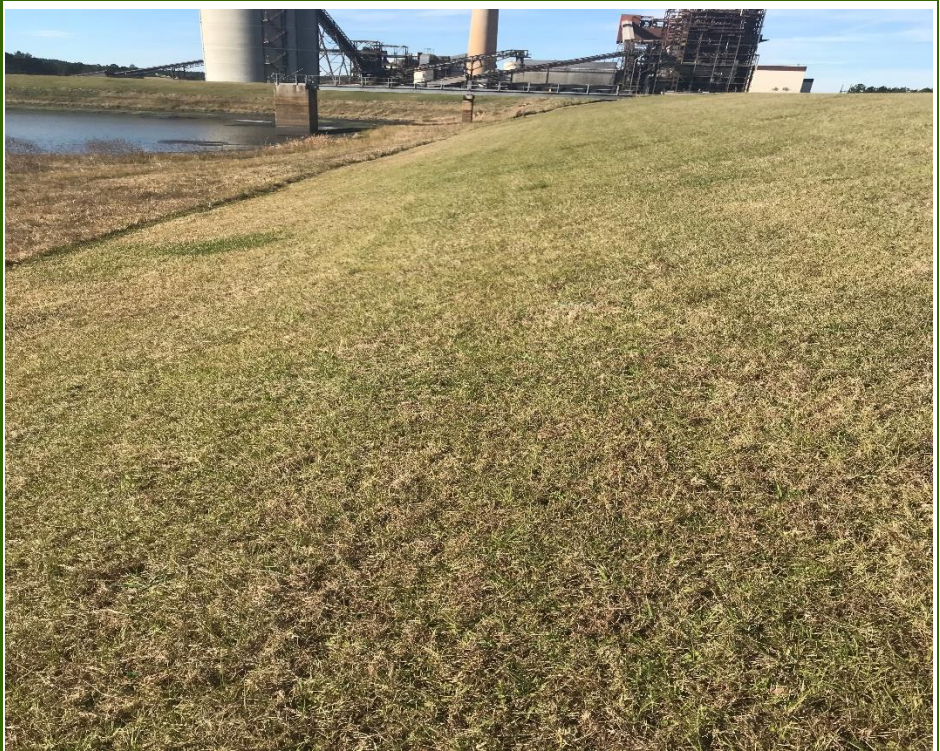
**Ash Basin No. 1**

**Comments:**  
Internal slope of northern levee.

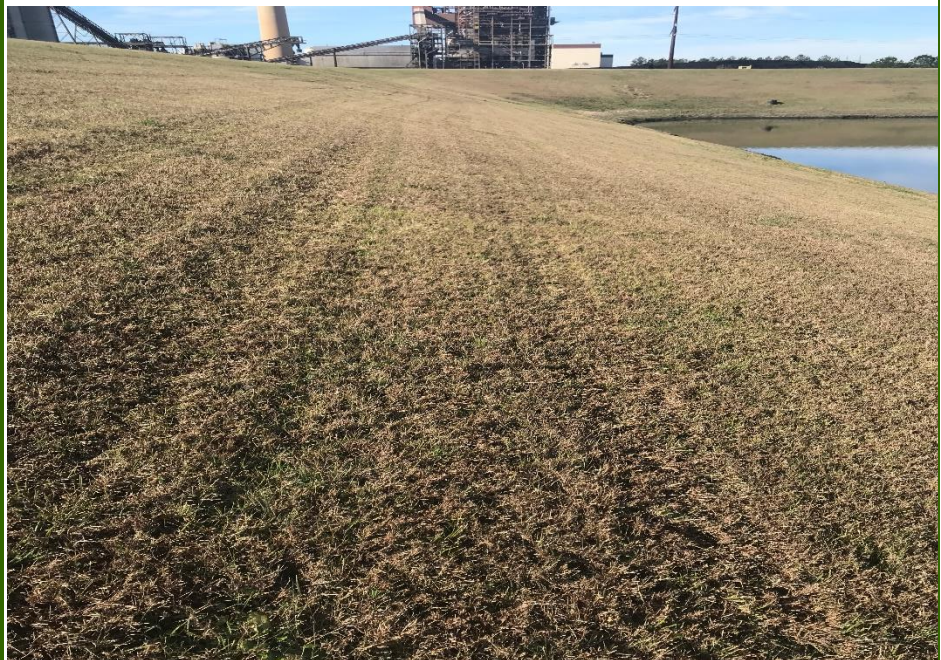
**Ash Basin No. 1**

External slope of northern levee.

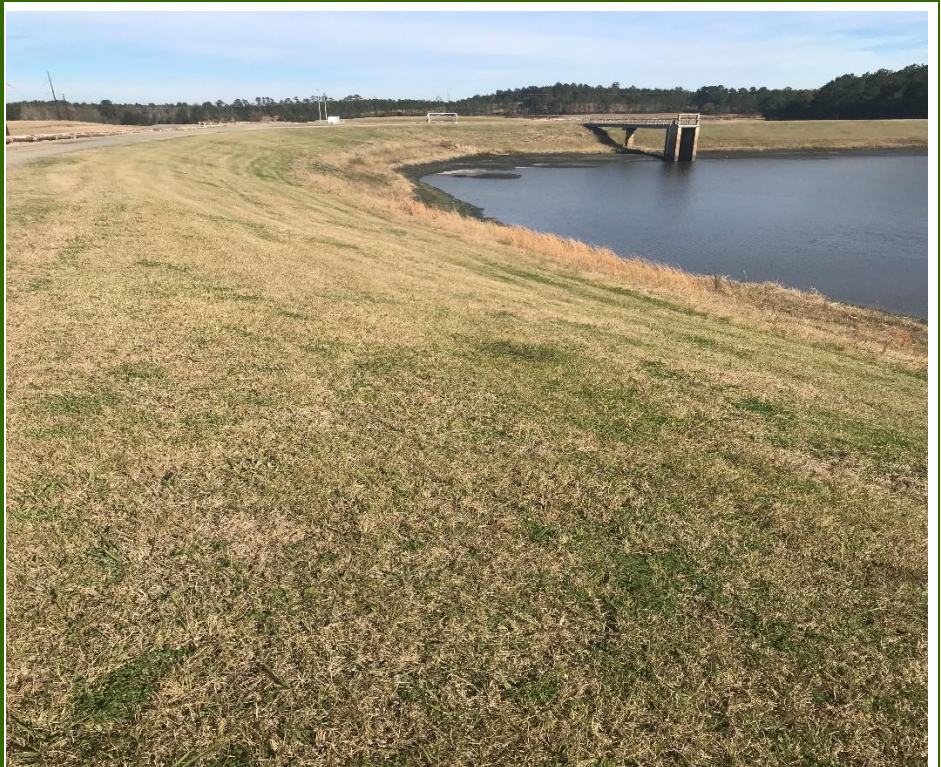
**Ash Basin No. 1**

Internal slope of western levee.

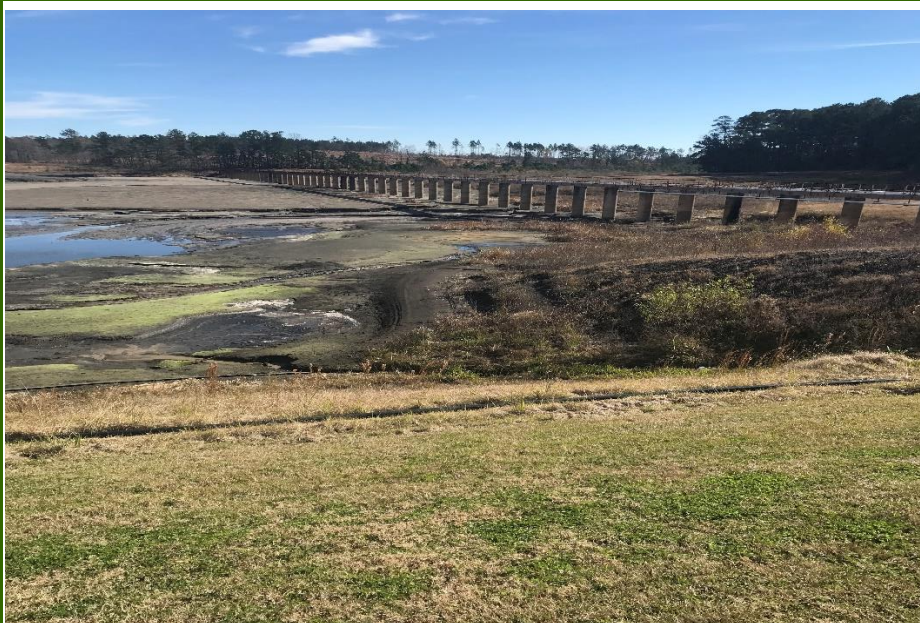
**Ash Basin No. 1**

Bottom ash sluicing structure in surface impoundment.

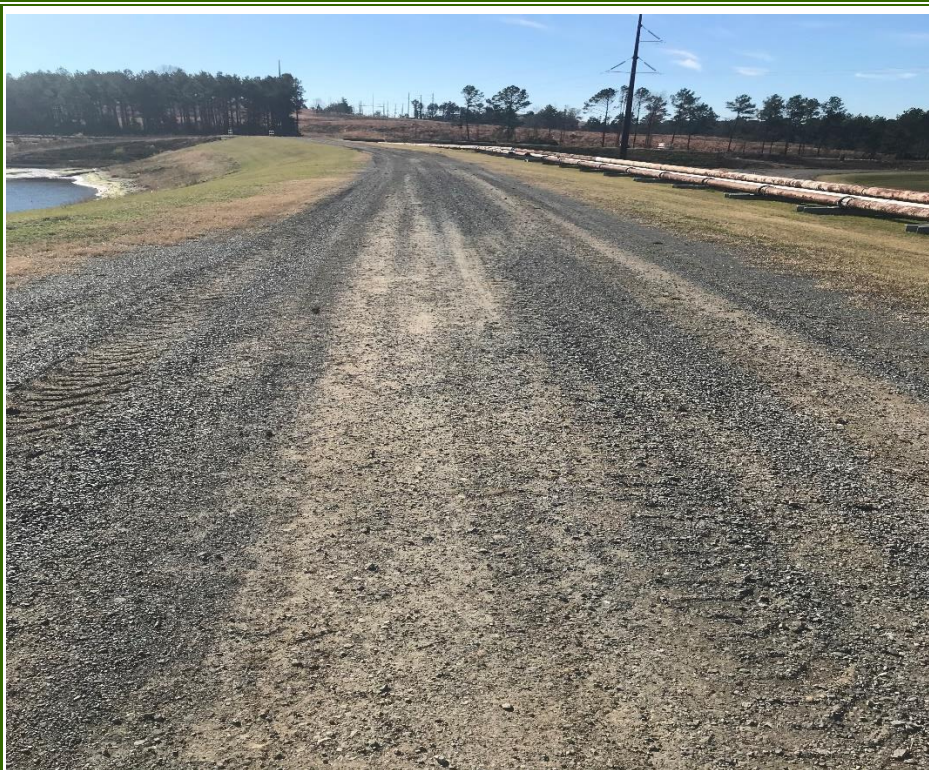
**Ash Basin No. 1**

Access road on western levee.

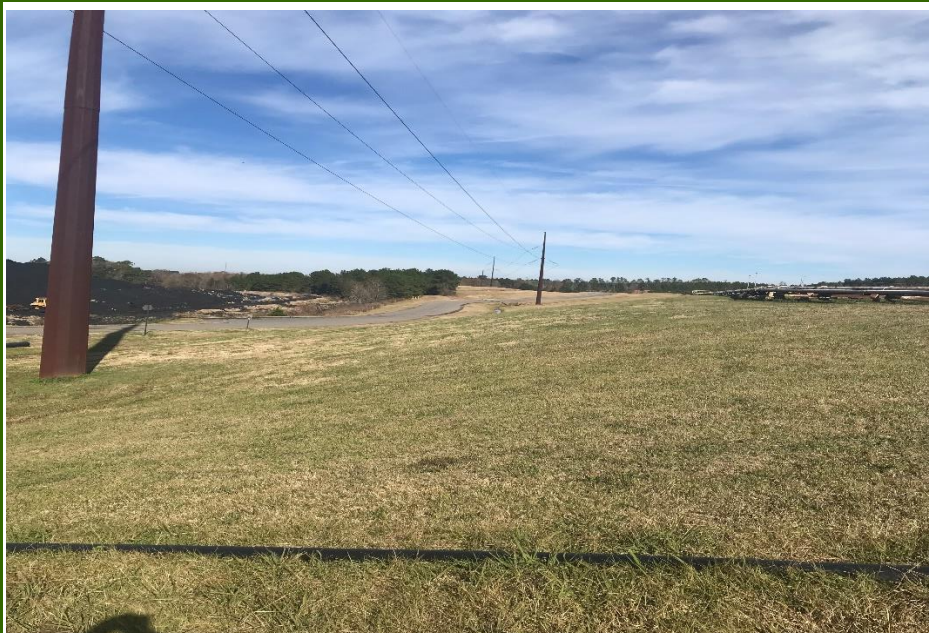
**Ash Basin No. 1**

Western exterior  
levee slope.

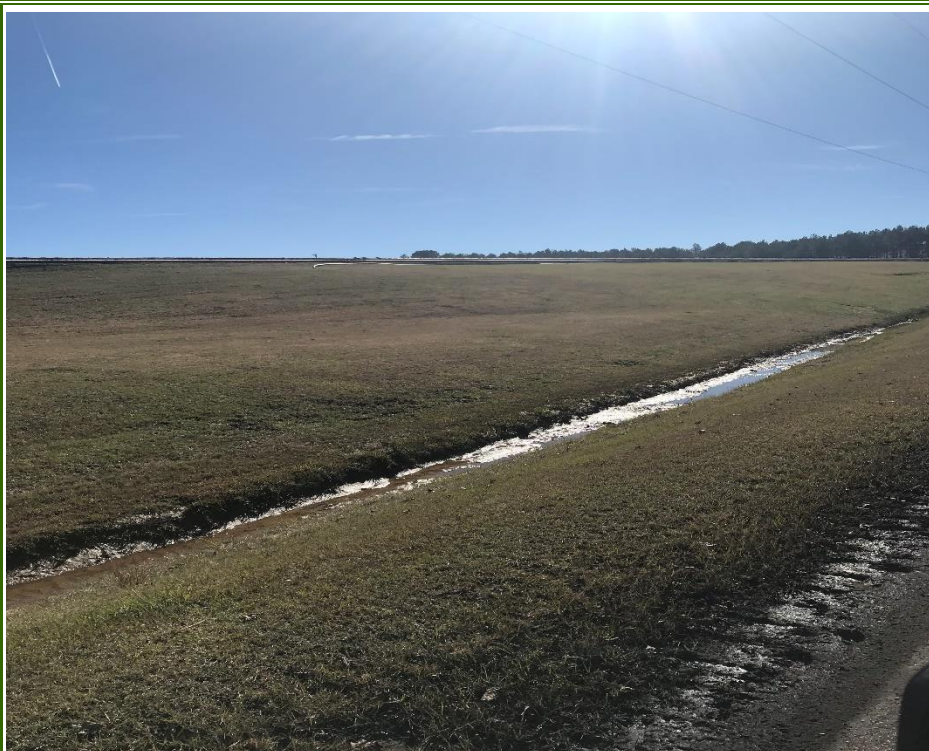
**Ash Basin No. 1**

Western exterior  
levee slope.
