# **CLECO POWER LLC**

## **DOLET HILLS POWER STATION**

### **CCR ANNUAL INSPECTION**

### **ASH BASIN NO. 2**

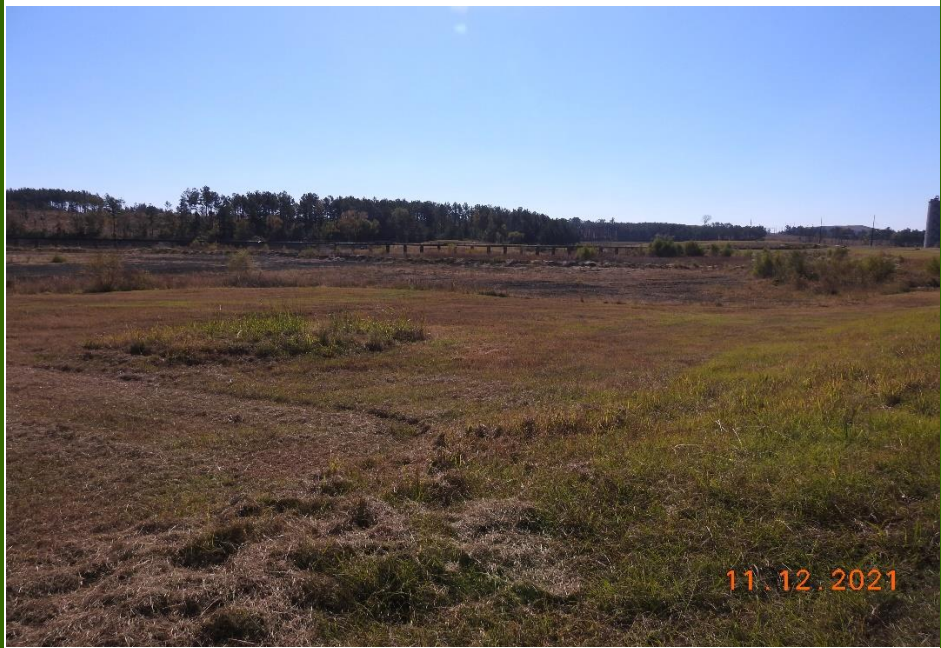
**Ash Basin No. 2**

Ash Basin looking at sluice structure.

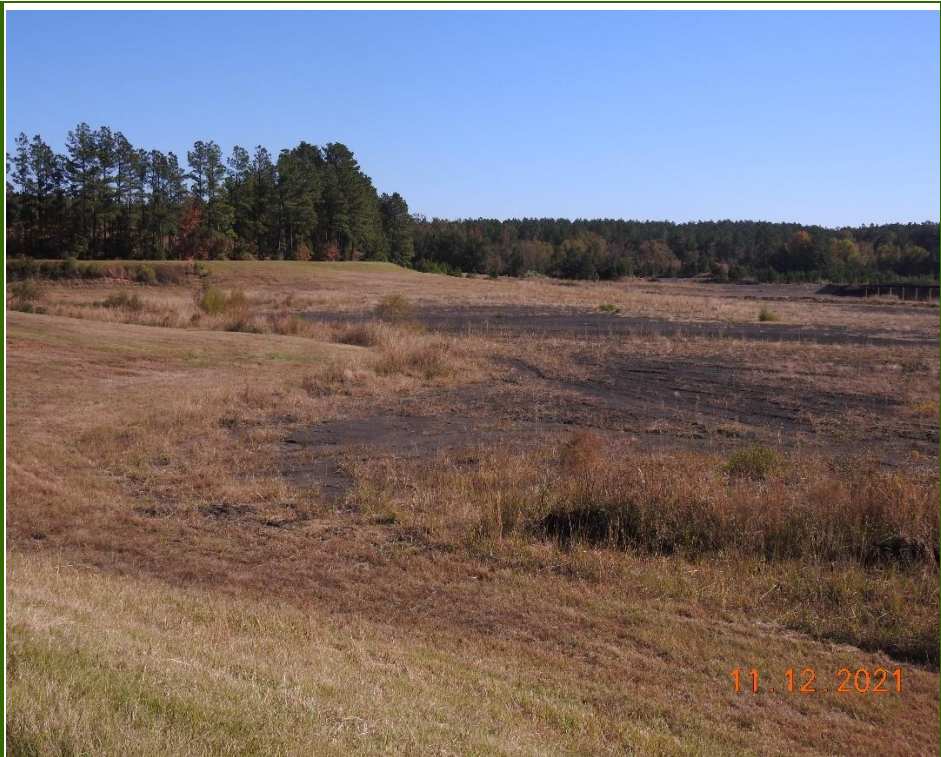
**Ash Basin No. 2**

Northern side of Ash Basin.

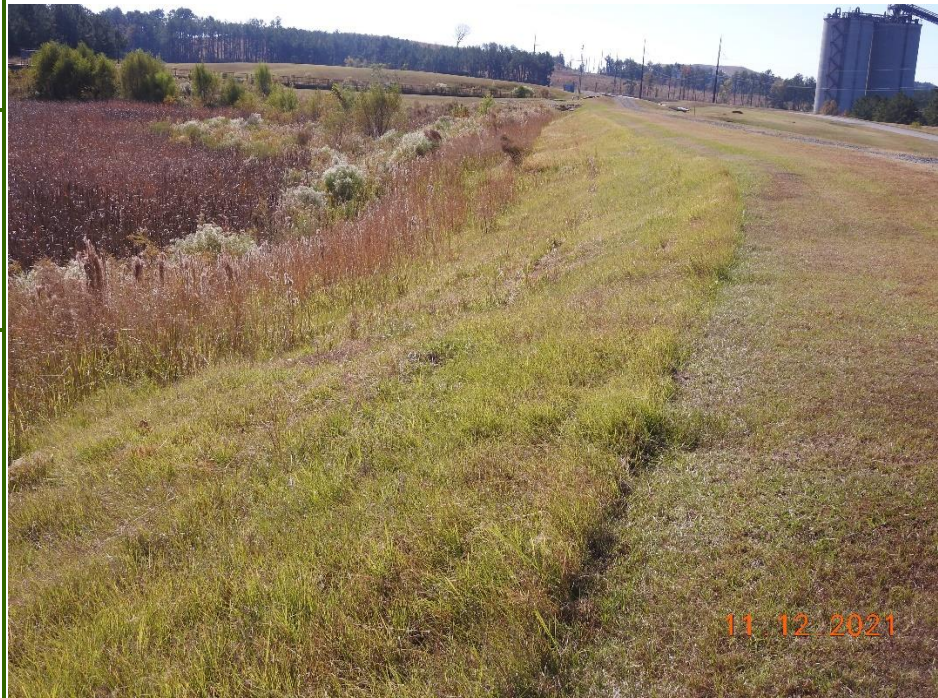
**Ash Basin No. 2**

If yes, describe (size of area, location, severity, etc.)	
<b>Findings:</b>	The interior slope was inspected and appeared to be in satisfactory condition. Minor corrective actions are required at this time. Small brush and small trees need to be removed on interior levee.
<b>Other observations on the interior slopes:</b>	None

Small brush and small trees need to be removed on internal slope of western levee.

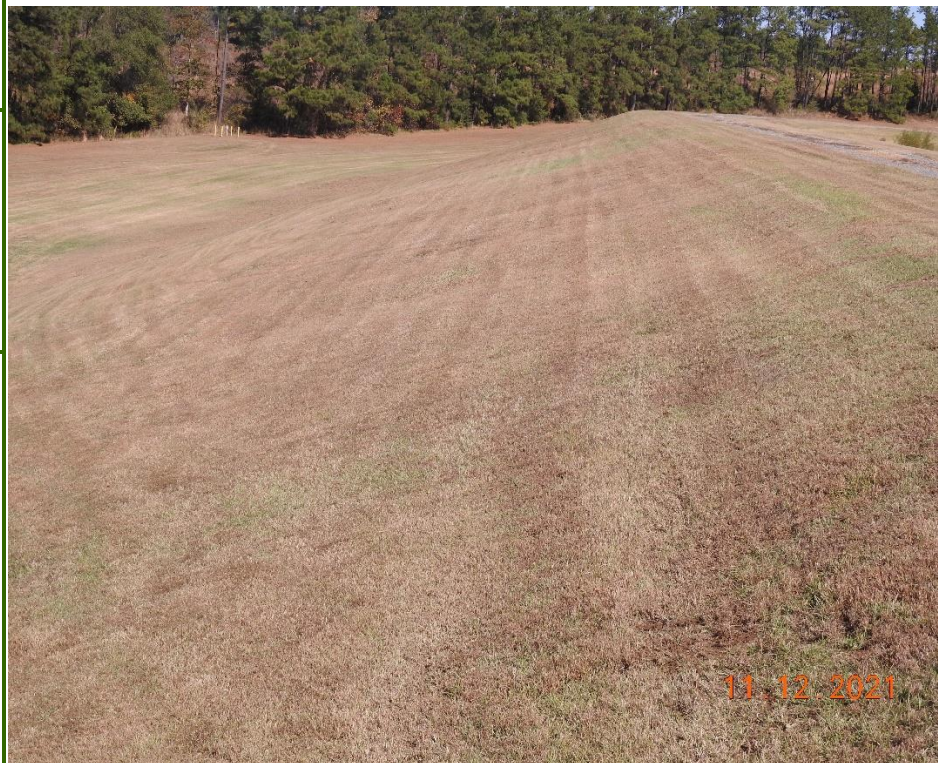
**Ash Basin No. 2**

External slope of western levee.

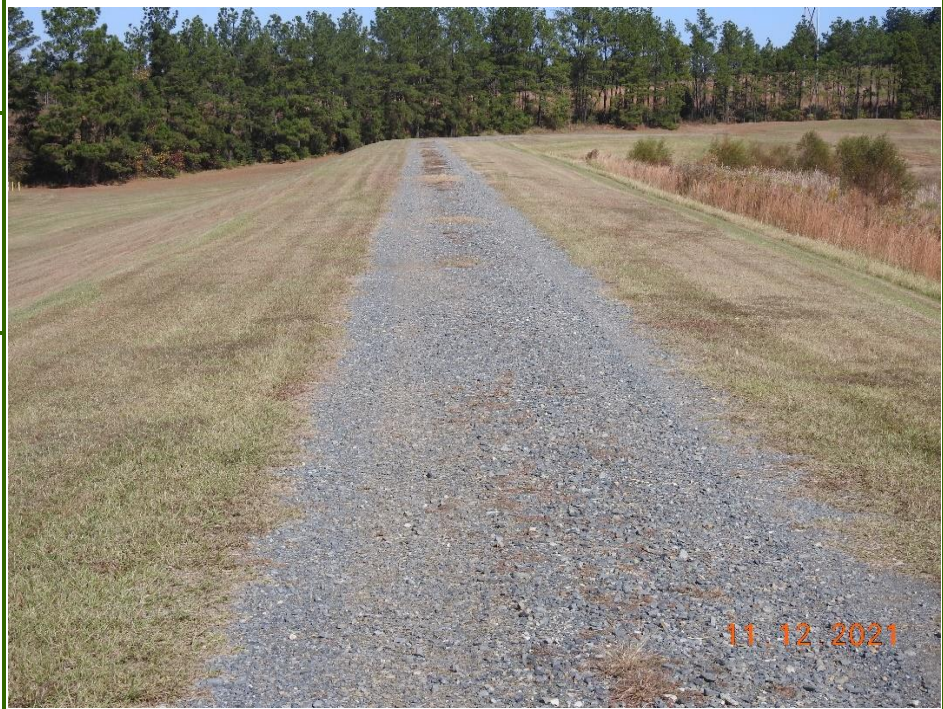
**Ash Basin No. 2**

Access road on western levee.

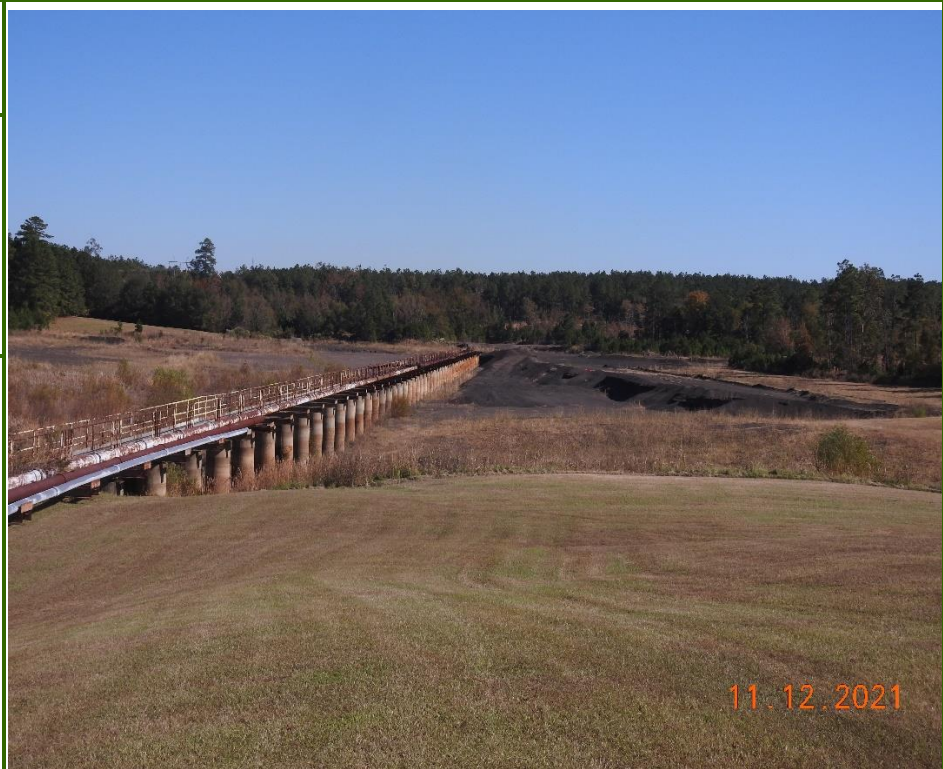
**Ash Basin No. 2**

Bottom ash sluice structure.

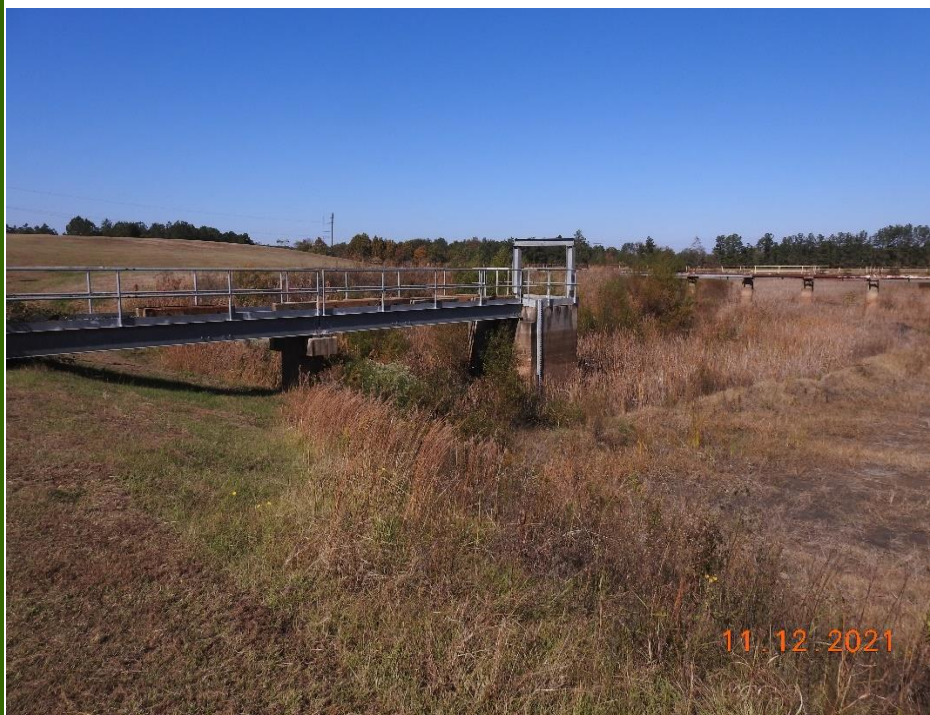
**Ash Basin No. 2**

Overflow weir structure with level gauge.

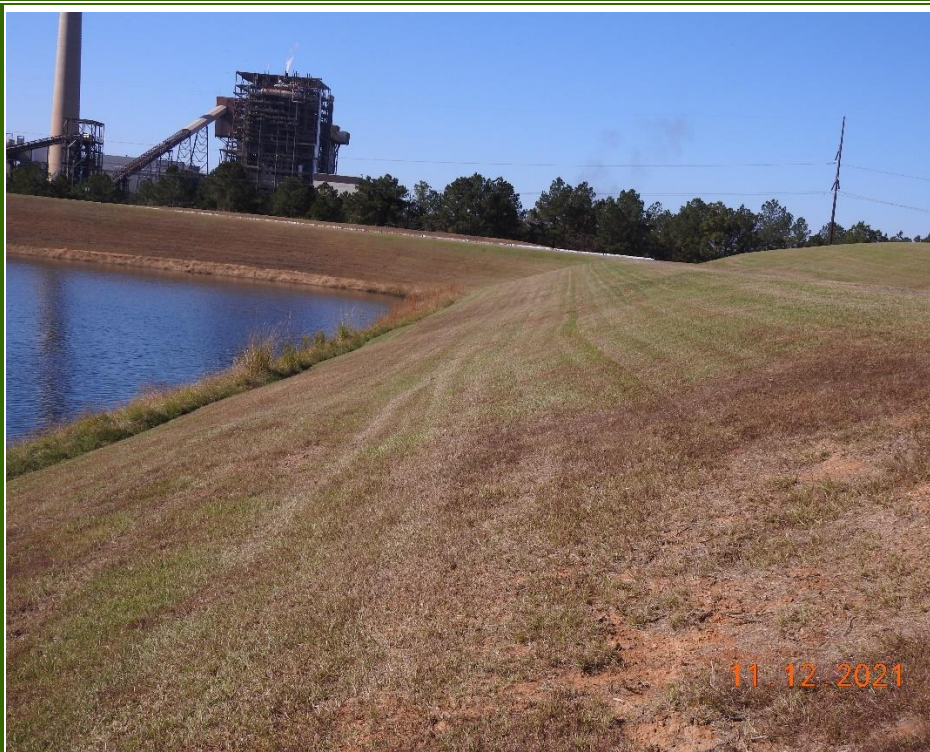
**Ash Basin No. 2**

Exterior slope of southern levee.
