DOLET HILLS POWER STATION

CCR ANNUAL INSPECTION

FLY ASH/SCRUBBER SLUDGE LANDFILL

DECEMBER 2021

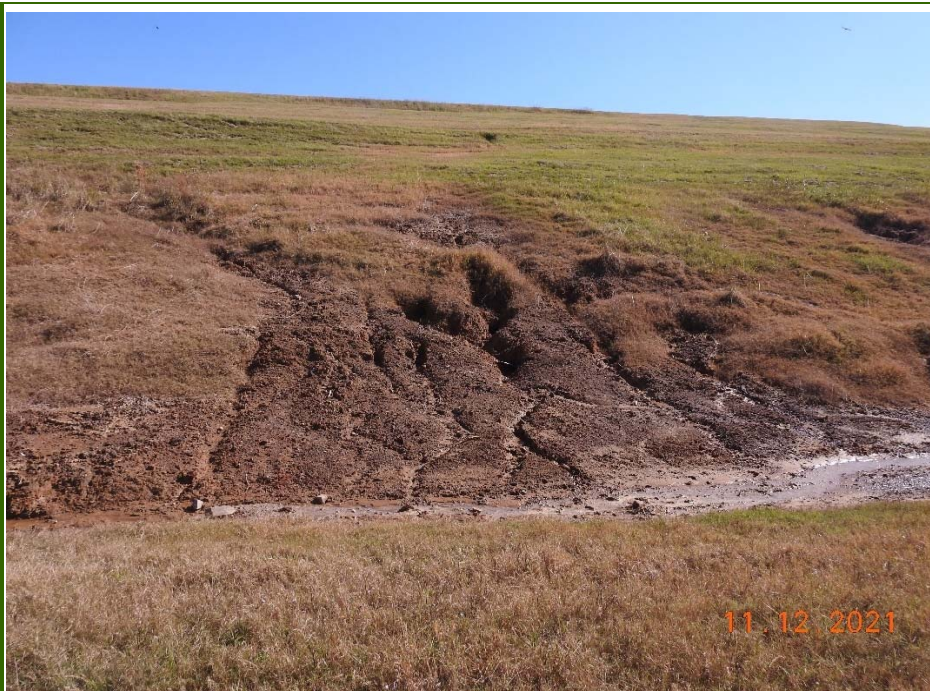
If yes, describe (size, location, etc.)	
Is the stormwater infrastructure in good condition?	<input checked="" type="checkbox"/> Yes <input type="checkbox"/> No
Findings:	The exterior slopes were inspected and appeared to be in fair condition on the western side of the landfill. Erosion and dead vegetation on western slope needs to be corrected.
Other observations on the exterior slopes:	None

Easterly

Several erosion and dead zone areas along western slope that need to be corrected.

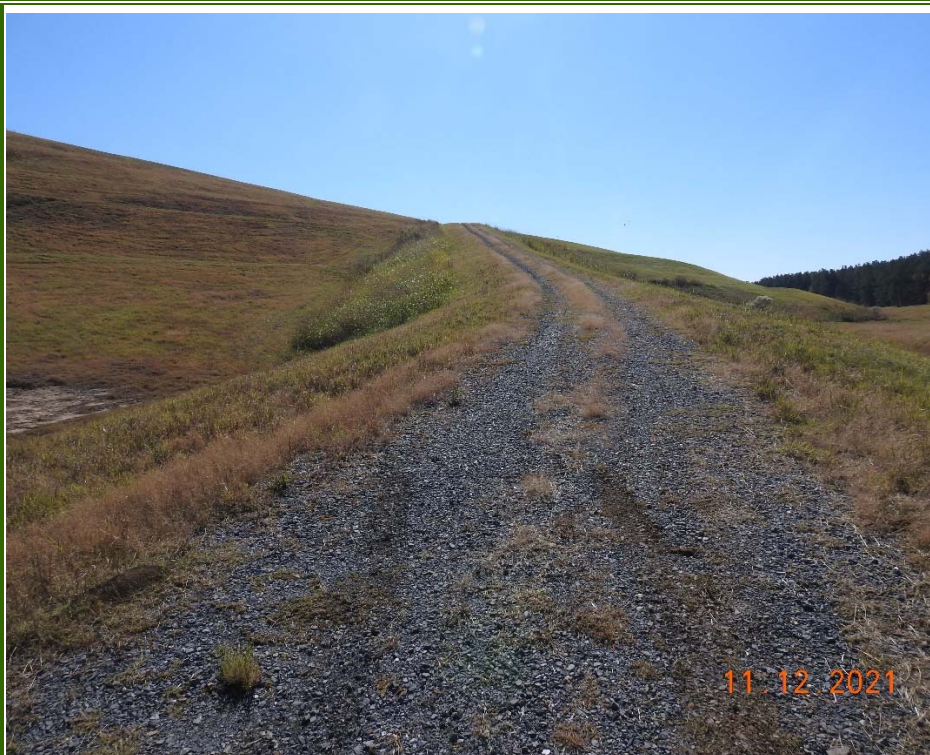
Southeasterly

Access ramp.

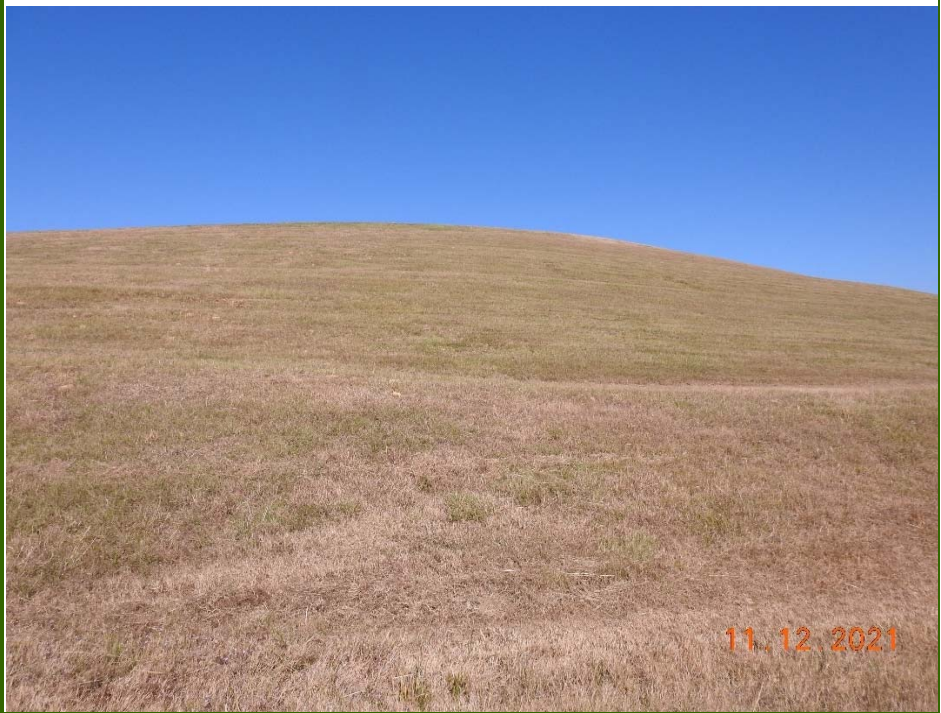
Northerly

Southern slope showing terraces.

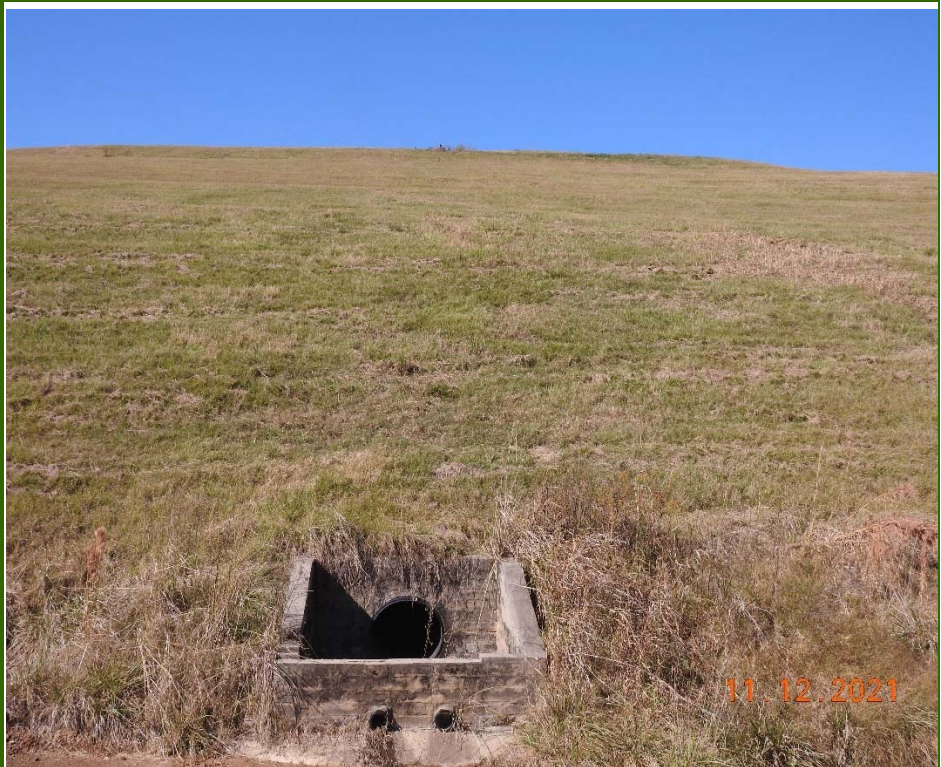
Westerly

Eastern exterior slope showing discharge opening for upper elevation inlet piping.

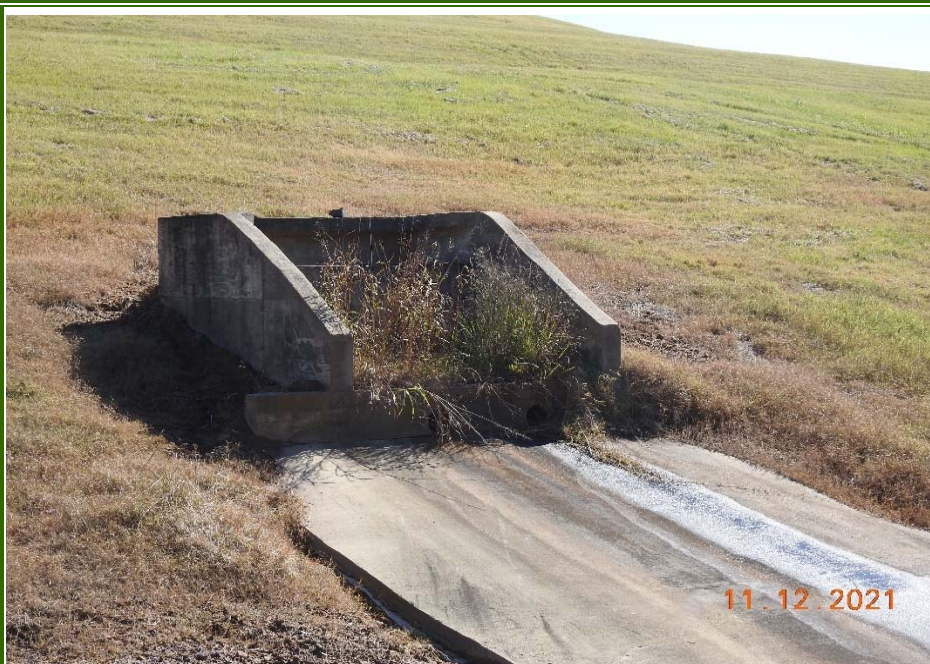
Easterly

Western exterior slope. Discharge opening for upper elevation inlet piping.

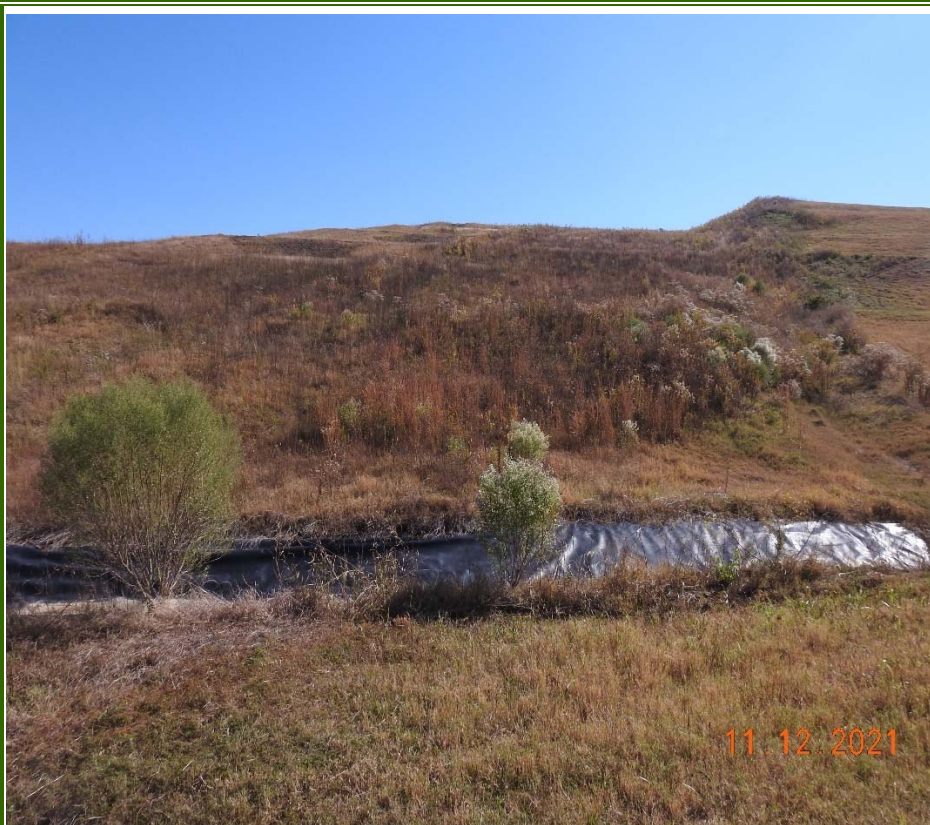
Easterly

Western slope of Cell 9 area needs to have small bushes removed.

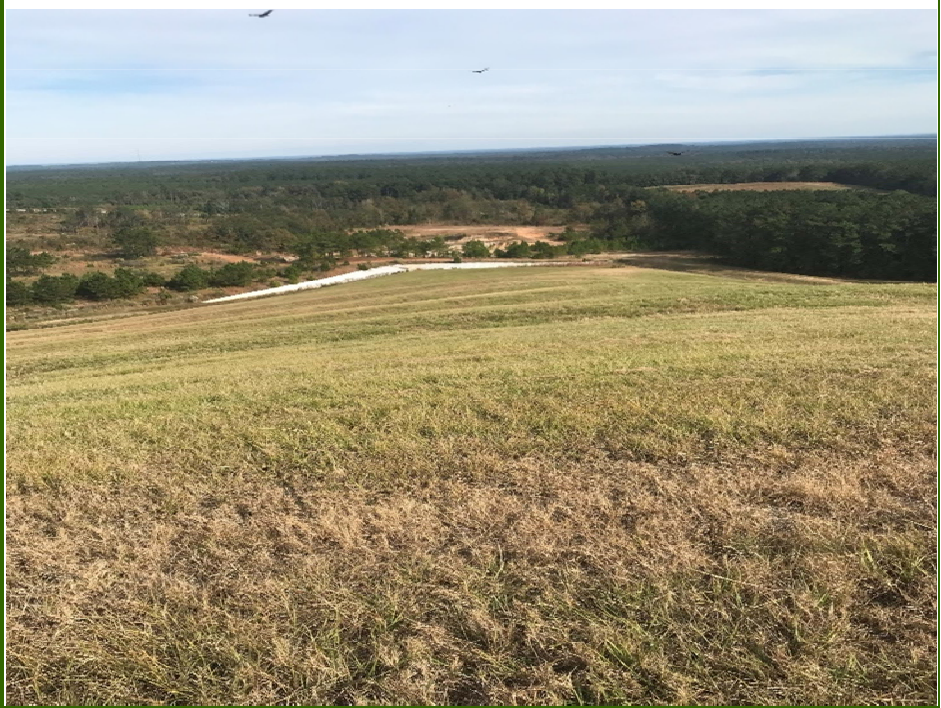
Easterly

Eastern slope of landfill.

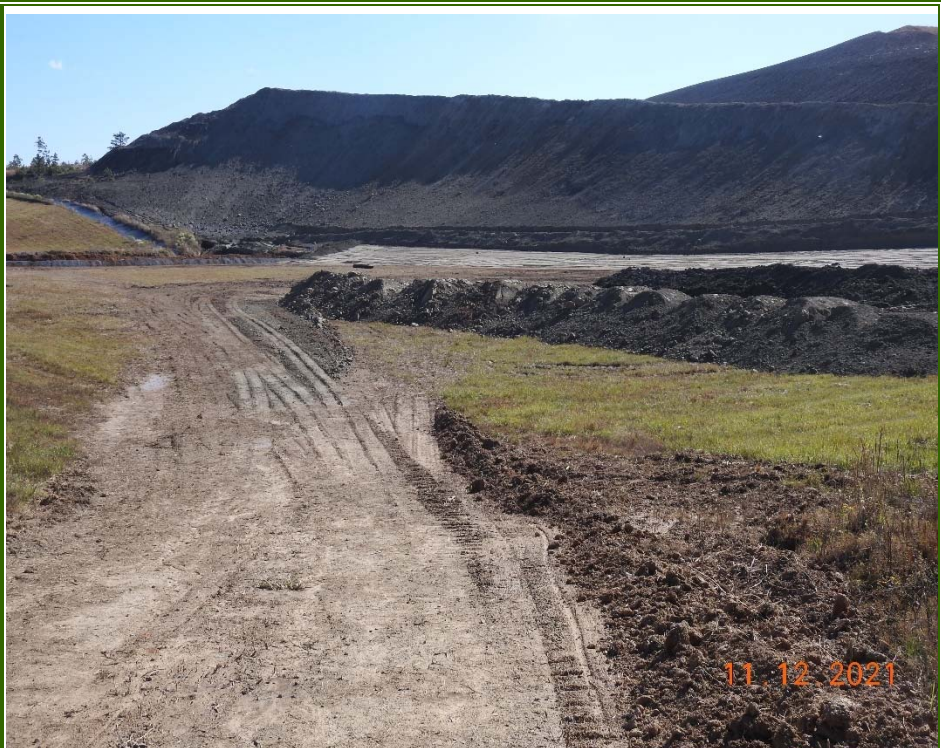
Southeasterly

Working face of the landfill.

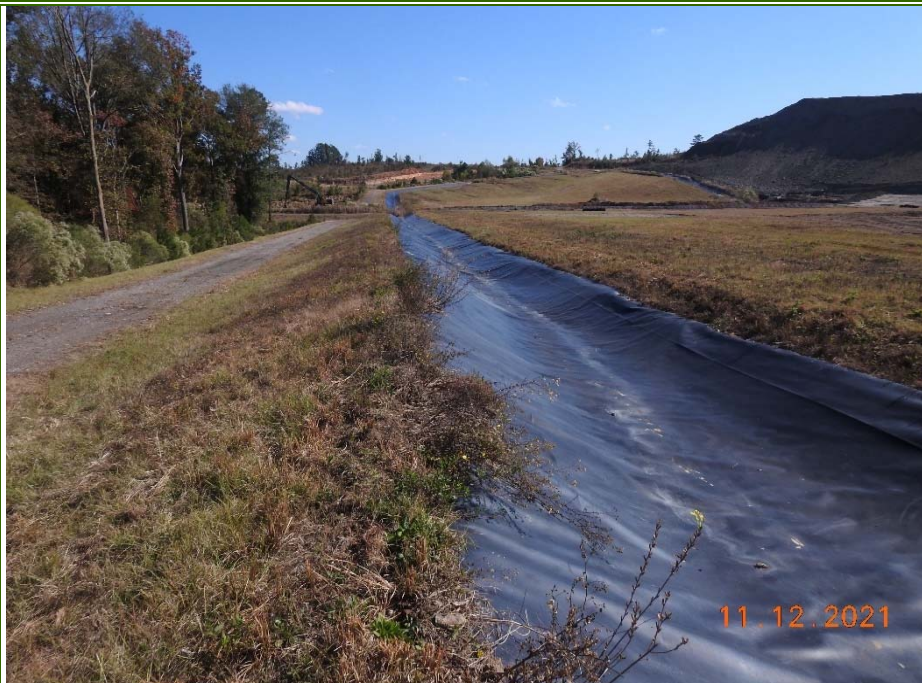
Easterly

Storm water drainage ditch on north side of cell 11 that drains to the landfill runoff pond.

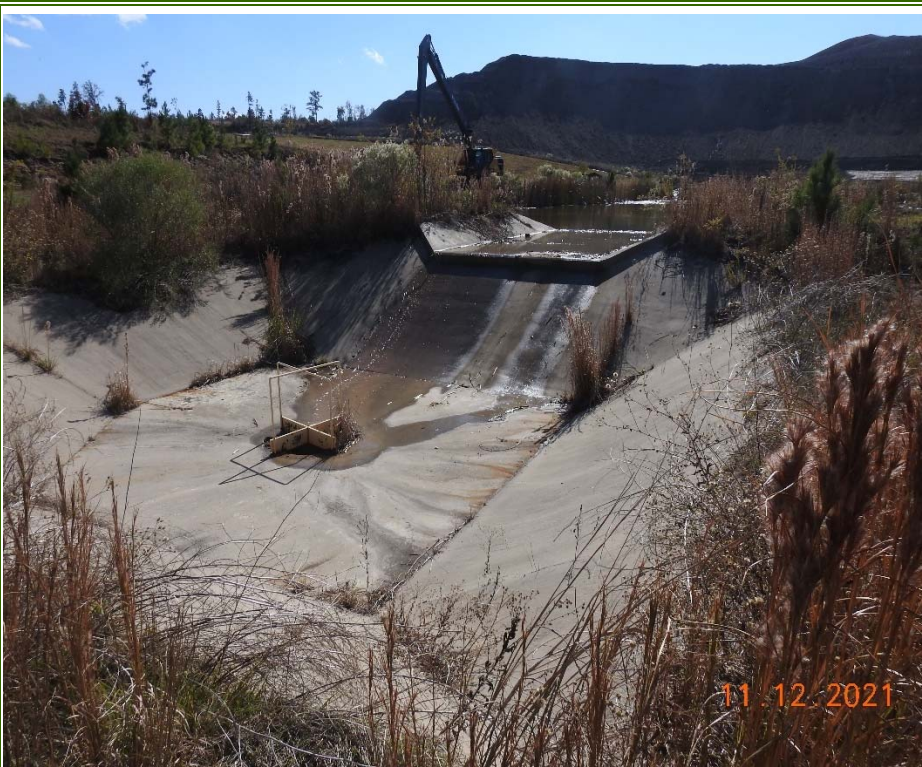
Southerly

Storm water overflow inlet that drains to the landfill runoff pond.

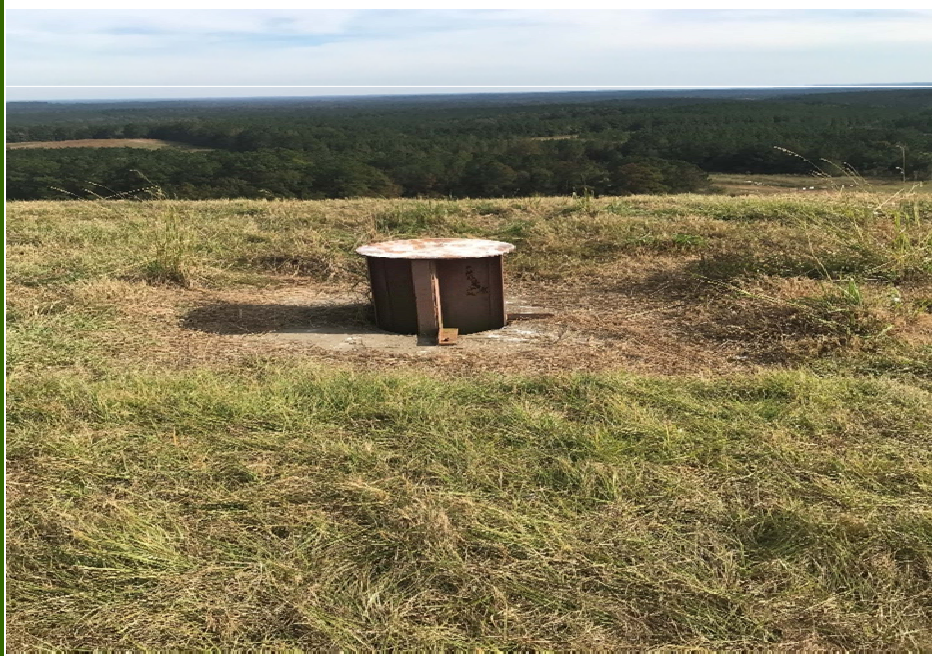
Easterly

Drop inlet structure on crown of landfill cap.

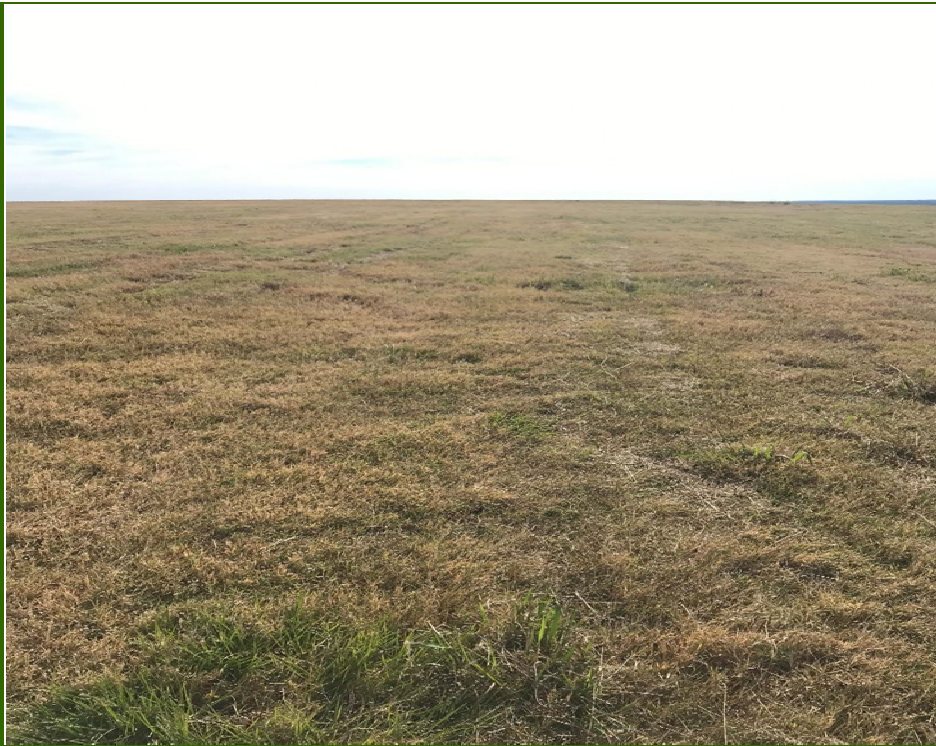
Findings:	The upper elevation flat cap area was inspected and appeared to be in satisfactory condition.
Other observations on the upper elevation flat cap area:	None

Southerly

Upper elevation flat crown area.

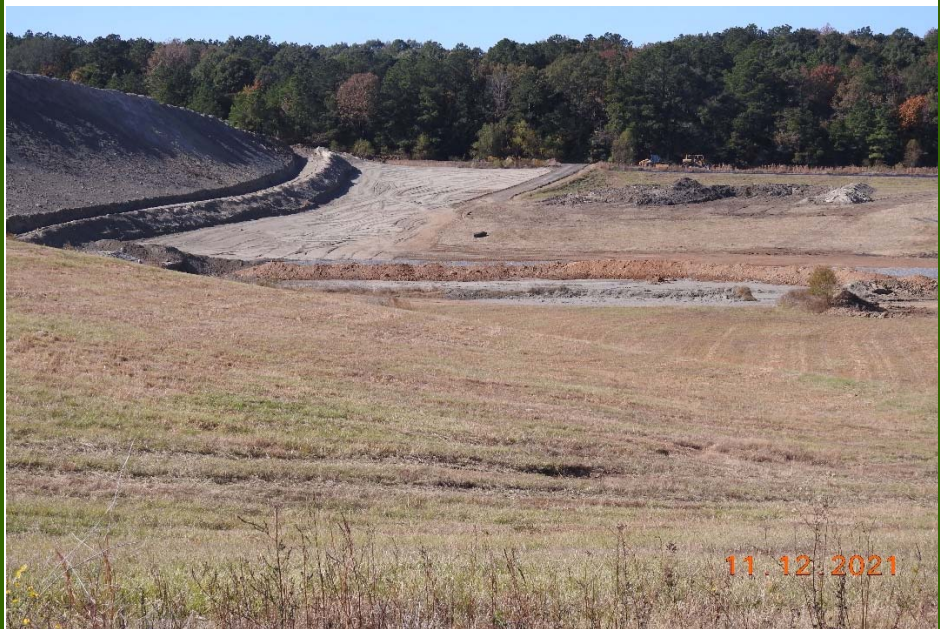
Westerly

Cell 11 area.

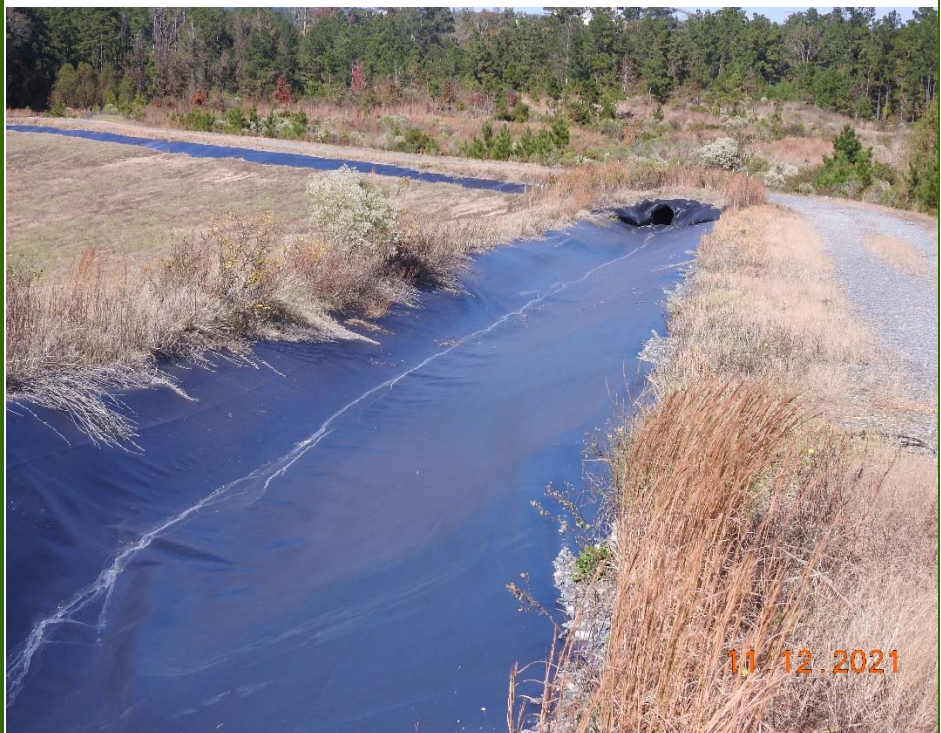
Southerly

Storm water drainage ditch on east side of cell 11 that drains to the landfill runoff pond.
