CLECO POWER LLC DOLET HILLS POWER STATION

CCR ANNUAL INSPECTION

FLY ASH/SCRUBBER SLUDGE LANDFILL

JANUARY 2024

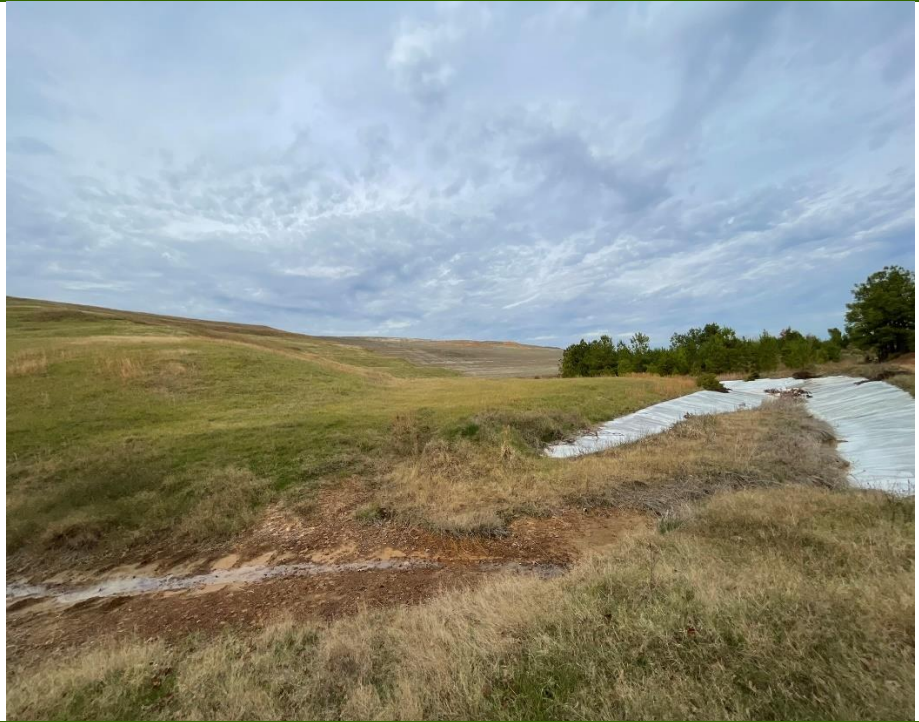
Southeast corner of landfill

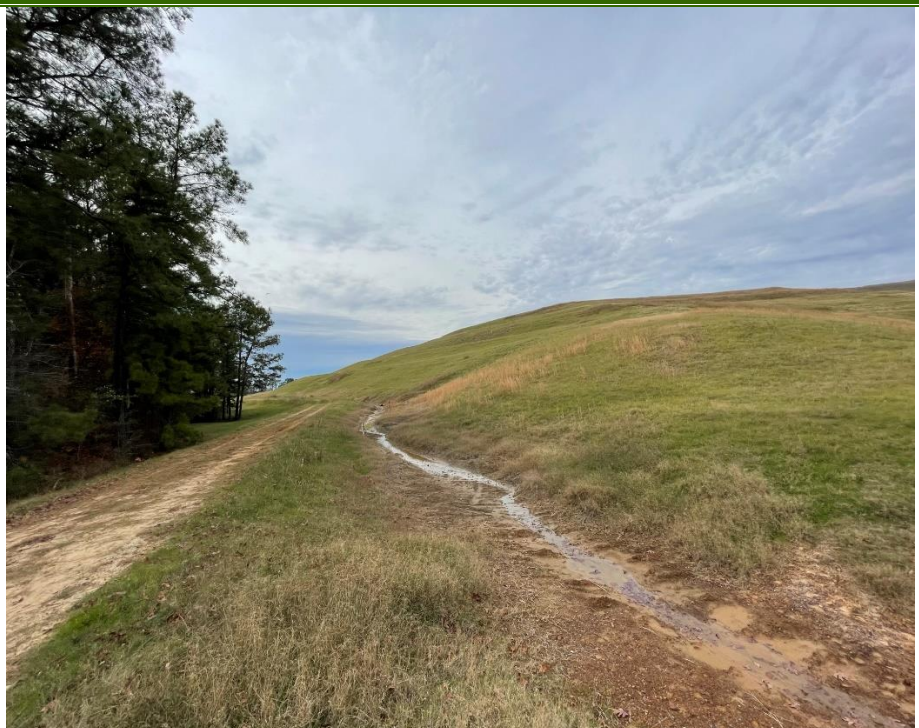
South side of landfill

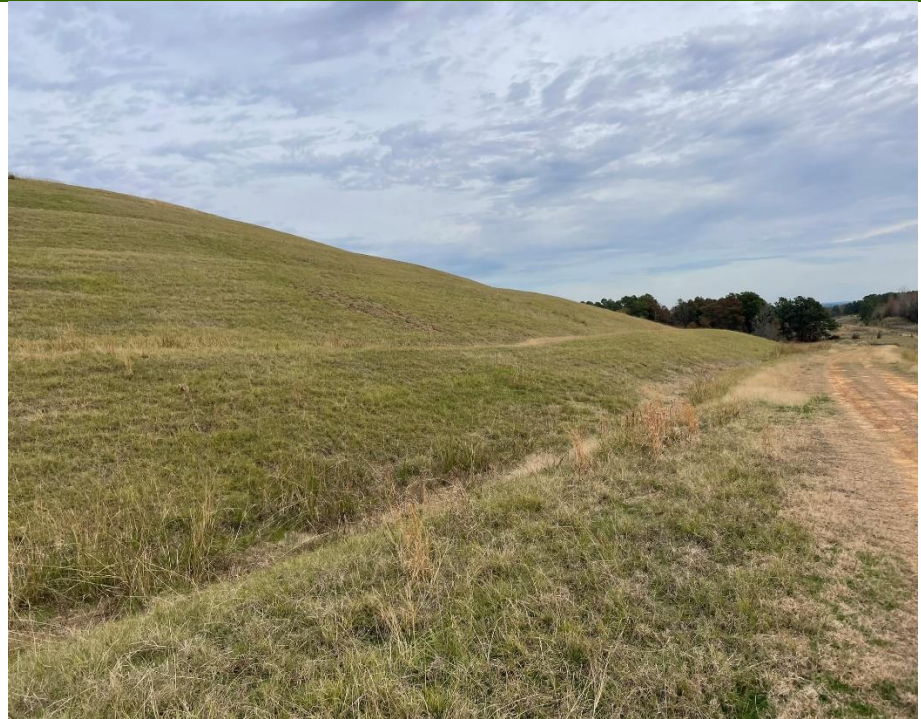
Southwest side of landfill

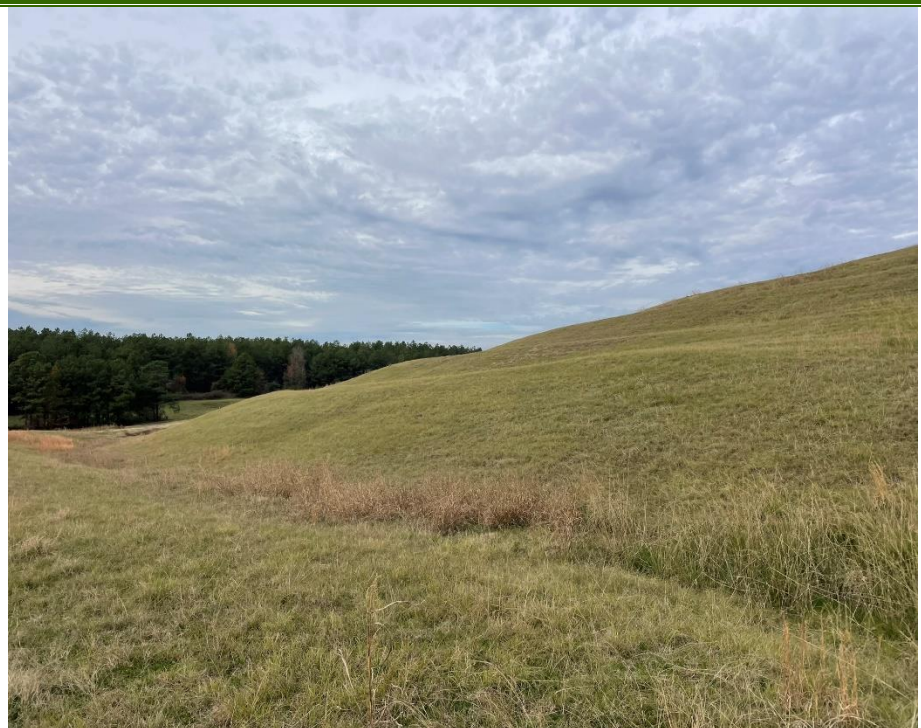
Southwest slope of landfill

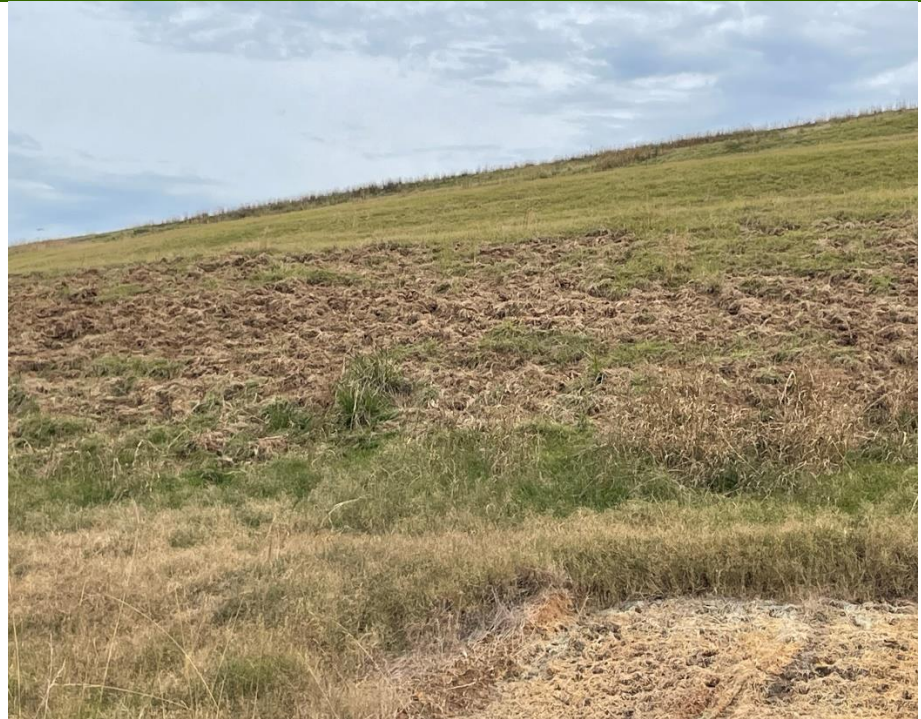
If yes, describe (size, location, etc.)	
Is the stormwater infrastructure in good condition?	<input checked="" type="checkbox"/> Yes <input type="checkbox"/> No
Findings:	The exterior slopes were inspected and appeared to be in fair to good condition. Evidence of feral hog rootings on the southwest portion of the landfill slope. Wet areas and some seepage on west slope above perimeter ditch.
Other observations on the exterior slopes:	None

Ferral hog disturbance on west slope of landfill

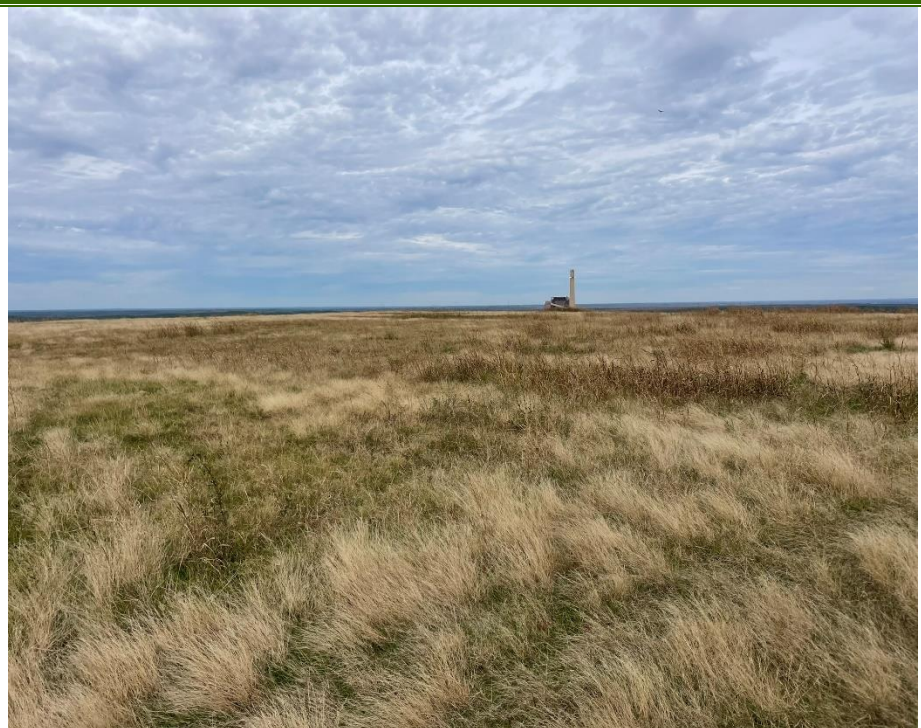
Top of landfill cap

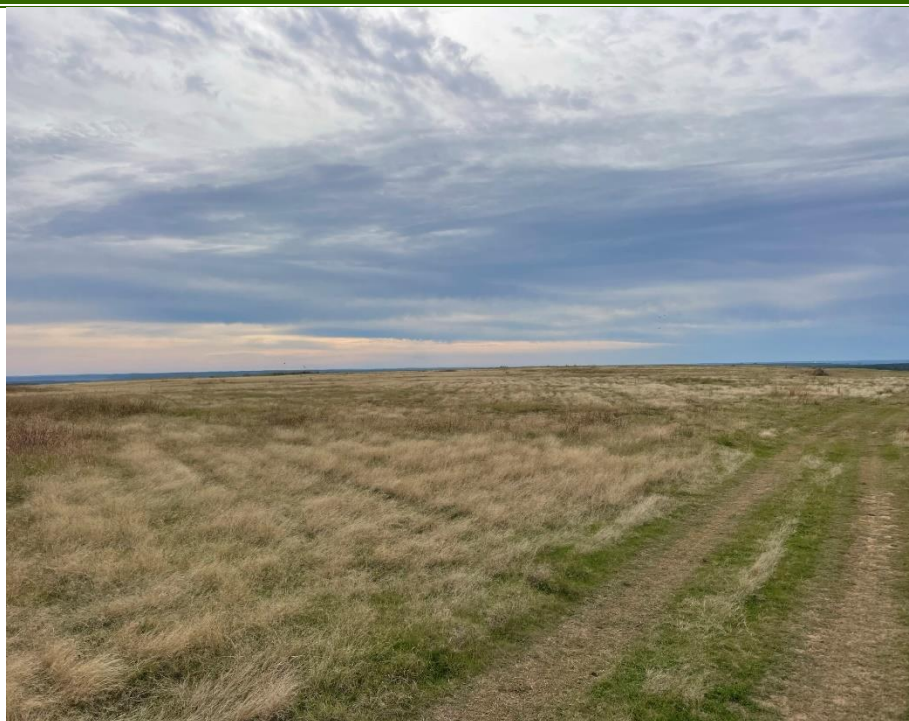
Top of landfill cap

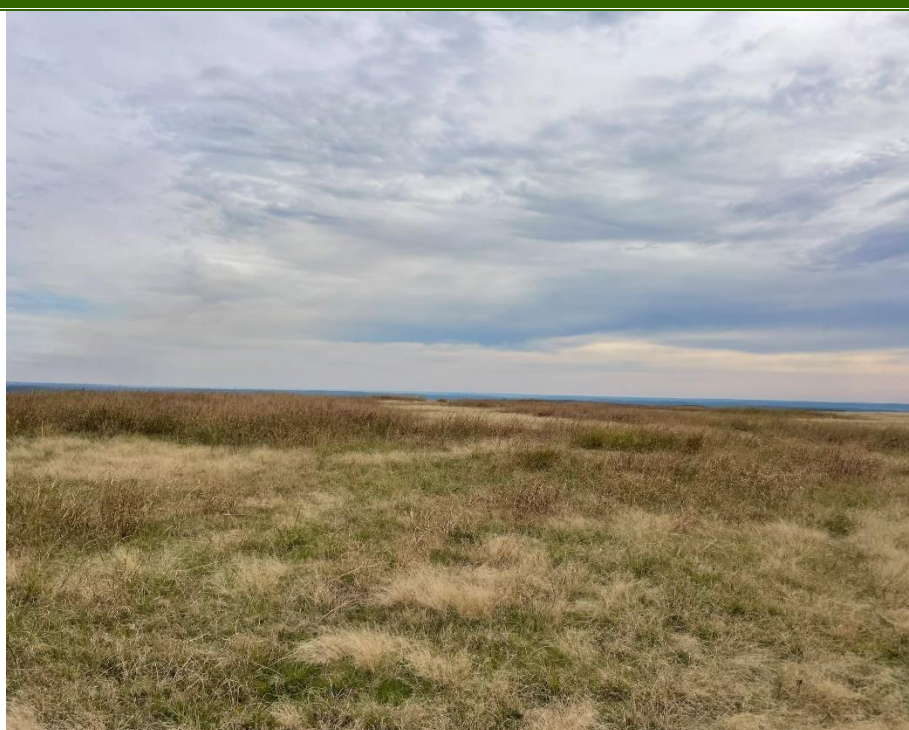
Top of landfill cap

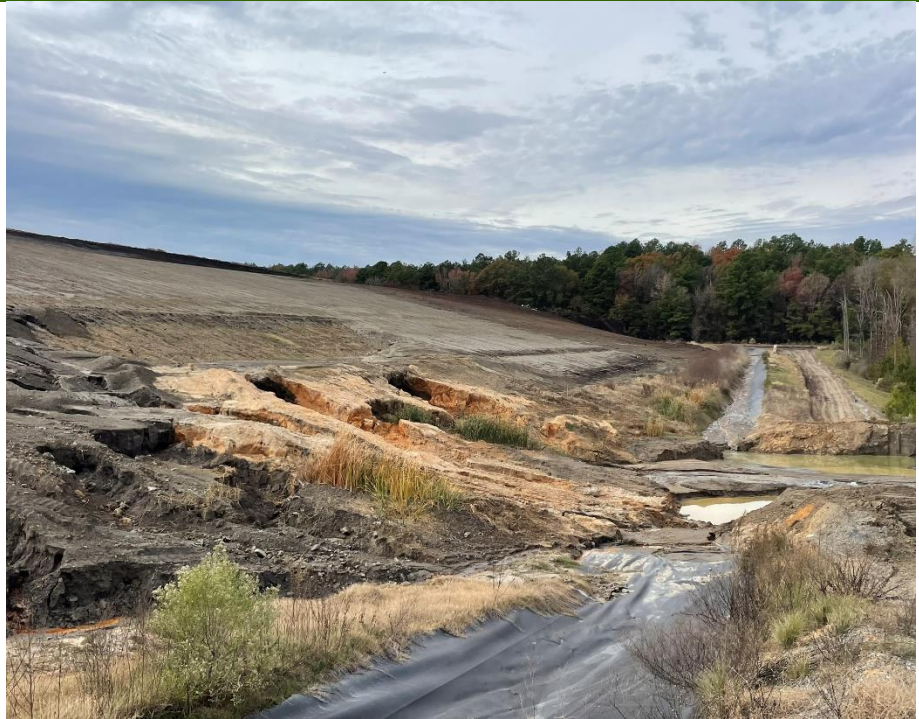
Northern slope and limits of landfill

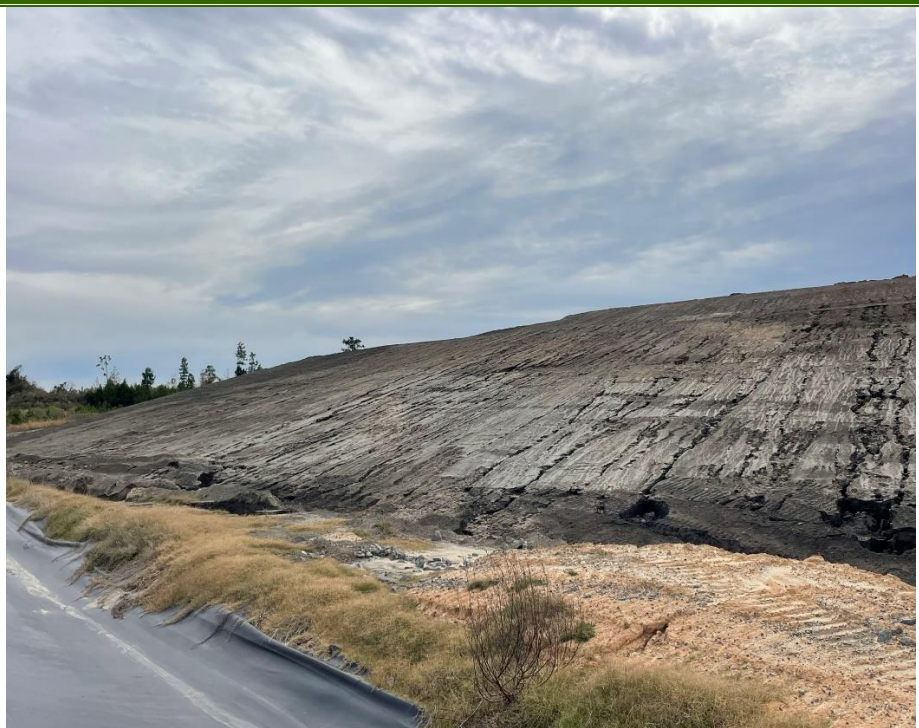
Northeast slope of landfill
