ANNUAL CCR SURFACE IMPOUNDMENT INSPECTION:			
Facility Name:		Cleco Dolet Hills Power Station	
Address:		963 Power Plant Rd. Mansfield, LA	
Surface Impoundment Name :	Ash Basin No. 1	Owner:	Cleco Power LLC
Surface Impoundment ID:	P-0037	Operator:	Cleco Power LLC
Nearest City:	Mansfield	Parish:	DeSoto
Inspector:		James C. Van Hoof, P.E.	
Company:		Providence Engineering & Environmental Group LLC	
Date of Inspection:		12/14/2016	
Weather at Time of Inspection:		Cloudy, Cool	
DESCRIPTION OF THE OPERATION OF THE SURFACE IMPOUNDMENTS:			
<p>The bottom ash and economizer ash are mixed with water and sluiced in a slurry form to either of the two Ash Basins. Ash slurry pipelines within each basin enable the discharge of the slurry at multiple points within each basin. The discharge into each respective basin begins at the end of the pipeline network at the point furthest from the weir box, and proceeds toward the front of the pond. As a basin fills with ash, sections of the discharge pipe are removed as needed so that ash can be uniformly deposited and the storage capacity of each basin fully utilized. The ash-laden water is retained in the Ash Basins for a period of time sufficient to set

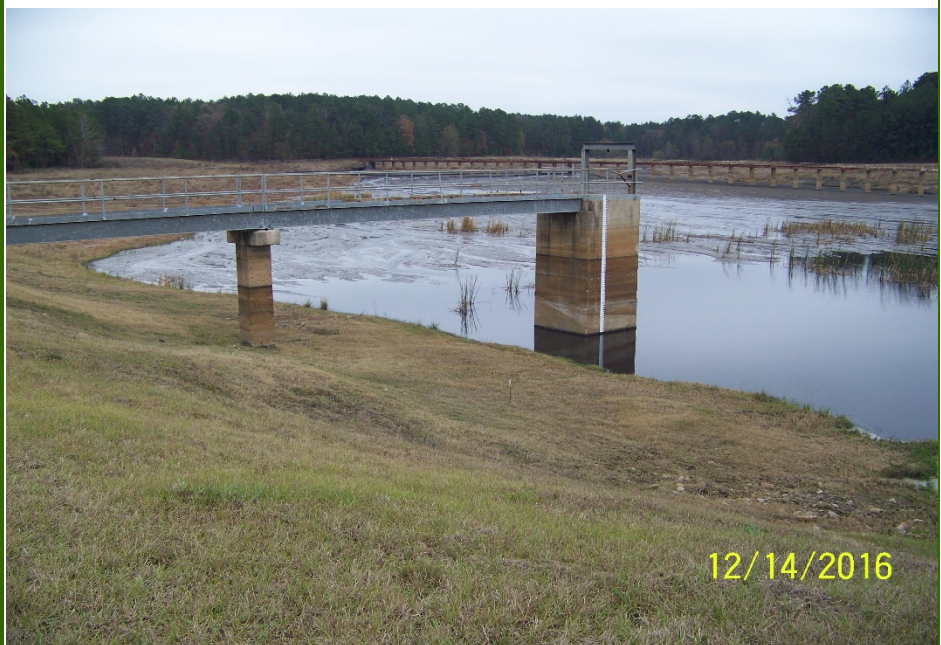
Overflow weir structure with concrete stoplogs. Level gauge attached to structure.

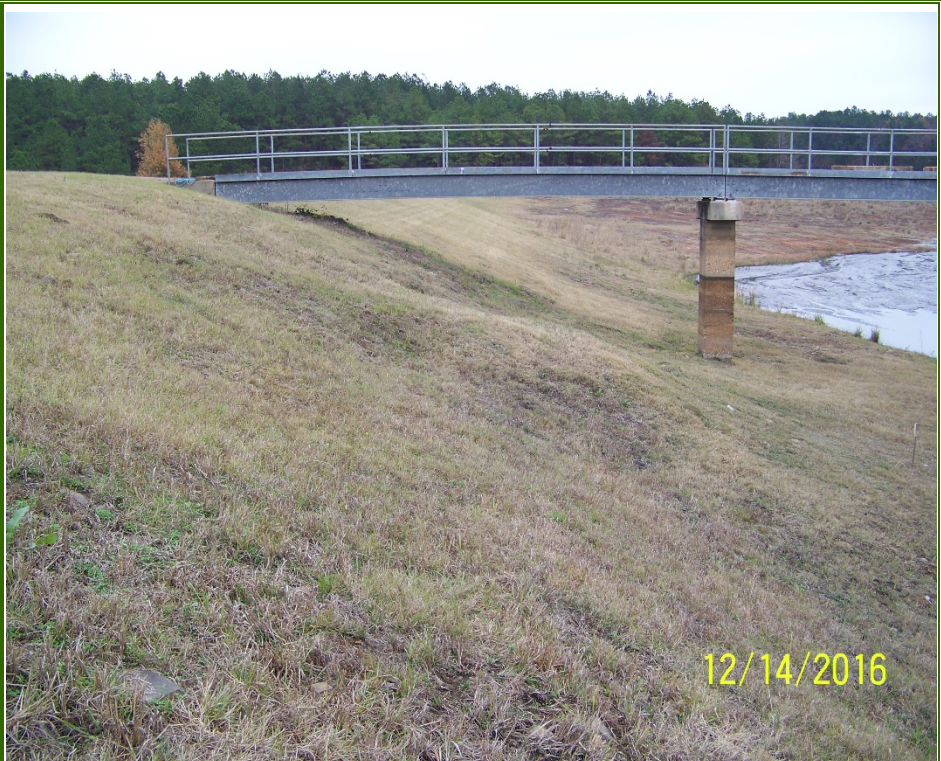
Internal slope of northern levee.

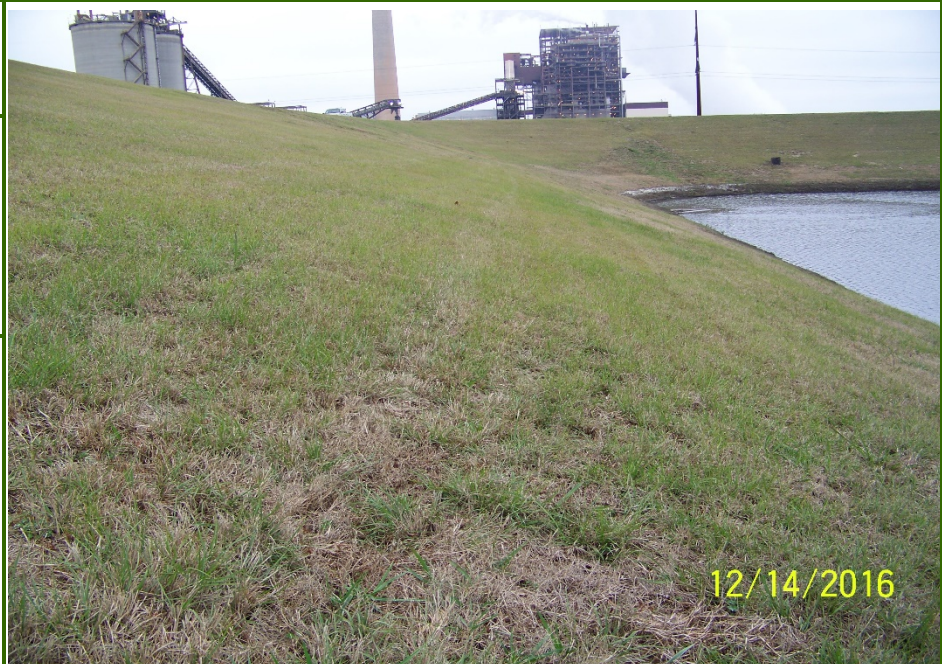
External slope of northern levee

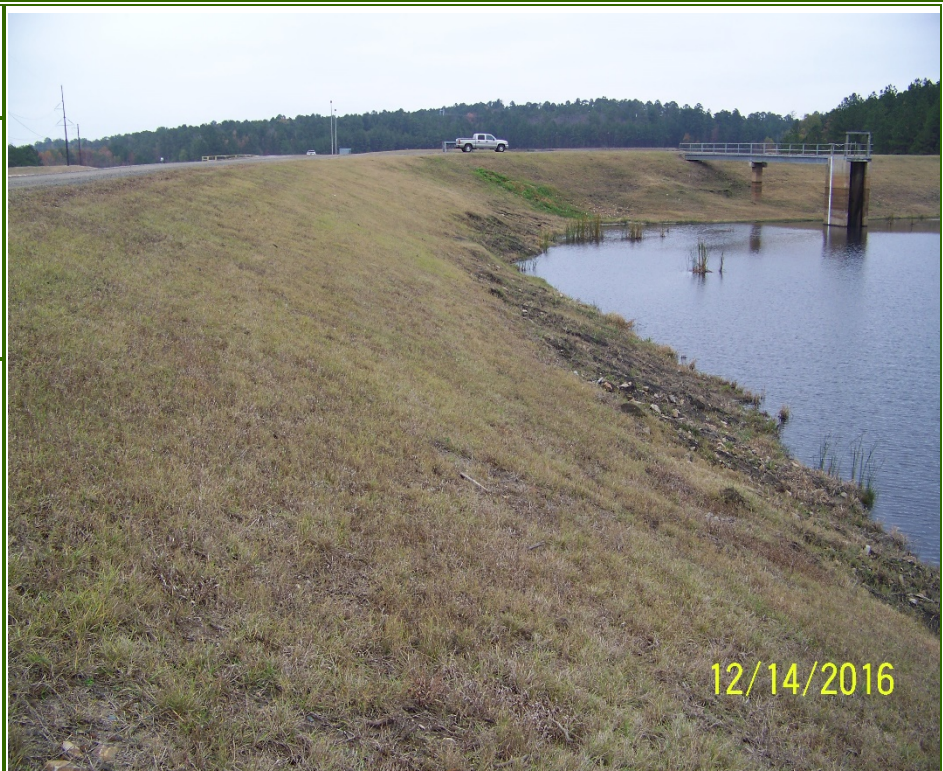
Internal slope of western levee.

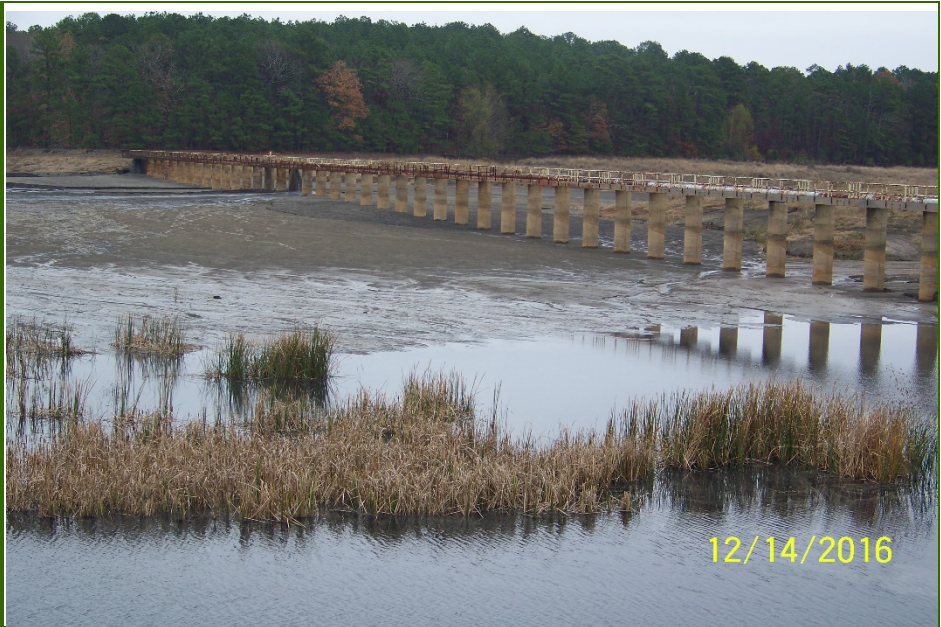
Bottom ash in surface impoundment along the sluice structure.

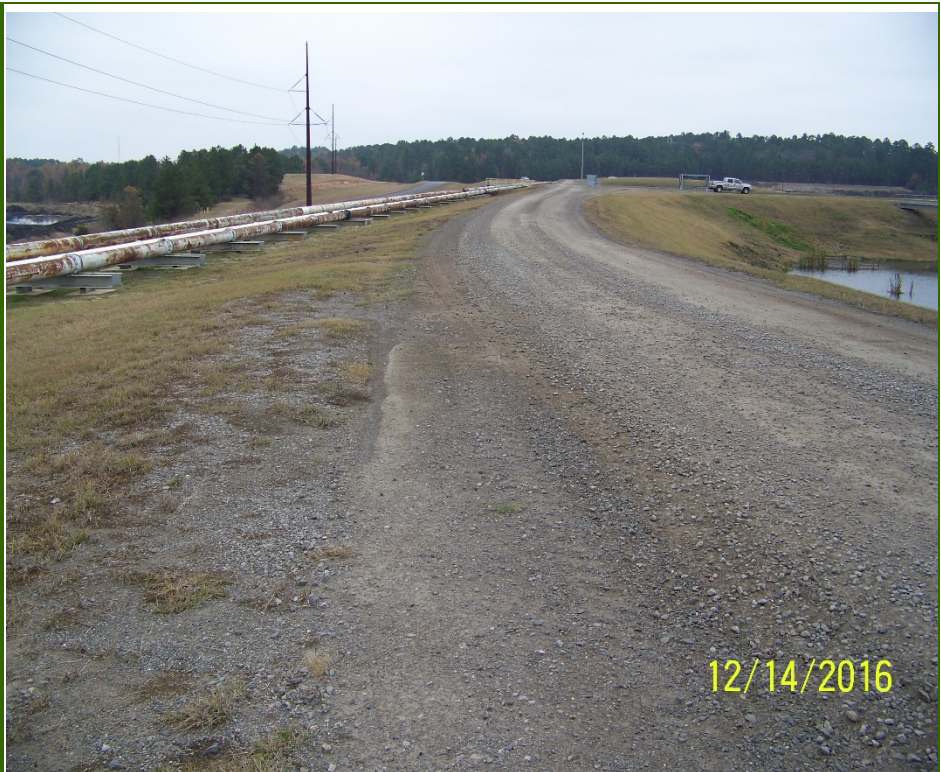
Access road on northern levee.

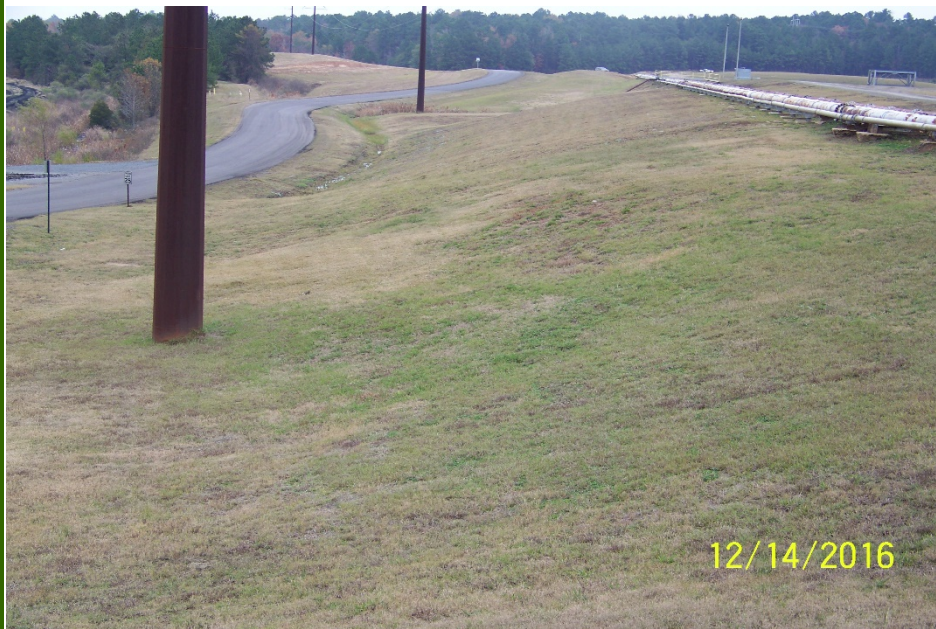
DOCUMENTATION REVIEW:	
Weekly Inspections Reviewed:	<input checked="" type="checkbox"/> Yes <input type="checkbox"/> No
Findings: Sparse cover areas on western levee were hydromulched.	
Monthly Instrument Inspections Reviewed:	<input checked="" type="checkbox"/> Yes <input type="checkbox"/> No
Findings: No issues	
Groundwater Monitoring:	Monitoring wells are in-place.
Drawings Reviewed:	<input checked="" type="checkbox"/> Yes <input type="checkbox"/> No
Are there any changes in the geometry of the surface impoundment structure since the previous inspection?	<input type="checkbox"/> Yes <input checked="" type="checkbox"/> No <input type="checkbox"/> NA
If yes, describe (size, location, etc.)	
Other observations:	Ash is being sluiced to the pond.

Western exterior levee slope showing recently corrected rills and hydromulching.

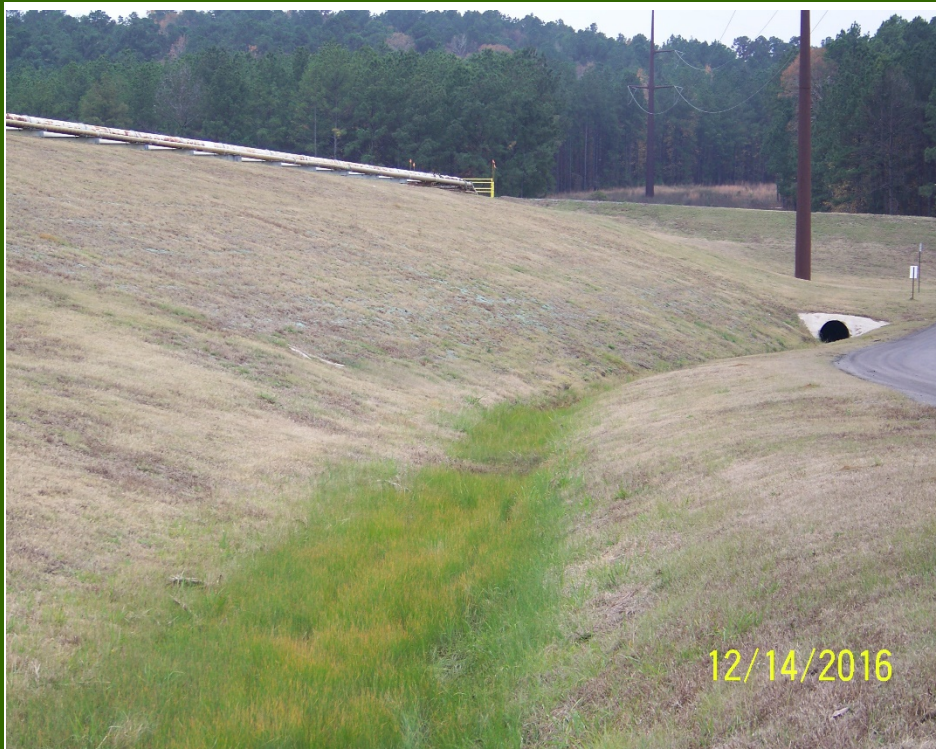
Western exterior levee slope.
