<b>ANNUAL CCR SURFACE IMPOUNDMENT INSPECTION:</b>			
<b>Facility Name:</b>		Cleco Dolet Hills Power Station	
<b>Address:</b>		963 Power Plant Rd. Mansfield, LA	
<b>Surface Impoundment Name :</b>	Ash Basin No. 2	<b>Owner:</b>	Cleco Power LLC
<b>Surface Impoundment ID:</b>	P-0037	<b>Operator:</b>	Cleco Power LLC
<b>Nearest City:</b>	Mansfield	<b>Parish:</b>	DeSoto
<b>Inspector:</b>		James C. Van Hoof, P.E.	
<b>Company:</b>		Providence Engineering & Environmental Group LLC	
<b>Date of Inspection:</b>		12/12/2017	
<b>Weather at Time of Inspection:</b>		Sunny, cool	
<b>DESCRIPTION OF THE OPERATION OF THE SURFACE IMPOUNDMENTS:</b>			
<p>The bottom ash and economizer ash are mixed with water and sluiced in a slurry form to either of the two Ash Basins. Ash slurry pipelines within each basin enable the discharge of the slurry at multiple points within each basin. The discharge into each respective basin begins at the end of the pipeline network at the point furthest from the weir box, and proceeds toward the front of the pond. As a basin fills with ash, sections of the discharge pipe are removed as needed so that ash can be uniformly deposited and the storage capacity of each basin fully u

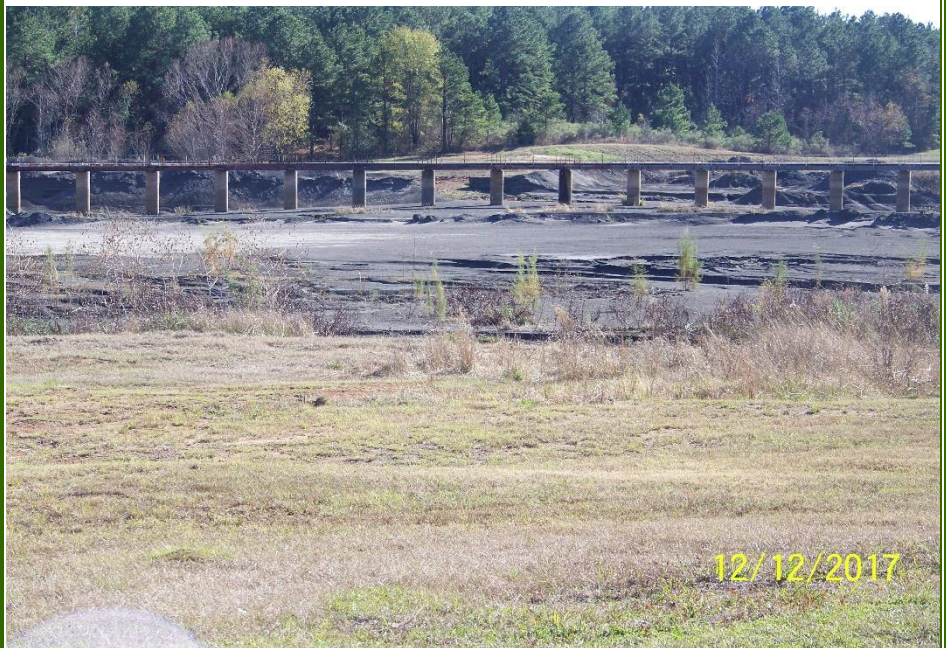
Ash Basin looking at sluice structure.

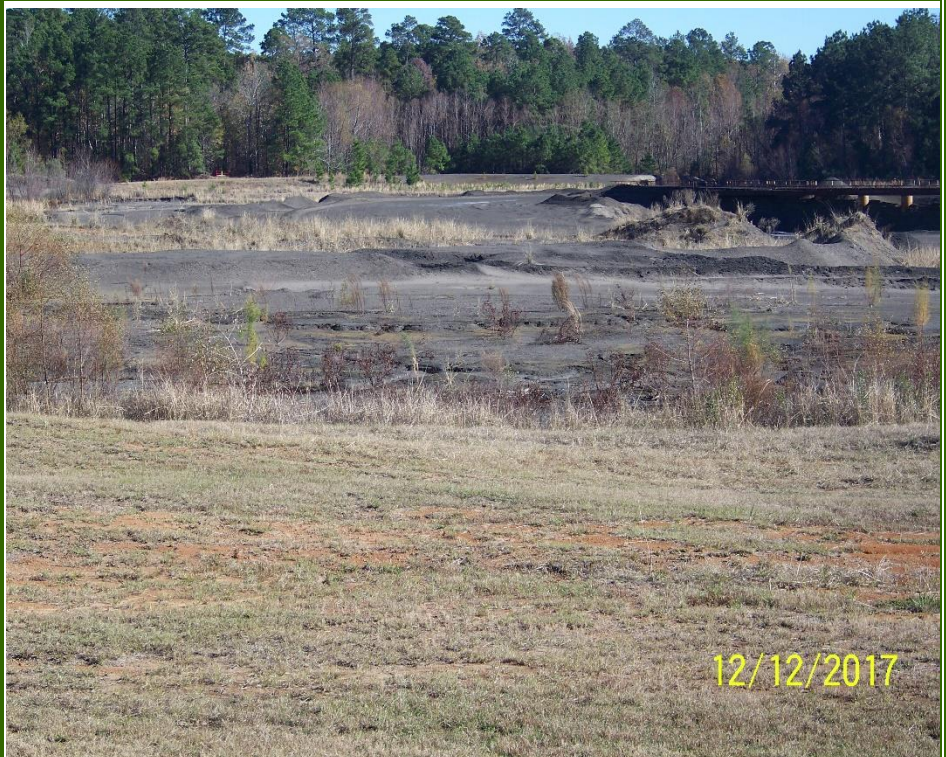
Ash Basin

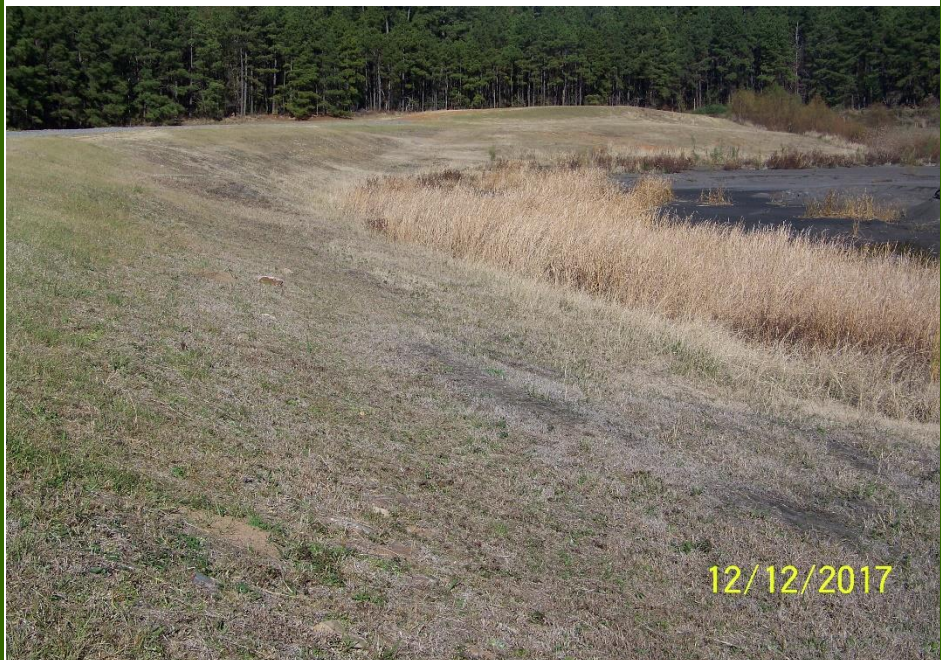
Internal slope of western levee.

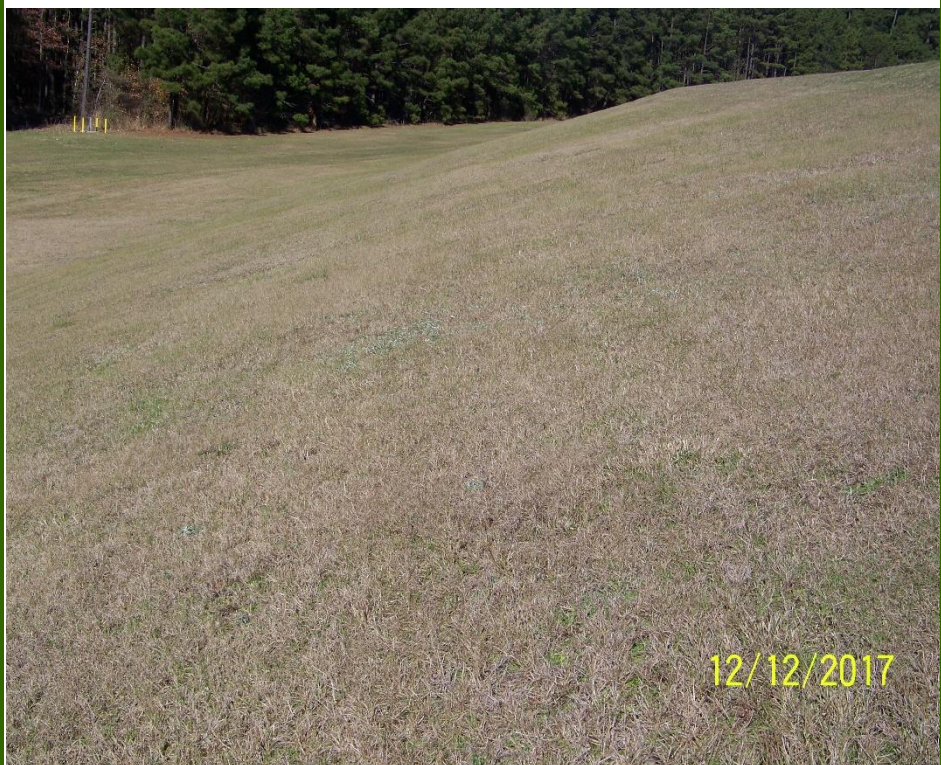
External slope of western levee.

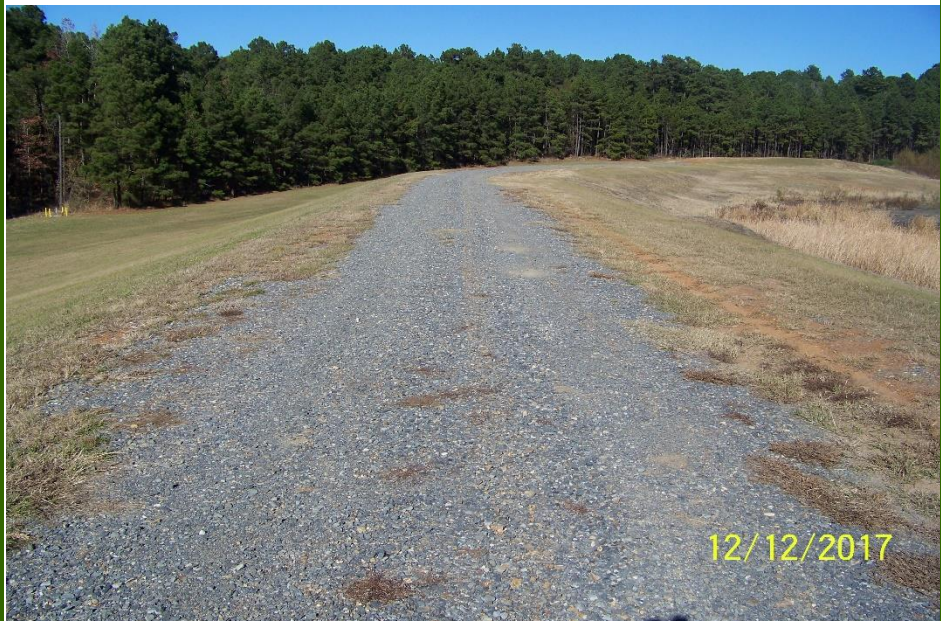
Access road on western levee.

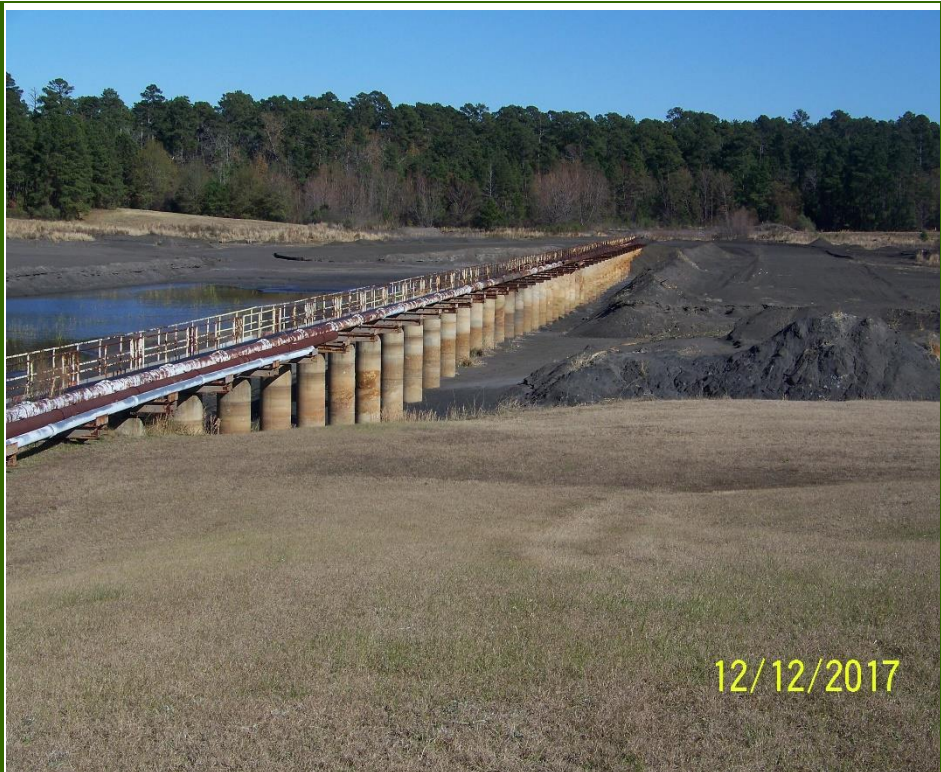
Bottom ash sluice structure.

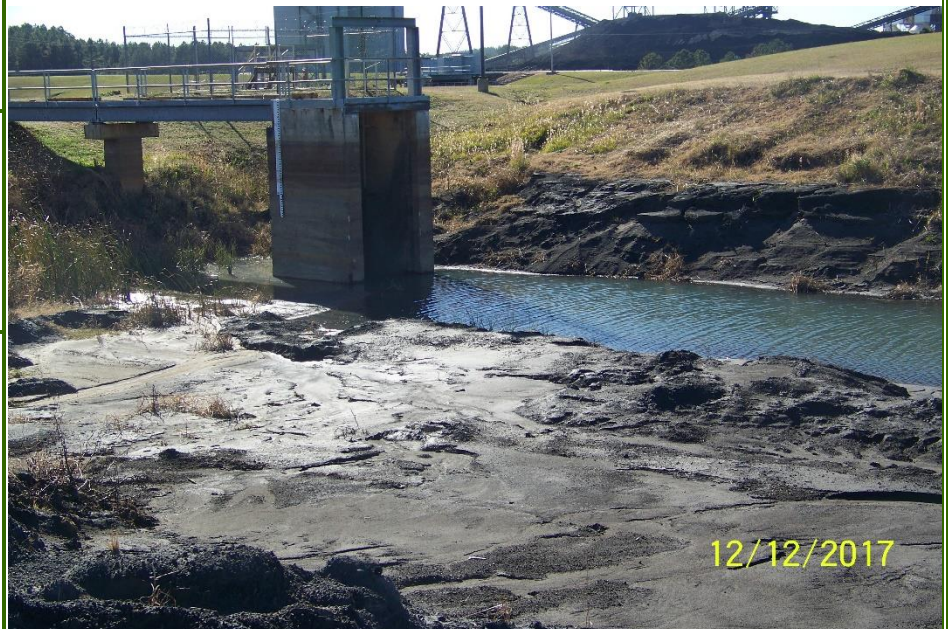
Overflow weir structure with level gauge.

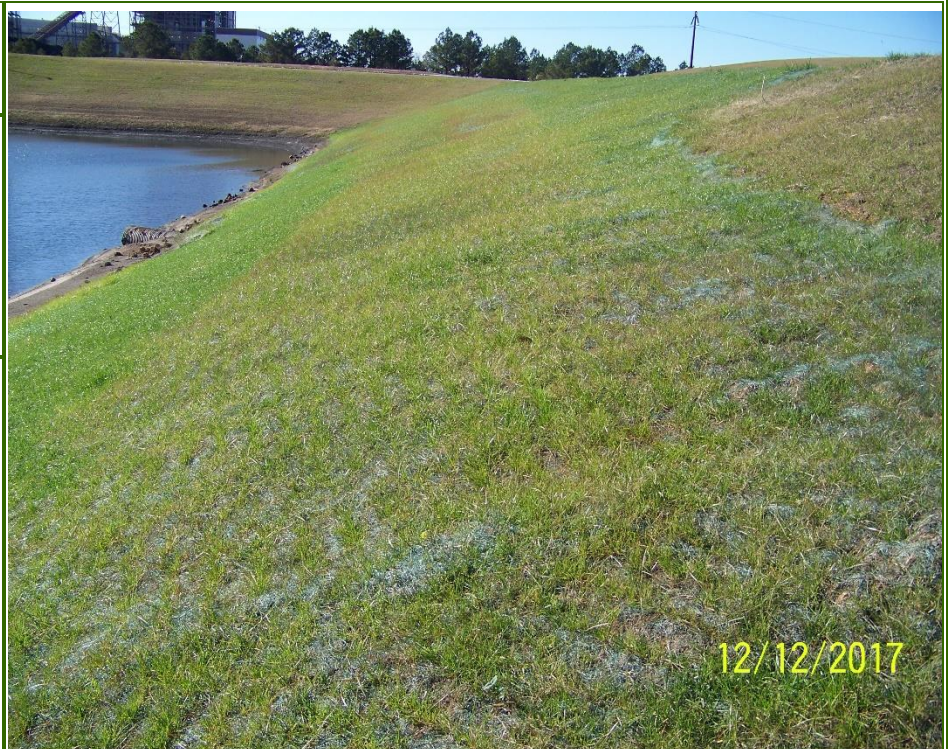
Exterior slope of southern levee.
