ANNUAL CCR SURFACE IMPOUNDMENT INSPECTION:			
Facility Name:		Cleco Dolet Hills Power Station	
Address:		963 Power Plant Rd. Mansfield, LA	
Surface Impoundment Name :	Ash Basin No. 1	Owner:	Cleco Power LLC
Surface Impoundment ID:	P-0037	Operator:	Cleco Power LLC
Nearest City:	Mansfield	Parish:	DeSoto
Inspector:		James C. Van Hoof, P.E.	
Company:		Providence Engineering & Environmental Group LLC	
Date of Inspection:		12/11/2019	
Weather at Time of Inspection:		Sunny, Cool	
DESCRIPTION OF THE OPERATION OF THE SURFACE IMPOUNDMENTS:			
<p>The bottom ash and economizer ash are mixed with water and sluiced in a slurry form to either of the two Ash Basins. Ash slurry pipelines within each basin enable the discharge of the slurry at multiple points within each basin. The discharge into each respective basin begins at the end of the pipeline network at the point furthest from the weir box, and proceeds toward the front of the pond. As a basin fills with ash, sections of the discharge pipe are removed as needed so that ash can be uniformly deposited and the storage capacity of each basin fully utilized. The ash-laden water is retained in the Ash Basins for a period of time sufficient to sett

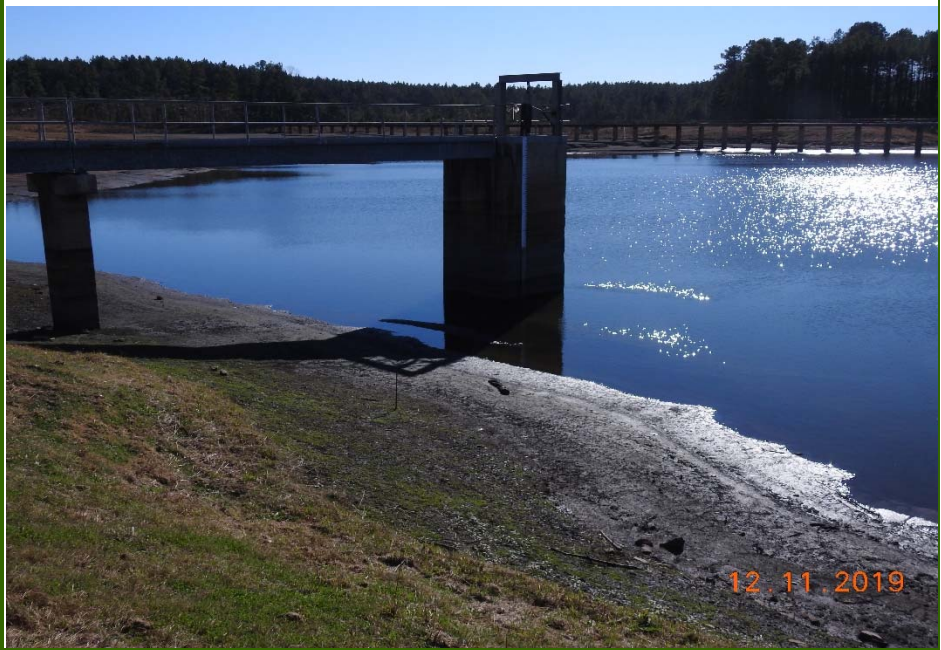
Ash Basin No. 1

Comments:
Overflow weir structure with concrete stoplogs. Level gauge attached to structure.

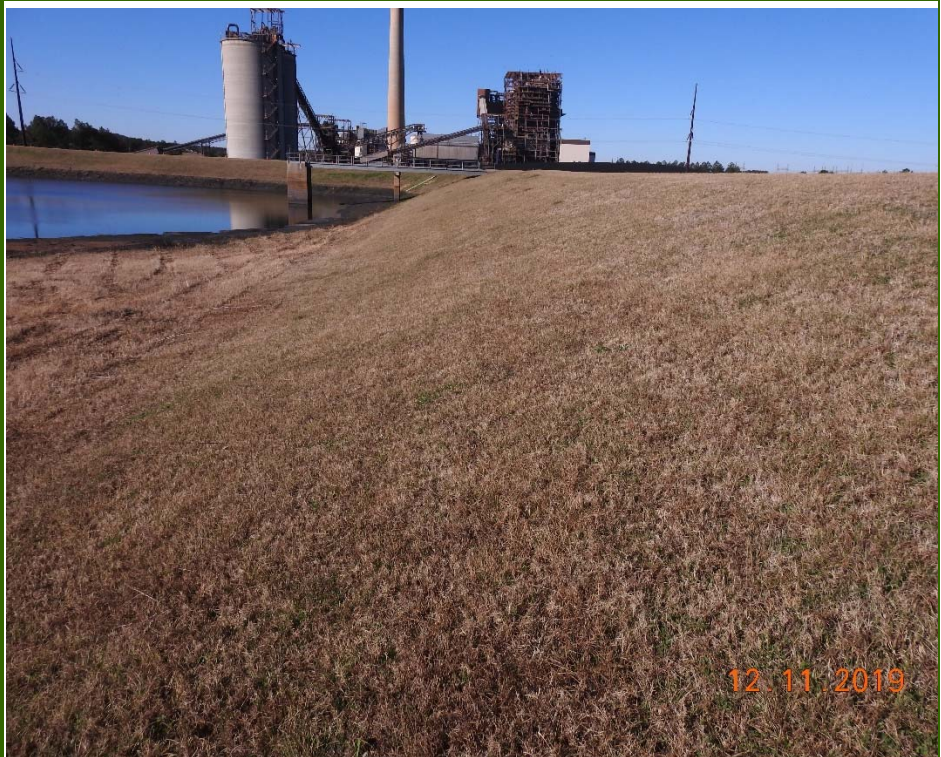
Ash Basin No. 1

Comments:
Internal slope of northern levee.

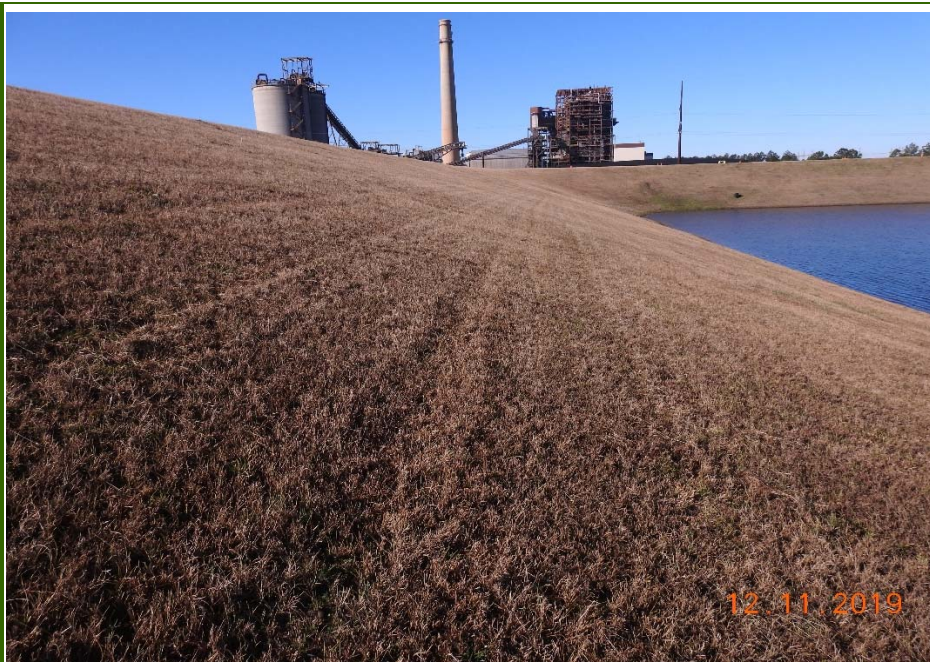
Ash Basin No. 1

External slope of northern levee.

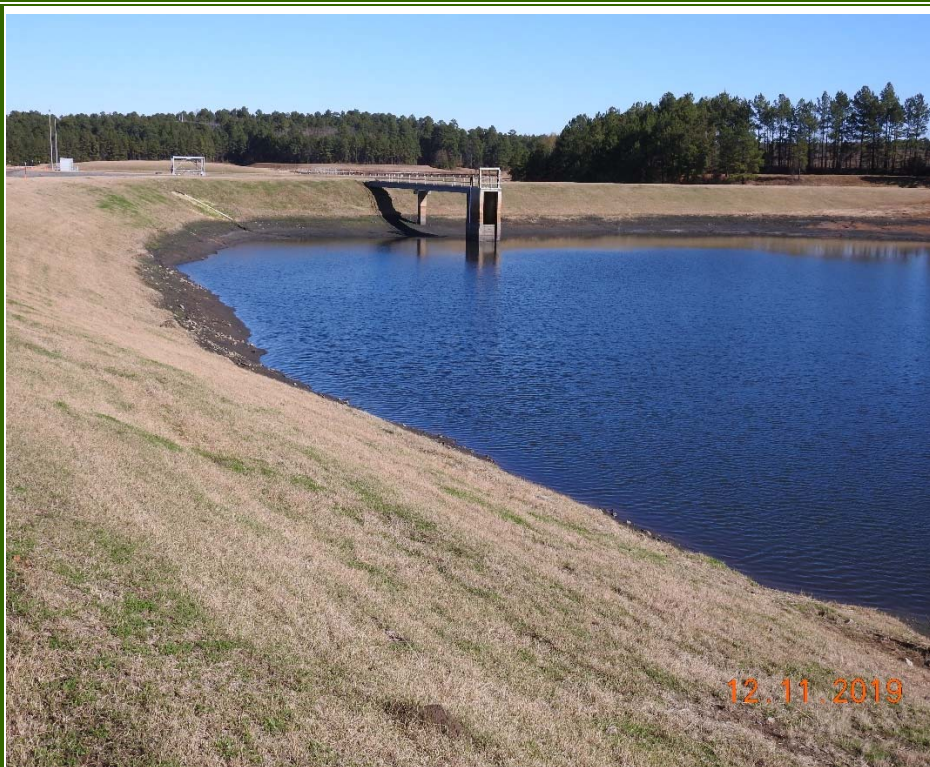
Ash Basin No. 1

Internal slope of western levee.

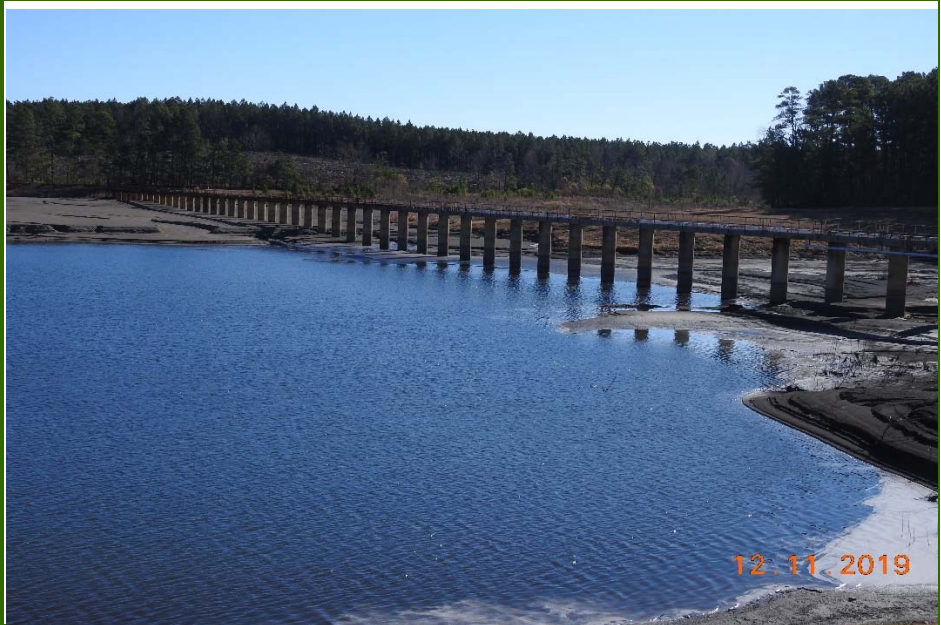
Ash Basin No. 1

Bottom ash sluicing structure in surface impoundment.

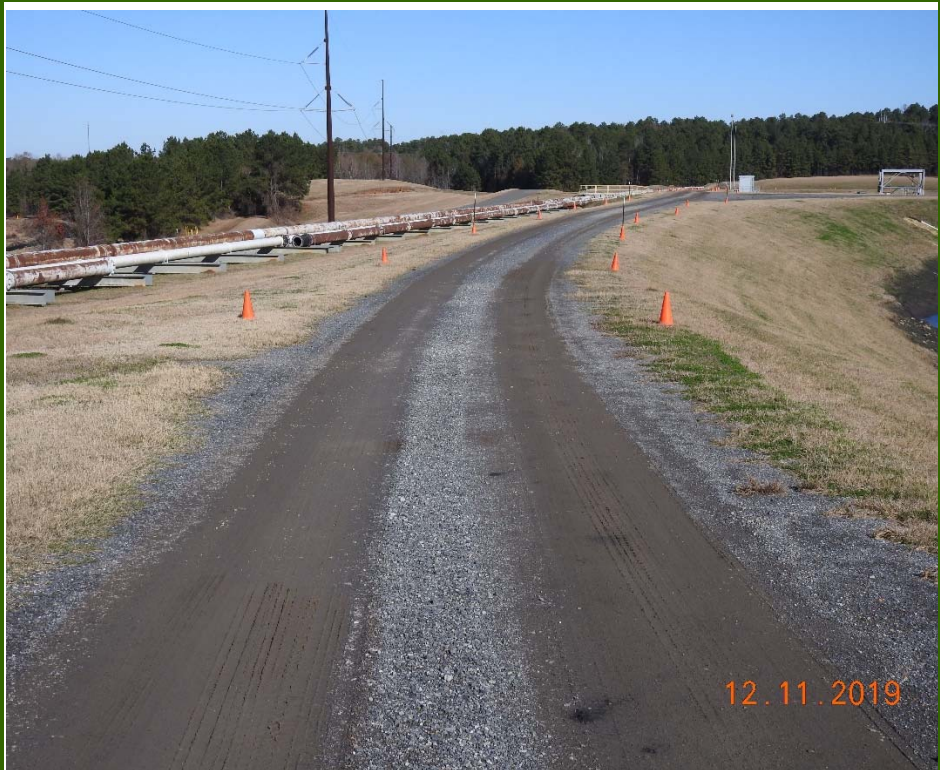
Ash Basin No. 1

Access road on western levee.

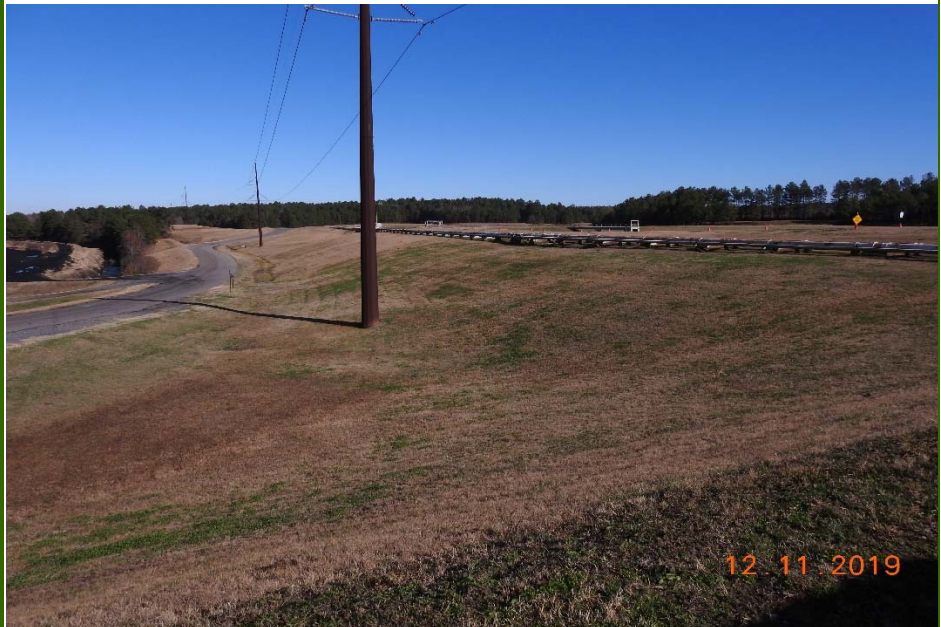
Ash Basin No. 1

Western exterior
levee slope.

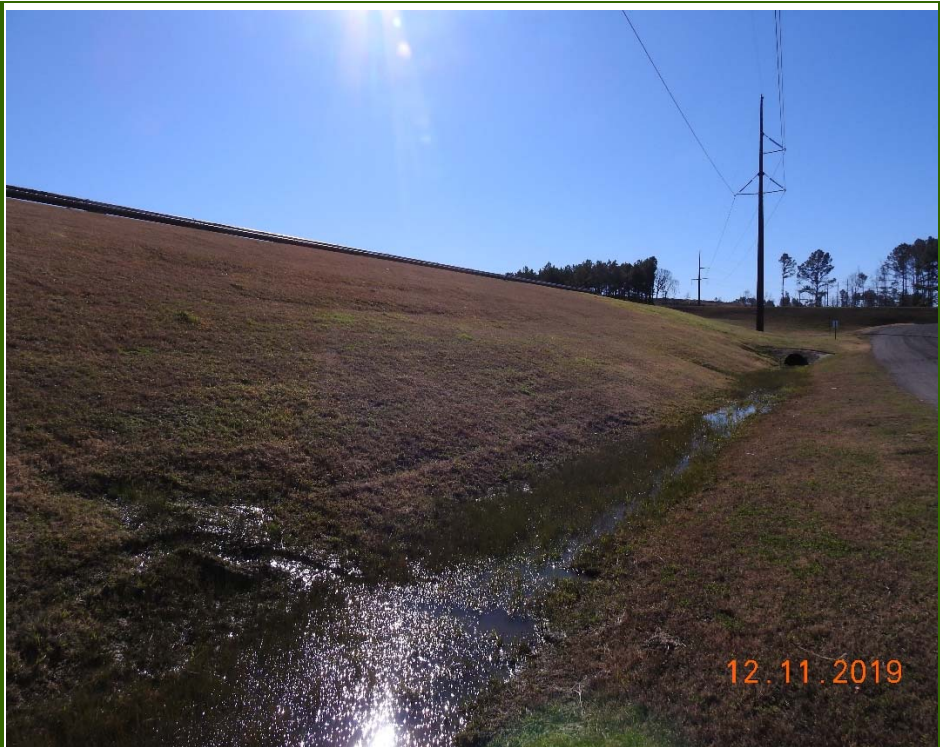
Ash Basin No. 1

Western exterior
levee slope.
