ANNUAL CCR SURFACE IMPOUNDMENT INSPECTION			
<b>Facility Name:</b>		Cleco Brame Energy Center	
<b>Address:</b>		275 Rodemacher Rd. Lena, LA	
<b>Surface Impoundment Name :</b>	Bottom Ash Pond	<b>Owner:</b>	Cleco Power LLC
<b>Surface Impoundment ID:</b>	P-0005R1	<b>Operator:</b>	Cleco Power LLC
<b>Nearest City:</b>	Boyce	<b>Parish:</b>	Rapides
<b>Inspector:</b>		James C. Van Hoof, P.E.	
<b>Company:</b>		Providence Engineering & Environmental Group LLC	
<b>Date of Inspection:</b>		12/17/2020	
<b>Weather at Time of Inspection:</b>		Sunny, Cool	
DESCRIPTION OF THE OPERATION OF THE SURFACE IMPOUNDMENTS:			
<p>The Brame Energy Center's Bottom Ash and Fly Ash surface impoundments are designed to accept the coal combustion residual (CCR) byproducts derived from burning of the Unit 2 coal for the generation of electricity. The ponds are classified by the Louisiana Department of Environmental Quality (LDEQ) as Type I Surface Impoundments. Water from the Fly Ash surface impoundment is pumped into the Bottom Ash impoundment which discharges by means of three pumps that discharge the wastewater through the outlet pipe on the western end of the pond. This water discharges into Lake Rodemacher via

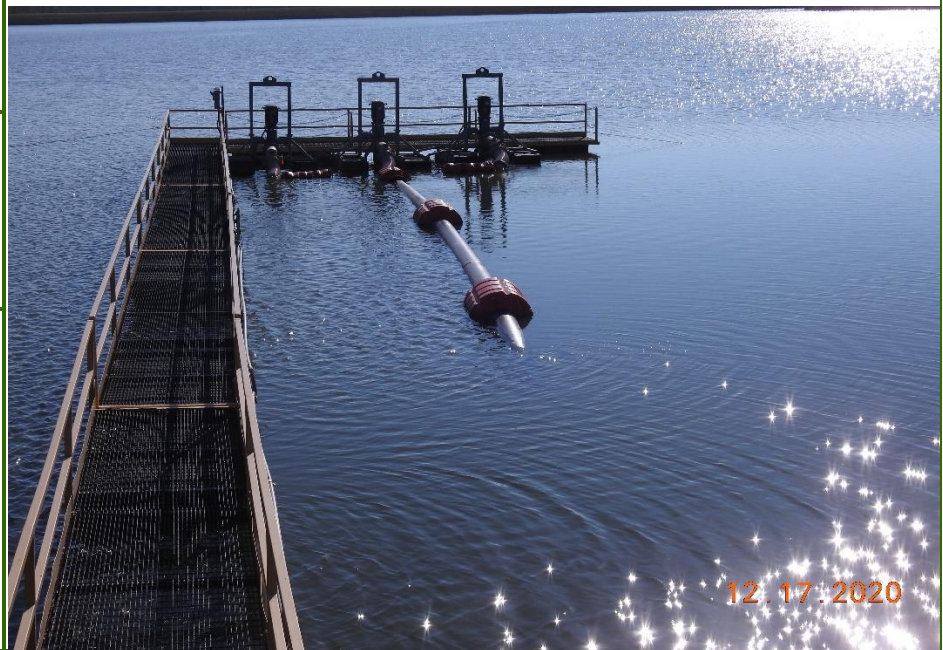
Floating pump structure in Bottom Ash Pond.

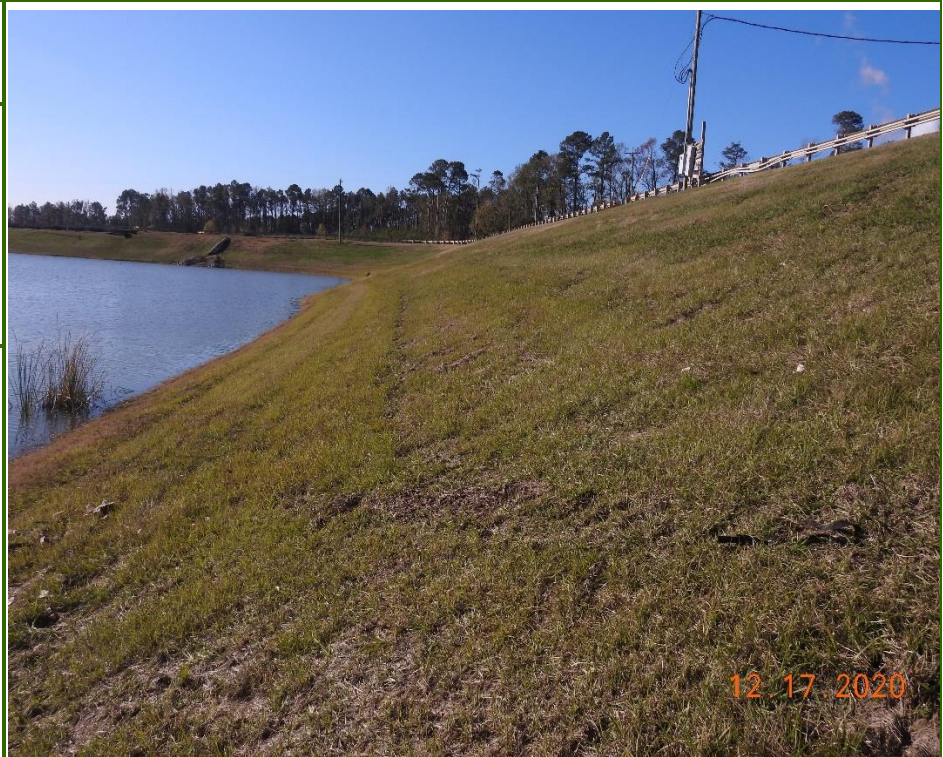
Western slope of interior levee.

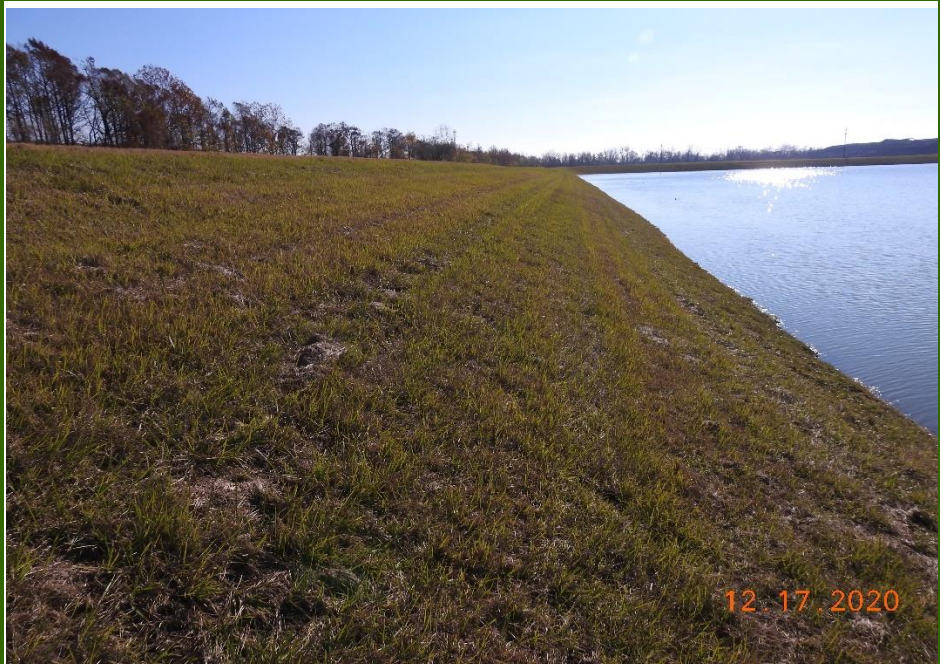
Northern slope of internal levee.

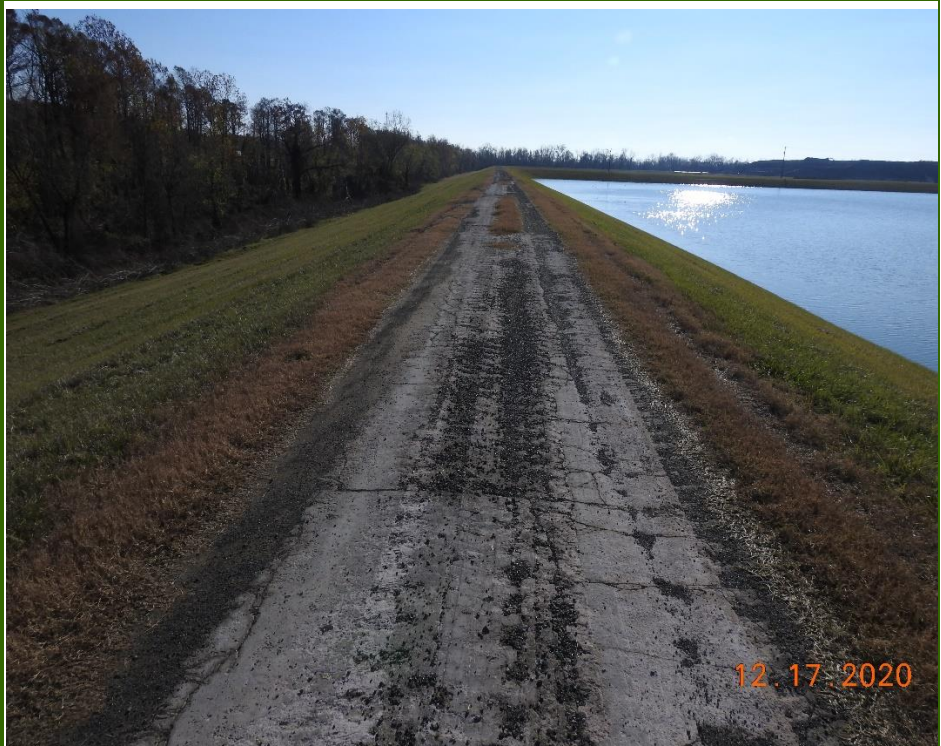
Crest of northern levee.

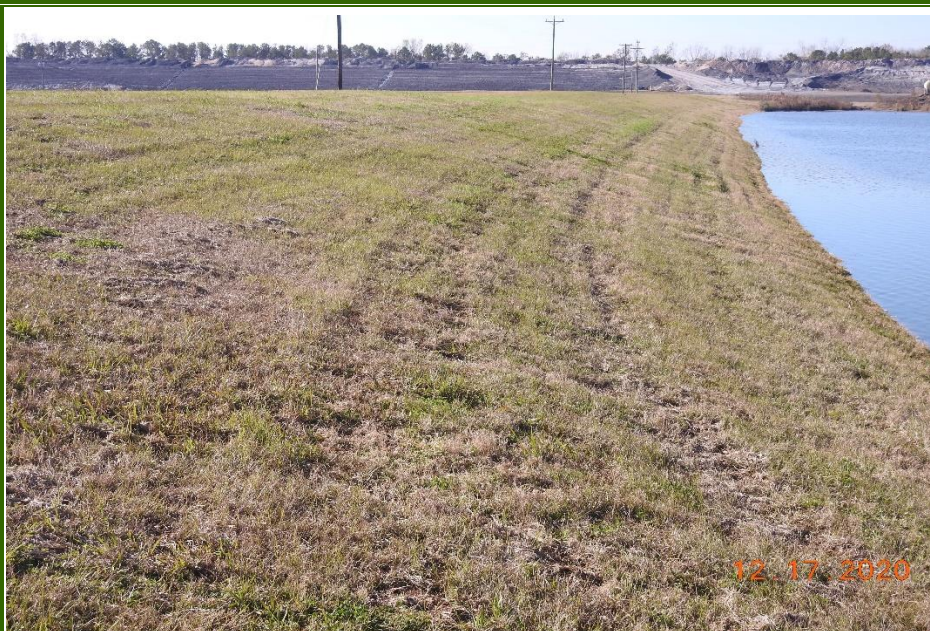
Inside slope of eastern levee.

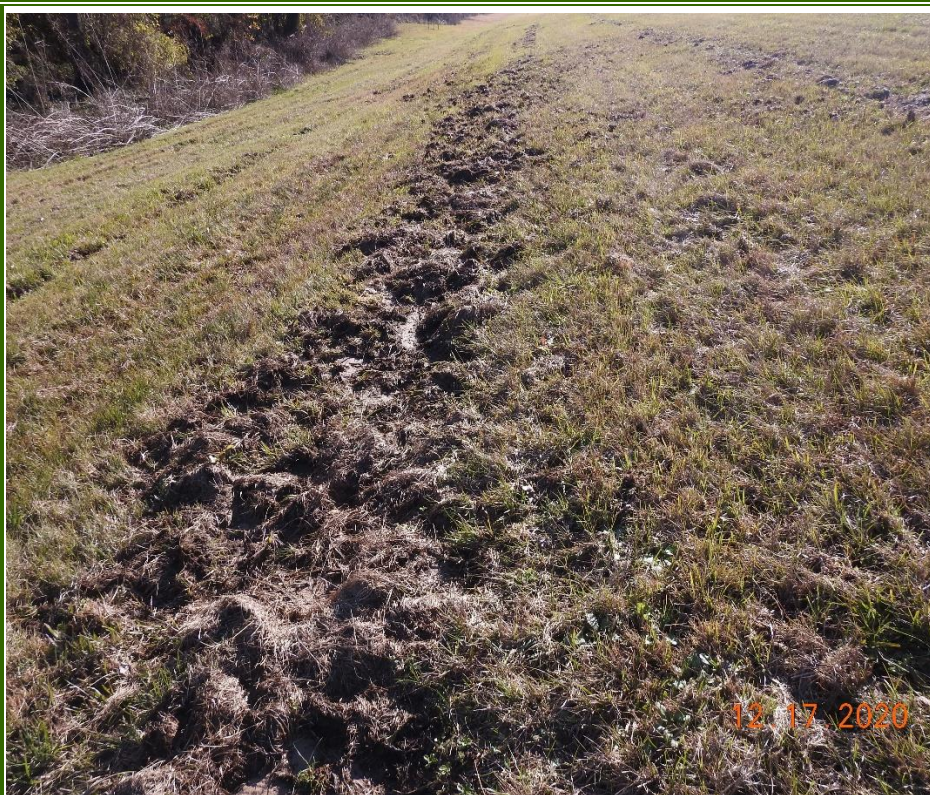
<b>DOCUMENTATION REVIEW:</b>	
<b>Weekly Inspections Reviewed:</b>	<input checked="" type="checkbox"/> Yes <input type="checkbox"/> No
<b>Findings:</b> Feral hogs rutted topsoil on levees. Storm debris from Hurricane Laura removed from levees.	
<b>Monthly Instrument Inspections Reviewed:</b>	<input checked="" type="checkbox"/> Yes <input type="checkbox"/> No
<b>Findings:</b> Level gauge leaning and then destroyed in Hurricane. New gauge to be installed.	
<b>Groundwater Monitoring:</b>	Monitoring wells are in-place.
<b>Drawings Reviewed:</b>	<input checked="" type="checkbox"/> Yes <input type="checkbox"/> No
<b>Are there any changes in the geometry of the surface impoundment structure since the previous inspection?</b>	<input type="checkbox"/> Yes <input checked="" type="checkbox"/> No <input type="checkbox"/> NA
If yes, describe (size, location, etc.)	
<b>Other observations:</b>	None

Area along the northern exterior levee showing where the feral hogs have recently rooted the topsoil.

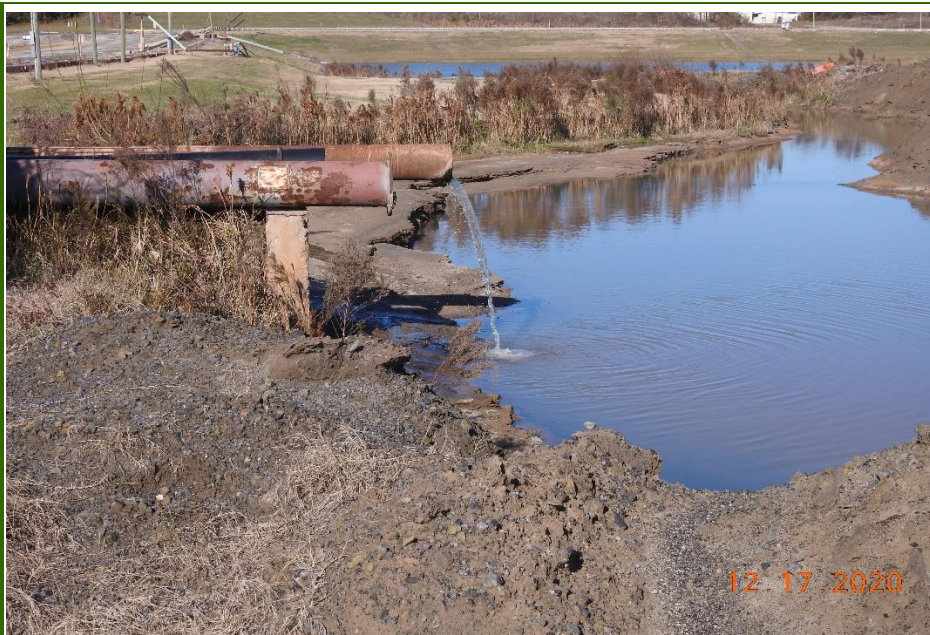
Sluice pipe discharging into the Bottom Ash Pond.

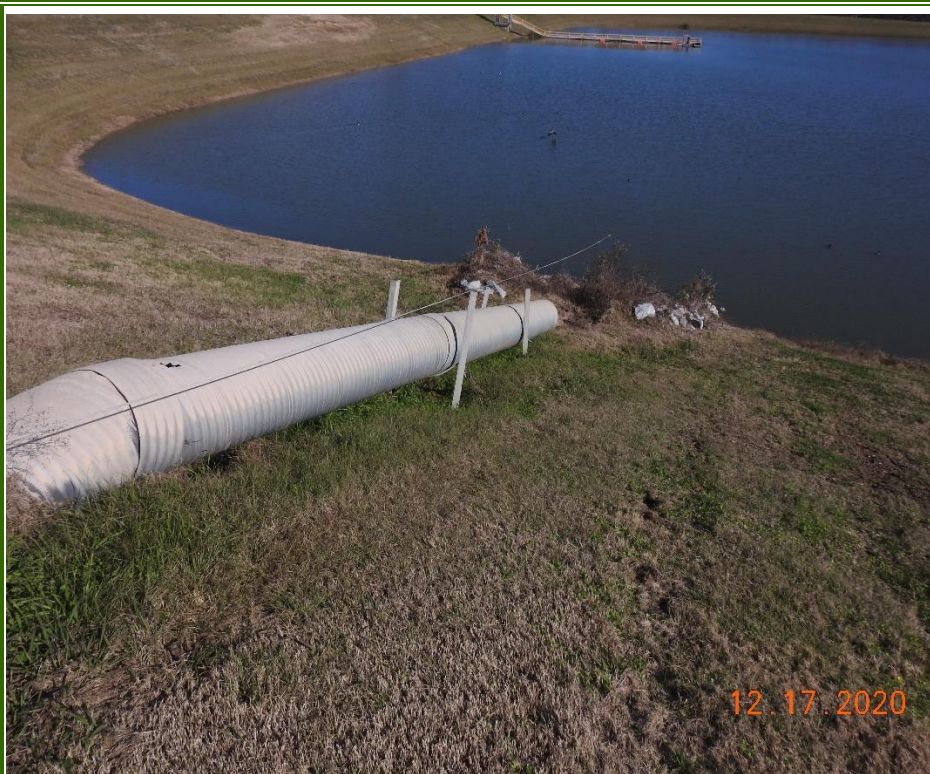
Storm water discharge pipe from sluice pipe trench.

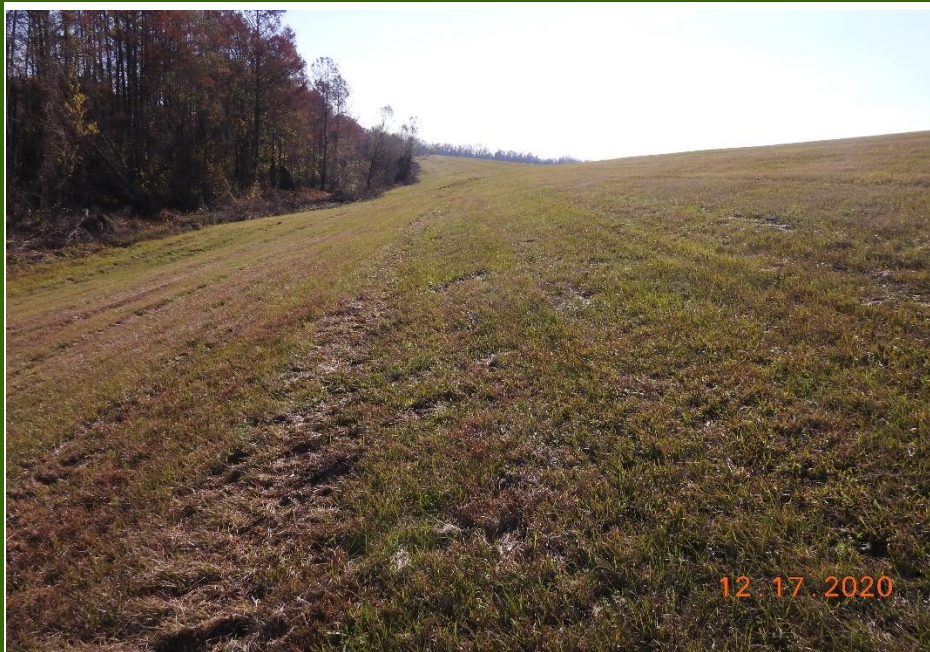
Exterior slope of northern levee.

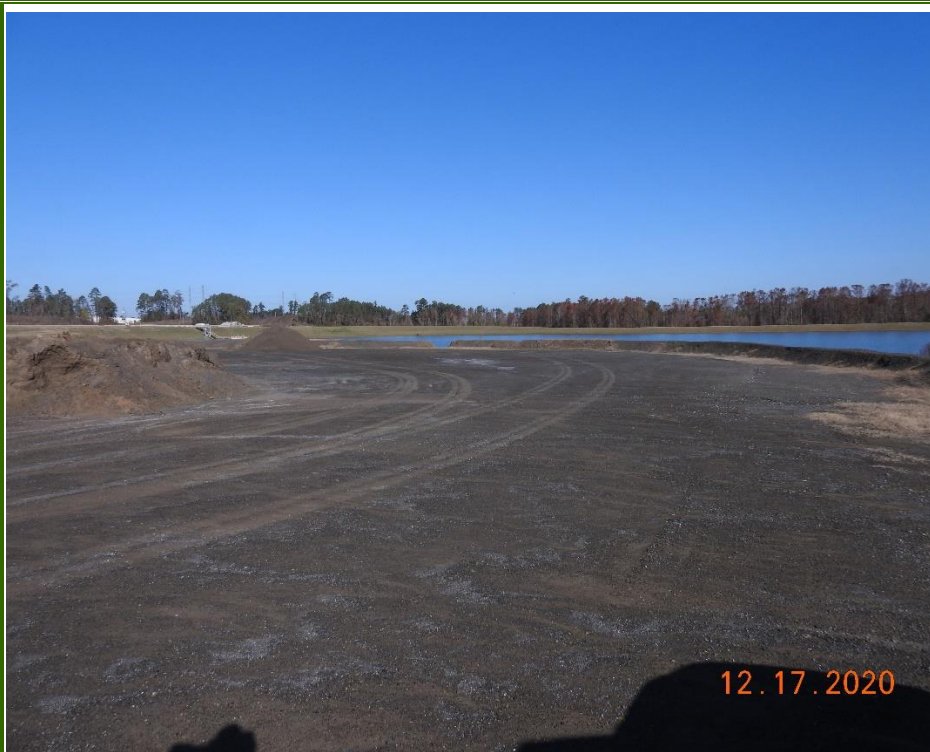
Bottom ash shown in southeast corner of Bottom Ash Pond.

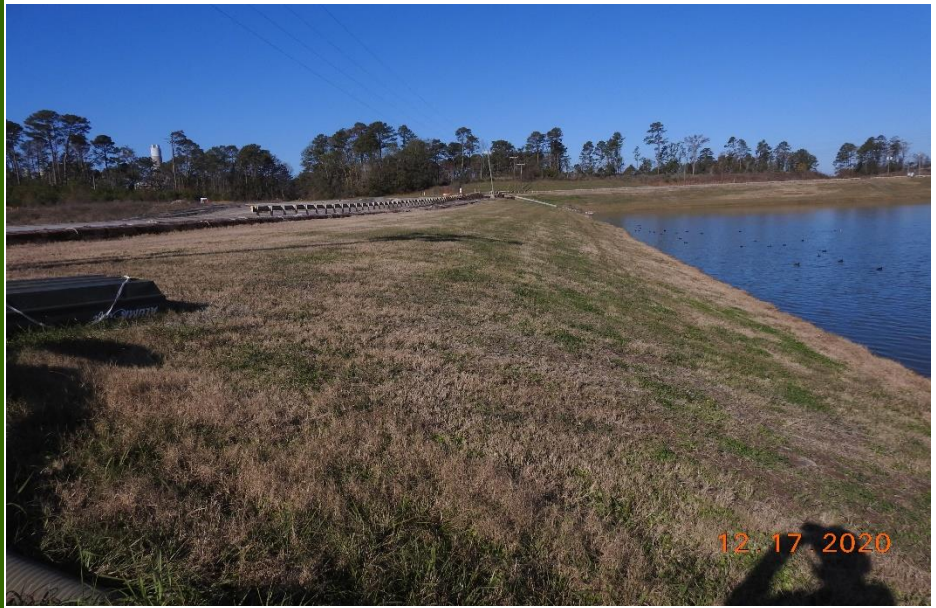
Interior slope of southern levee.

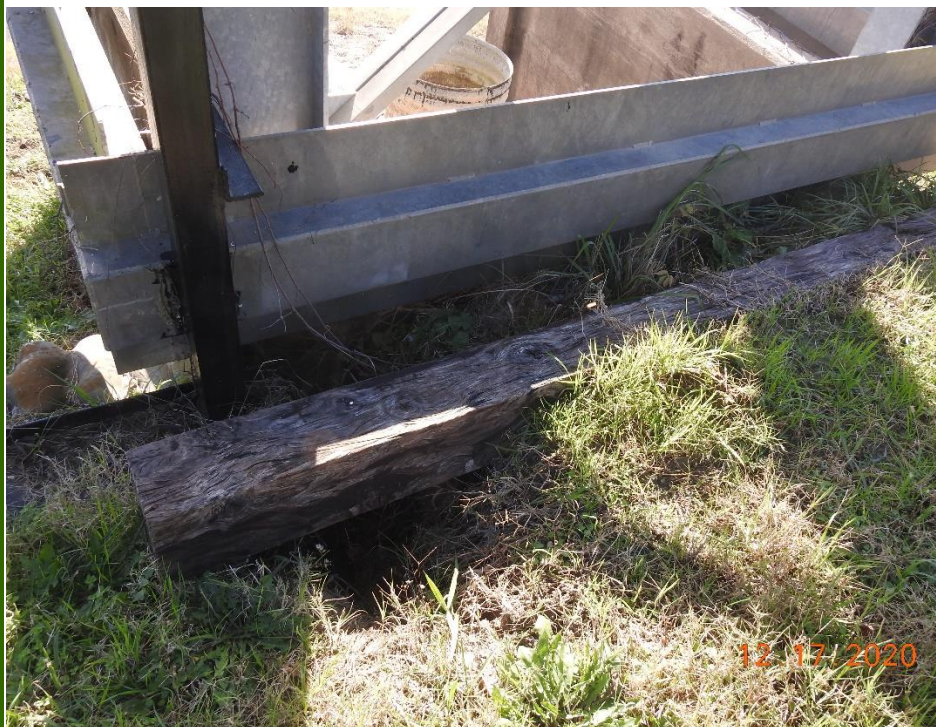
<b>PHYSICAL DAM FEATURES – OUTLET WORKS:</b>	
<b>Number of Outlets:</b>	One
<b>Outlets/Culvert Pipe Sizes:</b>	12 Inches
<b>Type of Pipes:</b>	HDPE that runs through 24 inch CMP
<b>Control:</b>	Pump level controls
<b>Can Flow be Shutoff or Bypassed:</b>	<input checked="" type="checkbox"/> Yes <input type="checkbox"/> No
<b>Describe the overall condition of the hydraulic structure: (Check all that apply)</b>	<input checked="" type="checkbox"/> Functioning Normally <input type="checkbox"/> Not Functional <input type="checkbox"/> Deteriorated <input type="checkbox"/> Damaged <input type="checkbox"/> Adequate <input type="checkbox"/> Inadequate Other:(describe)
<b>Is there evidence of erosion around the hydraulic structure?</b>	<input checked="" type="checkbox"/> Yes <input type="checkbox"/> No
If yes, describe (size of area, location, severity, etc.) Minor erosion at base of concrete structure needs to be corrected.

Minor erosion at discharge structure needs to be corrected.

<b>Is the hydraulic structure outlet flowing freely and unobstructed?</b>	<input checked="" type="checkbox"/> Yes <input type="checkbox"/> No
If no, describe ( type of debris, reason for obstruction, etc.)	
<b>Describe the quality of discharge from the hydraulic structure (turbidity, depth, etc.)</b>	The outflowing water is relatively clear and discharges to Lake Rodemacher via LPDES Outfall 401 which cycles back to the plant.
<b>Findings:</b>	The outlet works were inspected and appeared to be in satisfactory condition. Minor corrective actions are required at this time to correct erosion issues.
<b>Other observations on the outlet works:</b>	None
