CLECO POWER LLC

BRAME ENERGY CENTER

5-YEAR PERIODIC REVIEW

STRUCTURAL STABILITY ASSESSMENT

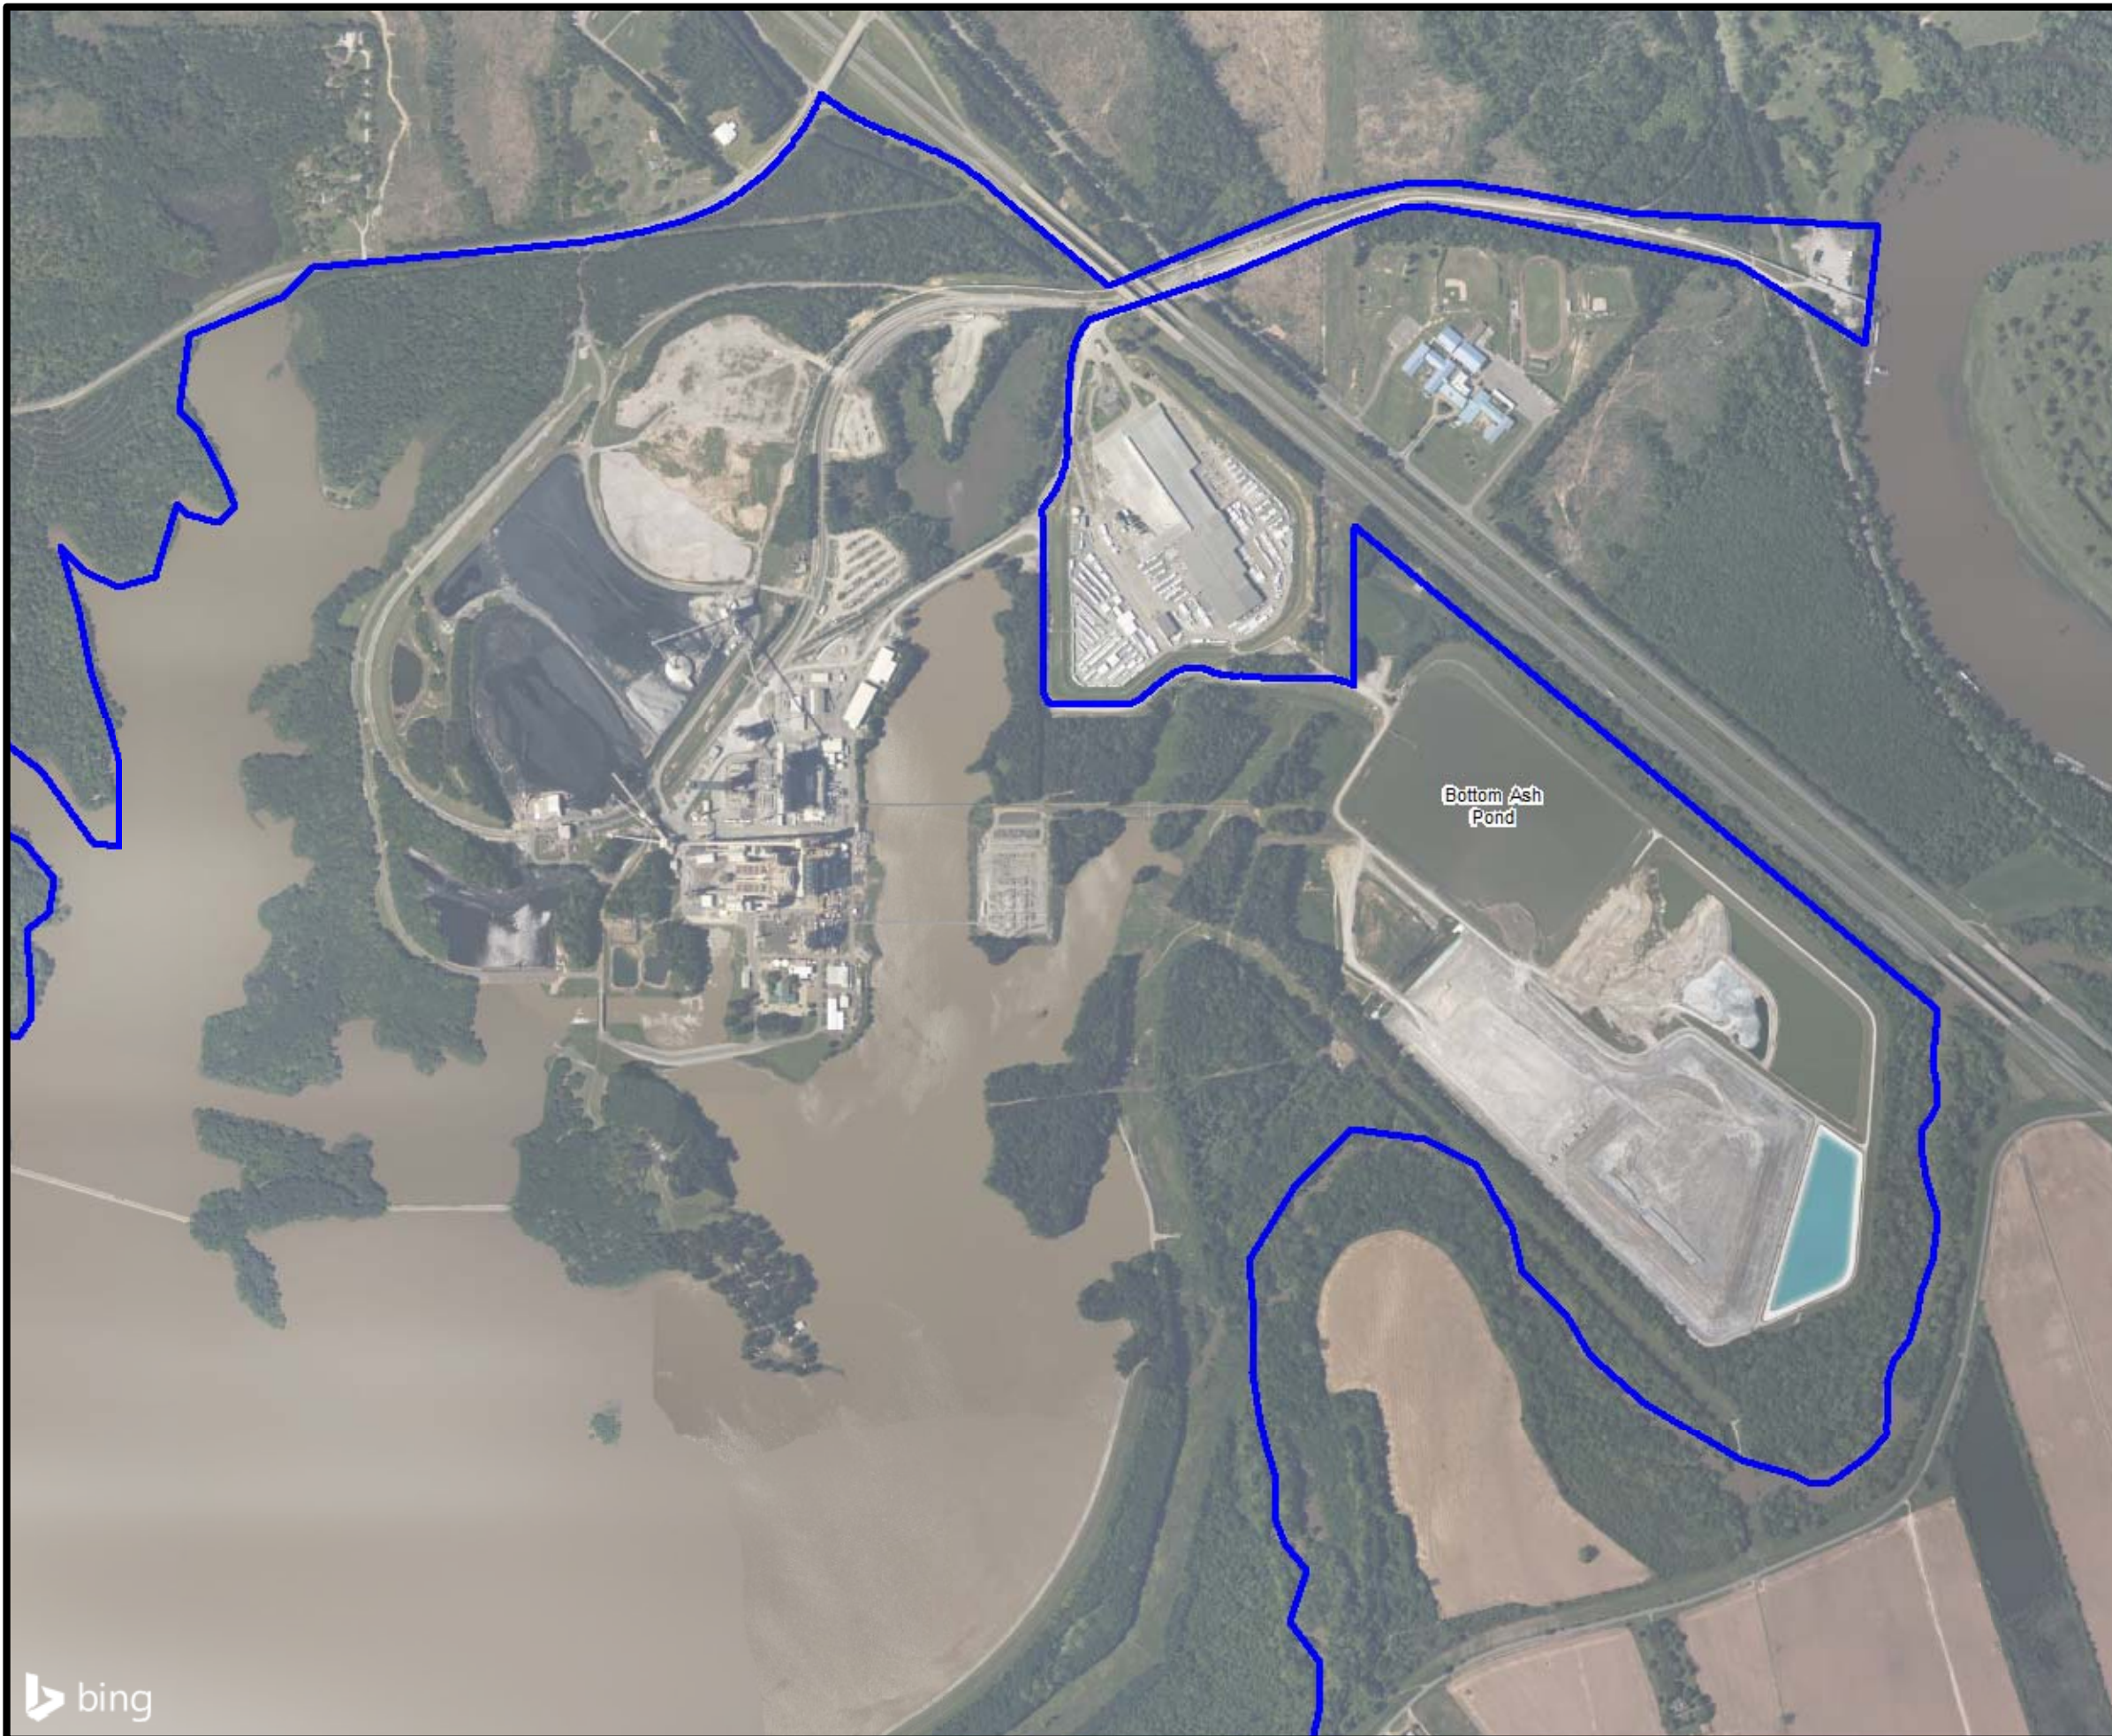
FIGURE 2
SITE MAP

This 5-year review of the structural stability assessment pertains to the Bottom Ash surface impoundment (Pond) that is utilized for the Rodemacher Unit 2 coal-fired generation unit. The Brame Energy center is located approximately 6 miles southeast of Lena, Rapides Parish, Louisiana. A site location map is included as **Figure 1**. The Bottom Ash Pond is shown on **Figure 2**.
