# **CLECO POWER LLC BRAME ENERGY CENTER**

## **5-YEAR PERIODIC REVIEW SAFETY FACTOR ASSESSMENT**

### **FLY ASH POND**

**OCTOBER 2021**

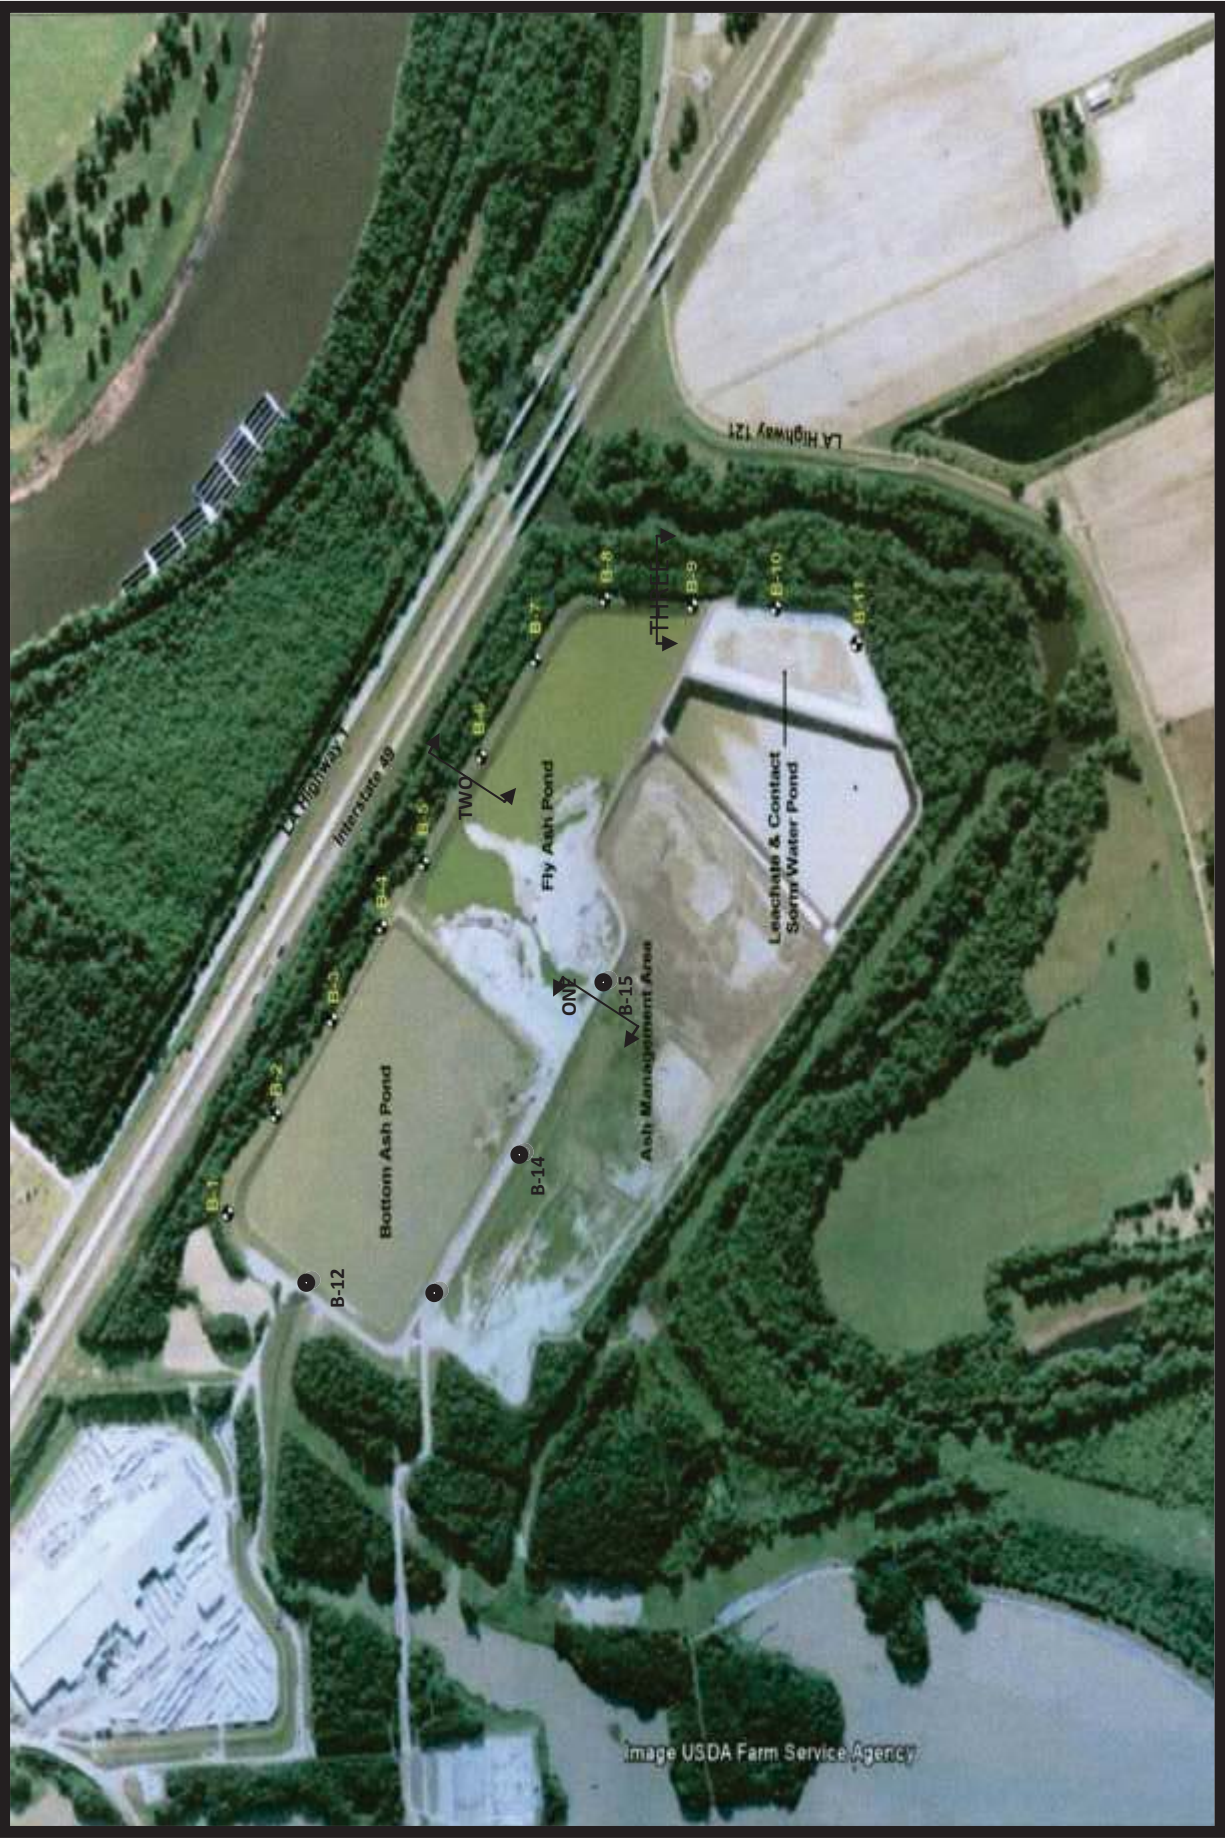
**CLECO BRAME ENERGY CENTER  
 FLY ASH POND - SECTION 1  
 SHORT TERM SLOPE STABILITY ANALYSIS  
 SOIL BORING B-15 (FROM GTL REPORT NO.: 04-16-061)**

Pond	Section #	Condition	Flood Side Water Elevation (feet, NAVD88)	Factor of Safety Obtained	Notes
Fly Ash Pond	1	Short Term	102.5	1.56	Landfill Material is required on the protected side of the levee to achieve min. FS.
	1	Long Term	102.5	2.48	--
	2	Short Term	102.5	1.80	--
	2	Long Term	102.5	1.53	--
	3	Short Term	102.5	2.71	--
	3	Long Term	102.5	1.79	--
