BRAME ENERGY CENTER

CCR ANNUAL INSPECTION

FLY ASH POND

JANUARY 2023

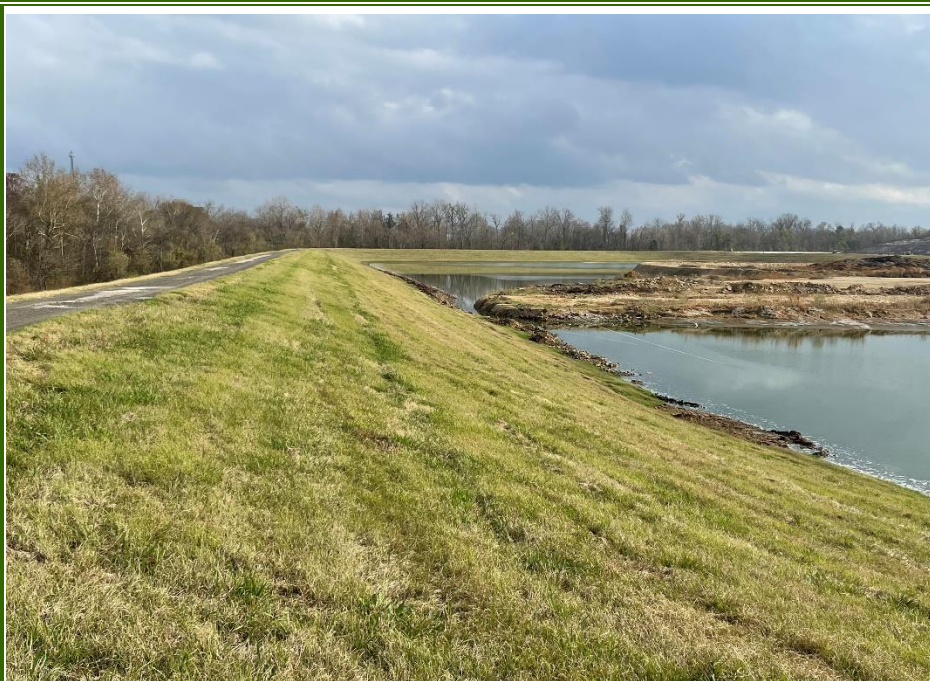
Interior slope of northern levee.

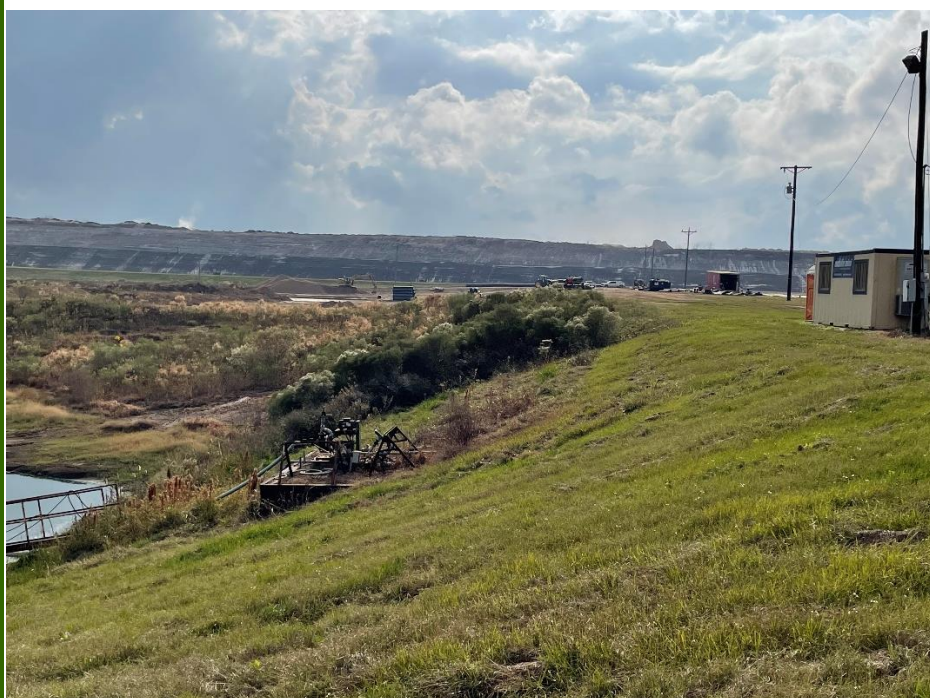
Pump system in Fly Ash Pond that pumps discharge water into the Bottom Ash Pond and Western interior levee slope.

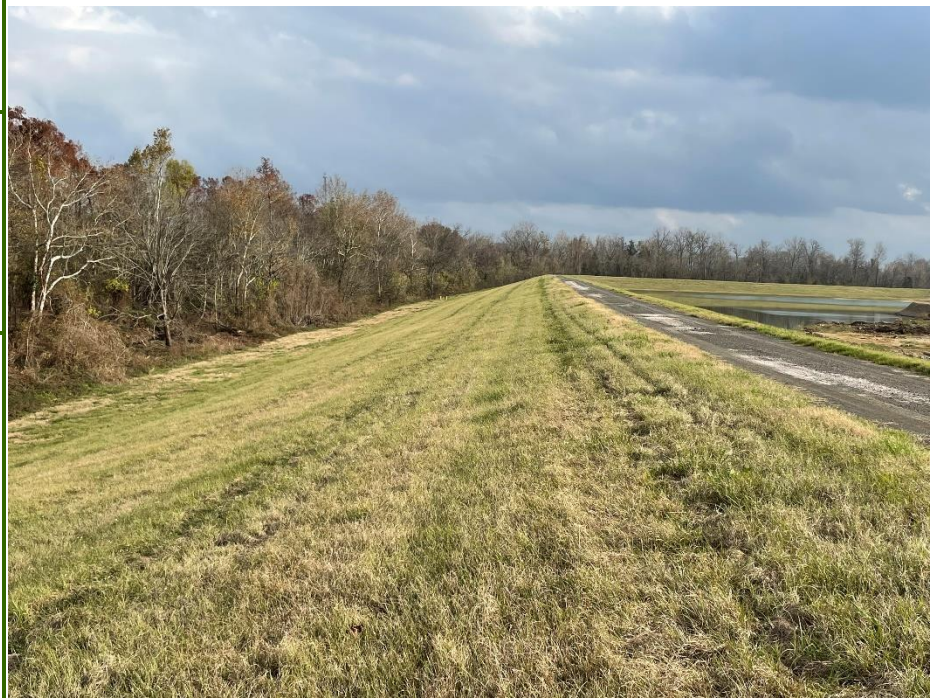
Crest along the northern levee and exterior slope.

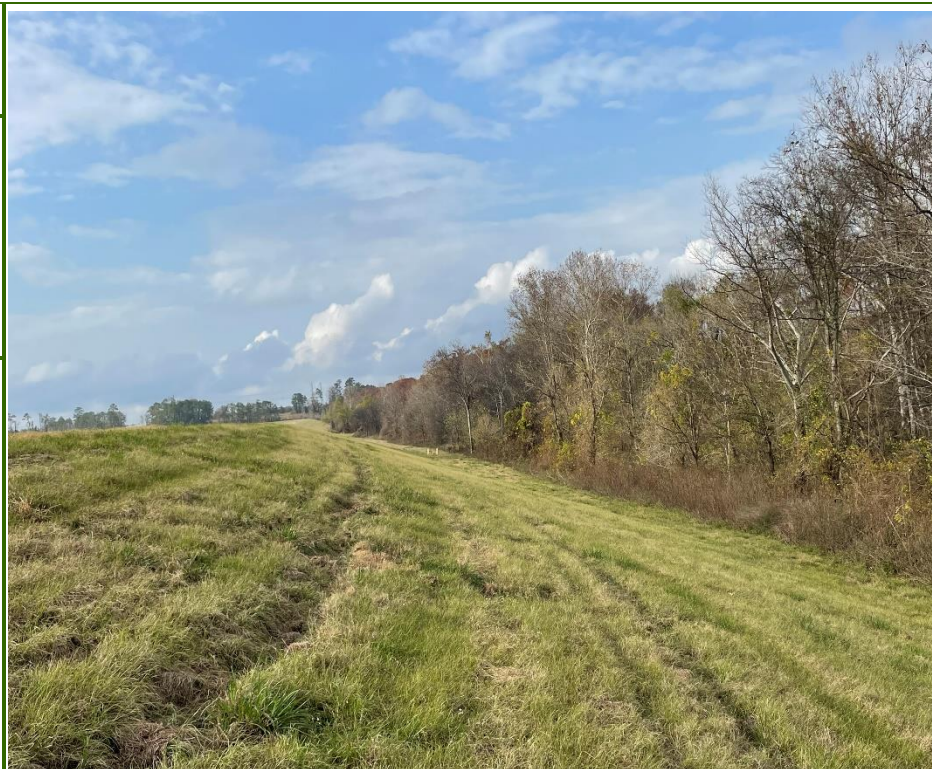
Northern exterior levee slope.

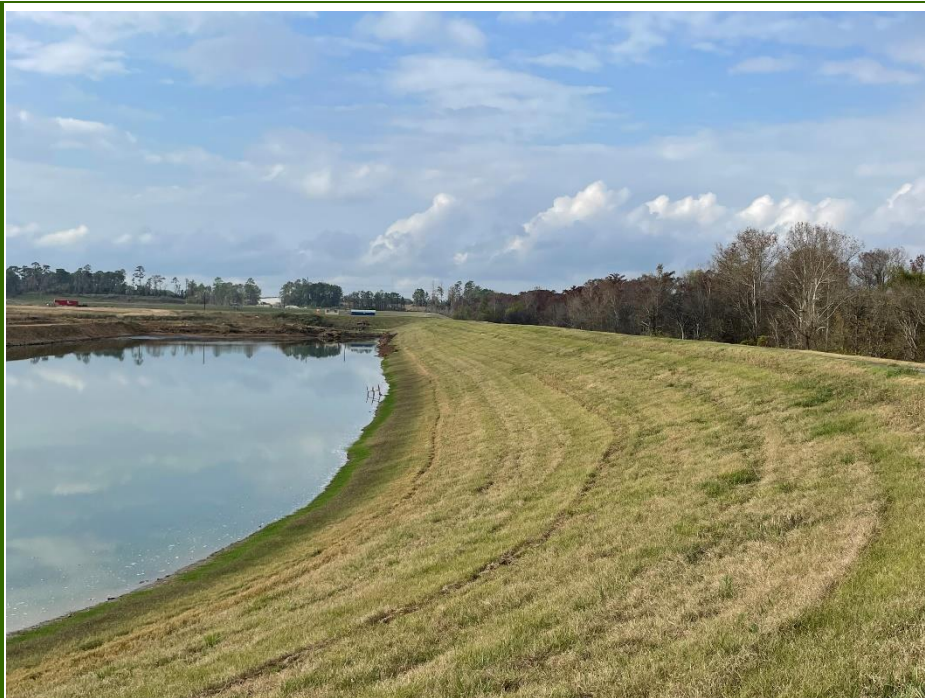
Interior slope of northern levee.

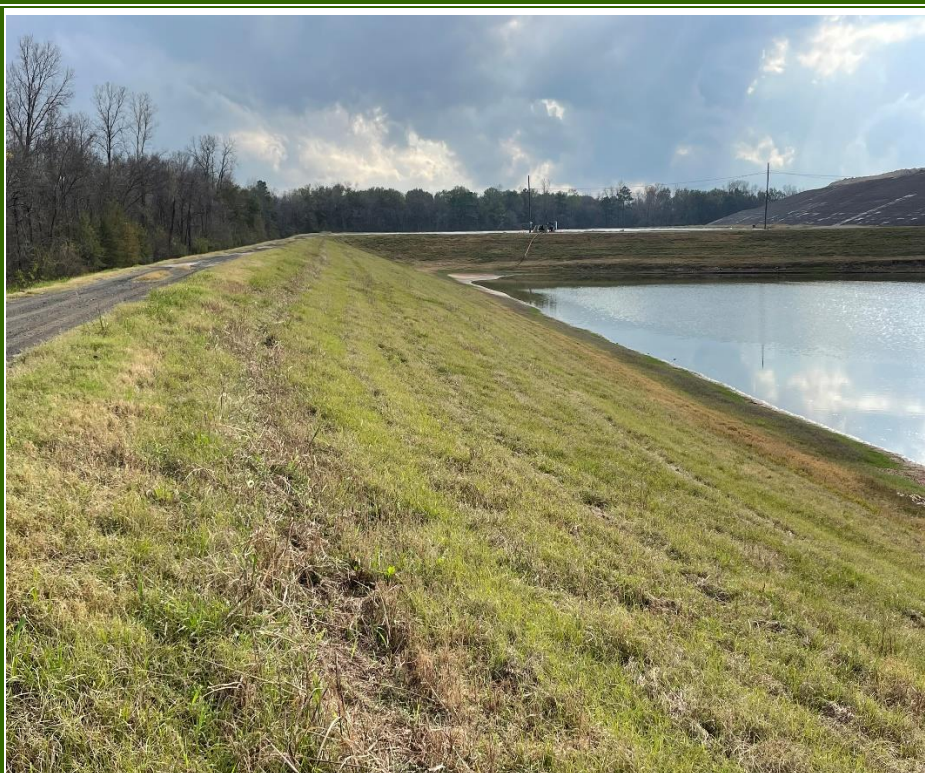
Interior slope of eastern levee.

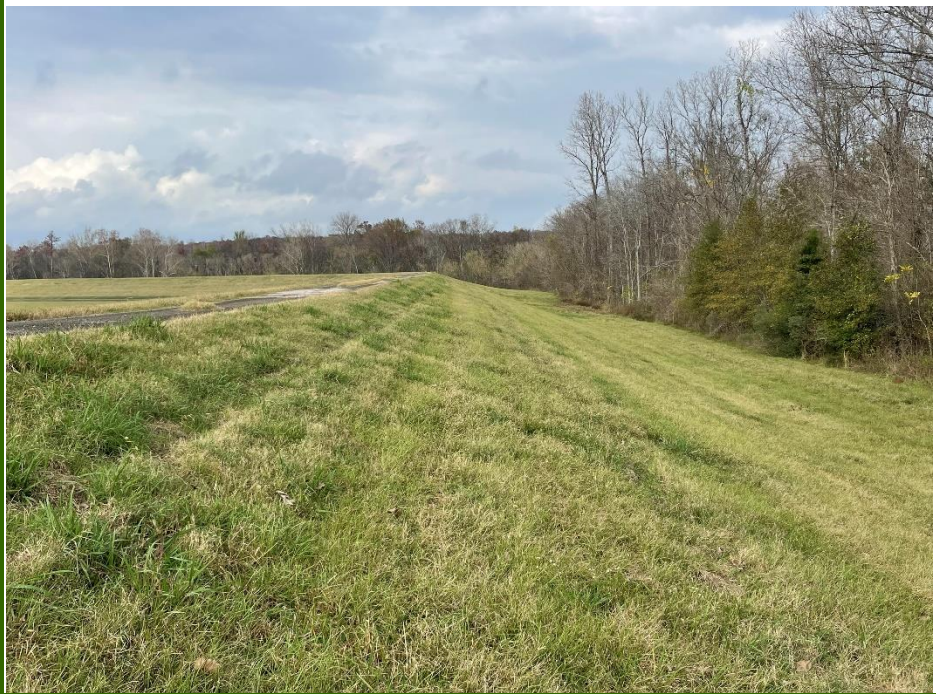
Exterior slope of eastern levee.

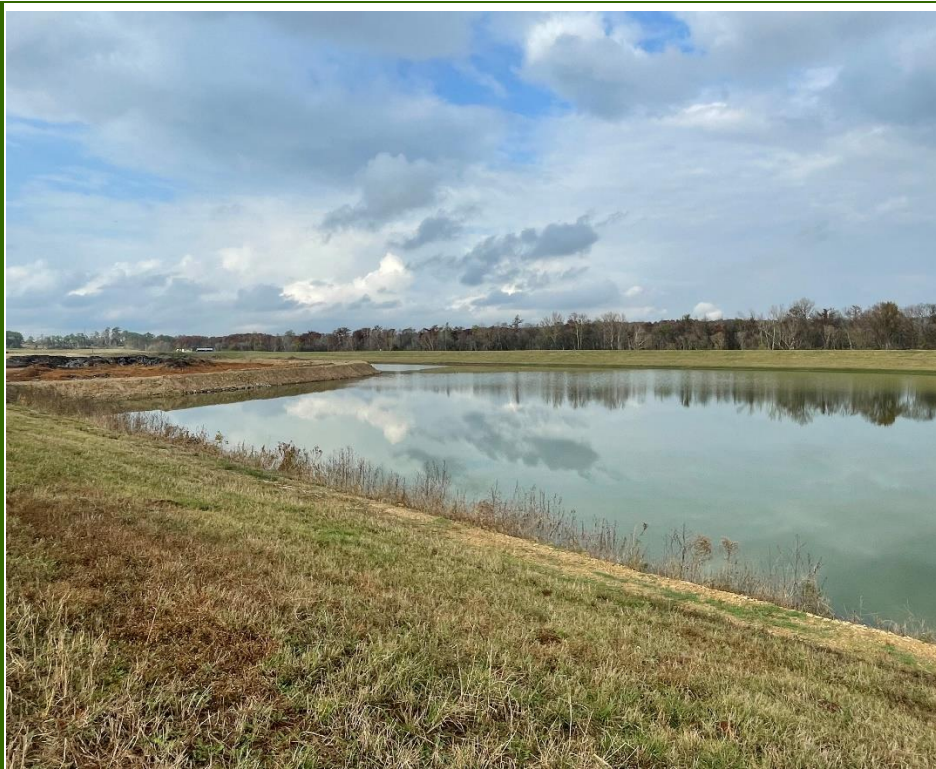
Interior slope of southern levee.

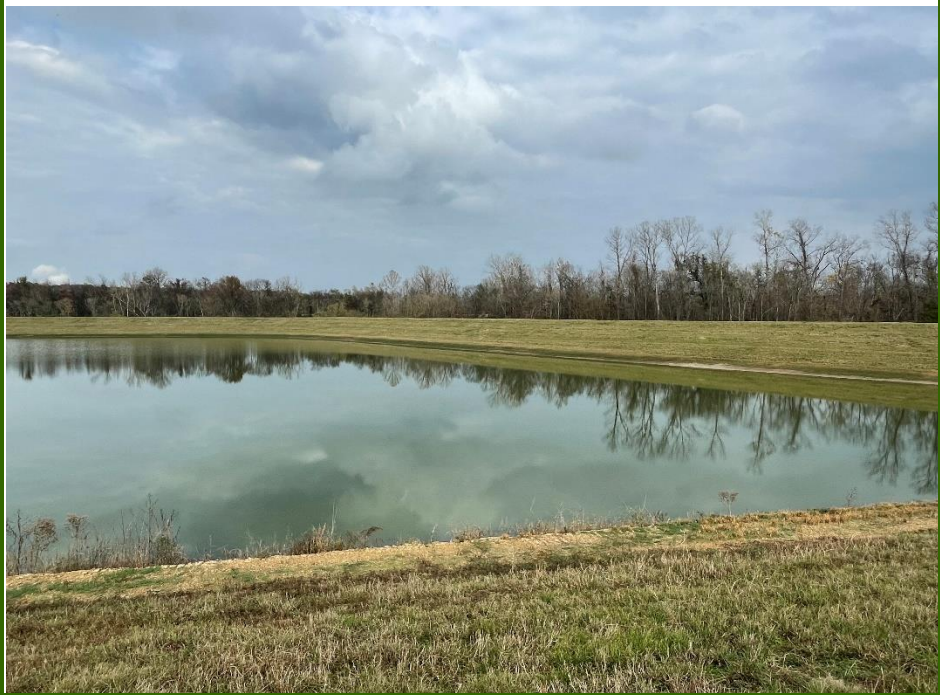
Comments:
Interior slope on eastern levee.

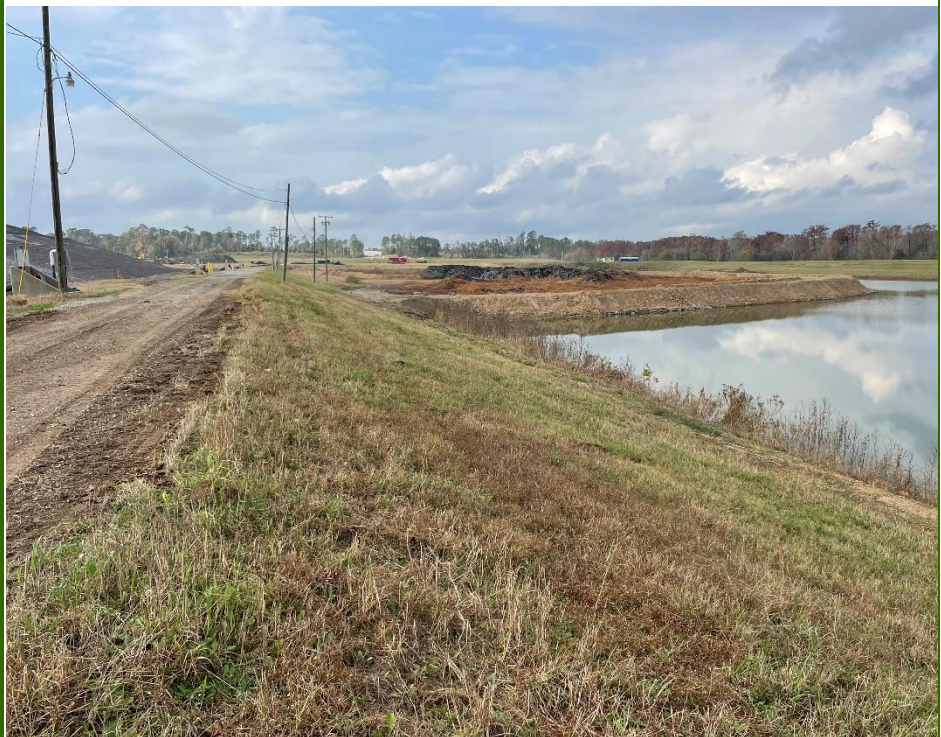
Comments:
Interior slope on southern levee.
