ANNUAL CCR SURFACE IMPOUNDMENT INSPECTION			
Facility Name:		Cleco Brame Energy Center	
Address:		275 Rodemacher Rd. Lena, LA	
Surface Impoundment Name :	Bottom Ash Pond	Owner:	Cleco Power LLC
Surface Impoundment ID:	P-0005	Operator:	Cleco Power LLC
Nearest City:	Boyce	Parish:	Rapides
Inspector:		James C. Van Hoof, P.E.	
Company:		Providence Engineering & Environmental Group LLC	
Date of Inspection:		12/11//2017	
Weather at Time of Inspection:		Sunny, Cool	
DESCRIPTION OF THE OPERATION OF THE SURFACE IMPOUNDMENTS:			
<p>The Brame Energy Center's Bottom Ash and Fly Ash surface impoundments are designed to accept the coal combustion residual (CCR) byproducts derived from burning of the Unit 2 coal for the generation of electricity. The ponds are classified by the Louisiana Department of Environmental Quality (LDEQ) as Type I Surface Impoundments. Water from the Fly Ash surface impoundment is pumped into the Bottom Ash impoundment which discharges by means of three pumps that discharge the wastewater through the outlet pipe on the western end of the pond. This water discharges into Lake Rodemacher via LPDES outfall 401, thence to Bayou Jean de Jean via LPDES outfall 001, then to the R

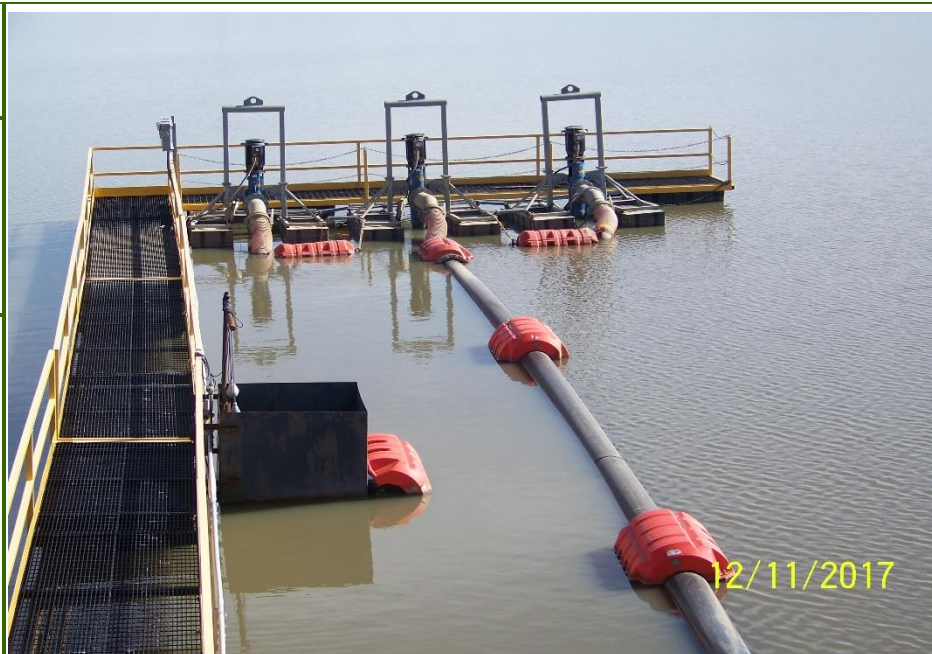
Floating pump structure in Bottom Ash Pond.

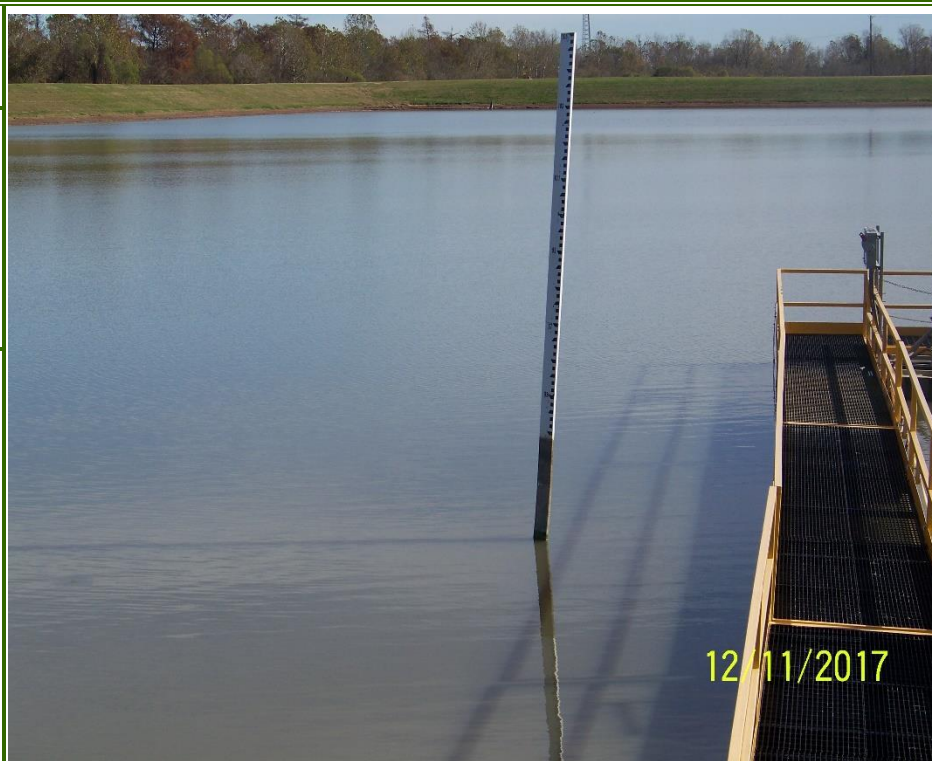
Level Gauge near floating pump structure in Bottom Ash Pond.

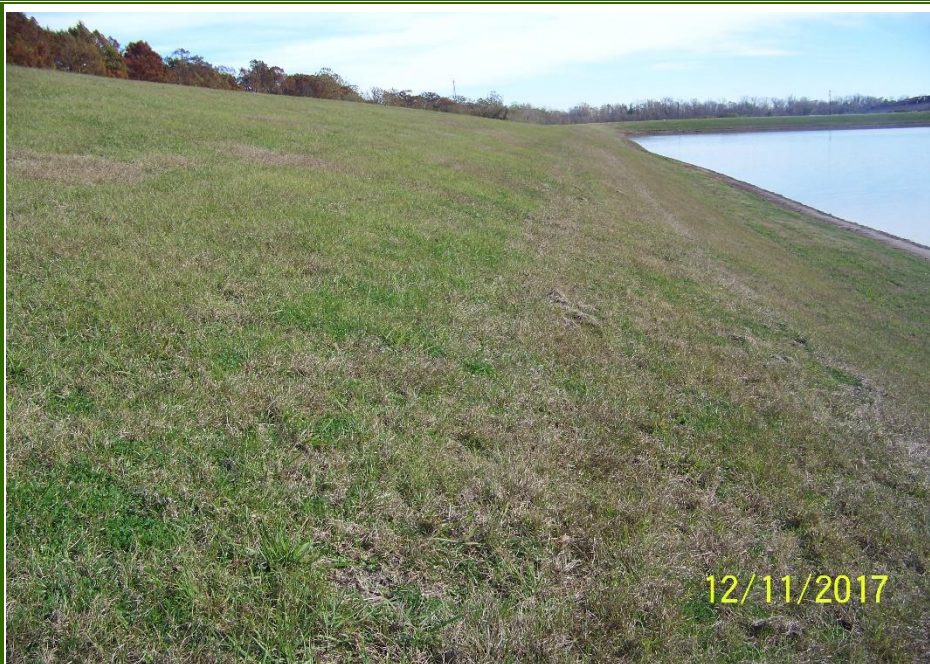
Northern slope of internal levee.

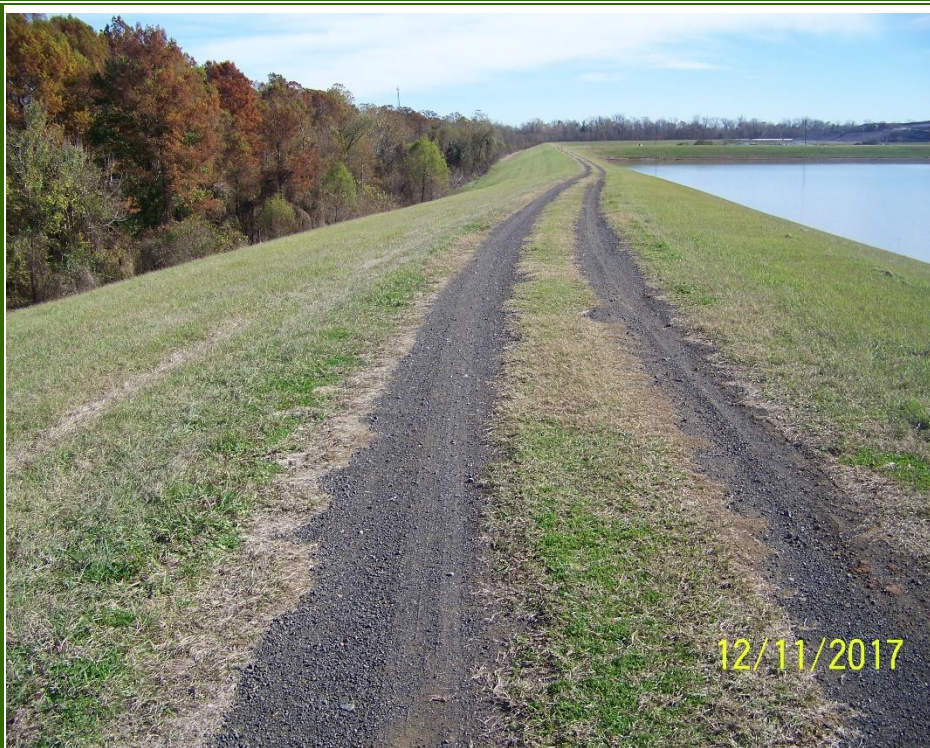
Crest of northern levee.

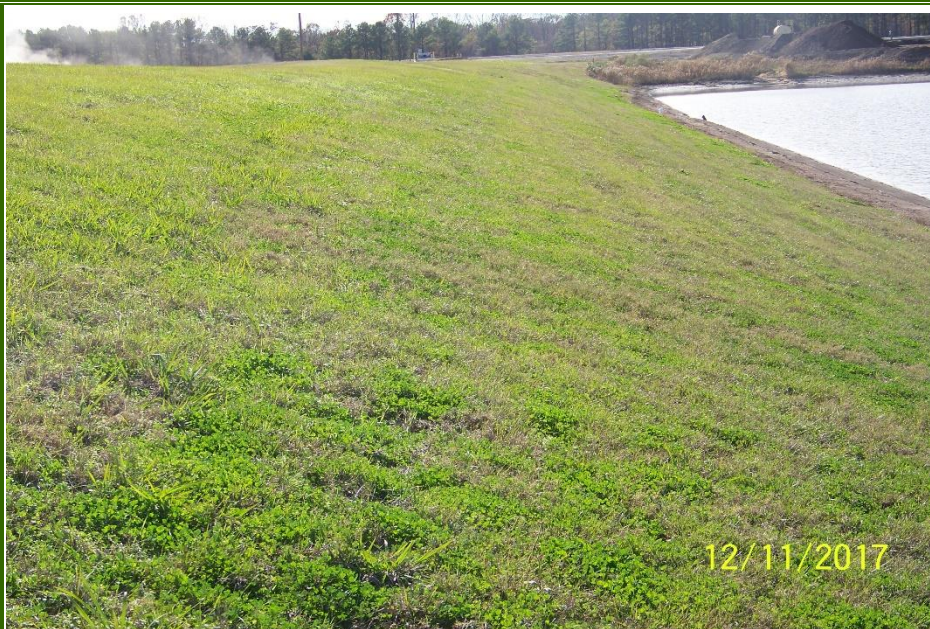
Inside slope of eastern levee.

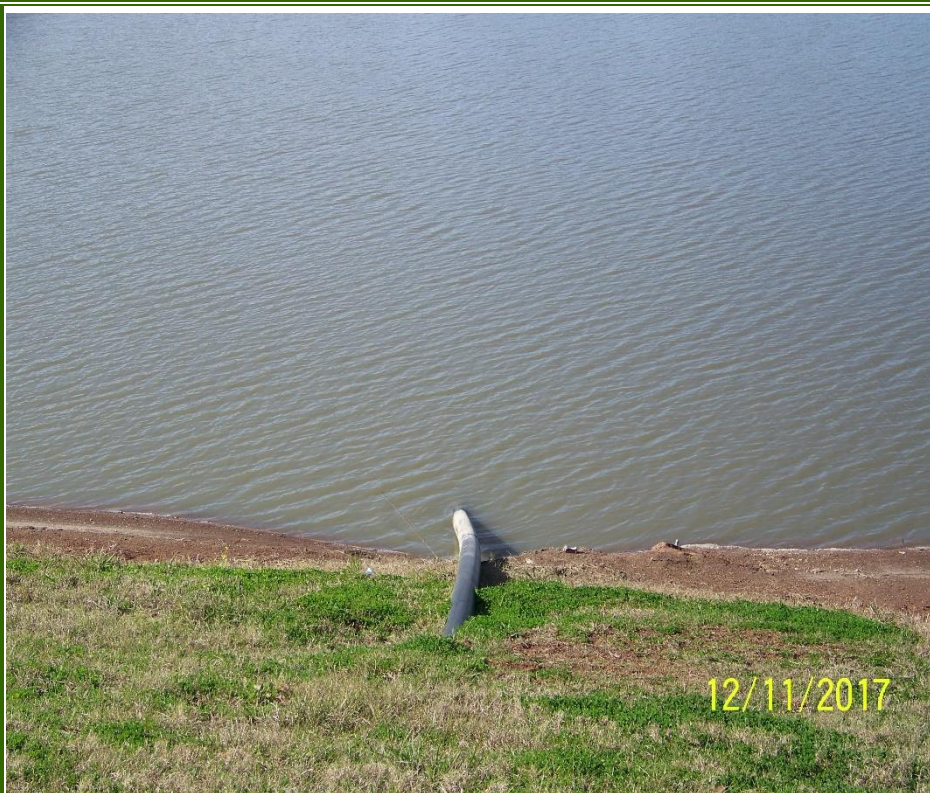
Discharge pipe from the Fly Ash Pond into the Bottom Ash Pond.

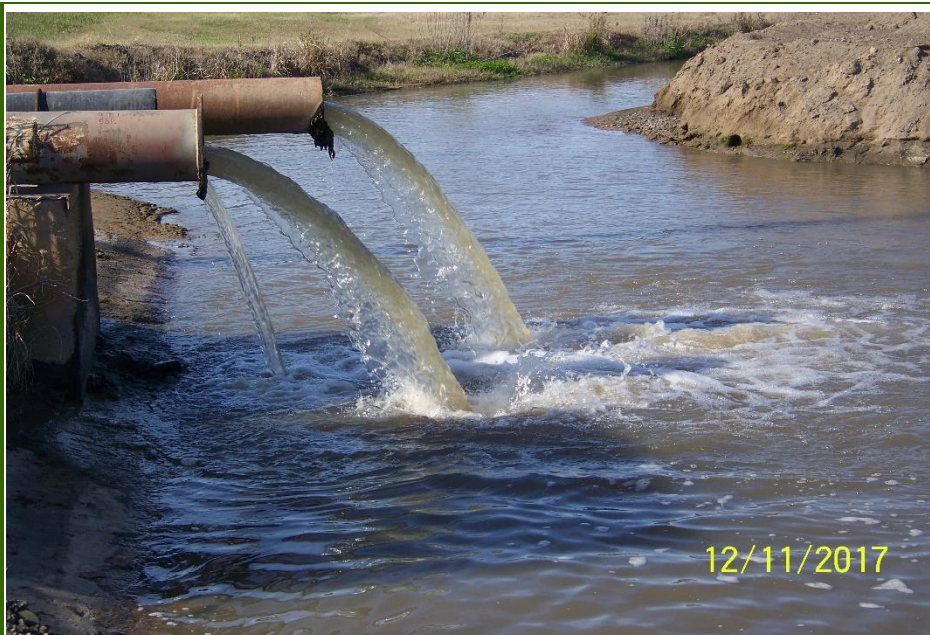
Sluice pipe discharging into the Bottom Ash Pond.

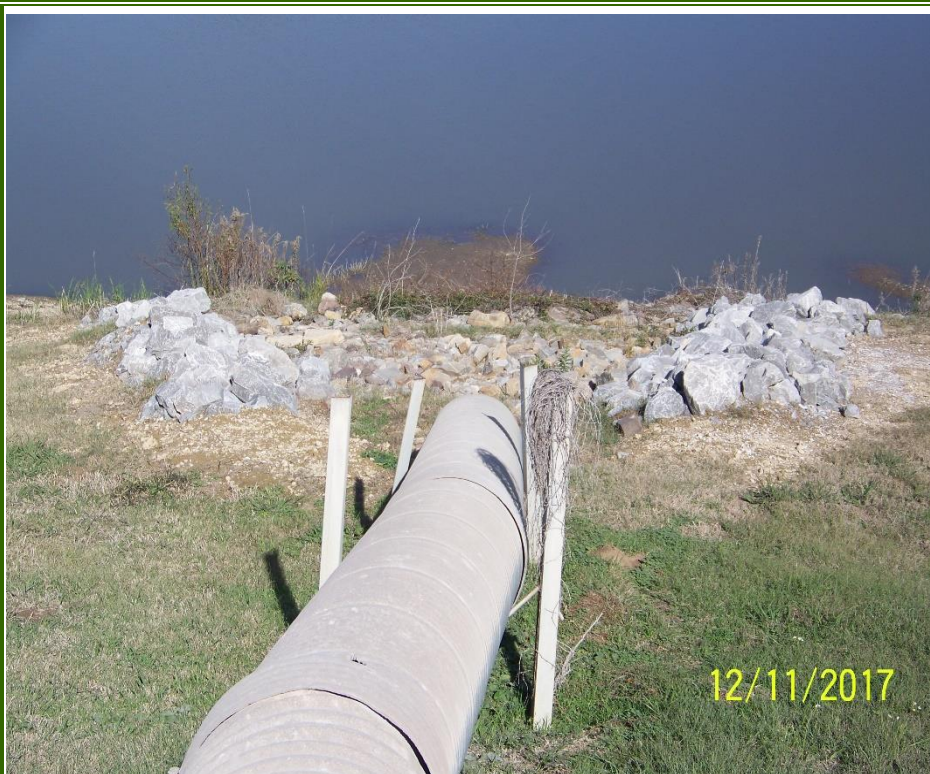
Storm water discharge pipe from sluice pipe trench.

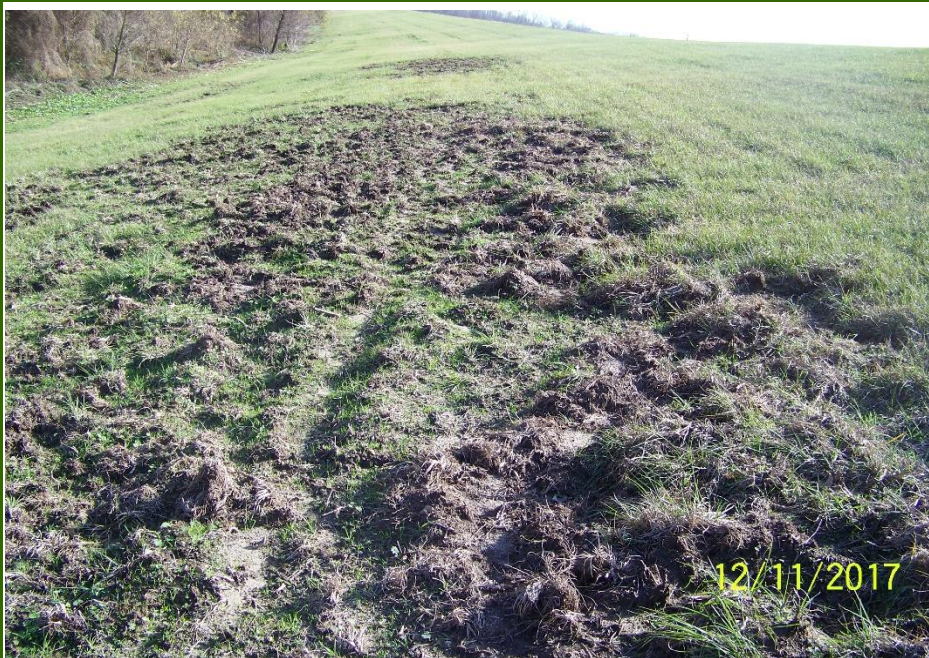
Are there any trees on the slopes?	<input type="checkbox"/> Yes <input checked="" type="checkbox"/> No
If yes, describe (type of vegetation, size, location, etc.)	
Findings:	The exterior slope was inspected and appeared to be in satisfactory condition. Only minor corrective actions are required at this time based on other observations below.
Other observations on the exterior slopes:	Feral hogs have rooted an approximate 1,500 square foot area on the exterior slope of the Bottom Ash Pond along the north levee. Cleco will smooth the rutted area, then seed and fertilize to prevent erosion.

Area along the northern exterior levee showing where the feral hogs have recently rooted the topsoil.

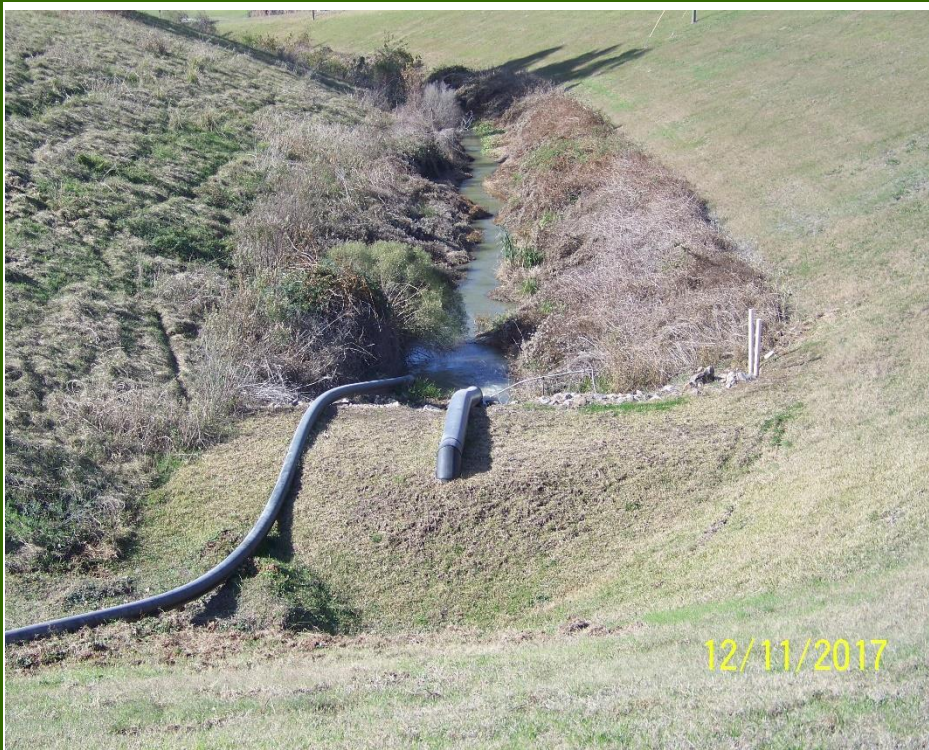
Bottom Ash discharge pipe shown outside the western levee towards Lake Rodemacher.

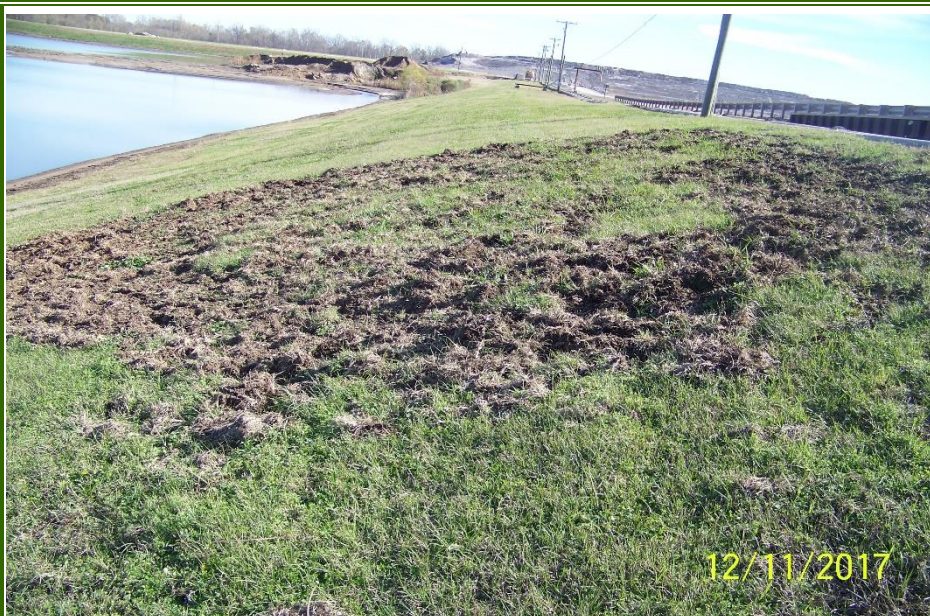
If yes, describe (size of area, location, severity, etc.)	
Findings:	The interior slope was inspected and appeared to be in satisfactory condition. Only minor corrective actions are required at this time based on other observations below.
Other observations on the interior slopes:	Feral hogs have rooted an approximate 4,000 square foot area on the interior slope of the Bottom Ash Pond along the south levee. Cleco will smooth the rutted area, then seed and fertilize to prevent erosion.

Area along the southern interior levee showing where the feral hogs have recently rooted the topsoil.

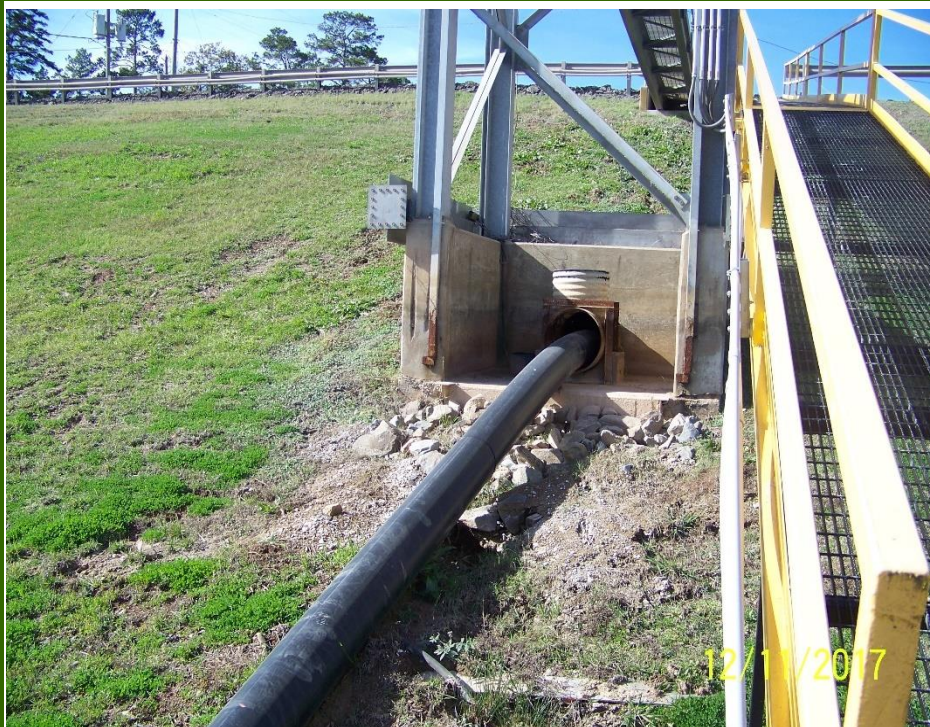
Bottom Ash discharge pipe shown on interior of the western levee.
