CLECO POWER LLC BRAME ENERGY CENTER

HAZARD POTENTIAL CLASSIFICATION ASSESSMENT: BOTTOM ASH POND

**LEVEE BREACH
ANALYSIS REPORT:
BOTTOM ASH POND**

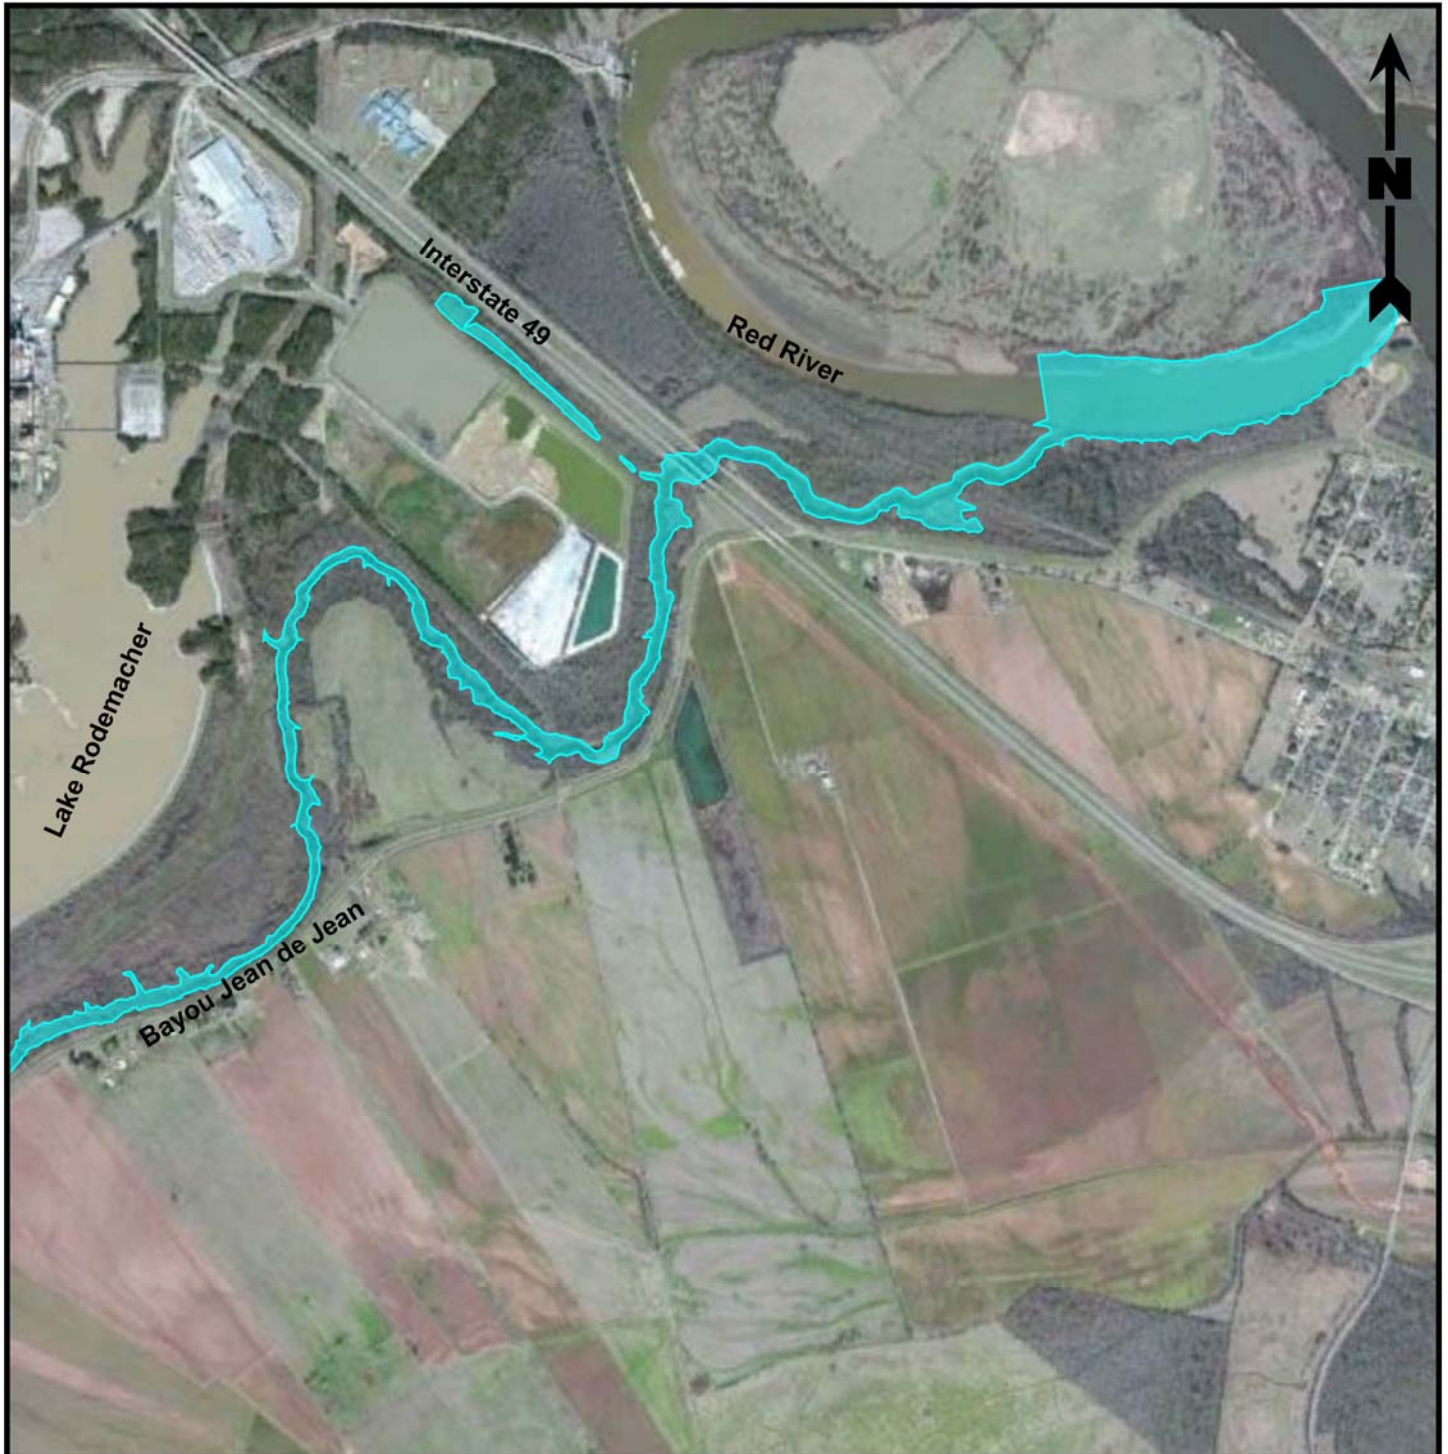
FIGURE 2
BOTTOM ASH POND MOST PROBABLE LOSS

For the Bottom Ash Pond, the Most Probable Loss condition results in no more than a 3' increase which is localized to the channel adjacent to the pond and has no effects to surrounding properties or Interstate 49. The Maximum condition results in no more than a 7' increase which is localized to the channel adjacent to the pond and has no effects to surrounding properties or Interstate 49. The Bottom Ash Pond results are presented in **Figure 2 and Figure 3**.

Most Probable Loss (Avg. El. 75.98')

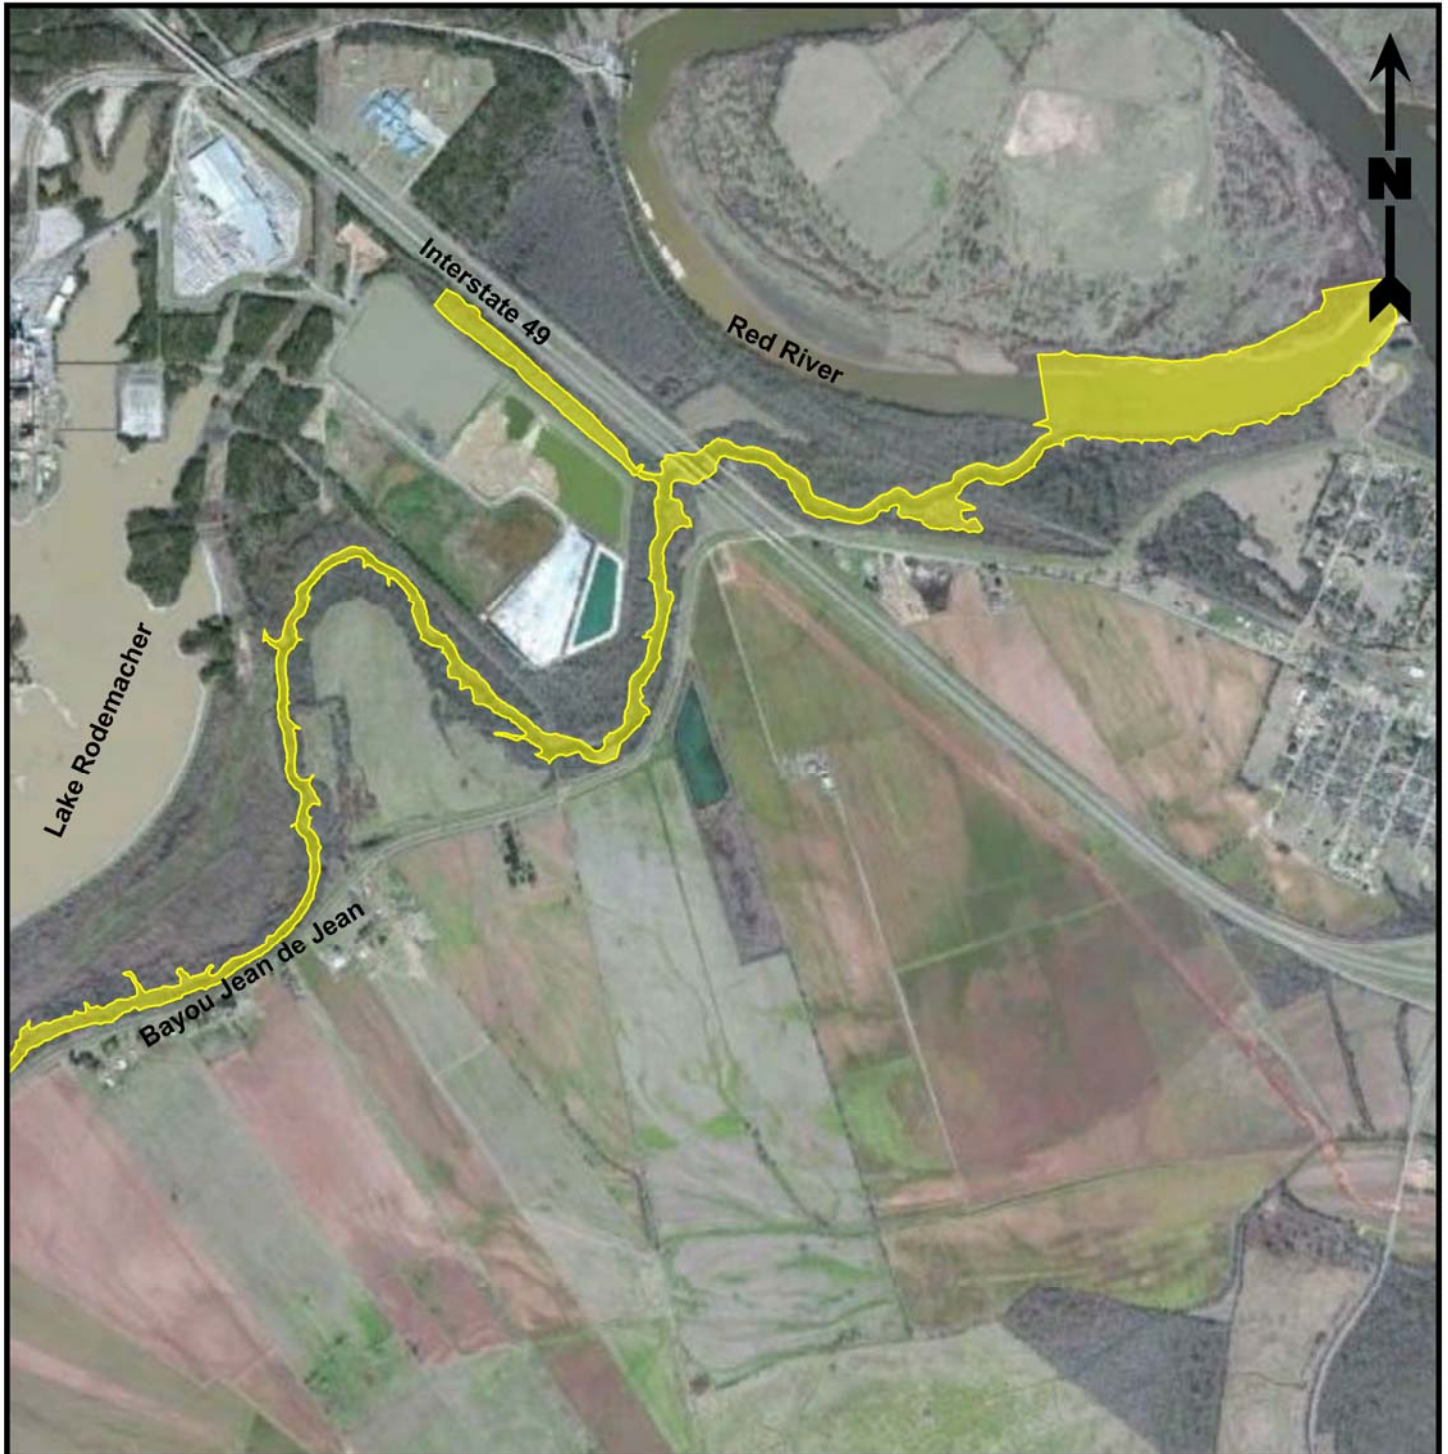
FIGURE 3
BOTTOM ASH POND MAXIMUM LOSS

Maximum Loss (Avg. El. 76.38')
