<b>ANNUAL CCR SURFACE IMPOUNDMENT INSPECTION</b>			
<b>Facility Name:</b>		Cleco Brame Energy Center	
<b>Address:</b>		275 Rodemacher Rd. Lena, LA	
<b>Surface Impoundment Name :</b>	Bottom Ash Pond	<b>Owner:</b>	Cleco Power LLC
<b>Surface Impoundment ID:</b>	P-0005	<b>Operator:</b>	Cleco Power LLC
<b>Nearest City:</b>	Boyce	<b>Parish:</b>	Rapides
<b>Inspector:</b>		James C. Van Hoof, P.E.	
<b>Company:</b>		Providence Engineering & Environmental Group LLC	
<b>Date of Inspection:</b>		12/10//2018	
<b>Weather at Time of Inspection:</b>		Sunny, Cool	
<b>DESCRIPTION OF THE OPERATION OF THE SURFACE IMPOUNDMENTS:</b>			
<p>The Brame Energy Center's Bottom Ash and Fly Ash surface impoundments are designed to accept the coal combustion residual (CCR) byproducts derived from burning of the Unit 2 coal for the generation of electricity. The ponds are classified by the Louisiana Department of Environmental Quality (LDEQ) as Type I Surface Impoundments. Water from the Fly Ash surface impoundment is pumped into the Bottom Ash impoundment which discharges by means of three pumps that discharge the wastewater through the outlet pipe on the western end of the pond. This water discharges into Lake R

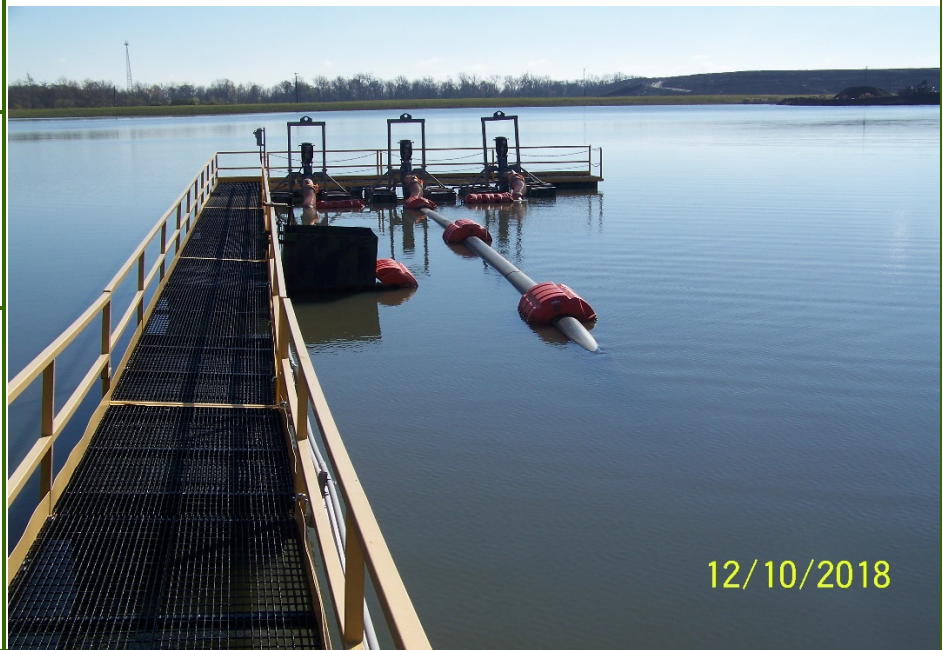
**Bottom Ash Pond**

Floating pump structure in Bottom Ash Pond.

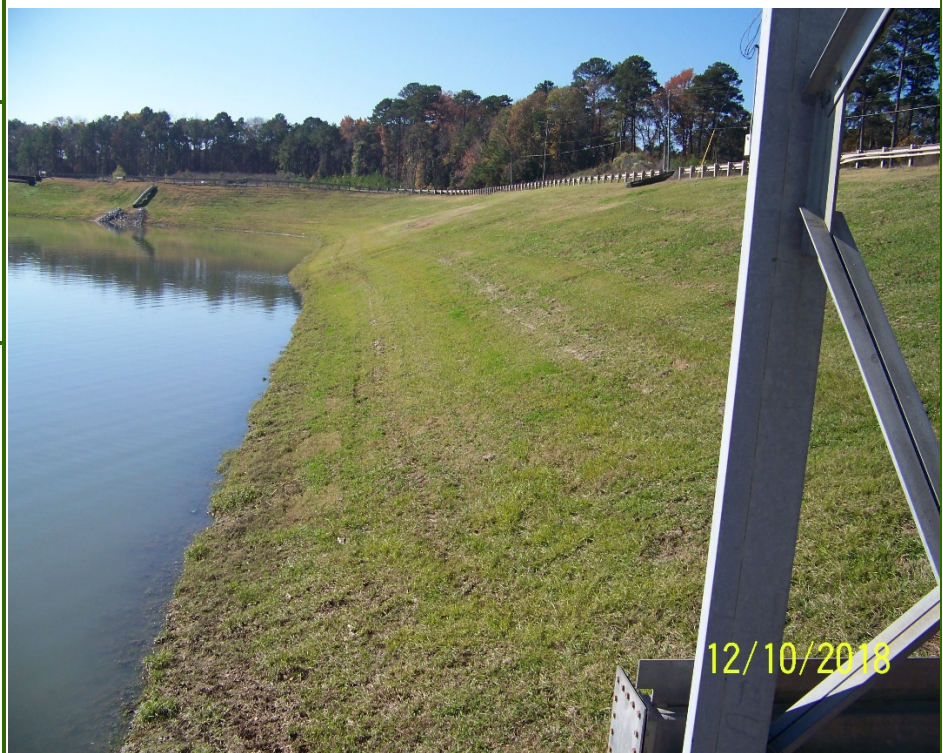
**Bottom Ash Pond**

Western slope of interior levee.

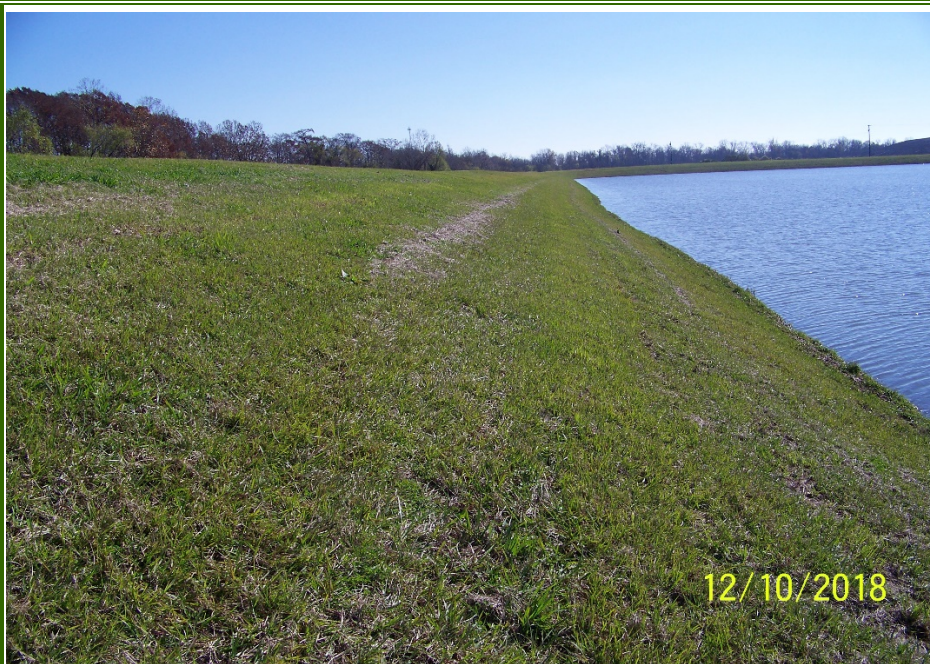
**Bottom Ash Pond**

Northern slope of internal levee.

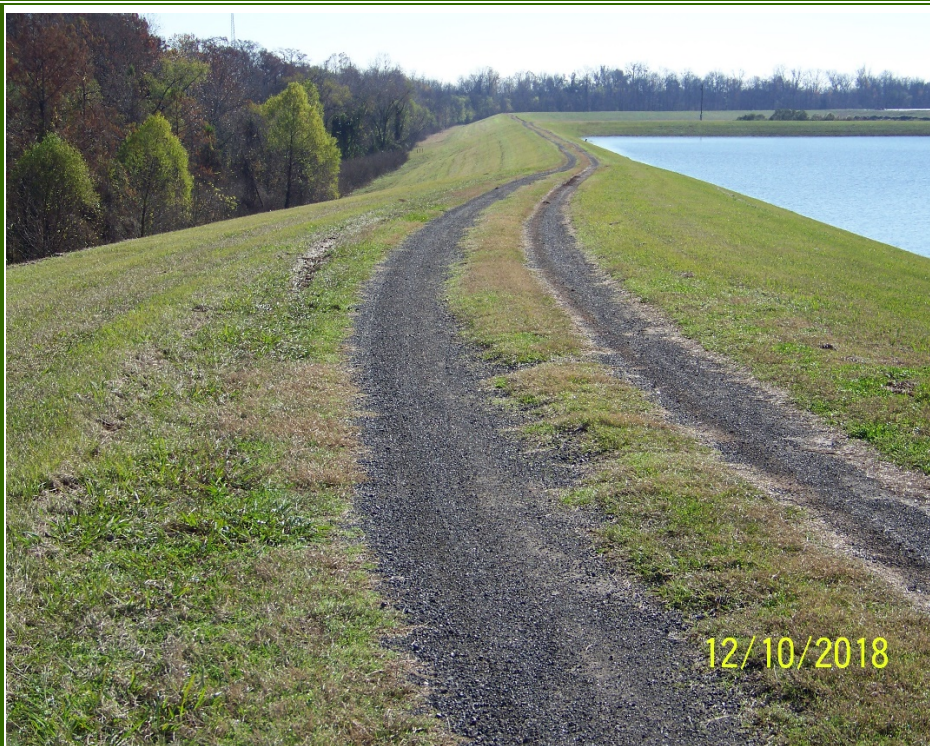
**Bottom Ash Pond**

Crest of northern levee.

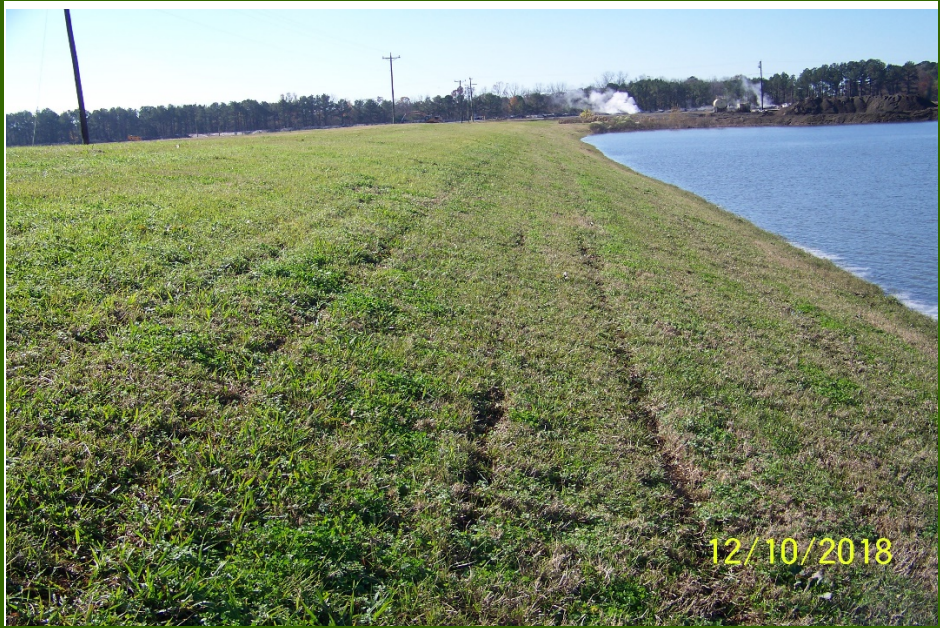
**Bottom Ash Pond**

Inside slope of eastern levee.

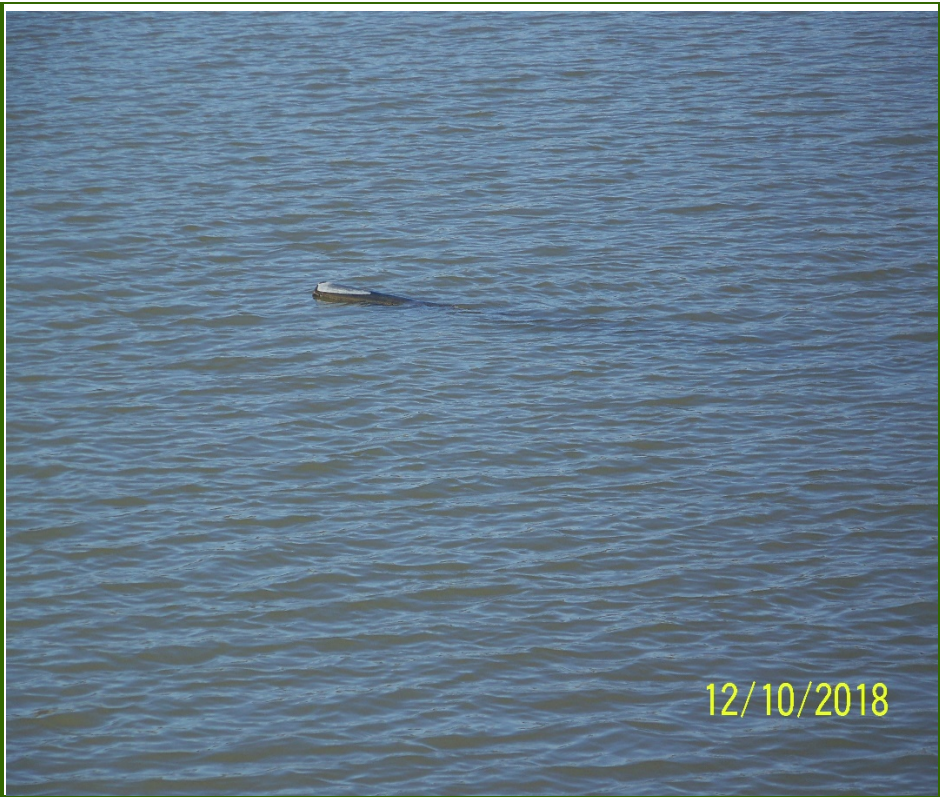
**Bottom Ash Pond**

Discharge pipe from the Fly Ash Pond into the Bottom Ash Pond.

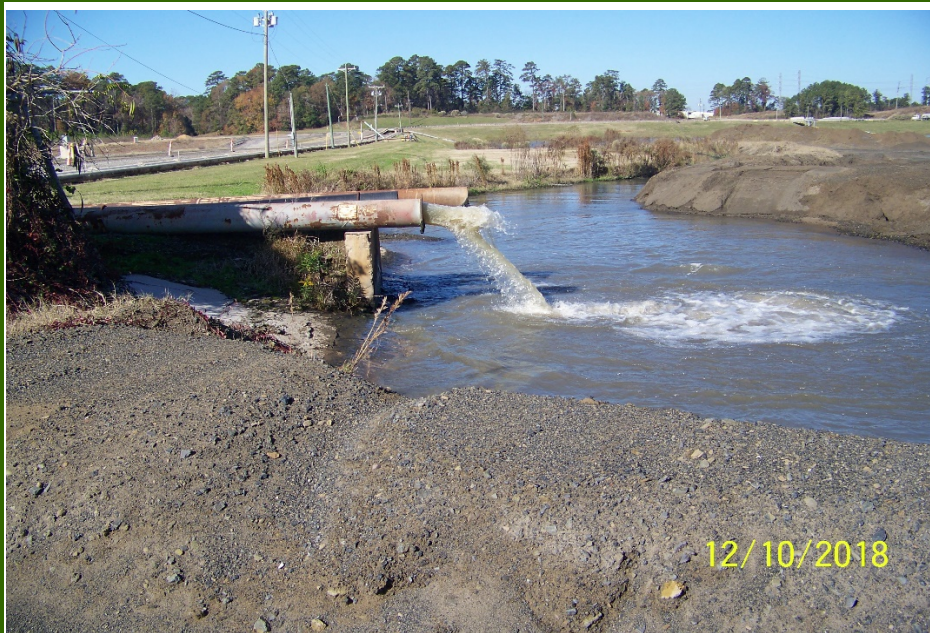
**Bottom Ash Pond**

Sluice pipe discharging into the Bottom Ash Pond.

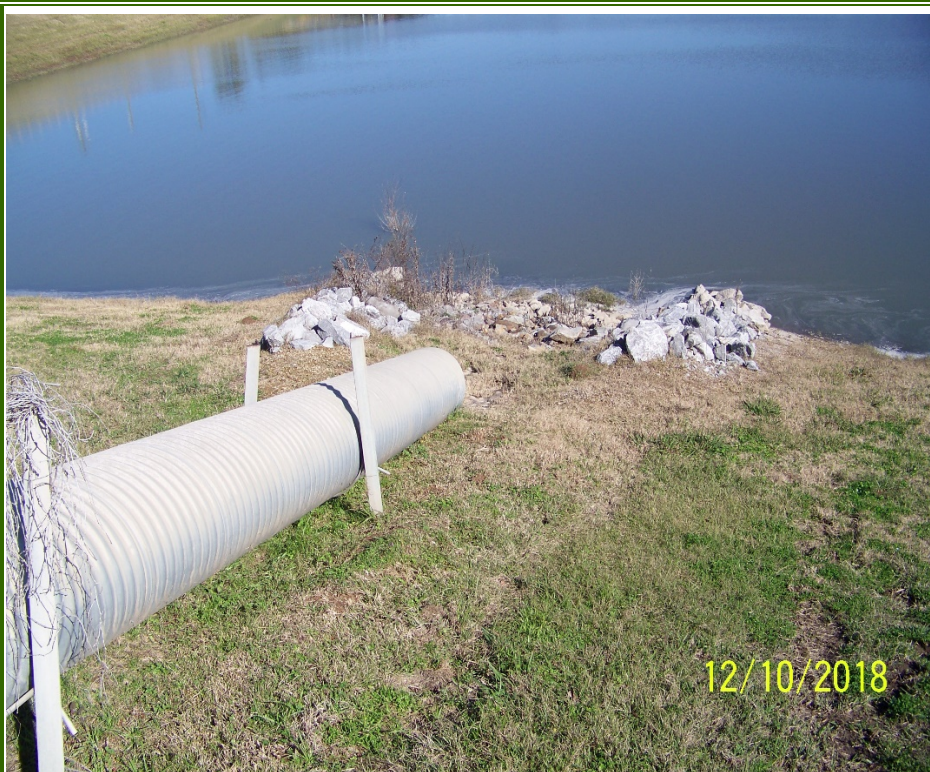
**Bottom Ash Pond**

Storm water discharge pipe from sluice pipe trench.

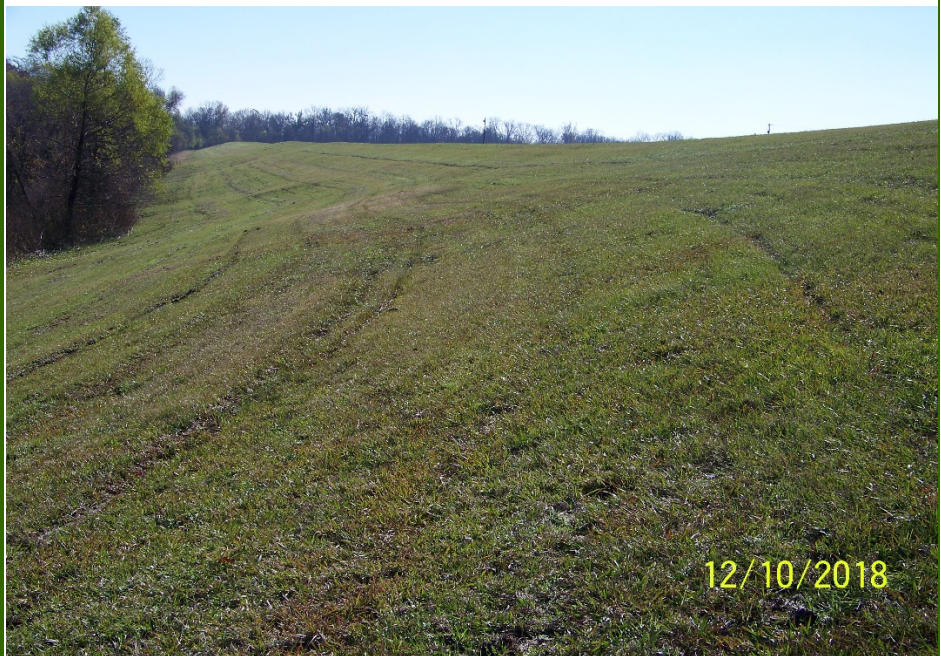
**Bottom Ash Pond**

Exterior slope of northern levee.

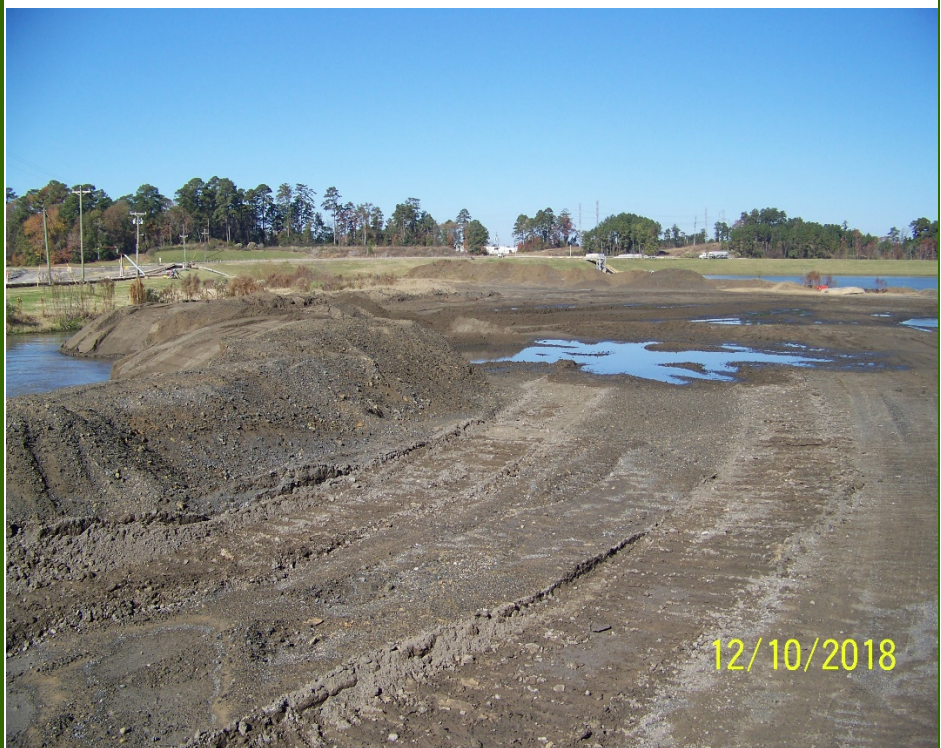
**Bottom Ash Pond**

Bottom Ash shown in southeast corner of Bottom Ash Pond.

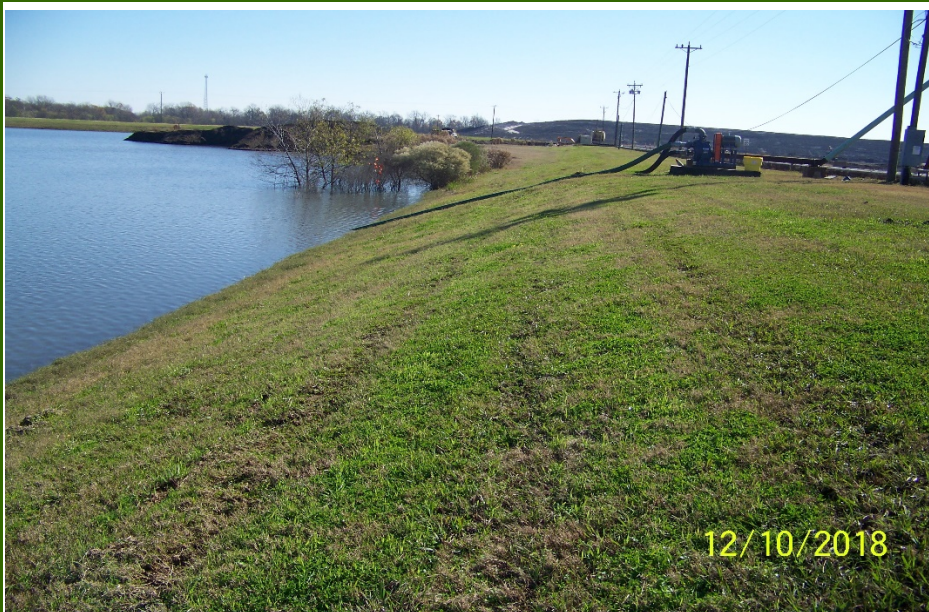
**Bottom Ash Pond**

<b>Are there any Sinkholes Observed?</b>	<input type="checkbox"/> Yes <input checked="" type="checkbox"/> No
If yes, describe (size of area, location, severity, etc.)	
<b>Findings:</b>	The interior slope was inspected and appeared to be in satisfactory condition. Only minor corrective actions are required at this time based on other observations below.
<b>Other observations on the interior slopes:</b>	Small trees were noted on the southern interior levee that need to be removed.

Area along the southern interior levee. Brush needs to be removed on interior of levee.

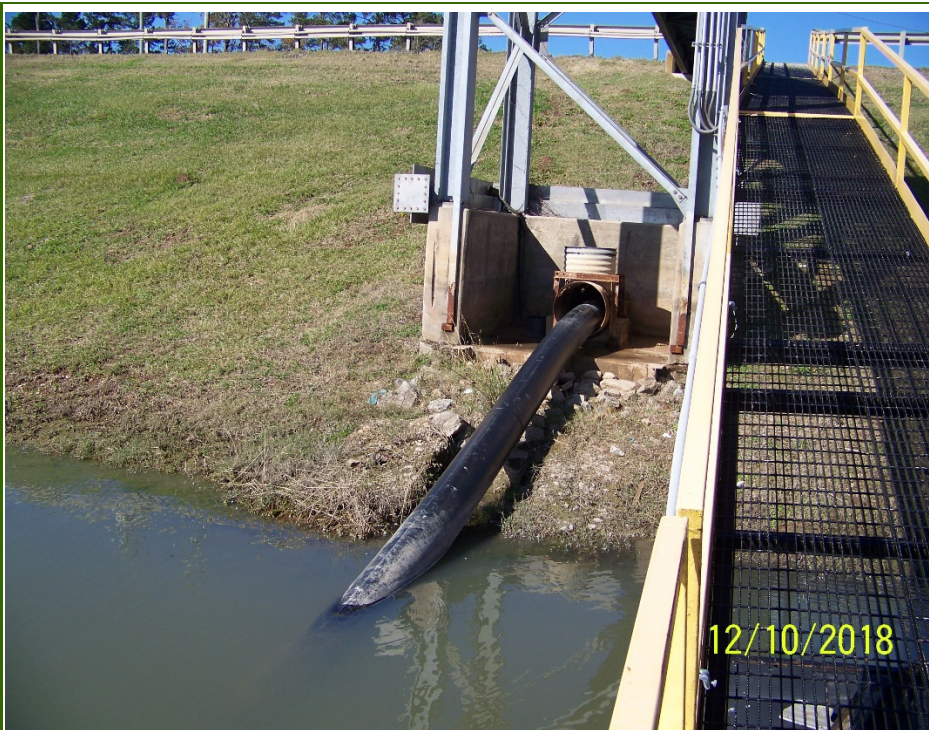
**Bottom Ash Pond**

Bottom Ash discharge pipe shown on interior of the western levee.
