# CLECO POWER LLC BRAME ENERGY CENTER

## SAFETY FACTOR ASSESSMENT:

## FLY ASH POND

Project Number 002-186

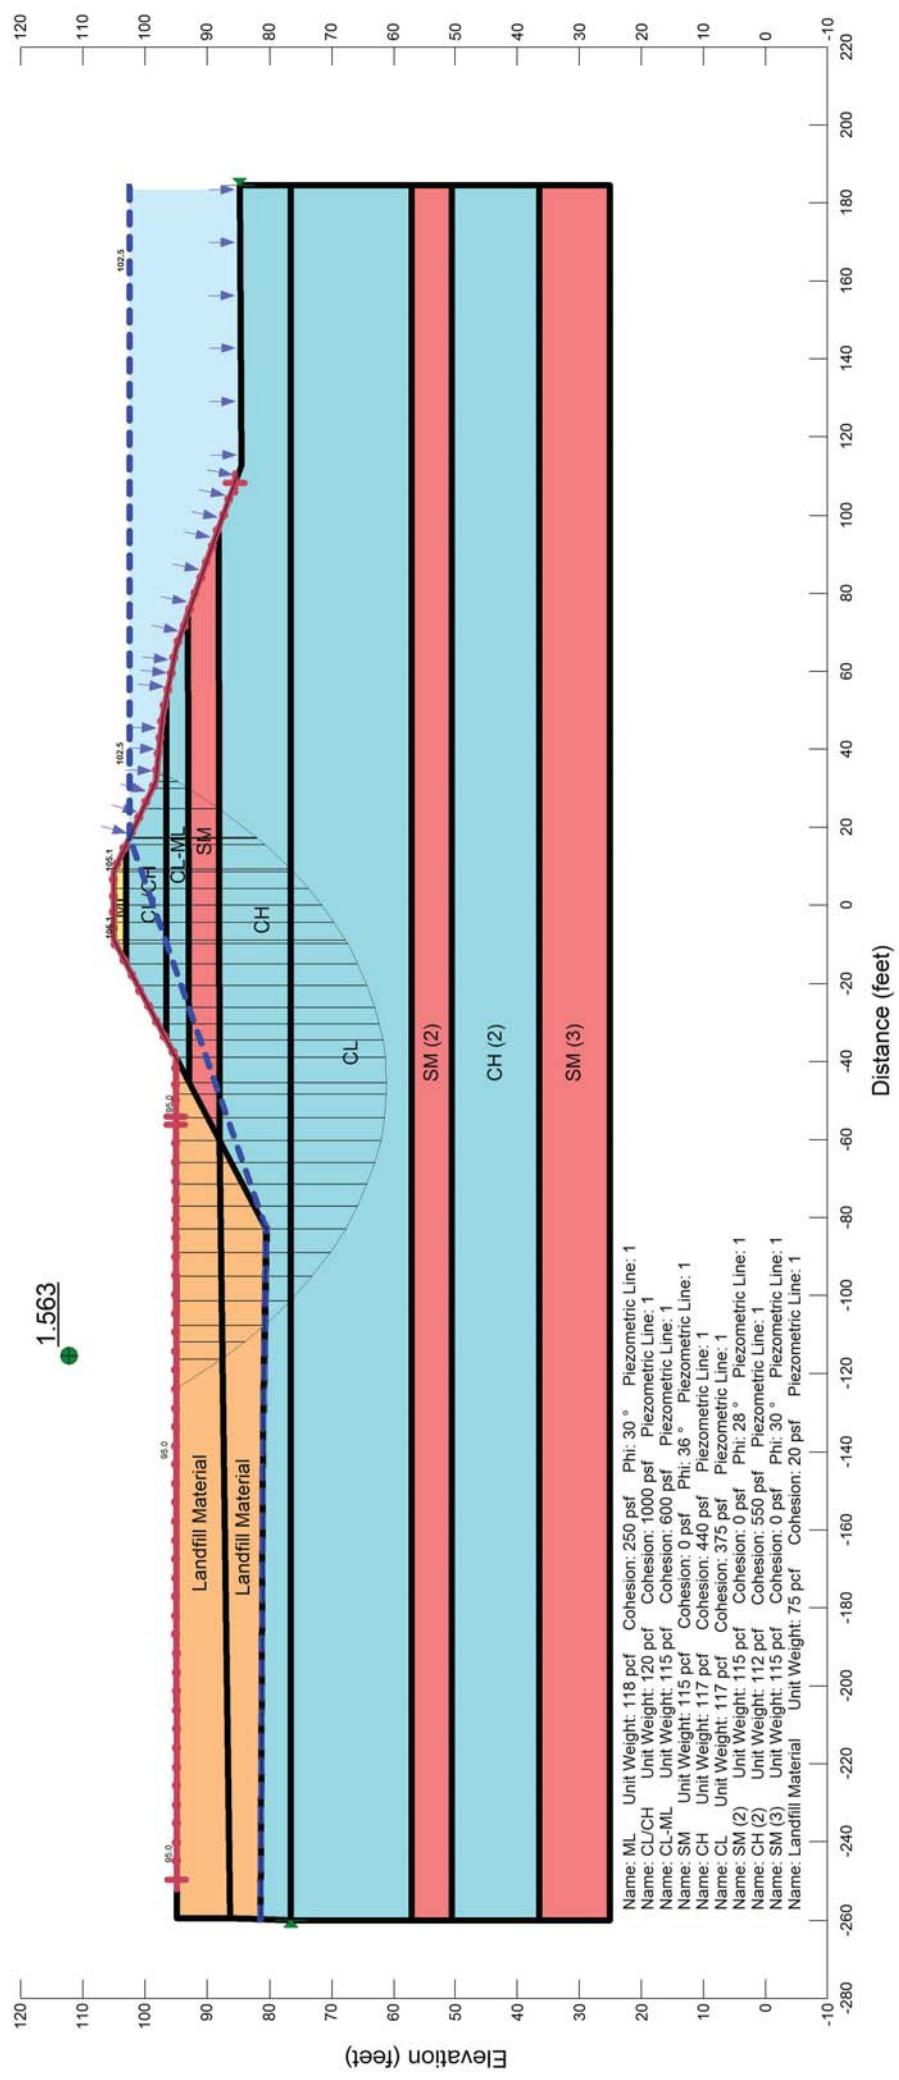
# CLECO BRAME ENERGY CENTER FLY ASH POND - SECTION 1 SHORT TERM SLOPE STABILITY ANALYSIS SOIL BORING B-15 (FROM GTL REPORT NO.: 04-16-061)

Pond	Section #	Condition	Flood Side Water Elevation (feet, NAVD88)	Factor of Safety Obtained	Notes
Fly Ash Pond	1	Short Term	102.5	1.56	Landfill Material is required on the protected side of the levee to achieve min. FS.
	1	Long Term	102.5	2.48	--
	2	Short Term	102.5	1.80	--
	2	Long Term	102.5	1.53	--
	3	Short Term	102.5	2.71	--
	3	Long Term	102.5	1.79	--
