ANNUAL CCR SURFACE IMPOUNDMENT INSPECTION			
Facility Name:		Cleco Brame Energy Center	
Address:		275 Rodemacher Rd. Lena, LA	
Surface Impoundment Name :	Fly Ash Pond	Owner:	Cleco Power LLC
Surface Impoundment ID:	P-0005	Operator:	Cleco Power LLC
Nearest City:	Boyce	Parish:	Rapides
Inspector:		James C. Van Hoof, P.E.	
Company:		Providence Engineering & Environmental Group LLC	
Date of Inspection:		12/10/2019	
Weather at Time of Inspection:		Cloudy, Cool	
DESCRIPTION OF THE OPERATION OF THE SURFACE IMPOUNDMENTS:			
<p>The Brame Energy Center's Bottom Ash and Fly Ash surface impoundments are designed to accept the coal combustion residual (CCR) byproducts derived from burning of the Unit 2 coal for the generation of electricity. The ponds are classified by the Louisiana Department of Environmental Quality (LDEQ) as Type I Surface Impoundments. Water from the Fly Ash surface impoundment is pumped into the Bottom Ash impoundment which discharges by means of three pumps that discharge the wastewater through the outlet pipe on the western end of the pond. This water discharges into Lake Rodemacher via LPDES outfall 401, thence to Bayou Jean de Jean via LPDES outfall 001, then to the Red

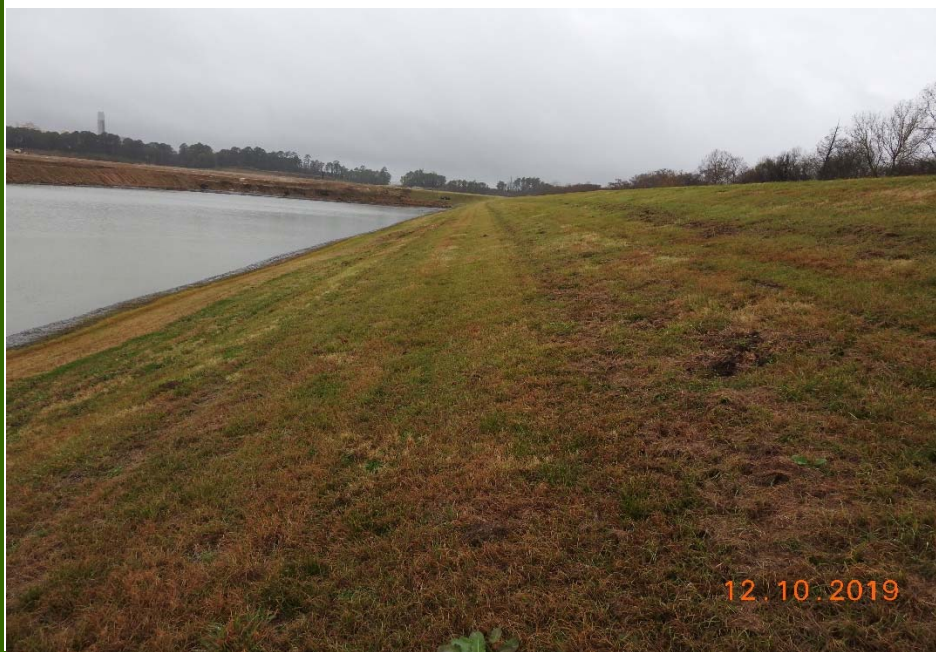
Interior slope of northern levee.

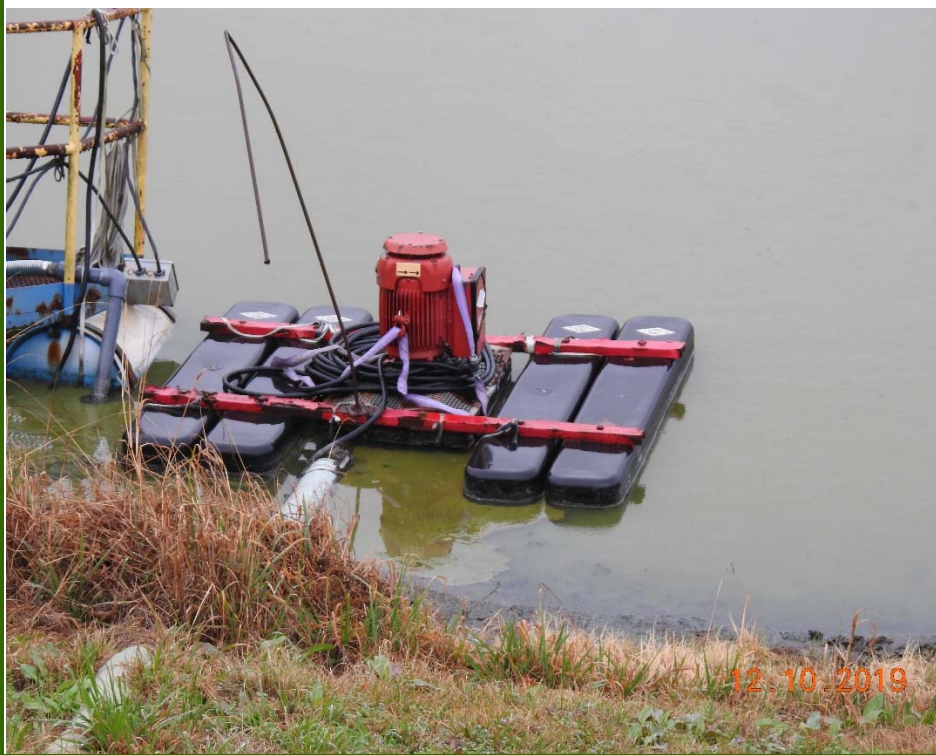
Pump system in Fly Ash Pond that pumps discharge water into the Bottom Ash Pond.

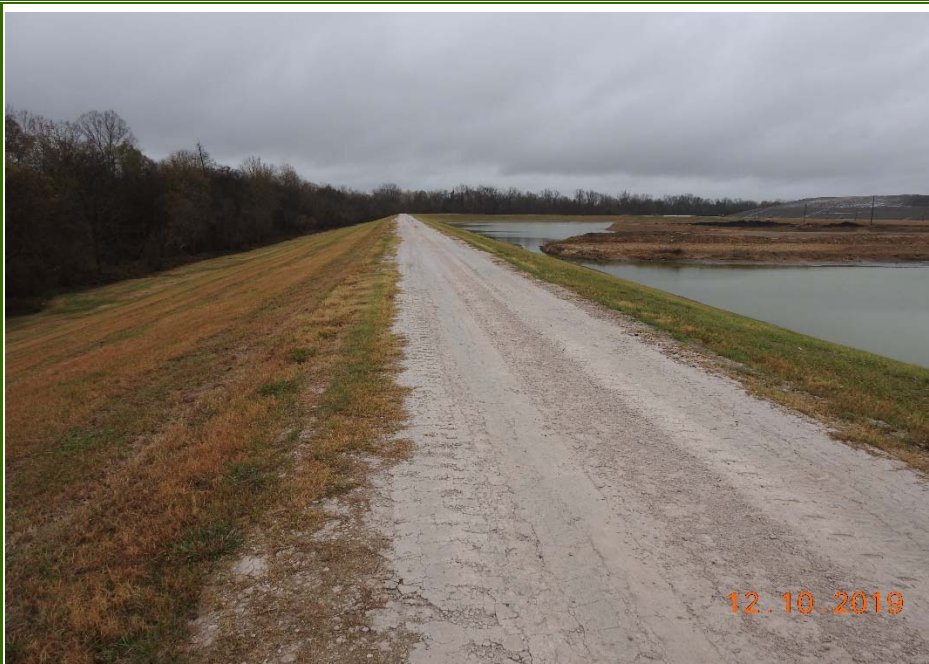
Crest along the northern levee.

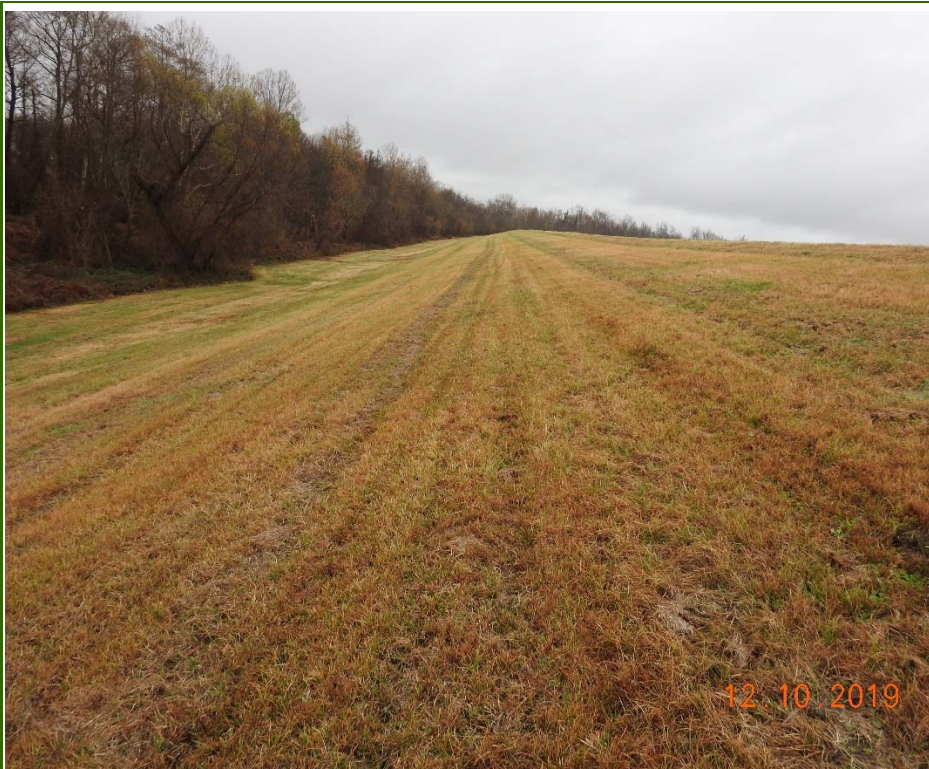
Northern exterior levee slope.

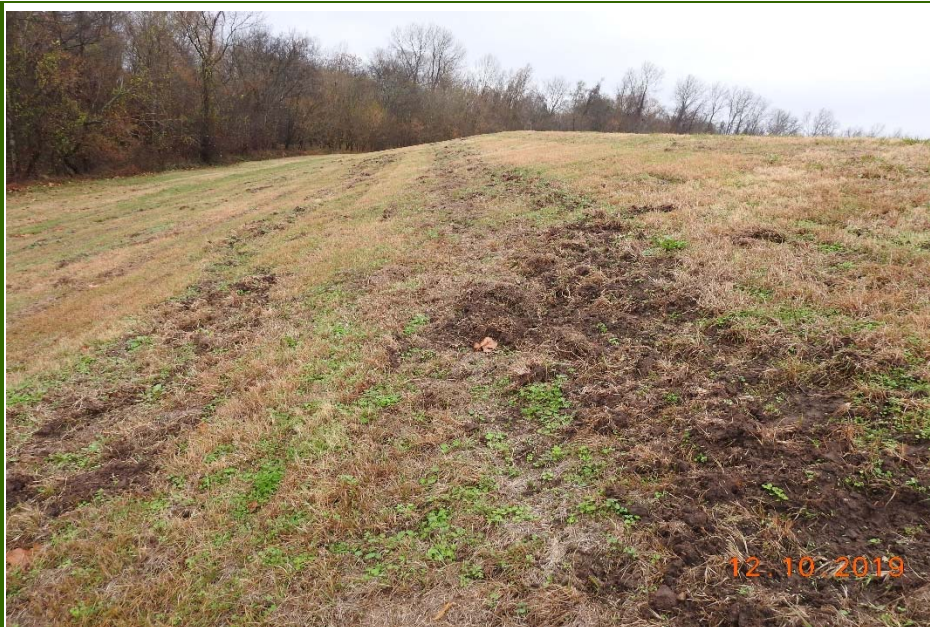
DOCUMENTATION REVIEW:	
Weekly Inspections Reviewed:	<input checked="" type="checkbox"/> Yes <input type="checkbox"/> No
Findings: Feral hogs rutted topsoil on levees. Level gauge realignment.	
Monthly Instrument Inspections Reviewed:	<input checked="" type="checkbox"/> Yes <input type="checkbox"/> No
Findings: No Issues.	
Groundwater Monitoring:	Monitoring wells are in-place.
Drawings Reviewed:	<input checked="" type="checkbox"/> Yes <input type="checkbox"/> No
Are there any changes in the geometry of the surface impoundment structure since the previous inspection?	<input type="checkbox"/> Yes <input checked="" type="checkbox"/> No <input type="checkbox"/> NA
If yes, describe (size, location, etc.)	
Other observations:	None.

Area along the exterior levee showing where the feral hogs have recently rooted the topsoil.

Are there any trees on the slopes?	<input type="checkbox"/> Yes <input checked="" type="checkbox"/> No
If yes, describe (type of vegetation, size, location, etc.)	
Findings:	The exterior slope was inspected and appeared to be in satisfactory condition. Only minor corrective actions are required at this time based on other observations below.
Other observations on the exterior slopes:	Feral hogs have rooted an approximate 1,500 square foot topsoil area on the exterior slope of the Fly Ash Pond along the northeast corner. The area needs to be smoothed, then seeded and fertilized to prevent erosion.

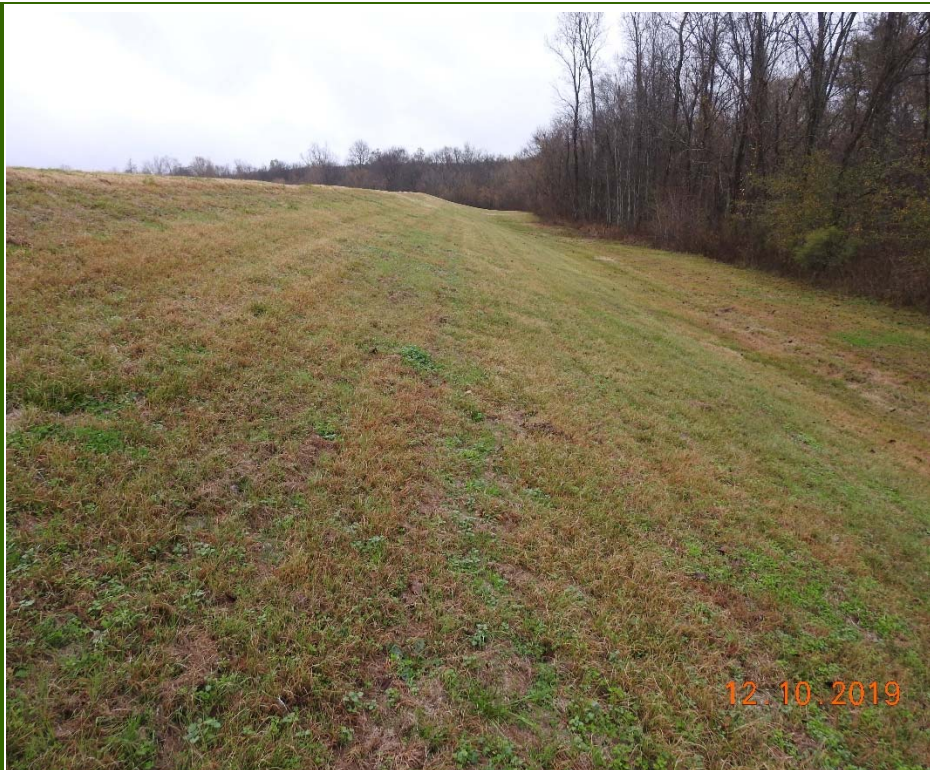
Eastern exterior slope of levee.

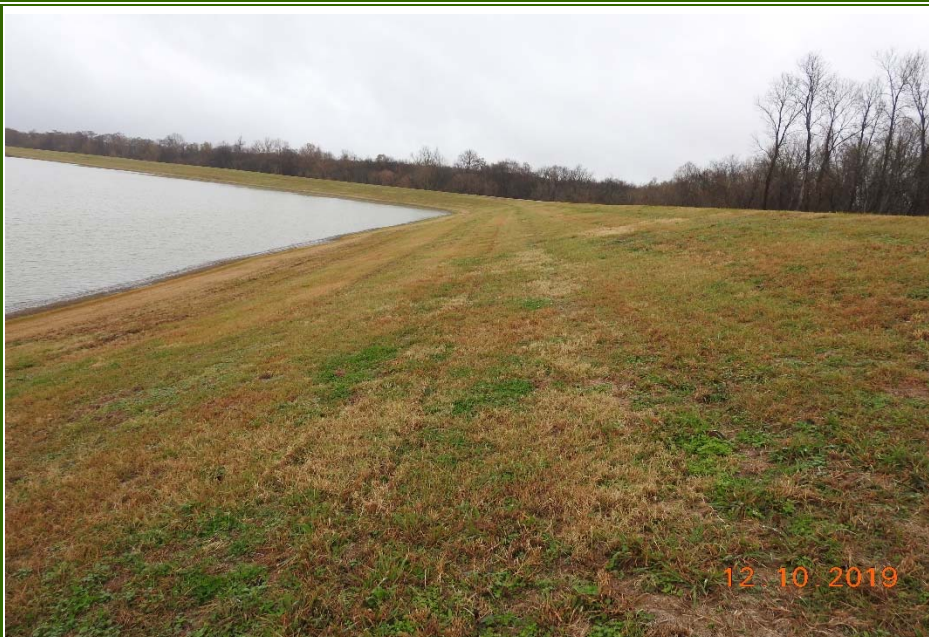
Eastern interior slope of levee.

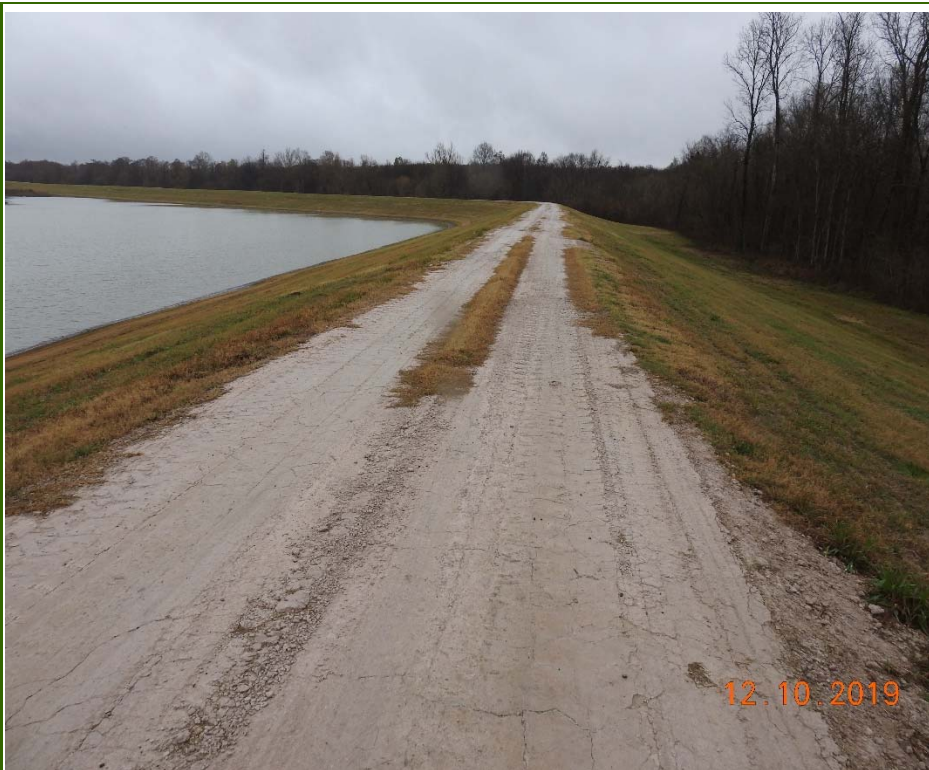
Crest along eastern levee.

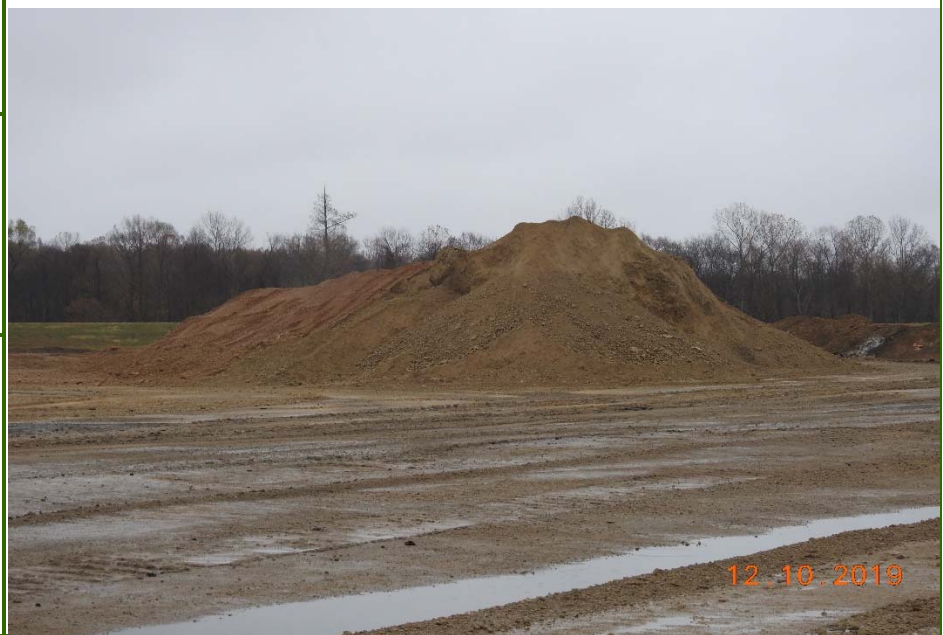
Comments:
Fly ash in the Fly
Ash Pond.

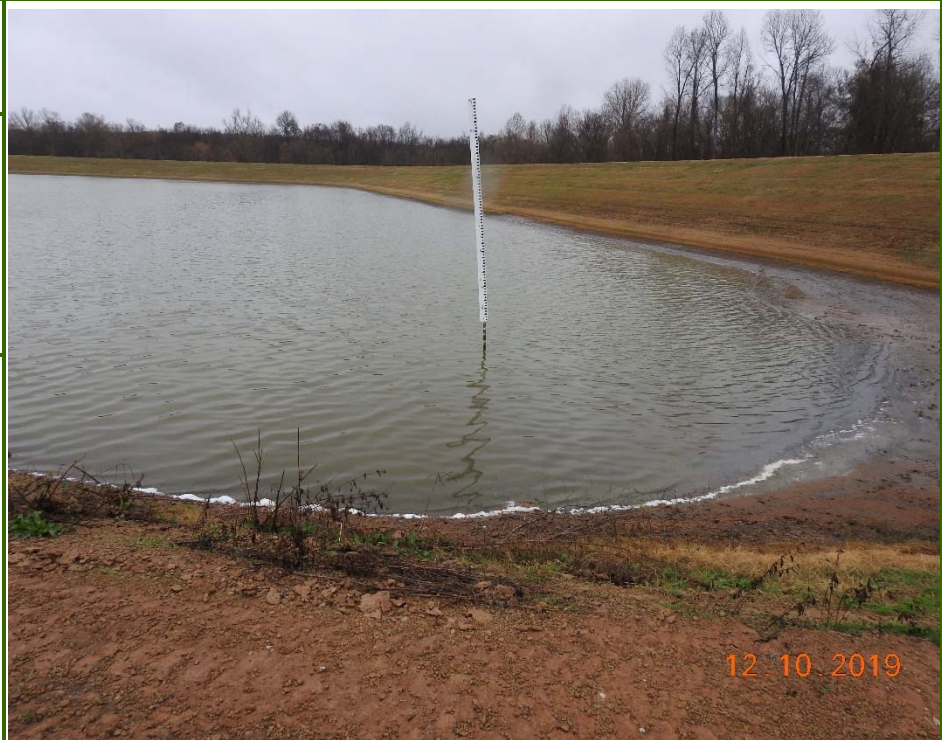
Comments:
Level Gauge in Fly
Ash Pond.
