**BIG CAJUN II  
COAL COMBUSTION RESIDUAL (CCR)  
ANNUAL INSPECTION REPORT**

*NRG Louisiana Generating, LLC (LaGen)  
NRG Energy, Inc.  
Baton Rouge, Louisiana*

*January 2017*

2016 ANNUAL CCR INSPECTION

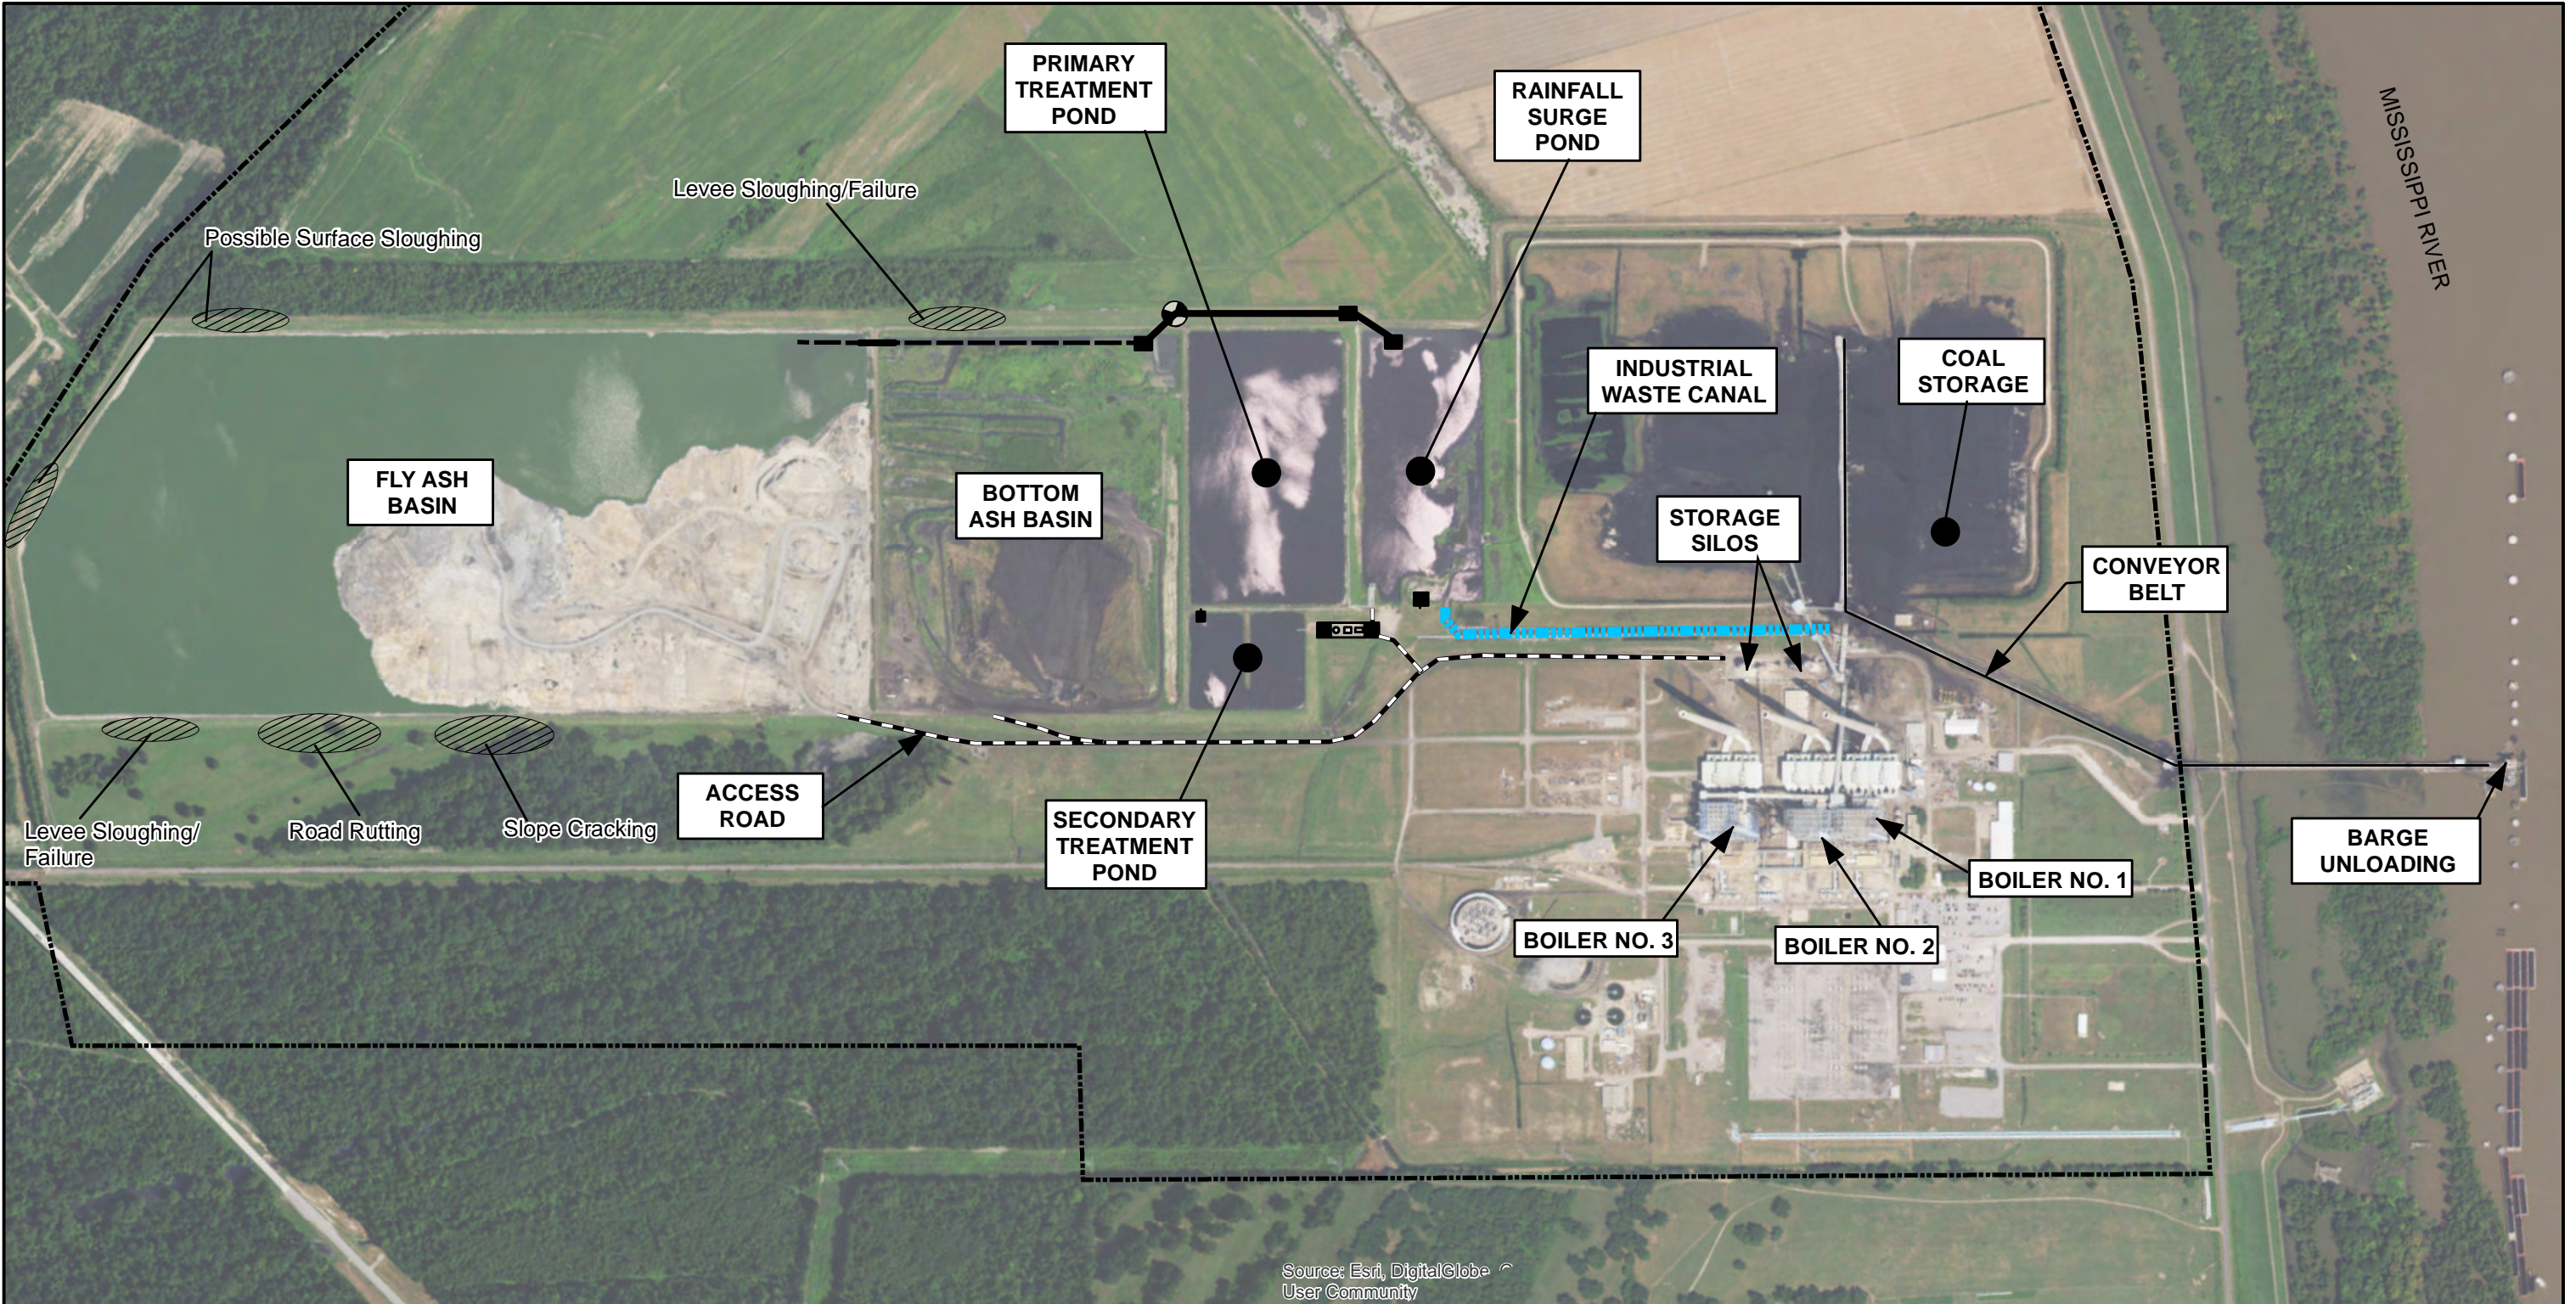
**LEVEE OBSERVATIONS**

The area of sloughing previously identified by NRG was observed along the south levee near the southwest corner of the Fly Ash Unit (**Figure 3**). This area was about 40 feet wide and about 3 feet of displacement (Photo 9). It was observed that this area was accompanied by cracking in the exterior wheel path of the road on the top of the levee (Photo 8). This may be an indication of weakness contributing to the sloughing. Other areas of cracking in the wheel paths were also observed along the south levee (**Figure 3**), however, indications of sloughing were not observed in these areas. Two areas were observed on the north levee and the west levee near the northwest corner of the Fly Ash Unit that present an irregularity in the slope that drops 3 to 4 inches (**Figure 3**). Each area is about 30 to 40 feet long and located 3 to 4 feet below the top of the levee. It could not be determined whether the “drop” is the result of the initial phase of sloughing or wheel ruts from grass mowing activities, however, these areas should be observed for changes.

The second area of sloughing previously identified by NRG was observed along the north levee near the northwest corner of the Bottom Ash Unit (**Figure 3**). The area was about 30 feet wide and about 2 feet of rotational displacement (Photo 12). No other sloughing or cracking was observed. Repairs of the unstable area referenced in the 2015 inspection report were observed along the north levee and the area appeared stable.

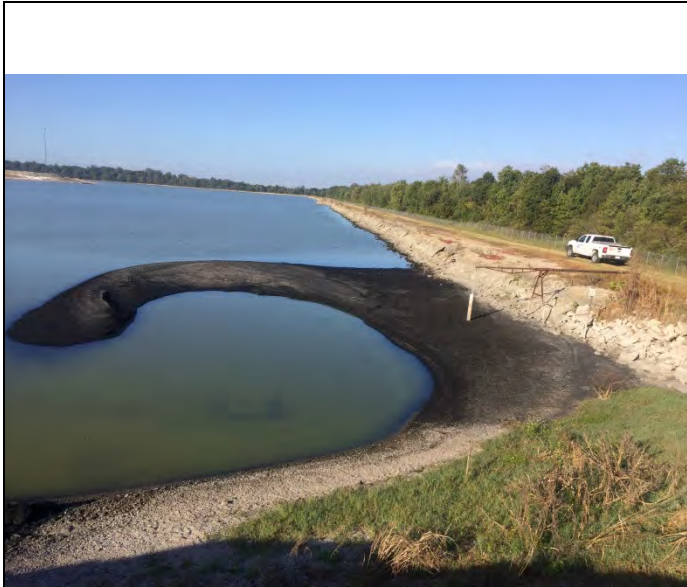
The area within the Fly Ash Unit surrounding the discharge pipe to the Bottom Ash Unit showed signs of significant ash buildup (Photo 1). This is the result of backflow from the Bottom Ash Unit during recent high rainfall.

**Photo No: 1**                      **Picture Direction: W**  
**Description:** Northeast corner of Fly Ash Unit washout of Bottom Ash Unit into Fly Ash Basin

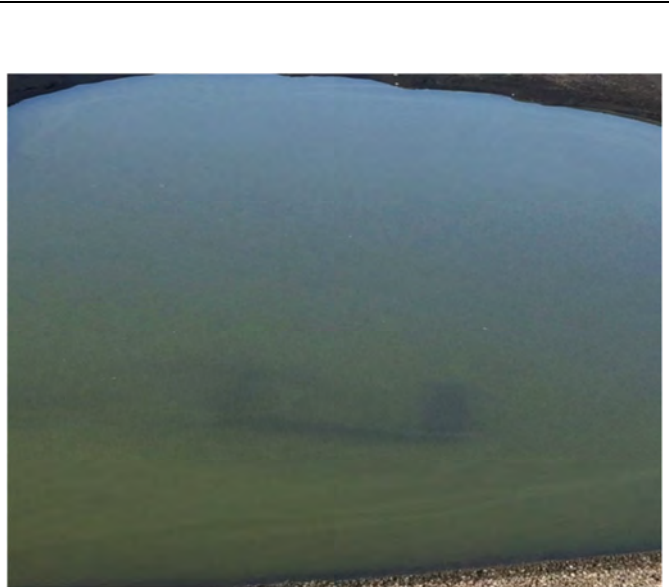
**Photo No: 2**                      **Picture Direction: W**  
**Description:** Submerged Fly Ash Unit discharge pipe to Bottom Ash Basin

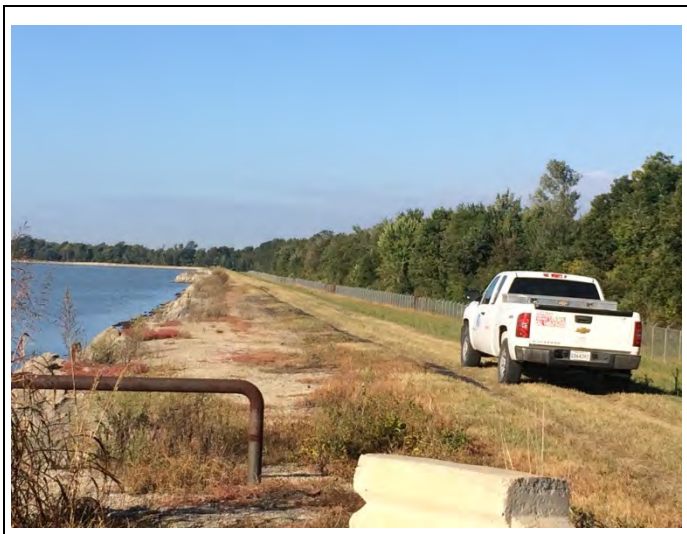
**Photo No: 3**                      **Picture Direction: W**  
**Description:** Northeast corner of Fly Ash Unit along north levee

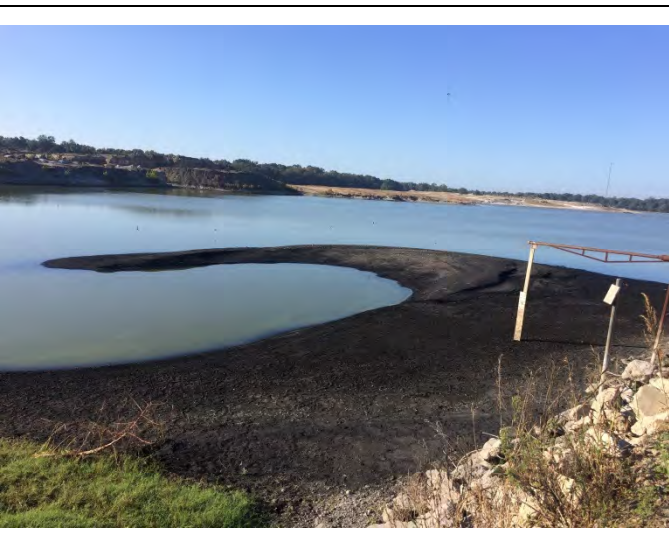
**Photo No: 4**                      **Picture Direction: S**  
**Description:** Northeast corner of Fly Ash Unit

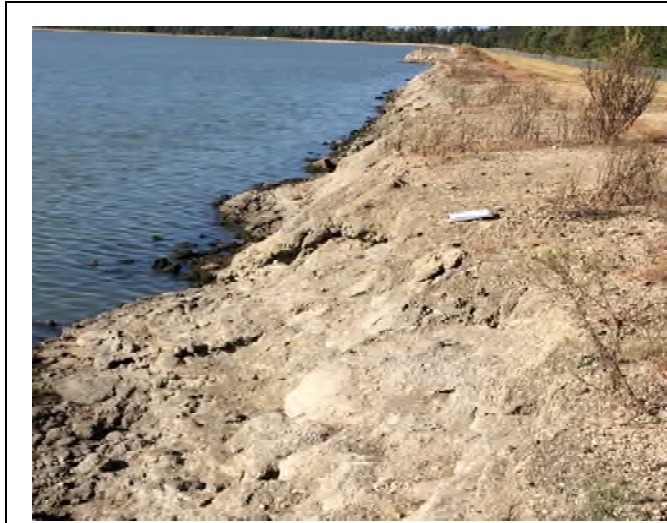
Fly ash that had been placed along the inside of the levee for erosion protection showed areas of erosion of the fly ash (Photo 5 and 7), however, there was no evidence of erosion of the levee material.

<b>Photo No:</b> 5	<b>Picture Direction:</b> W	<b>Photo No:</b> 6	<b>Picture Direction:</b> W
<b>Description:</b> Example of erosion protection undercut along north Fly Ash Basin levee.		<b>Description:</b> NW corner of Fly Ash Basin. Note coloration of rocks indicating the high water mark.

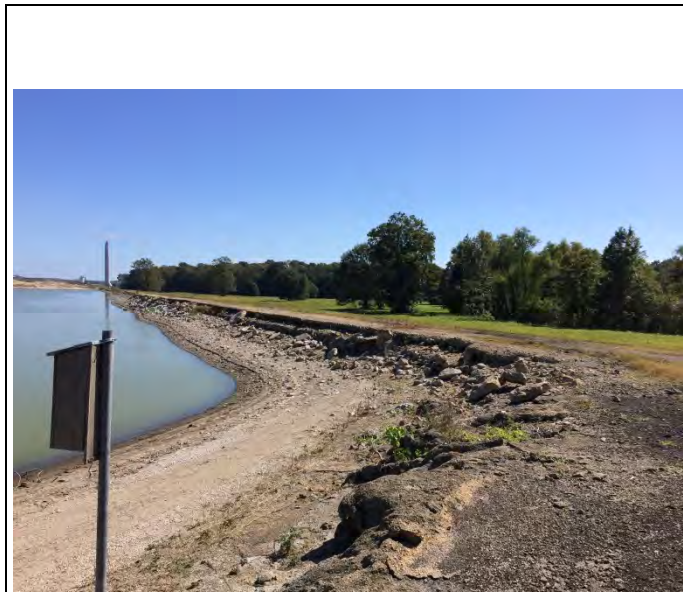
<b>Photo No:</b> 7	<b>Picture Direction:</b> E	<b>Photo No:</b> 8	<b>Picture Direction:</b> E
<b>Description:</b> SW corner of Fly Ash Basin looking along south levee		<b>Description:</b> Tension cracks in road surface at a slough in SW corner of Fly Ash Basin.

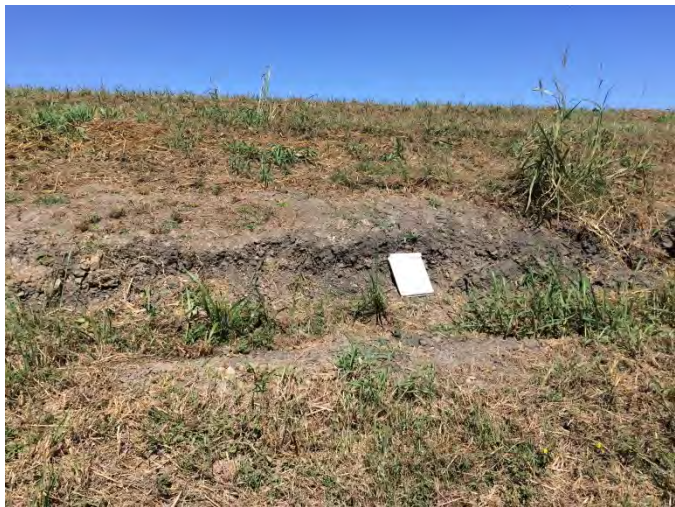
**Photo No:** 9                      **Picture Direction:** N  
**Description:** Slope escarpment below tension cracked section along south levee of FAB

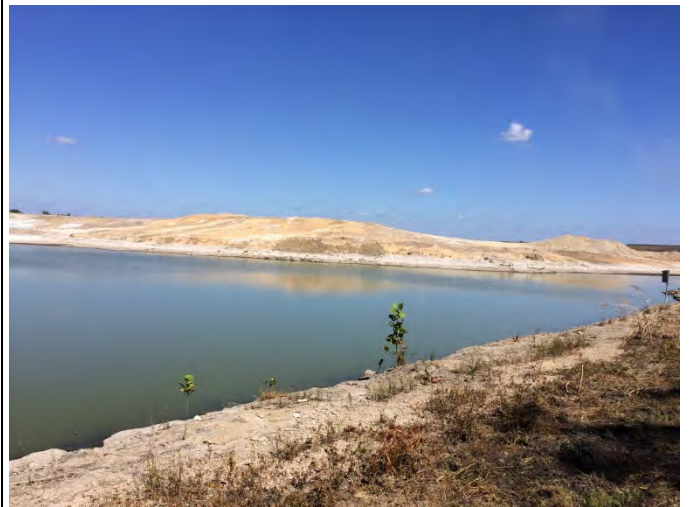
**Photo No:** 10                      **Picture Direction:** NE  
**Description:** Southwest corner of Fly Ash Basin from 30° 43' 19.51"W 91° 23' 29.22"N

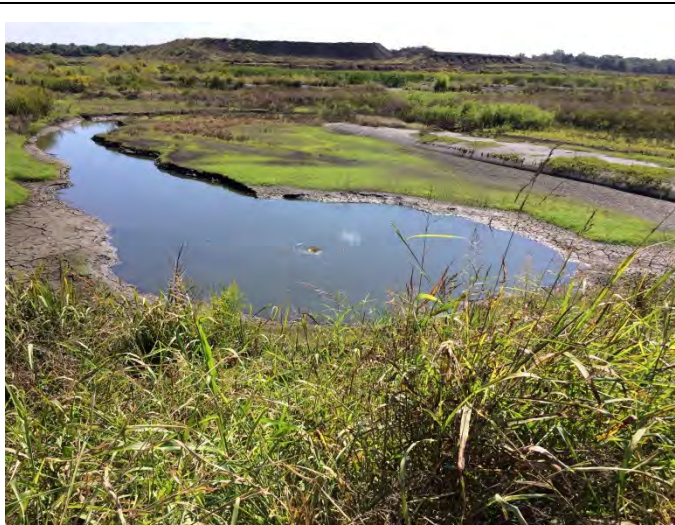
**Photo No:** 11                      **Picture Direction:** SW  
**Description:** Whirlpool at Bottom Ash Basin discharge in NE corner of Bottom Ash Basin

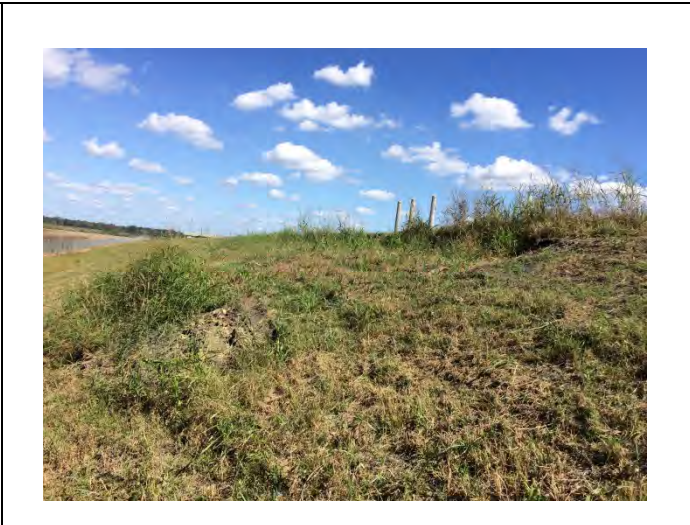
**Photo No:** 12                      **Picture Direction:** S  
**Description:** Slough and bulge of Bottom Ash Berm near northeast corner.

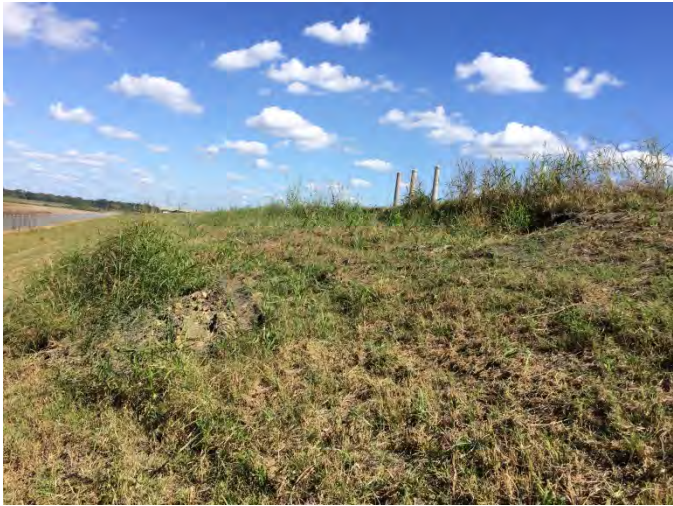
**Photo No:** 13                      **Picture Direction:** W

**Description:** Slope sloughing with soil rotation along the north Bottom Ash Basin levee.

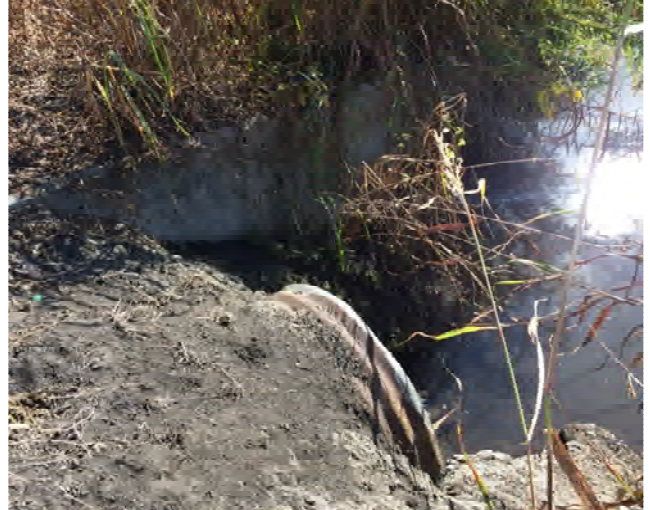
**Photo No:** 14                      **Picture Direction:** W

**Description:** Overflow inlet on east side of Bottom Ash Unit

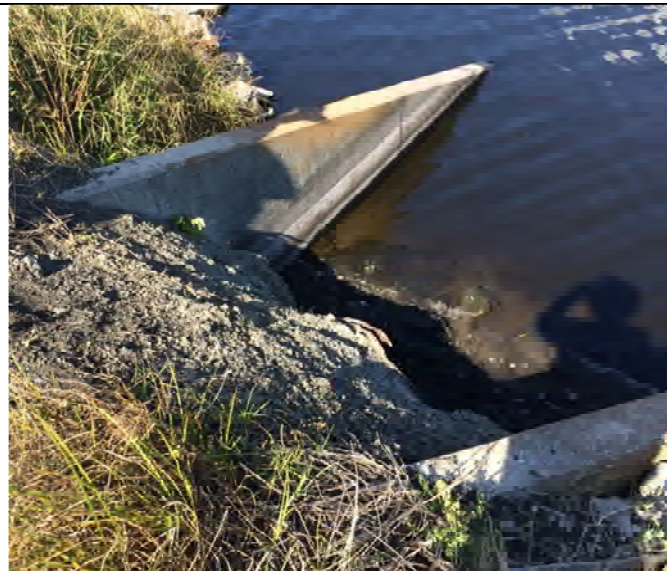
**Photo No:** 15                      **Picture Direction:** E

**Description:** Overflow outlet on east side of Bottom Ash Unit

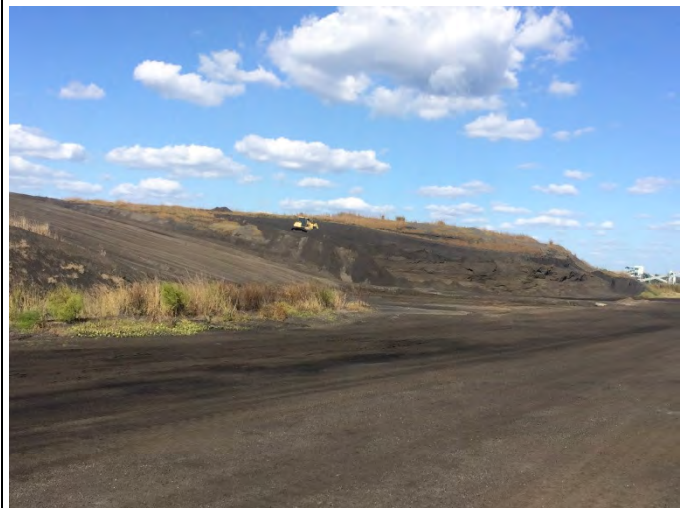
**Photo No:** 16                      **Picture Direction:** E

**Description:** Bottom Ash Unit side slope
