CLECO POWER LLC

DOLET HILLS POWER STATION

CCR ANNUAL INSPECTION

ASH BASIN NO. 1

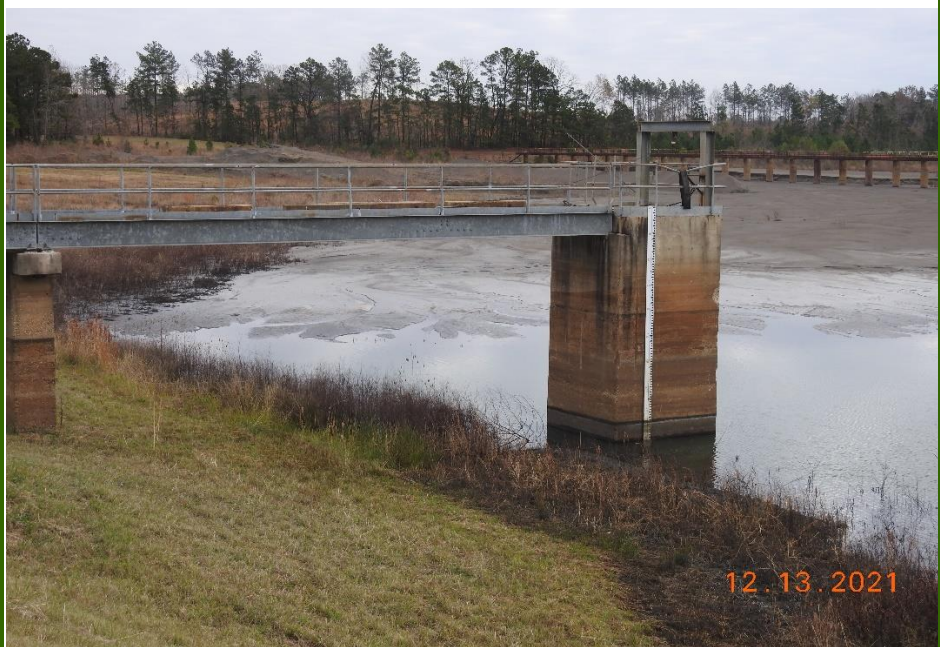
Ash Basin No. 1

Comments:
Overflow weir structure with concrete stoplogs. Level gauge attached to structure.

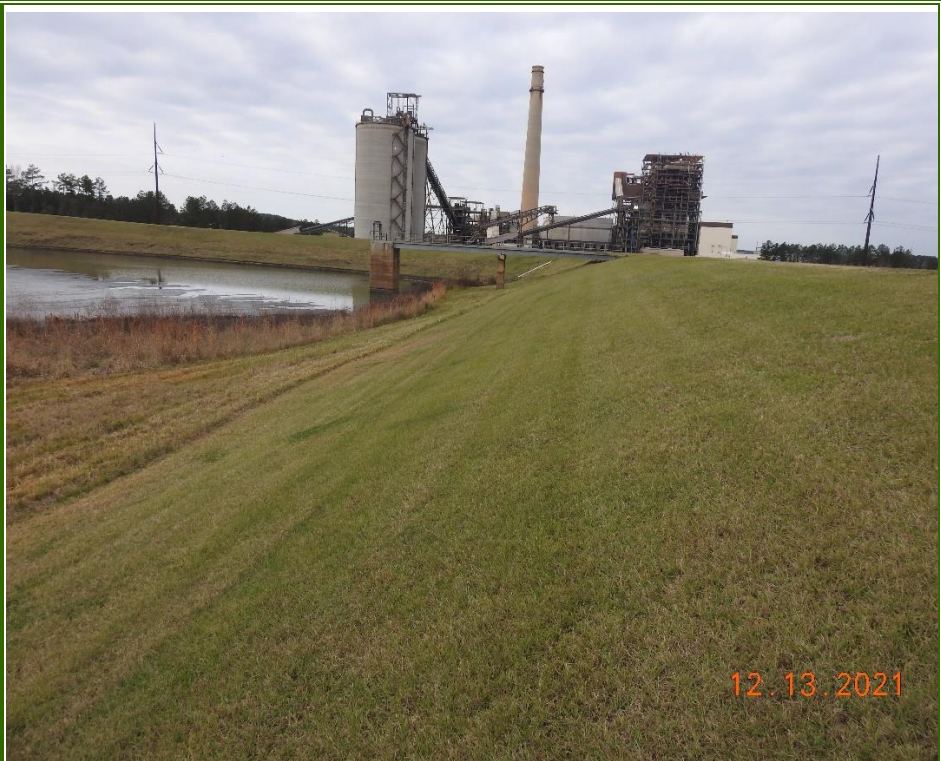
Ash Basin No. 1

Comments:
Internal slope of northern levee.

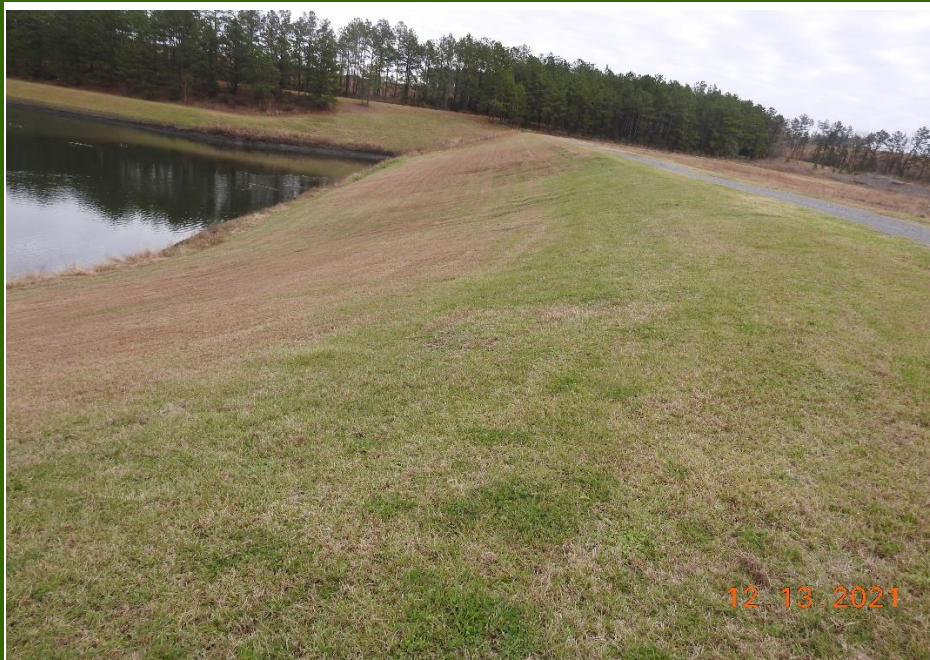
Ash Basin No. 1

External slope of northern levee.

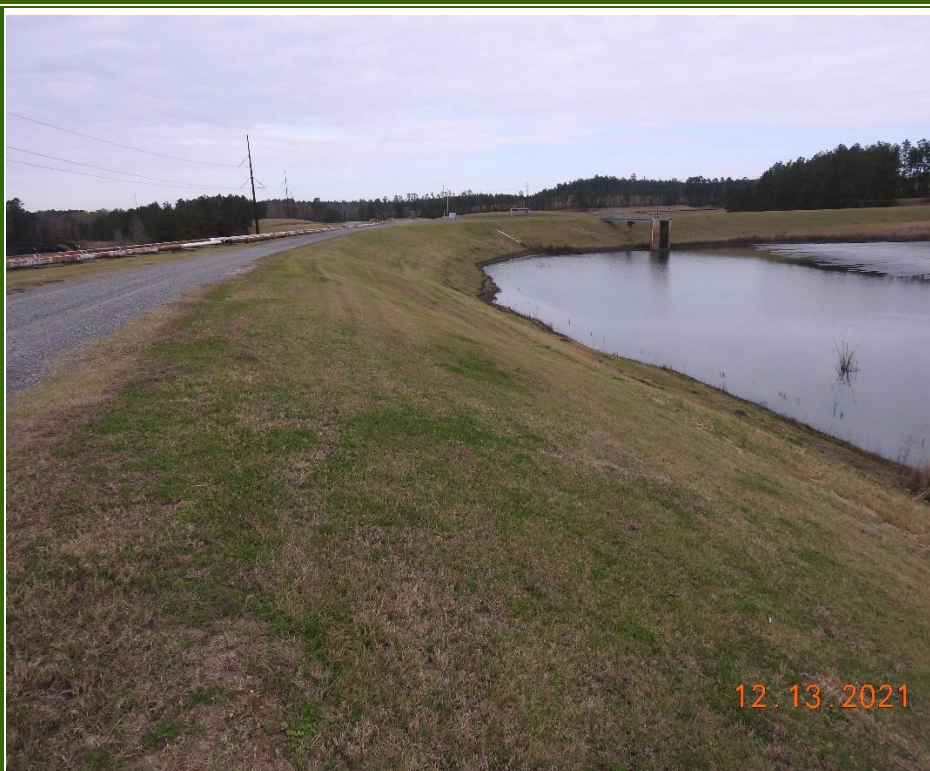
Ash Basin No. 1

Internal slope of western levee.

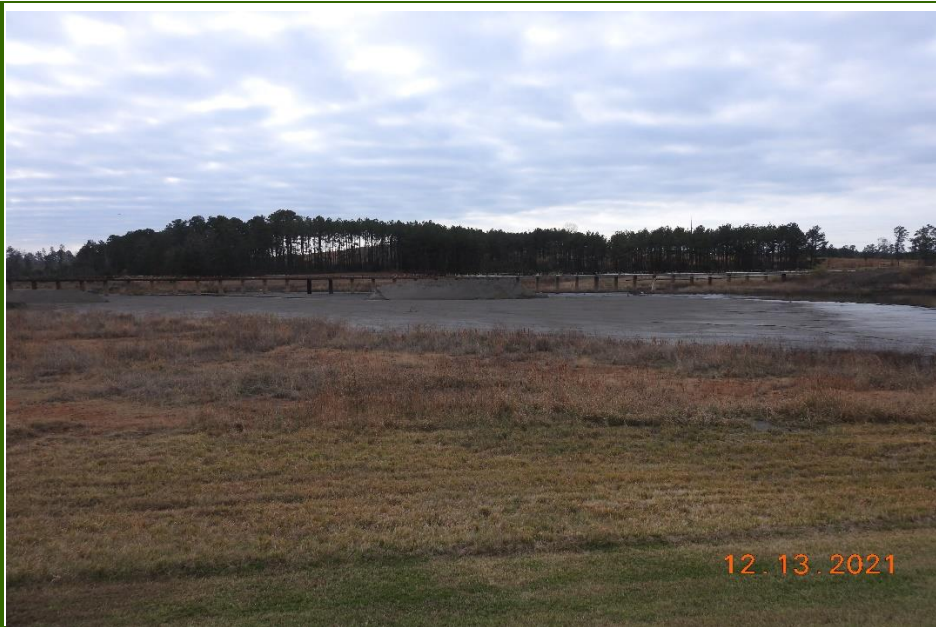
Ash Basin No. 1

Bottom ash sluicing structure in surface impoundment.

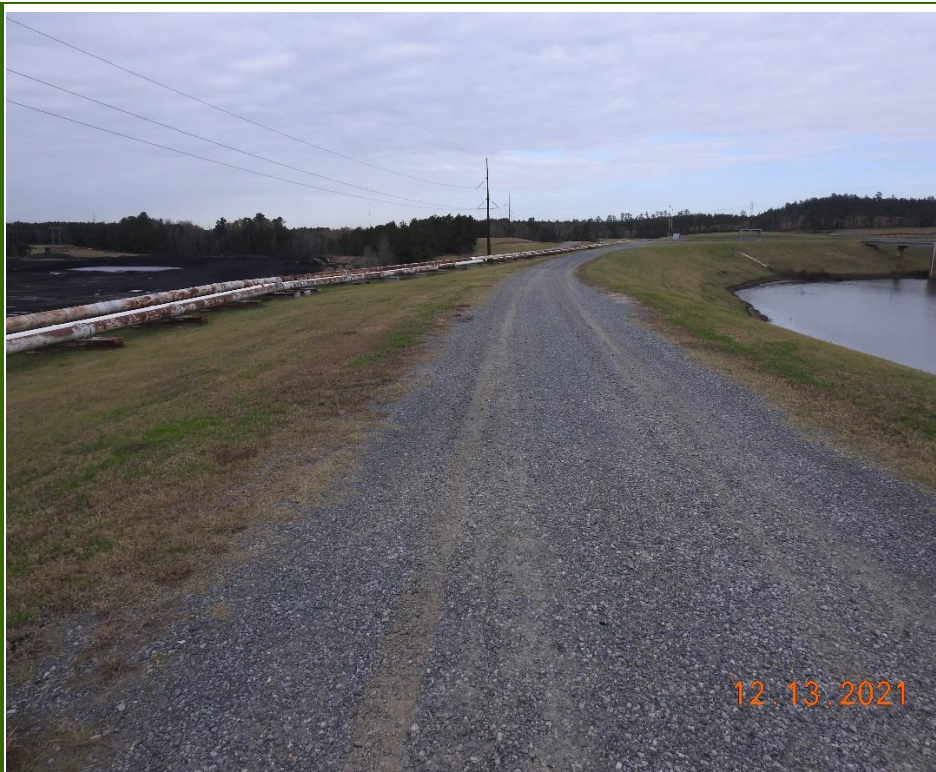
Ash Basin No. 1

Access road on western levee.

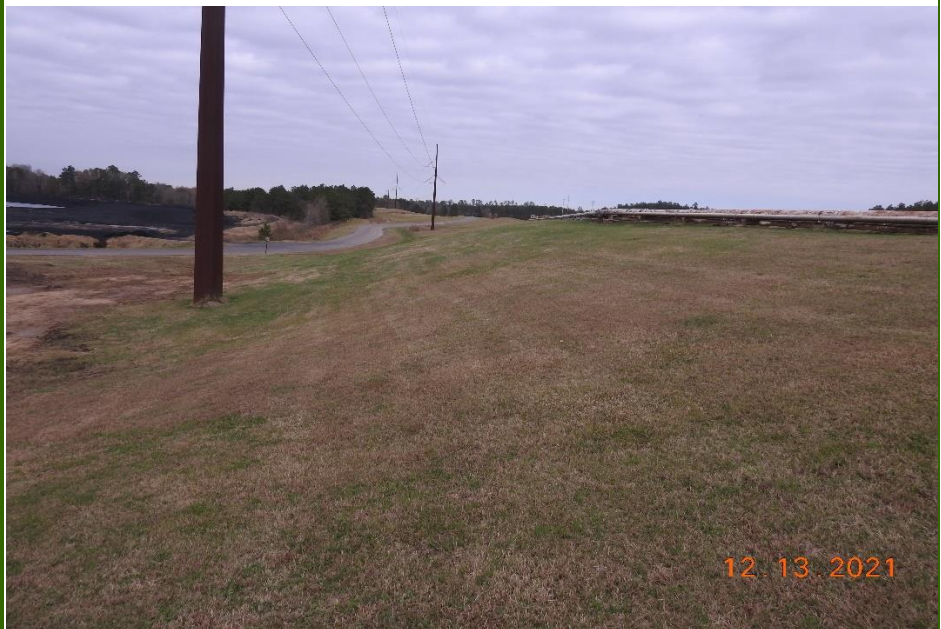
Ash Basin No. 1

Western exterior
levee slope.

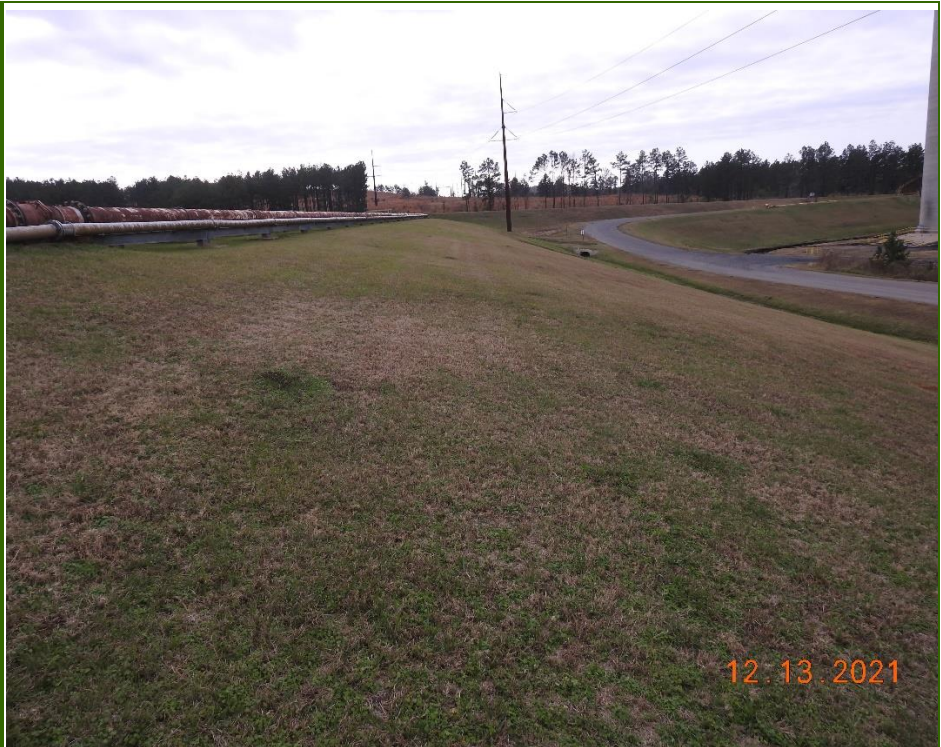
Ash Basin No. 1

Western exterior
levee slope.
