CLECO POWER LLC DOLET HILLS POWER STATION

CCR ANNUAL INSPECTION

FLY ASH/SCRUBBER SLUDGE LANDFILL

JANUARY 2023

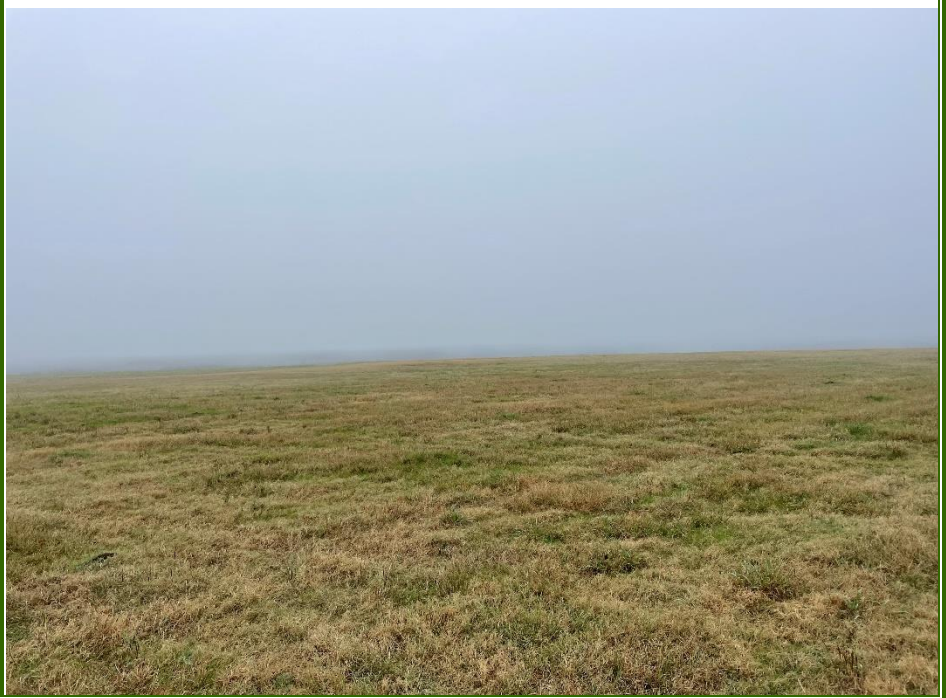
Crown of landfill.

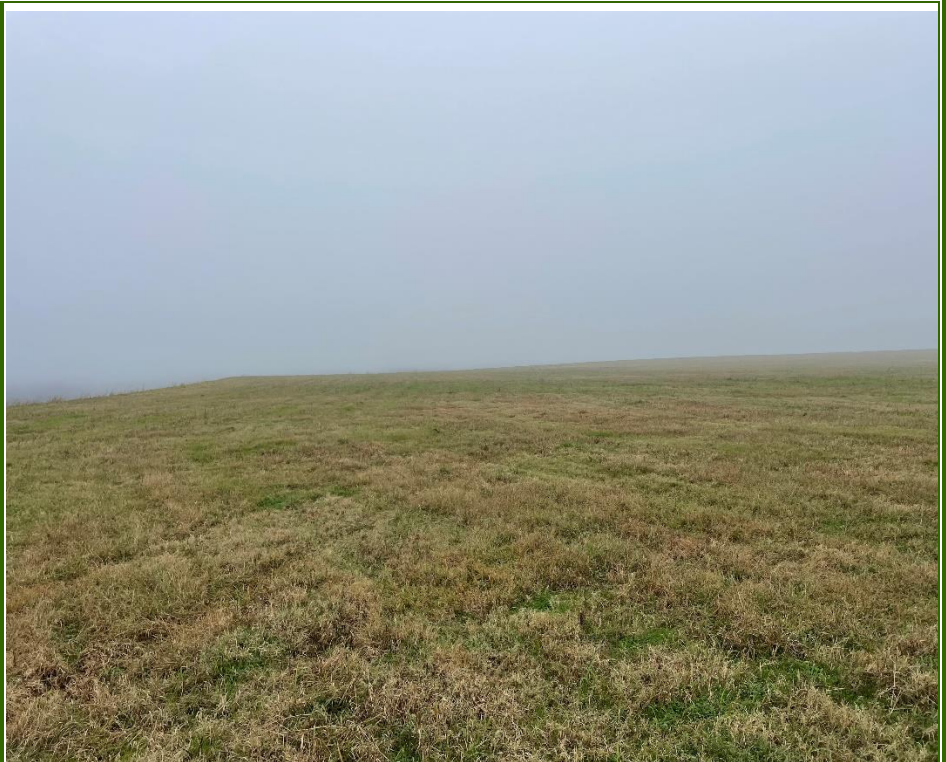
Crown of landfill.

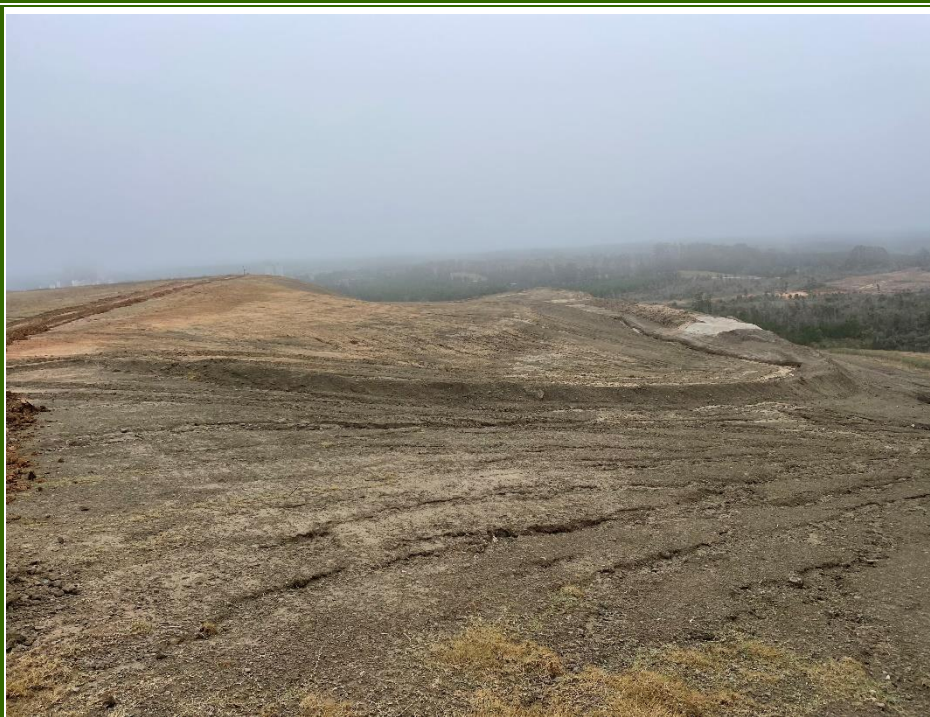
Eastern slope of active landfill.

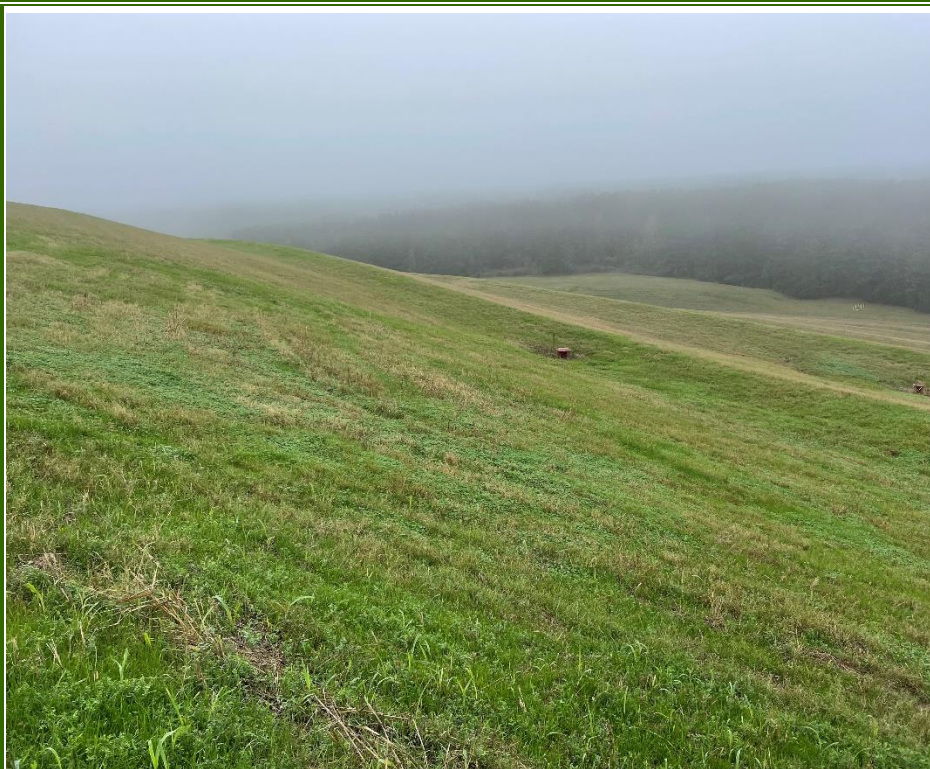
If yes, describe (size, location, etc.)	
Is the stormwater infrastructure in good condition?	<input checked="" type="checkbox"/> Yes <input type="checkbox"/> No
Findings:	The exterior slopes were inspected and appeared to be in fair condition on the western side of the landfill. Erosion, wet areas, and stressed vegetation on western slope near toe of landfill.
Other observations on the exterior slopes:	None

Western exterior slope vegetative cover.

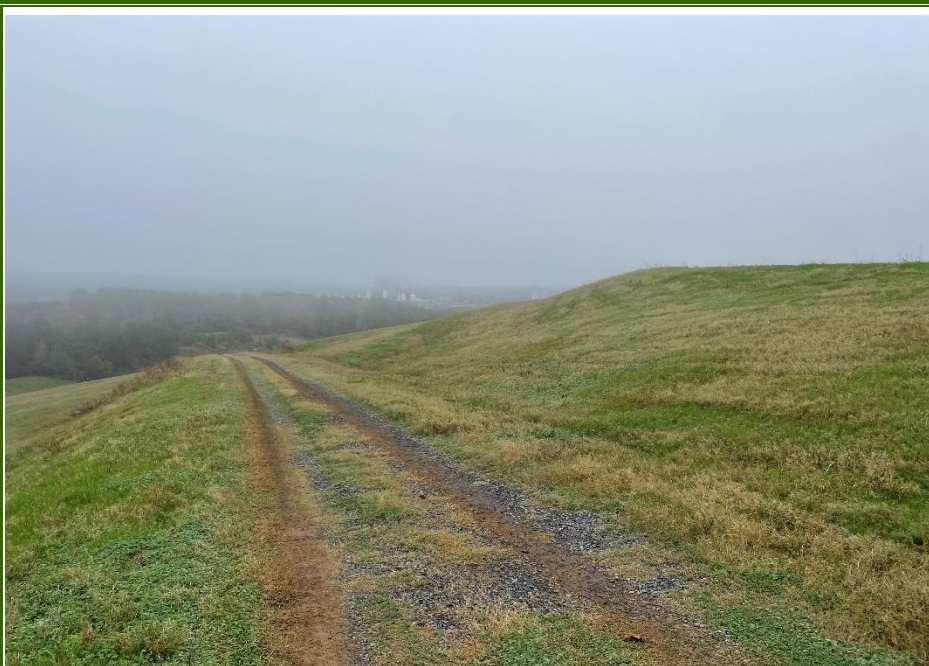
Western exterior slope and access road.

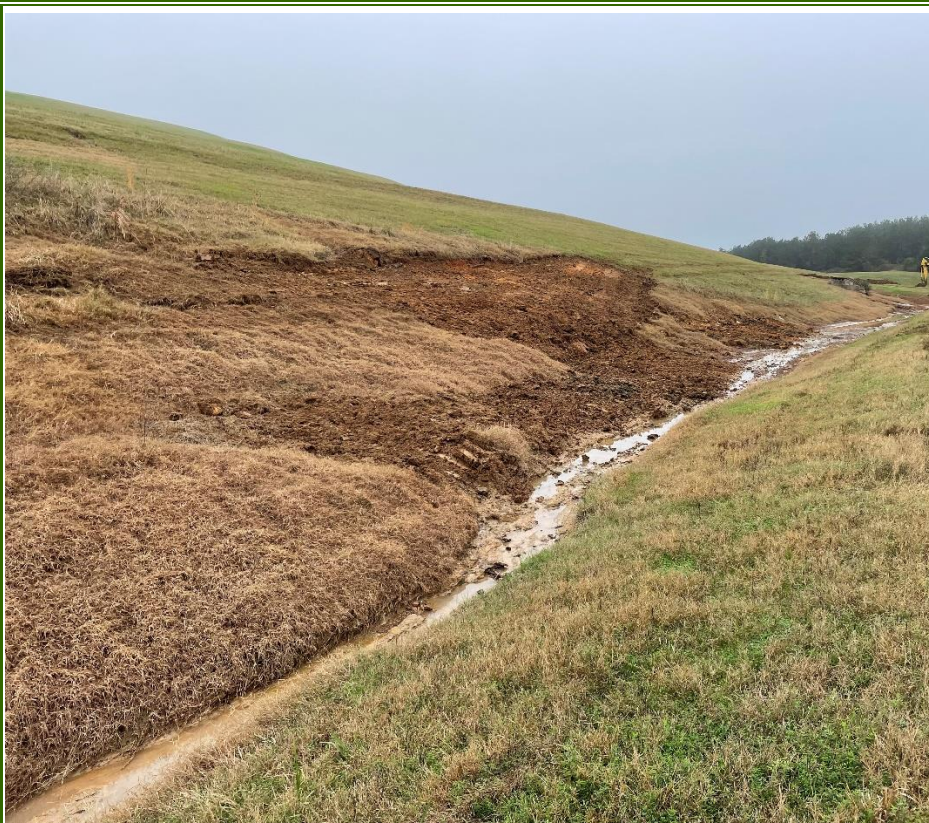
Western toe of landfill slope with areas of seepage and stressed vegetation.

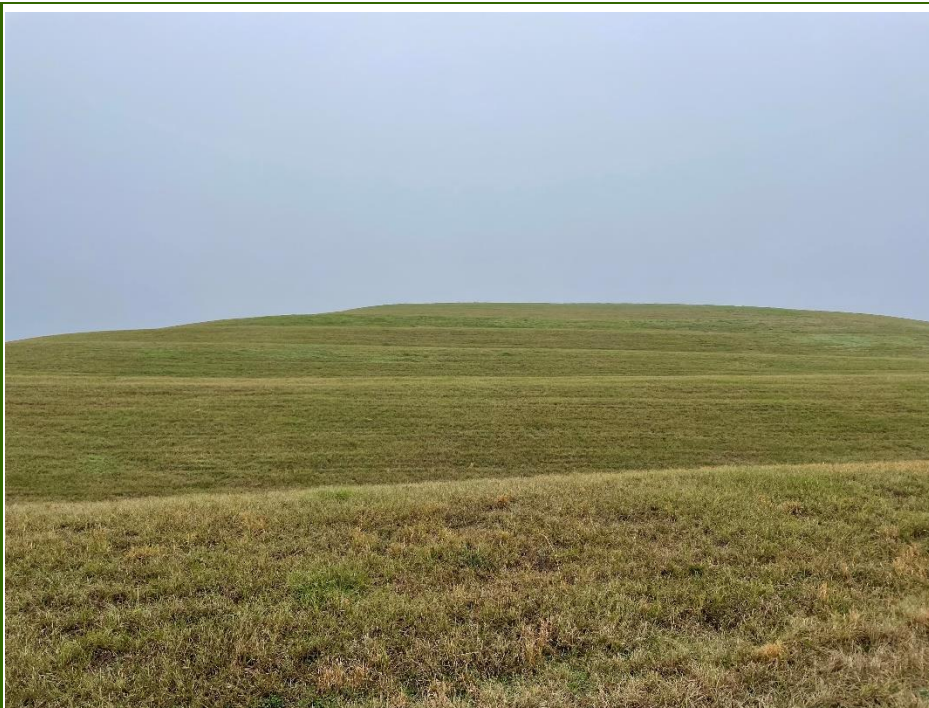
Southern slope of landfill.

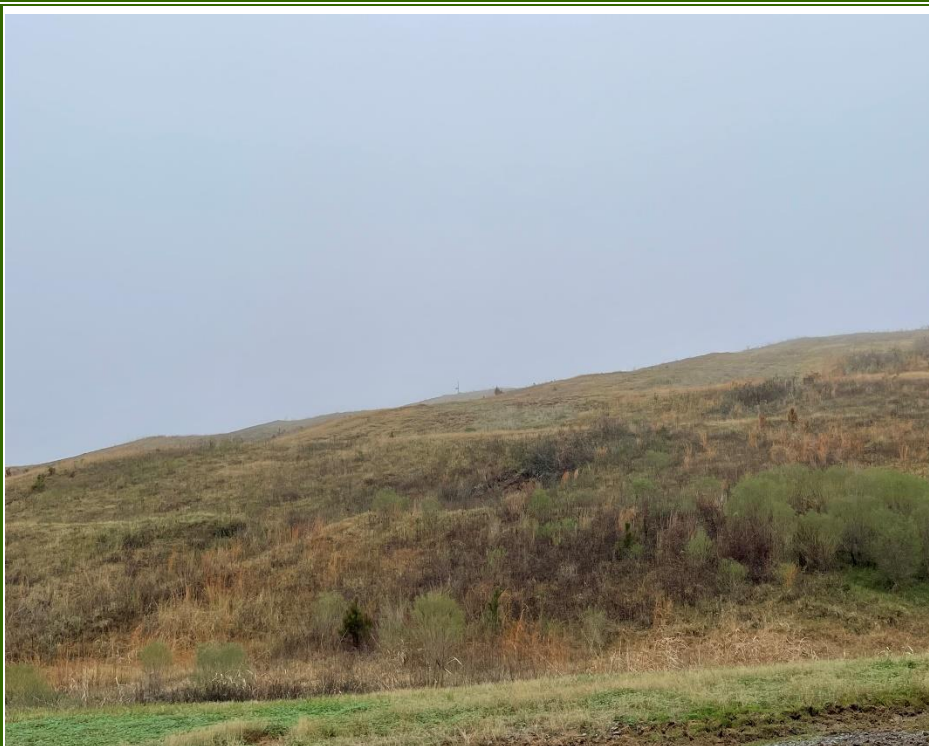
West slope of landfill with some excess vegetation.

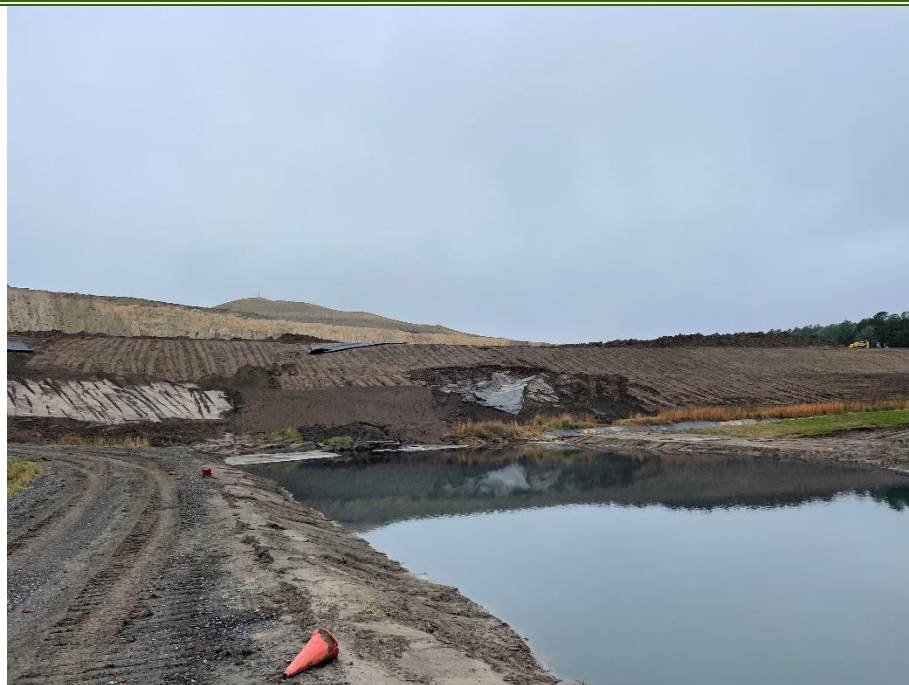
Sedimentation pond and active landfill cell.

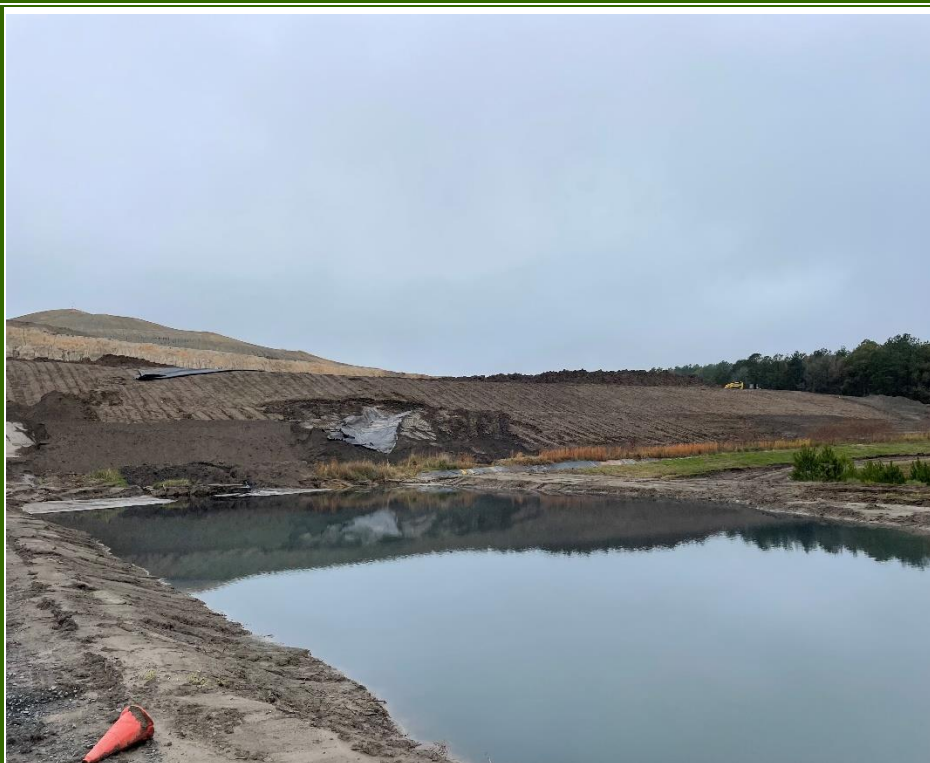
Sedimentation pond and active landfill cell.
