CLECO POWER LLC

DOLET HILLS POWER STATION

CCR ANNUAL INSPECTION

ASH BASIN NO. 1

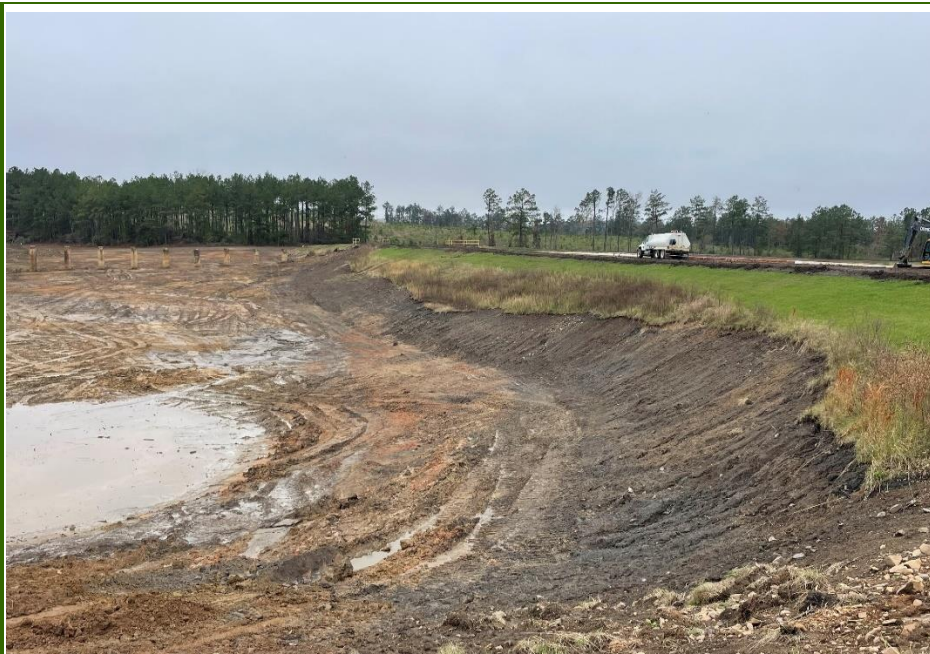
Ash Basin No. 1

Southerly

Interior slope of western levee.

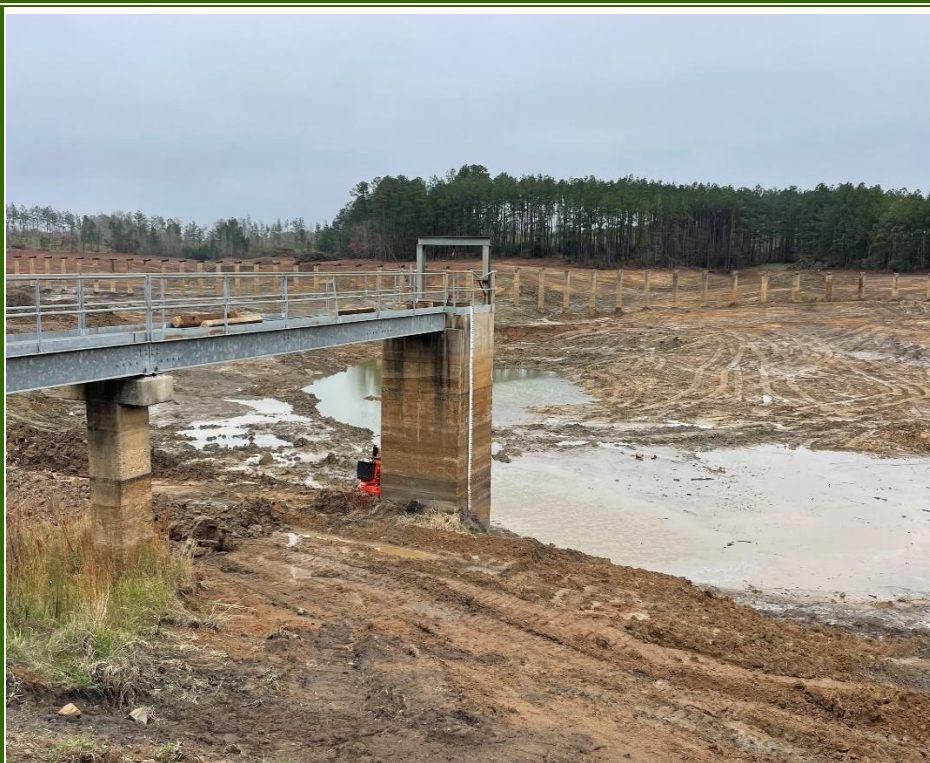
Ash Basin No. 1

Southeasterly

Remains of Bottom Ash sluicing structure and outfall structure.

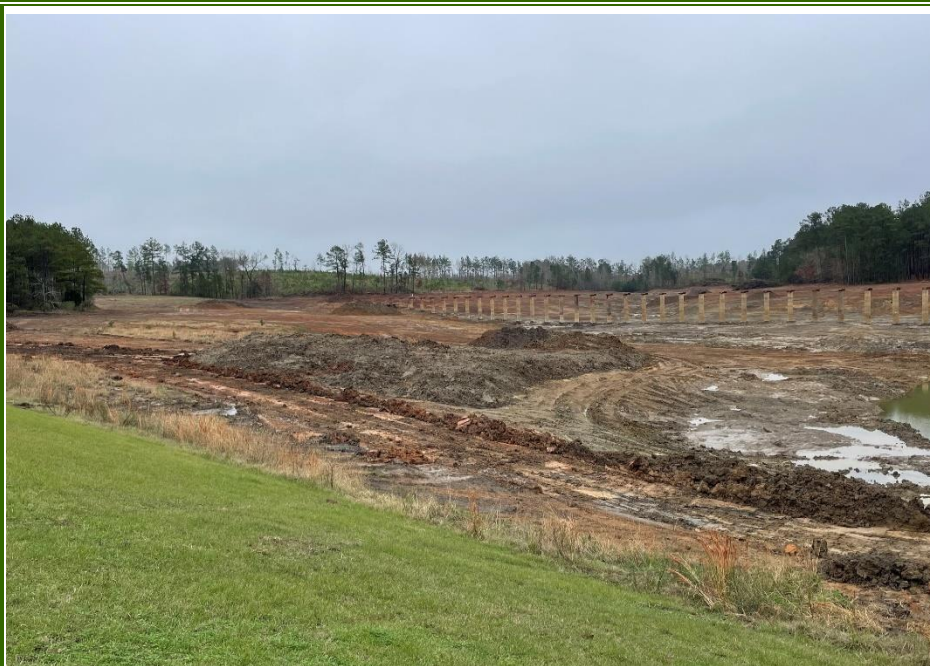
Ash Basin No. 1

Southeasterly

Remains of Bottom Ash sluicing structure in surface impoundment.

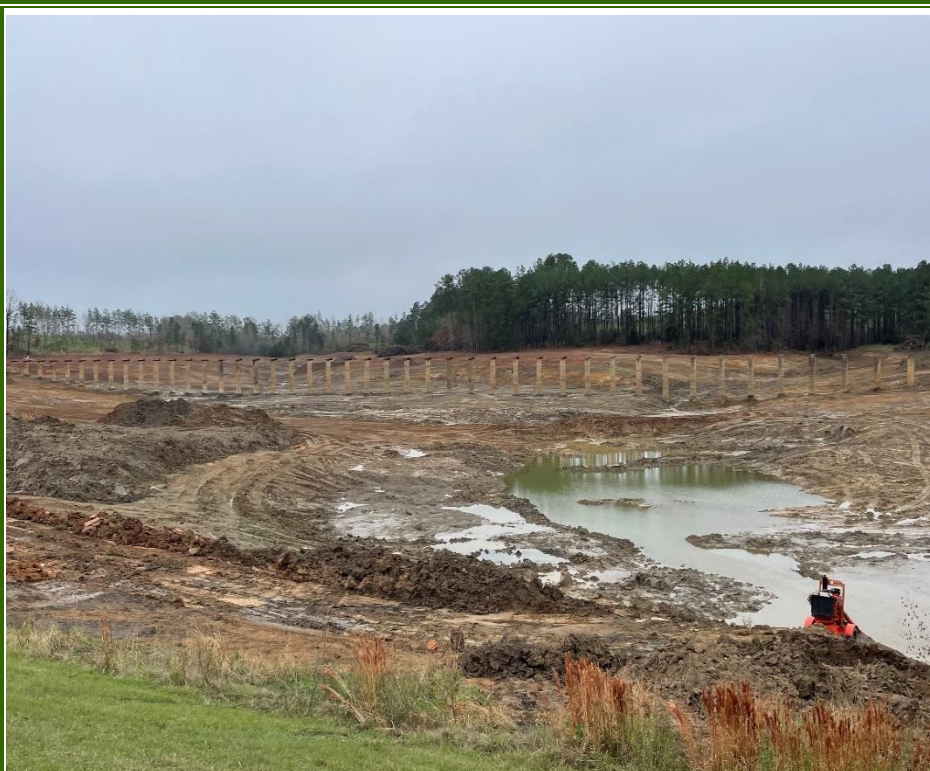
Ash Basin No. 1

Southeasterly

Remains of Bottom Ash sluicing structure in surface impoundment.
