CLECO POWER LLC

DOLET HILLS POWER STATION

CCR ANNUAL INSPECTION

ASH BASIN NO. 2

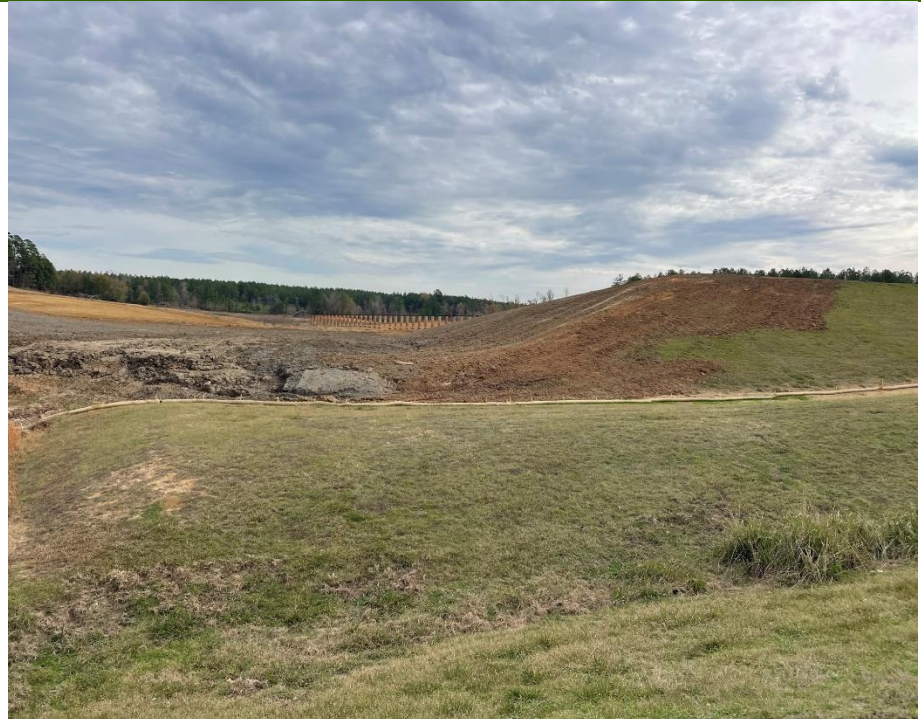
If yes, describe (size of area, location, severity, etc.)	
Are there any trees on the slopes?	<input type="checkbox"/> Yes <input checked="" type="checkbox"/> No
If yes, describe (type of vegetation, size, location, etc.)	
Findings:	Ash Basin No. 2 is undergoing final regulatory closure. Western levee degrading has been completed.
Other observations on the exterior slopes:	Ash Basin No. 2 is undergoing final regulatory closure.

Degraded western
levee

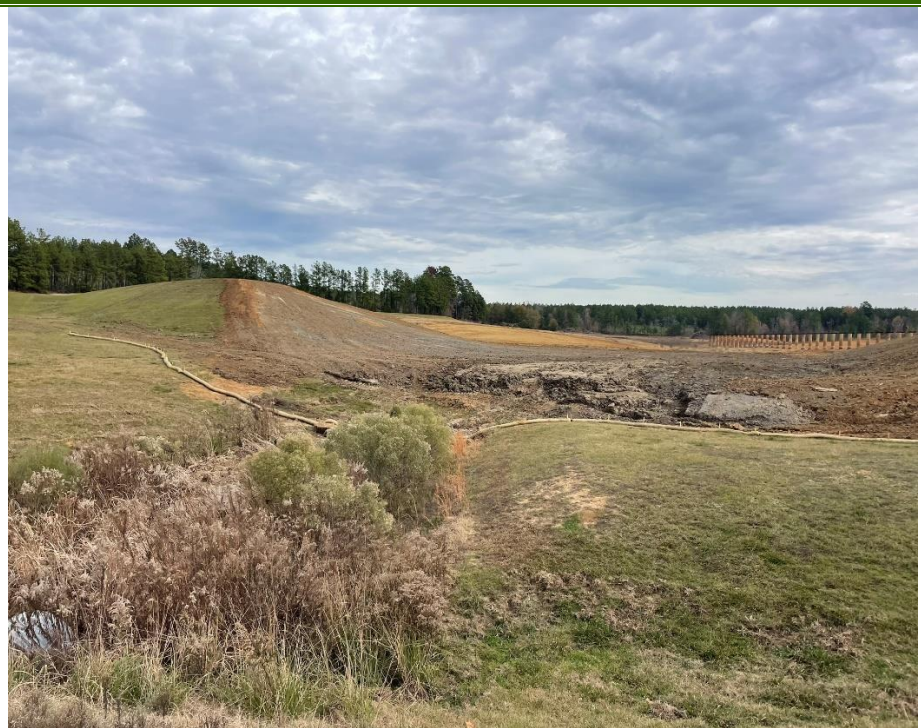
Ash Basin No. 2

Degraded western
levee

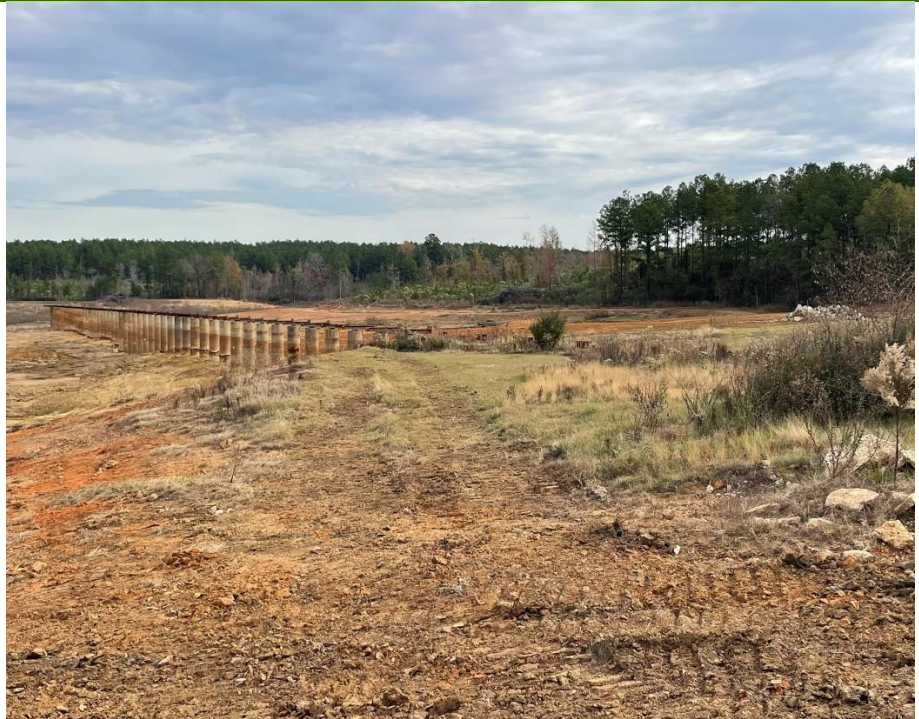
Ash Basin No. 2

Former ash sluice structure

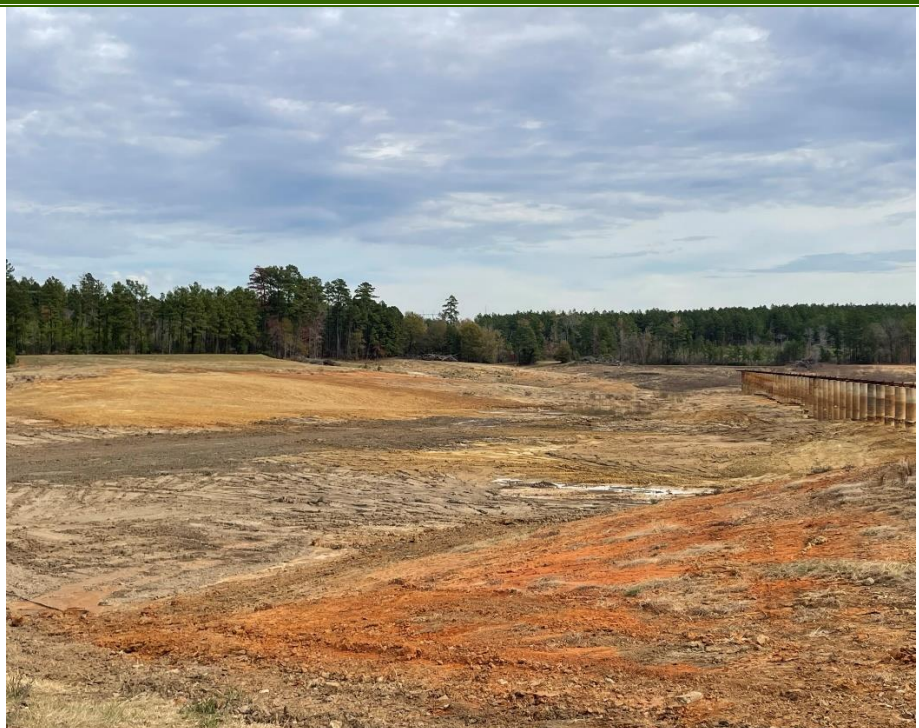
Former Ash Basin No. 2
