ANNUAL CCR SURFACE IMPOUNDMENT INSPECTION:			
Facility Name:		Cleco Dolet Hills Power Station	
Address:		963 Power Plant Rd. Mansfield, LA	
Surface Impoundment Name :	Ash Basin No. 1	Owner:	Cleco Power LLC
Surface Impoundment ID:	P-0037	Operator:	Cleco Power LLC
Nearest City:	Mansfield	Parish:	DeSoto
Inspector:		James C. Van Hoof, P.E.	
Company:		Providence Engineering & Environmental Group LLC	
Date of Inspection:		12/12/2017	
Weather at Time of Inspection:		Sunny, Cool	
DESCRIPTION OF THE OPERATION OF THE SURFACE IMPOUNDMENTS:			
<p>The bottom ash and economizer ash are mixed with water and sluiced in a slurry form to either of the two Ash Basins. Ash slurry pipelines within each basin enable the discharge of the slurry at multiple points within each basin. The discharge into each respective basin begins at the end of the pipeline network at the point furthest from the weir box, and proceeds toward the front of the pond. As a basin fills with ash, sections of the discharge pipe are removed as needed so that ash can be uniformly deposited and the storage capacity of each basin fully utilized. The ash-laden water is retained in the Ash Basins for a period of time sufficient to sett

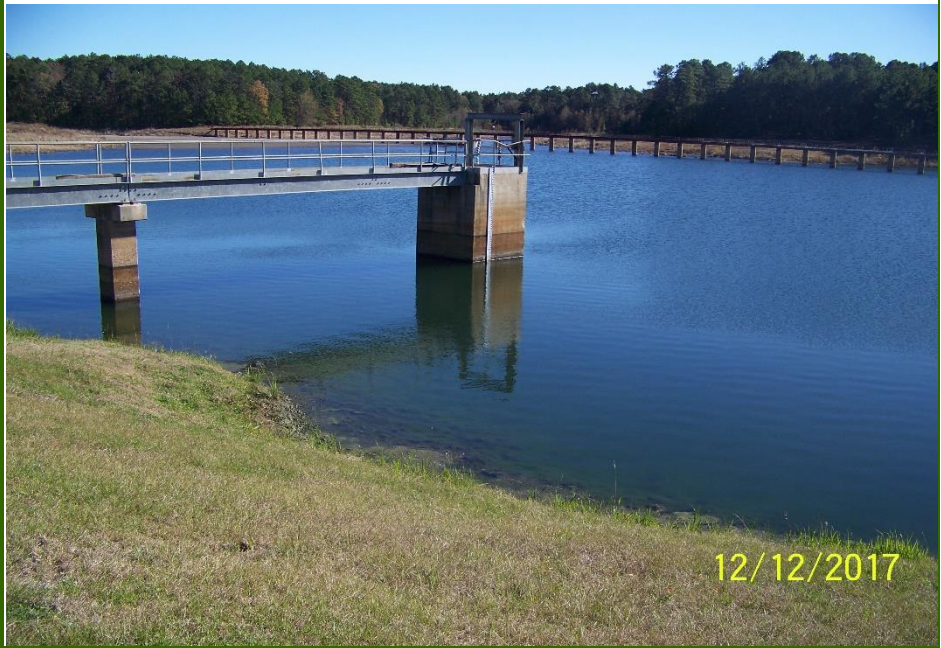
Ash Basin No. 1

Comments:
Overflow weir structure with concrete stoplogs. Level gauge attached to structure.

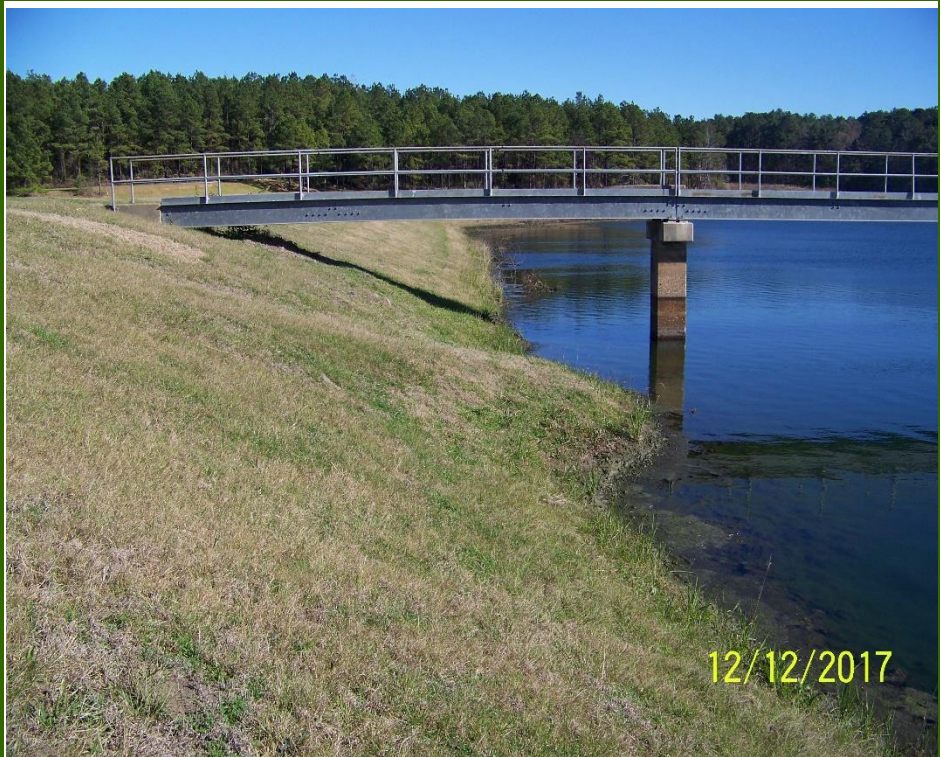
Ash Basin No. 1

Comments:
Internal slope of northern levee.

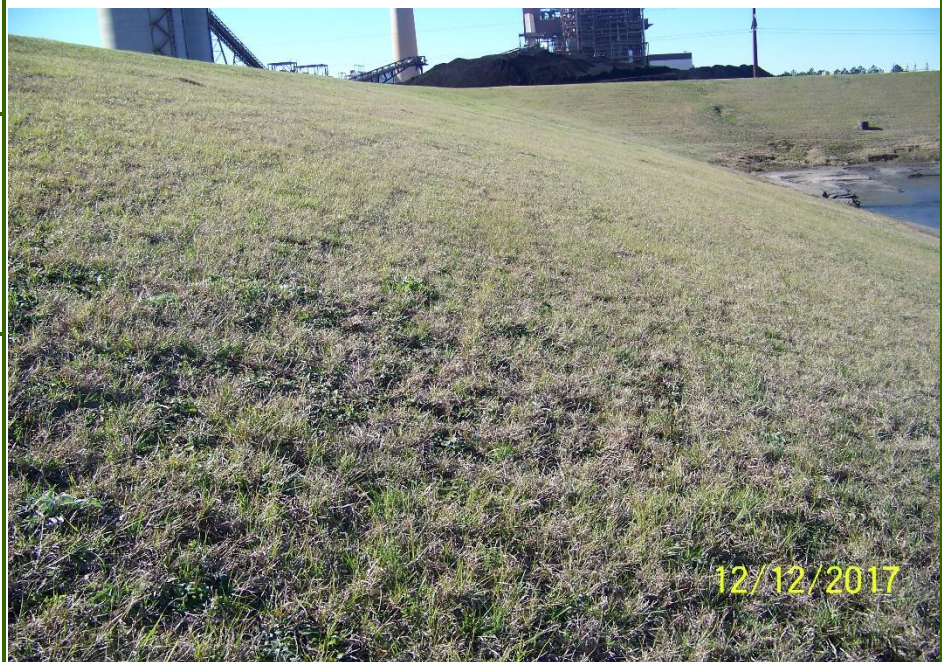
Ash Basin No. 1

External slope of northern levee

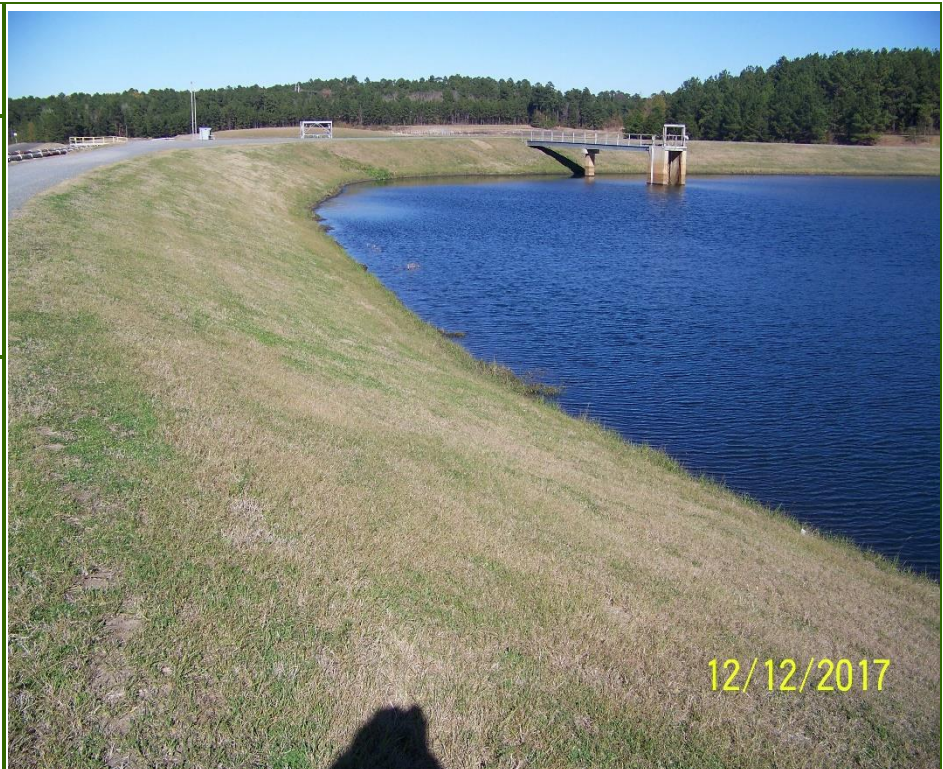
Ash Basin No. 1

Internal slope of western levee.

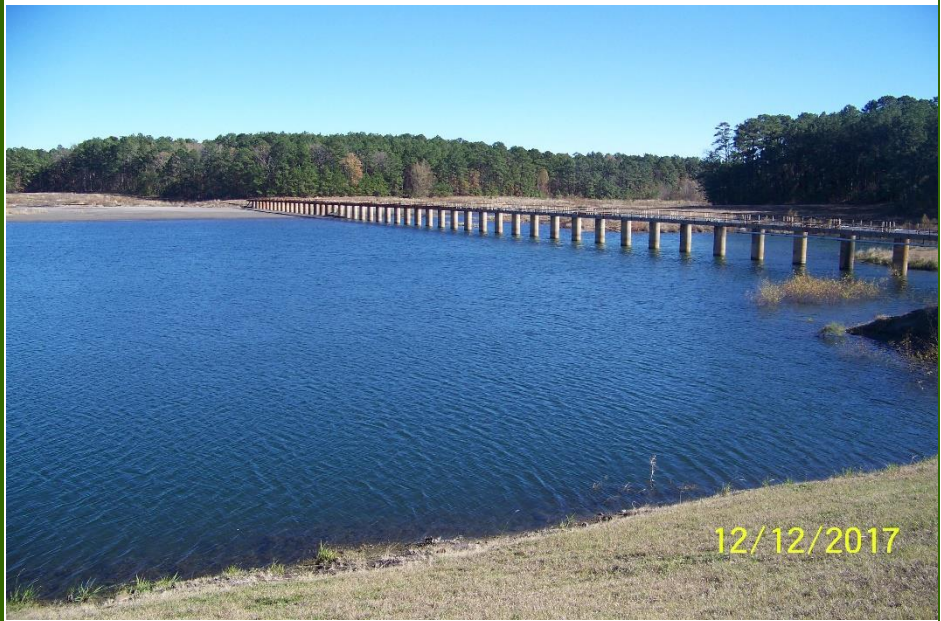
Ash Basin No. 1

Bottom ash sluicing structure in surface impoundment.

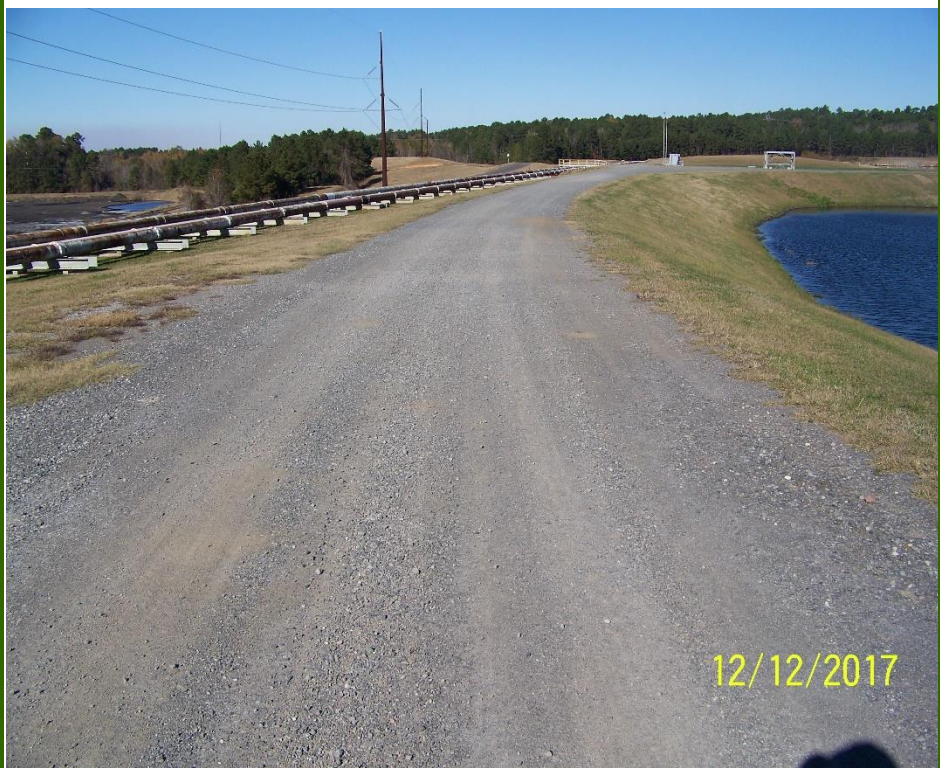
Ash Basin No. 1

Access road on western levee.

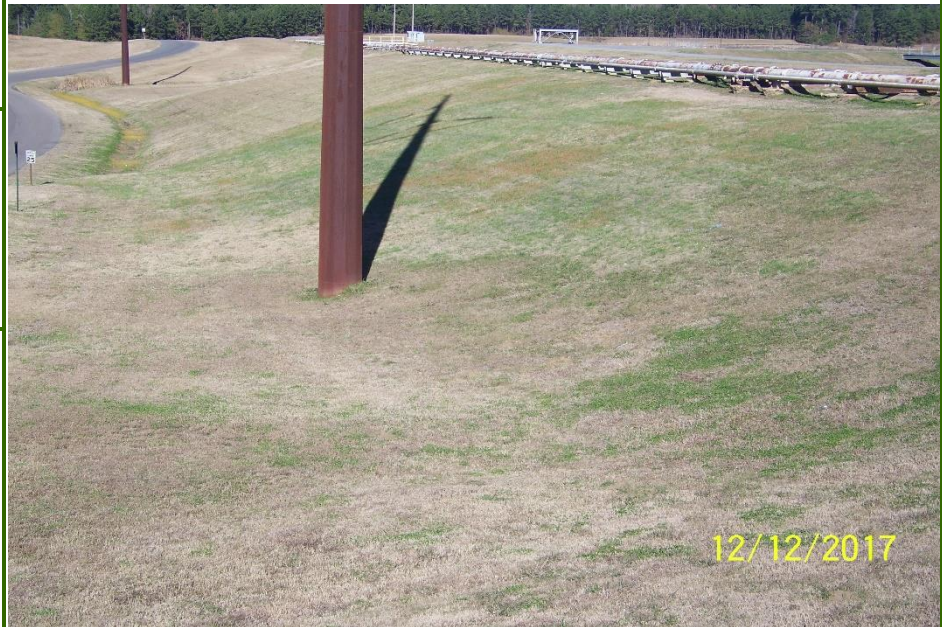
Ash Basin No. 1

Western exterior
levee slope.

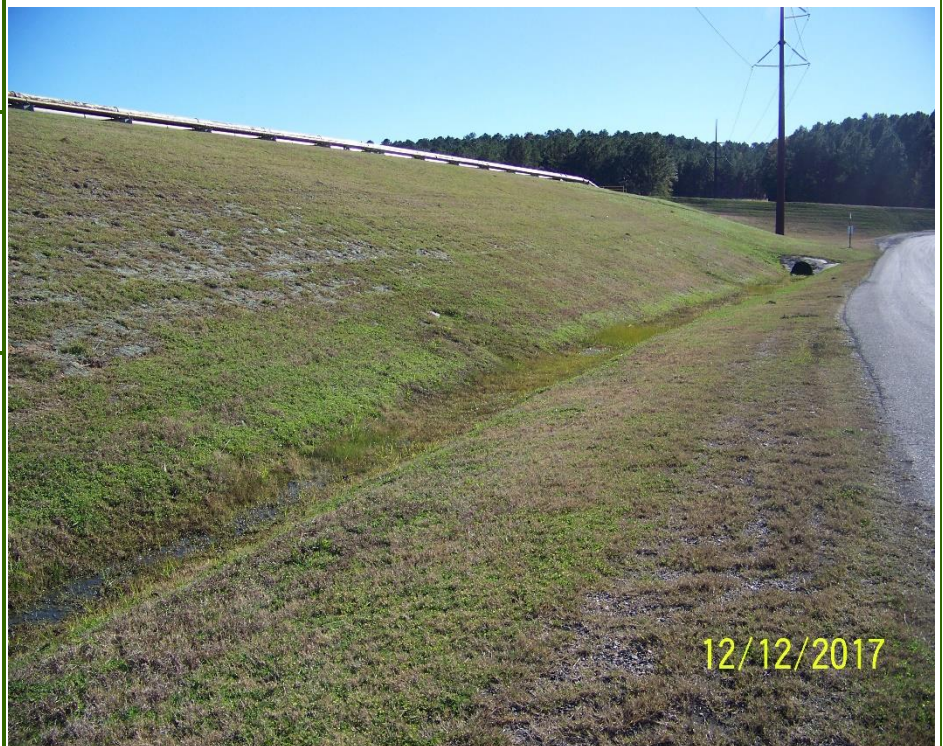
Ash Basin No. 1

Western exterior
levee slope.
