ANNUAL CCR SURFACE IMPOUNDMENT INSPECTION:			
Facility Name:		Cleco Dolet Hills Power Station	
Address:		963 Power Plant Rd. Mansfield, LA	
Surface Impoundment Name :	Ash Basin No. 1	Owner:	Cleco Power LLC
Surface Impoundment ID:	P-0037	Operator:	Cleco Power LLC
Nearest City:	Mansfield	Parish:	DeSoto
Inspector:		James C. Van Hoof, P.E.	
Company:		Providence Engineering & Environmental Group LLC	
Date of Inspection:		1/13/2016	
Weather at Time of Inspection:		Sunny	
DESCRIPTION OF THE OPERATION OF THE SURFACE IMPOUNDMENTS:			
<p>The bottom ash and economizer ash are mixed with water and sluiced in a slurry form to either of the two Ash Basins. Ash slurry pipelines within each basin enable the discharge of the slurry at multiple points within each basin. The discharge into each respective basin begins at the end of the pipeline network at the point furthest from the weir box, and proceeds toward the front of the pond. As a basin fills with ash, sections of the discharge pipe are removed as needed so that ash can be uniformly deposited and the storage capacity of each basin fully utilized. The ash-laden water is retained in the Ash Basins for a period of time sufficient to settle most

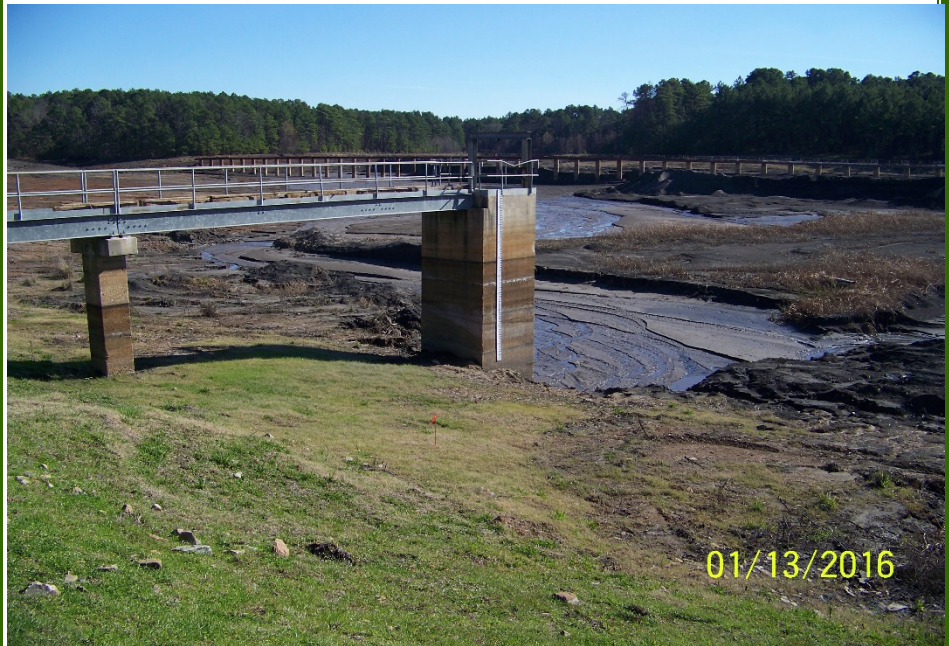
Ash Basin No. 1

Overflow weir structure with concrete stoplogs. Level gauge attached to structure.

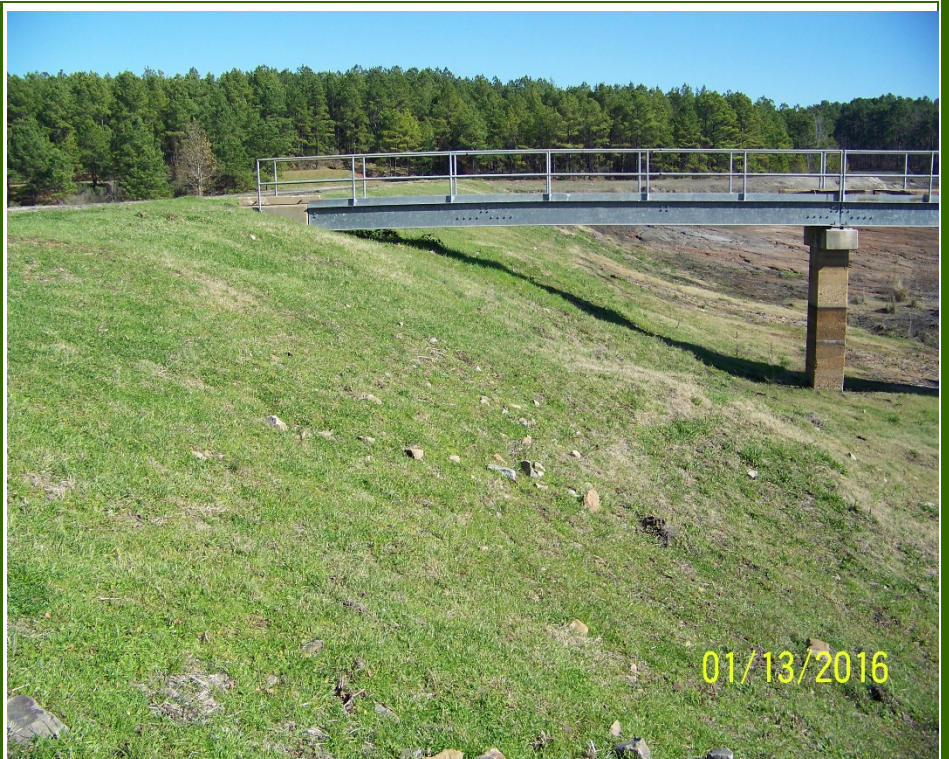
Ash Basin No. 1

If yes, describe (size of area, location, severity, etc.)	
Findings:	The interior slope was inspected and appeared to be in satisfactory condition. No corrective actions are required at this time.
Other observations on the interior slopes: None

Internal slope of northern levee.

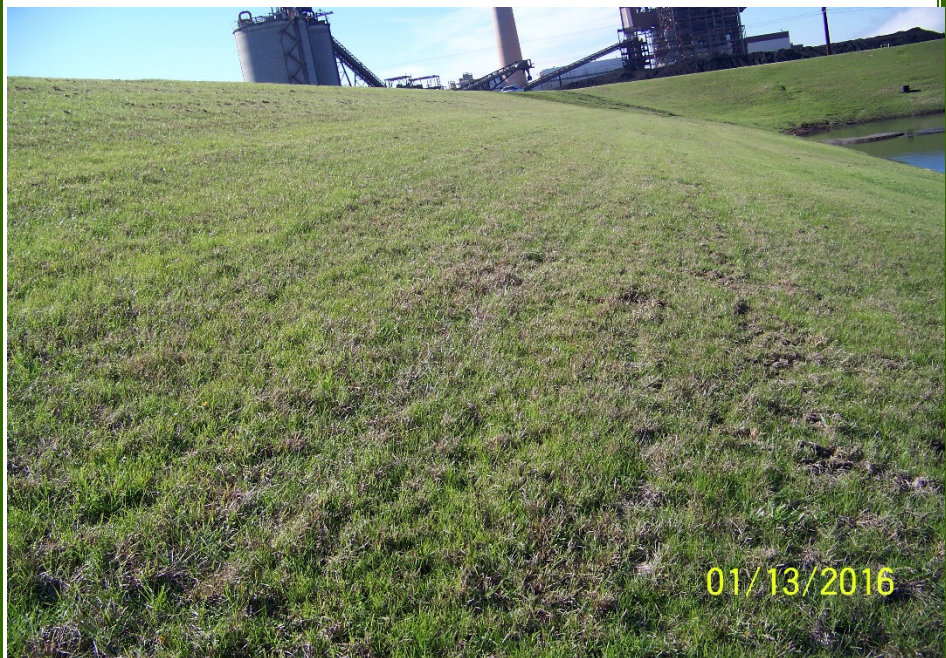
Ash Basin No. 1

If yes, describe (size of area, location, severity, etc.)	
Are there any trees on the slopes?	<input type="checkbox"/> Yes <input checked="" type="checkbox"/> No
If yes, describe (type of vegetation, size, location, etc.)	
Findings:	The exterior slope was inspected and appeared to be in satisfactory condition. No corrective actions are required at this time.
Other observations on the exterior slopes:	Contractor recently smoothed rills on the exterior slope and hydromulched the area.

External slope of northern levee

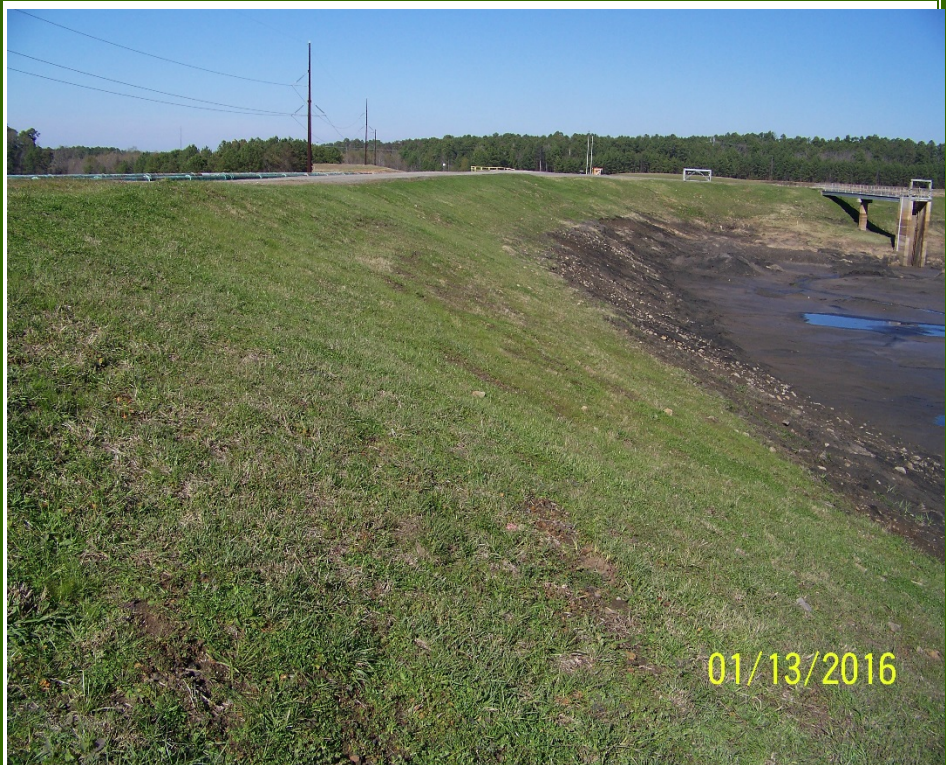
Ash Basin No. 1

Internal slope of western levee.

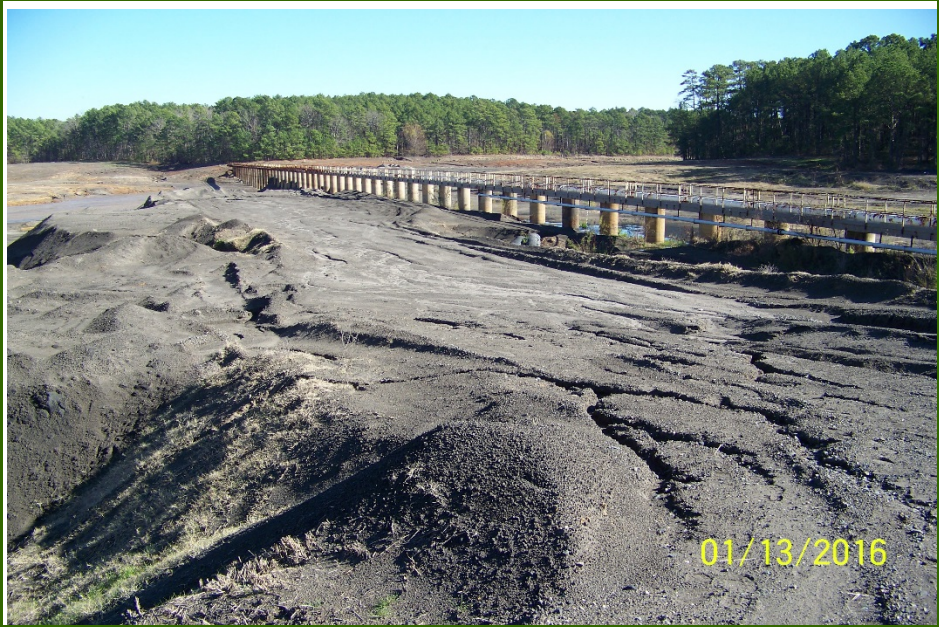
Ash Basin No. 1

Bottom ash in surface impoundment along the sluice structure.

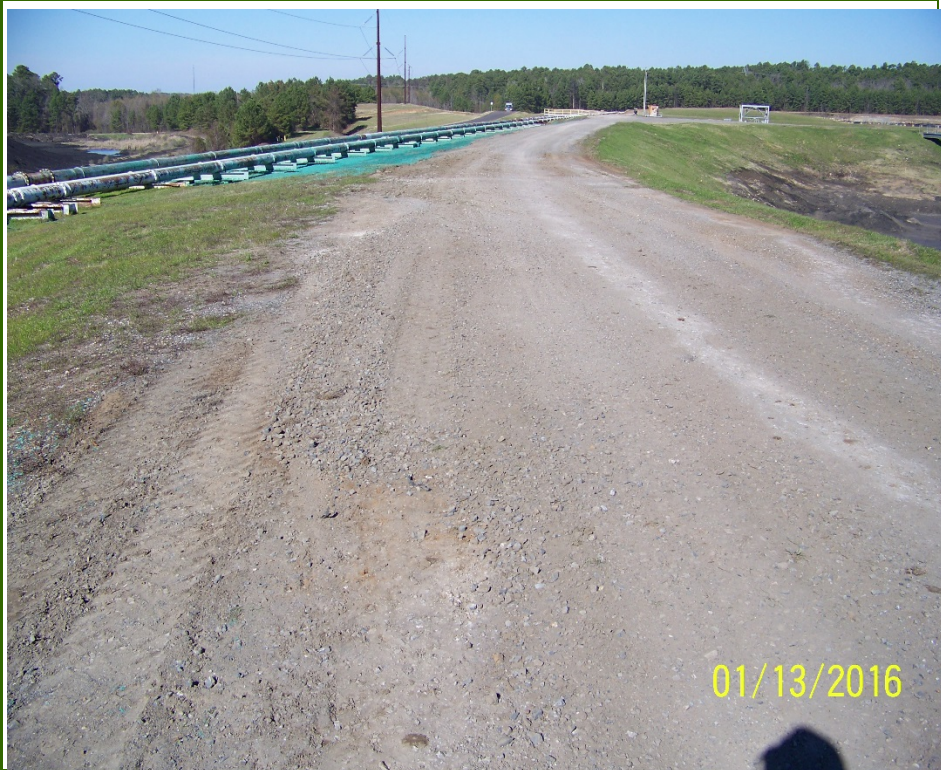
Ash Basin No. 1

Access road on northern levee.

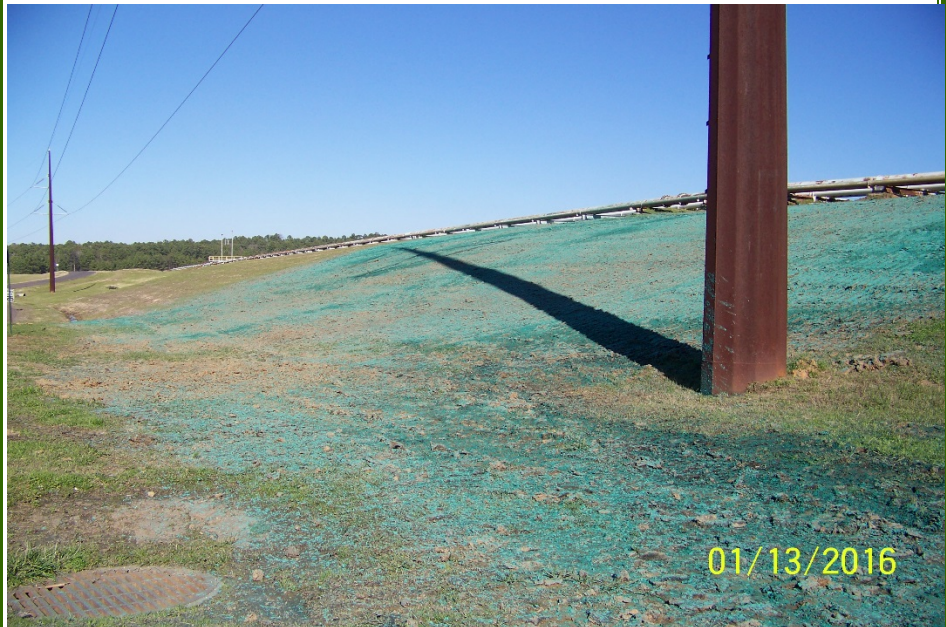
Ash Basin No. 1

If yes, describe (size of area, location, severity, etc.)	
Findings:	The abutment/toe was inspected and appeared to be in satisfactory condition. No corrective actions are required at this time.
Other observations on the abutment/toe:	Contractor recently smoothed rills on the exterior slope and hydromulched the area.

Western exterior levee slope showing recently corrected rills and hydromulching.

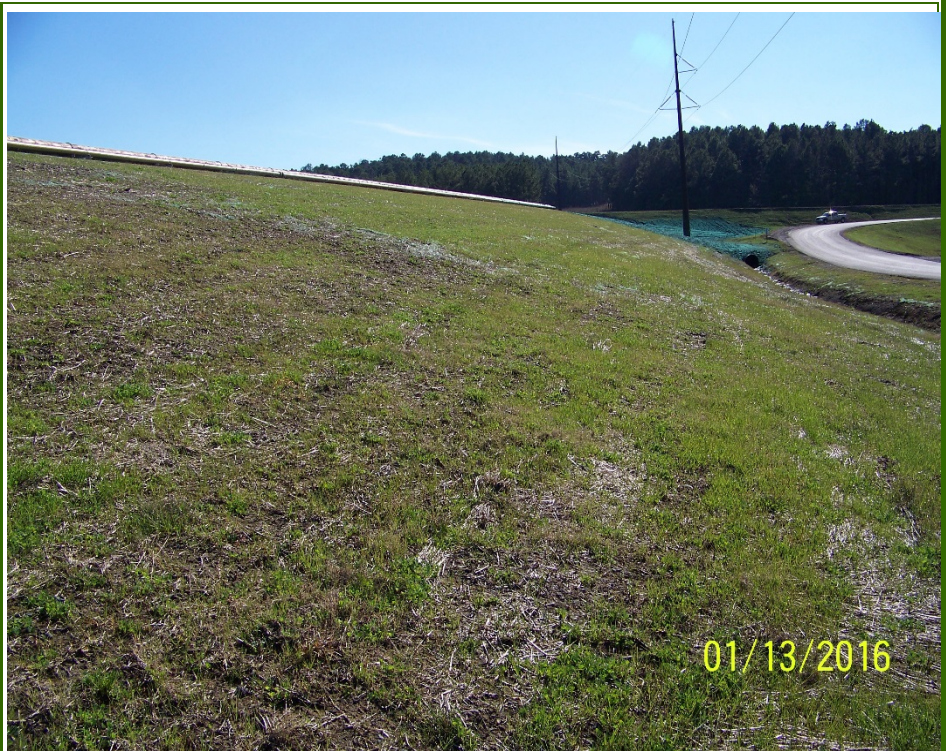
Ash Basin No. 1

Western exterior levee slope.
