ANNUAL CCR LANDFILL INSPECTION:			
Facility Name:		Cleco Dolet Hills Power Station	
Address:		963 Power Plant Rd. Mansfield, LA	
Landfill Name :	Dolet Hills Landfill	Owner:	Cleco Power LLC
Surface Impoundment ID:	P-0064	Operator:	Cleco Power LLC
Nearest City:	Mansfield	Parish:	DeSoto
Inspector:		James C. Van Hoof, P.E.	
Company:		Providence Engineering & Environmental Group LLC	
Date of Inspection:		12/14/2016	
Weather at Time of Inspection:		Cloudy, Cool	
DESCRIPTION OF THE OPERATION OF THE LANDFILL:			
<p>Cleco Dolet Hills Power Station (Dolet Hills) operates a Fly Ash/Scrubber Sludge Landfill used for the disposal of noncombustible by-product of lignite combustion from the Dolet Hills Power Station.</p> <p>Dolet Hills operates a landfill for the disposal of nonhazardous on-site generated waste only. None of the wastes disposed is characterized as hazardous or is listed hazardous waste as defined by LAC 33:V.Subpart I or by federal regulations. The non-hazardous nature of each waste stream is confirmed by process knowledge. The primary waste that is disposed in the landfill is fly ash and flue gas desulfurization (FGD or scrubber) sludge. The fly ash is a fine particulate compose

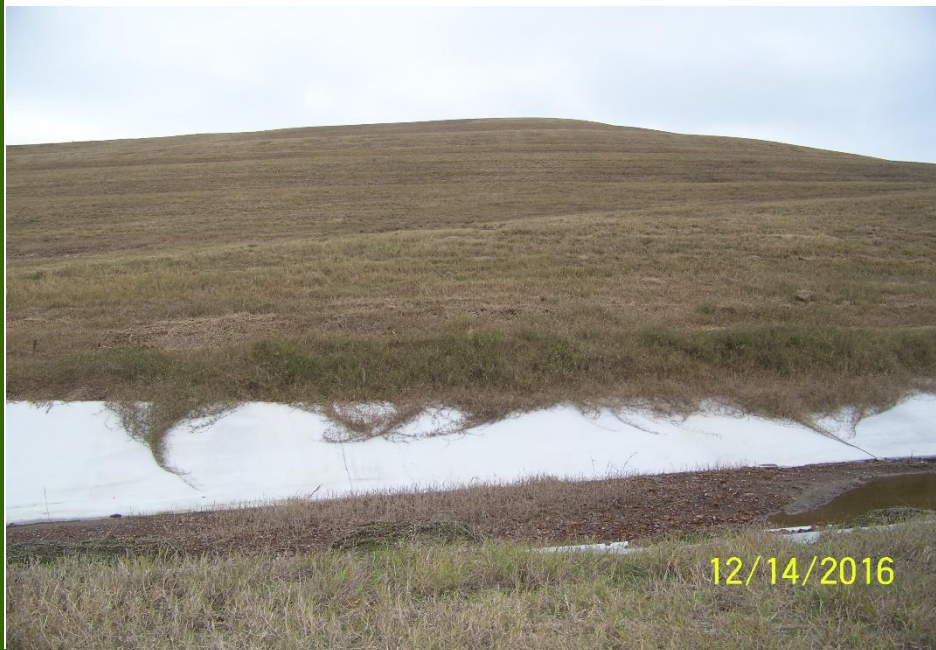
Western side slope.

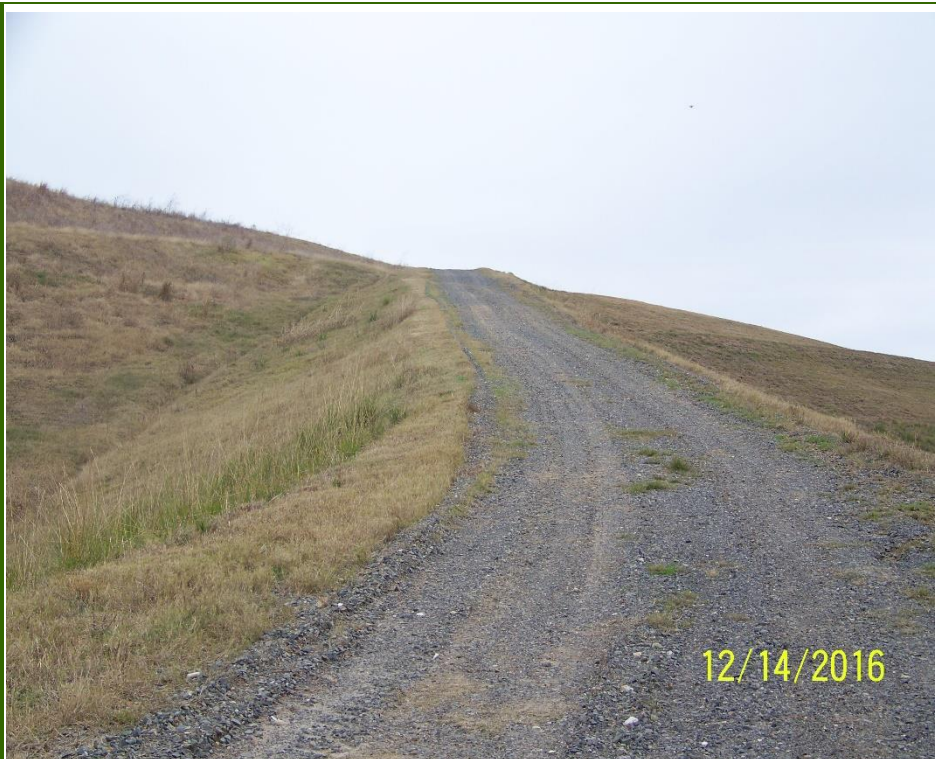
Access ramp.

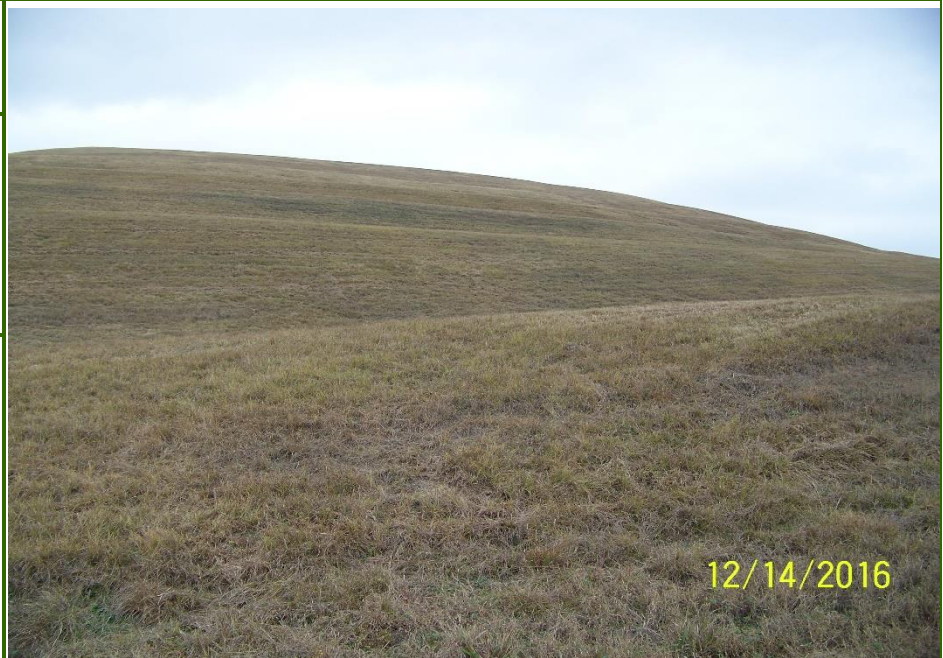
Southern slope showing terraces.

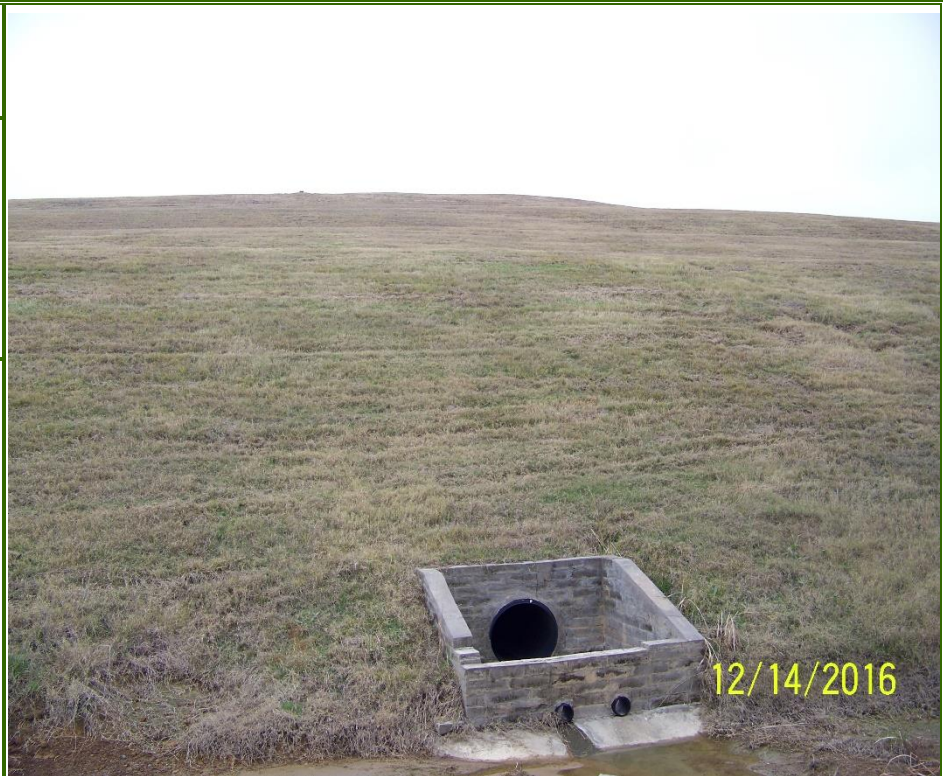
Eastern exterior slope showing discharge opening for upper elevation inlet piping.

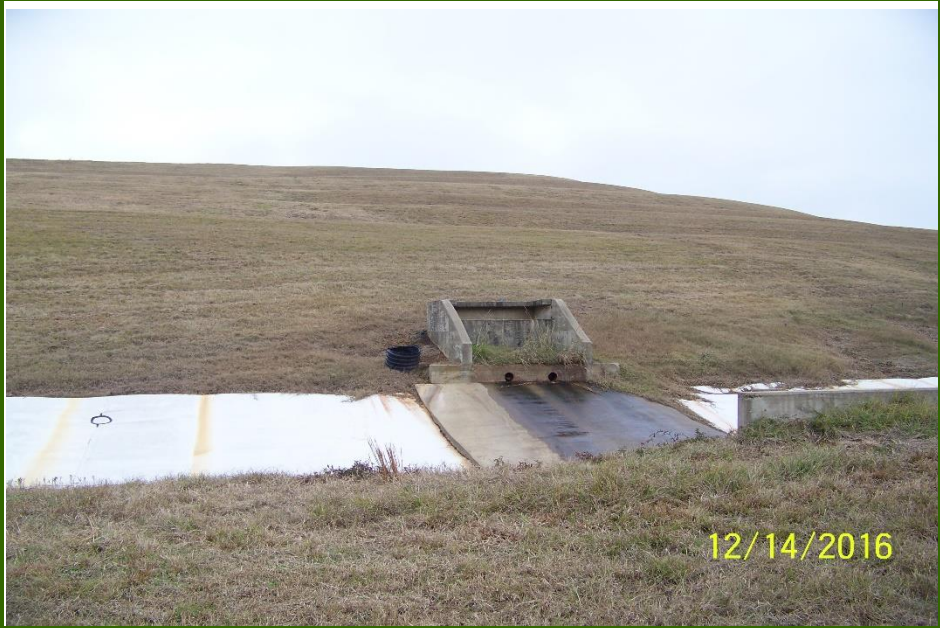
Western exterior slope showing discharge opening for upper elevation inlet piping.

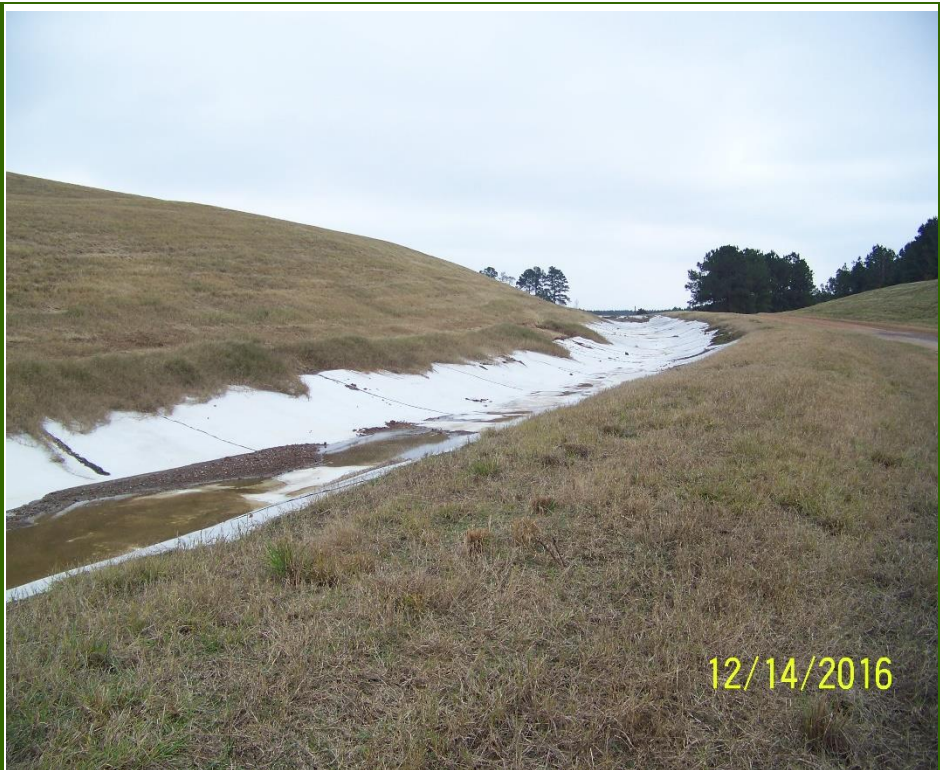
Western exterior slope showing storm water drainage ditch.

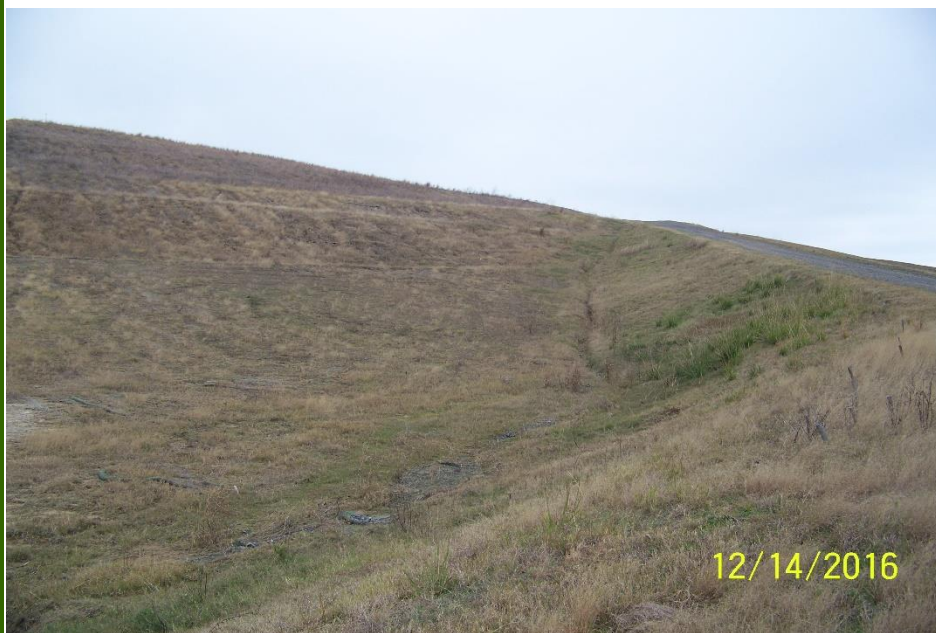
If yes, describe (size, location, etc.)	
Is the stormwater infrastructure in good condition?	<input checked="" type="checkbox"/> Yes <input type="checkbox"/> No
Findings:	The exterior slopes were inspected and appeared to be in fair condition. The rills on approximately 3 acres of the closed cap on the west side slope must be smoothed and reseeded.
Other observations on the exterior slopes:	None

Rills on the western slope of most recent cap closure needs to be corrected.

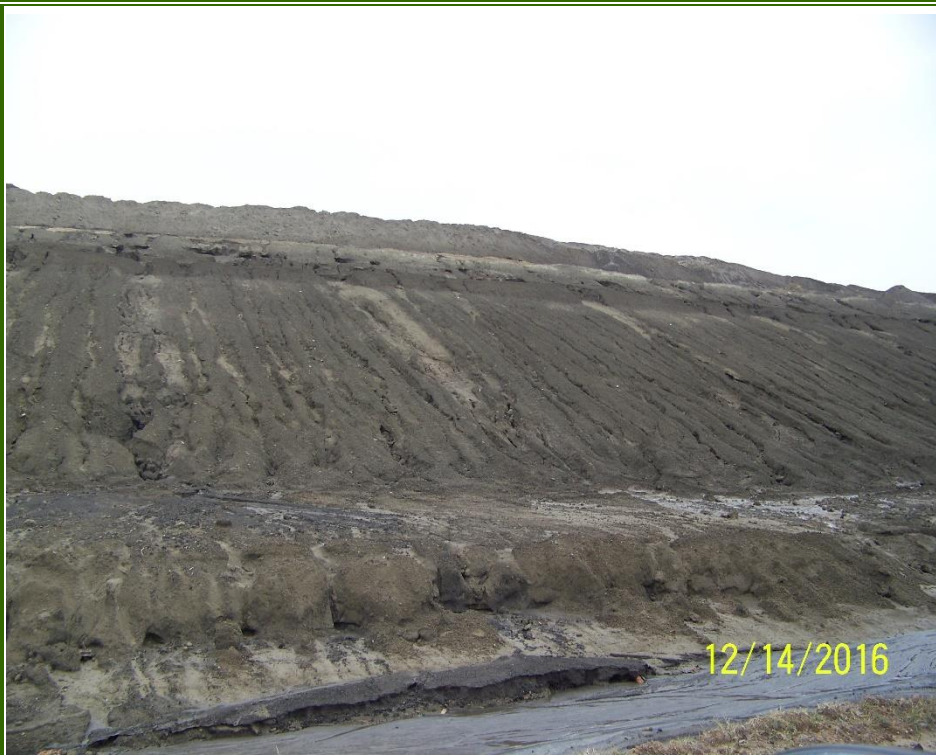
Working face of the landfill.

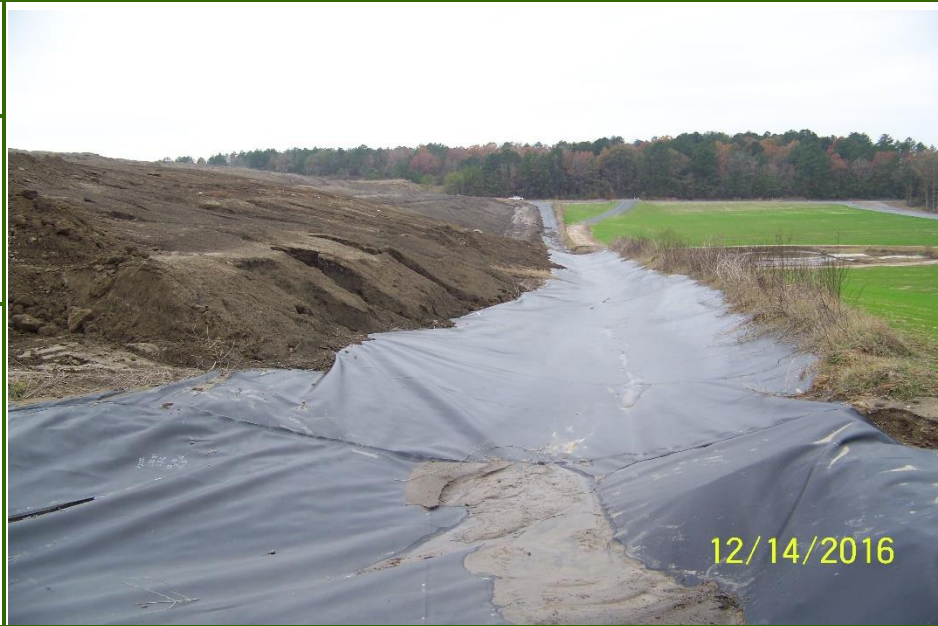
Storm water drainage ditch on edge of working face of landfill that drains to the landfill runoff pond.

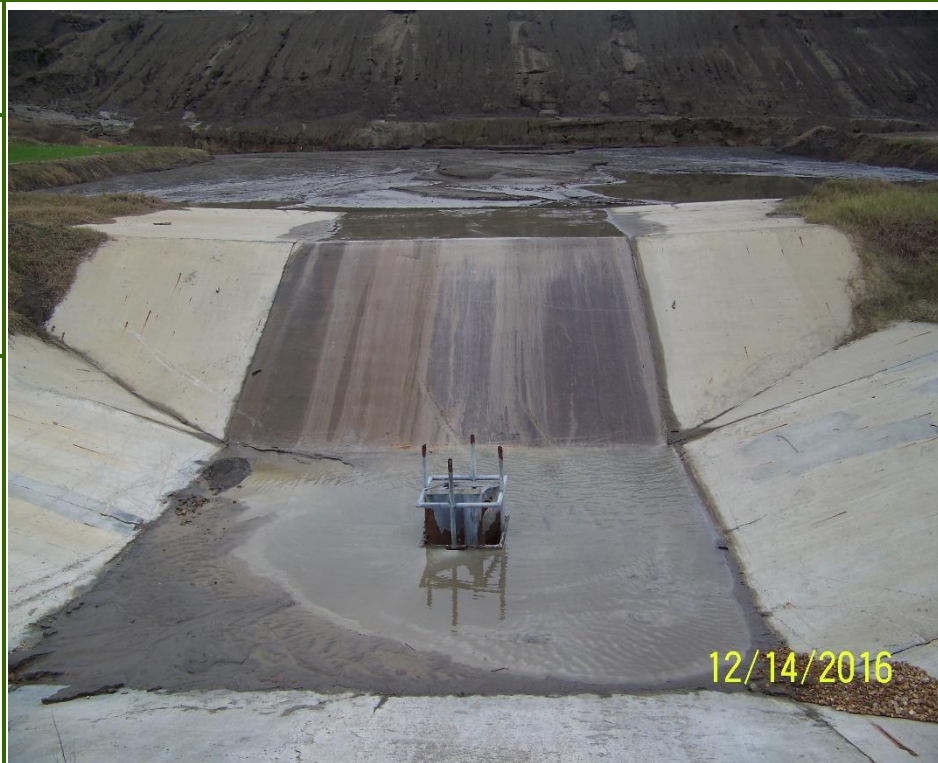
Storm water overflow inlet that drains to the landfill runoff pond.

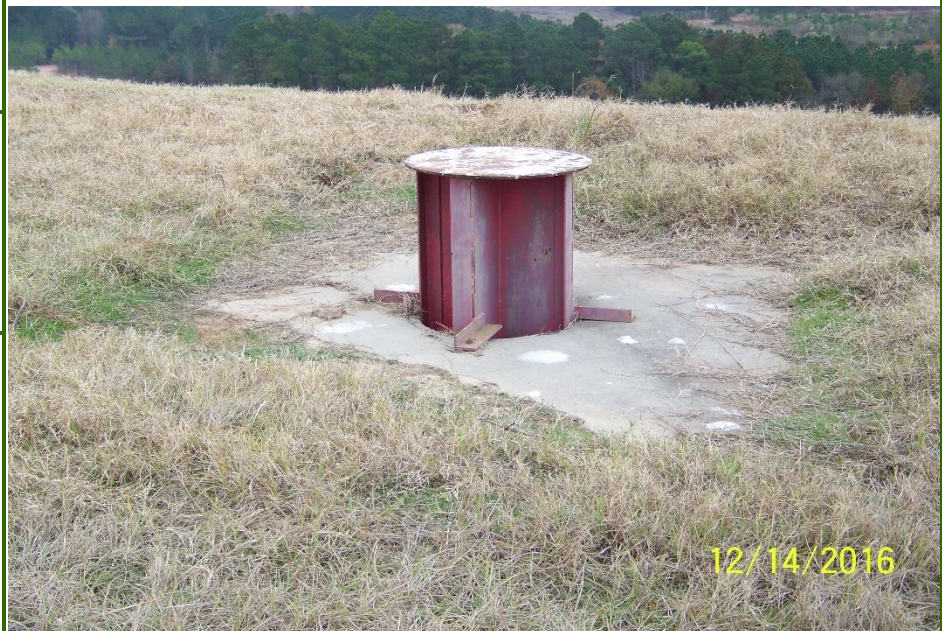
Drop inlet structure on crown of landfill cap.

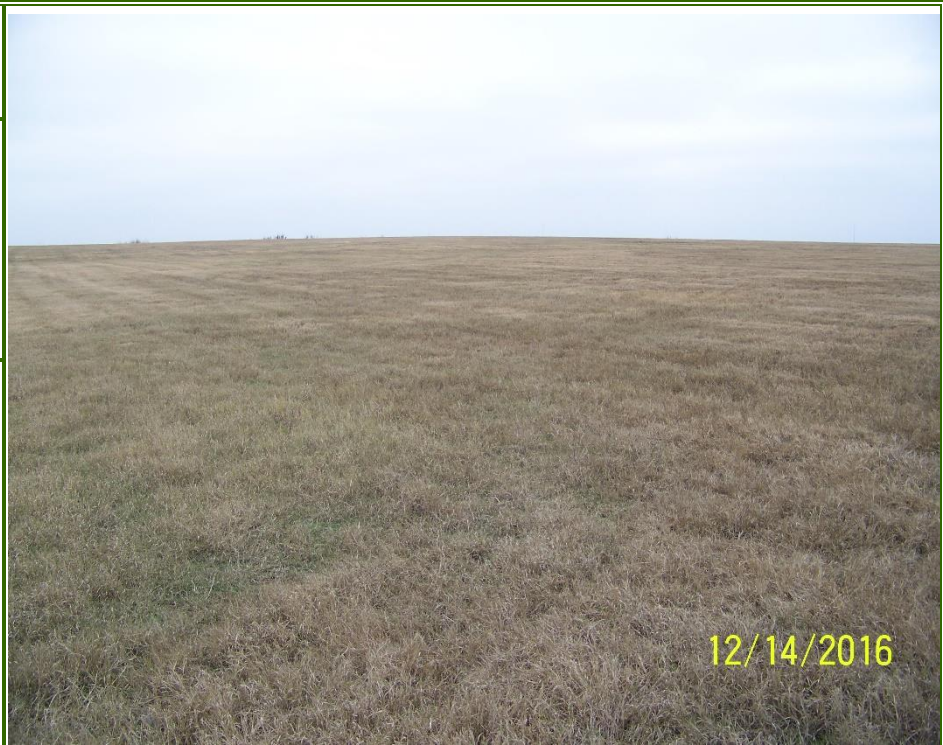
Upper elevation flat crown area.
