ANNUAL CCR LANDFILL INSPECTION:			
Facility Name:		Cleco Dolet Hills Power Station	
Address:		963 Power Plant Rd. Mansfield, LA	
Landfill Name :	Dolet Hills Landfill	Owner:	Cleco Power LLC
Surface Impoundment ID:	P-0064	Operator:	Cleco Power LLC
Nearest City:	Mansfield	Parish:	DeSoto
Inspector:		James C. Van Hoof, P.E.	
Company:		Providence Engineering & Environmental Group LLC	
Date of Inspection:		1/13/2016	
Weather at Time of Inspection:		Sunny	
DESCRIPTION OF THE OPERATION OF THE LANDFILL:			
<p>Cleco Dolet Hills Power Station (Dolet Hills) operates a Fly Ash/Scrubber Sludge Landfill used for the disposal of noncombustible by-product of lignite combustion from the Dolet Hills Power Station.</p> <p>Dolet Hills operates a landfill for the disposal of nonhazardous on-site generated waste only. None of the wastes disposed is characterized as hazardous or is listed hazardous waste as defined by LAC 33:V.Subpart I or by federal regulations. The non-hazardous nature of each waste stream is confirmed by process knowledge. The primary waste that is disposed in the landfill is fly ash and flue gas desulfurization (FGD or scrubber) sludge. The fly ash is a fine particulate composed of non

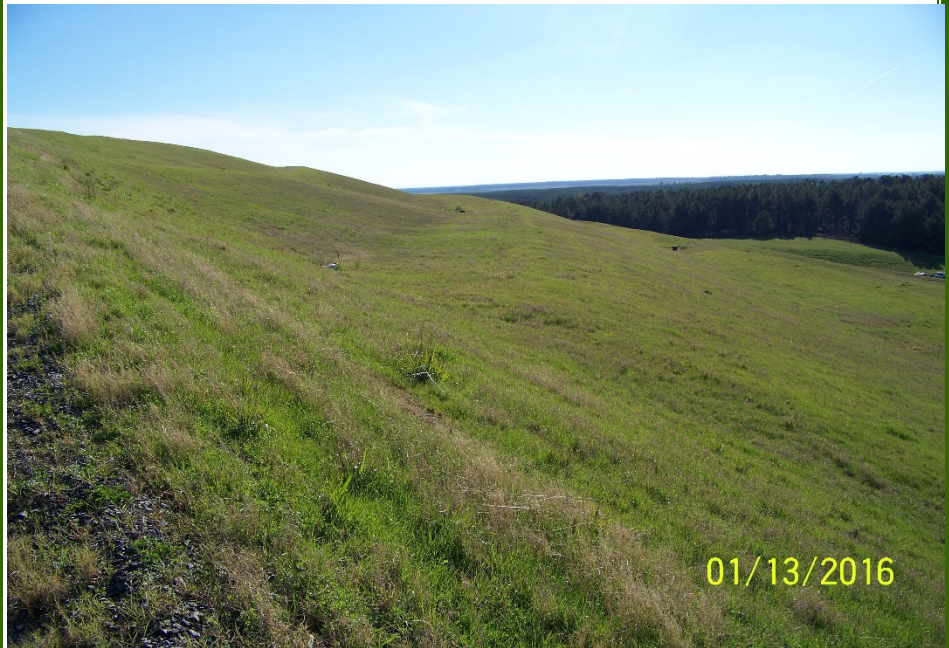
Western side slope.

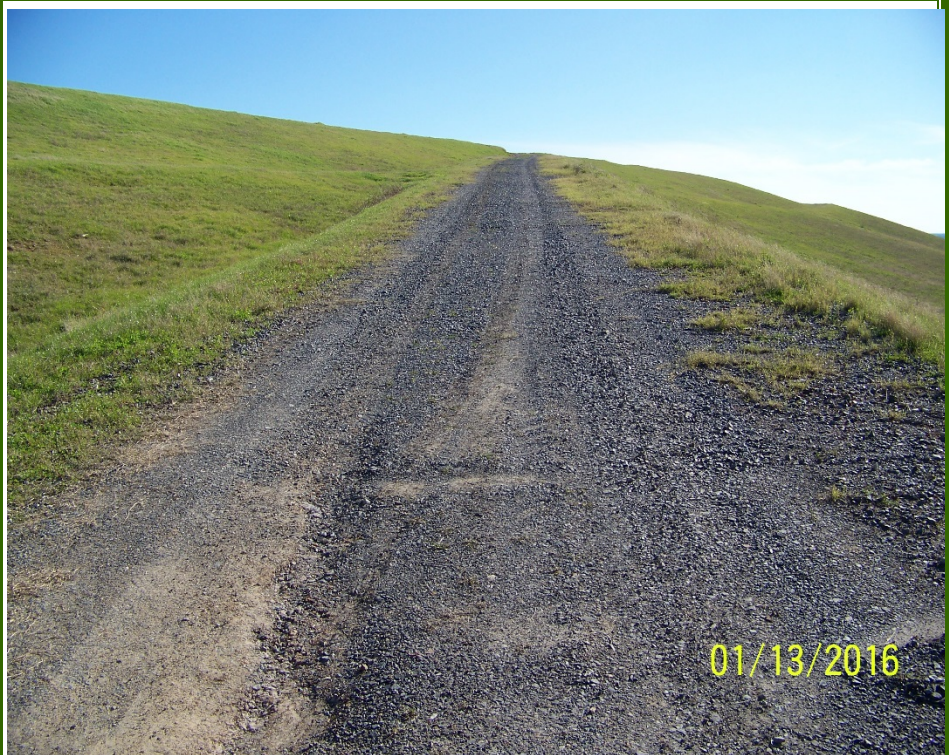
Access ramp.

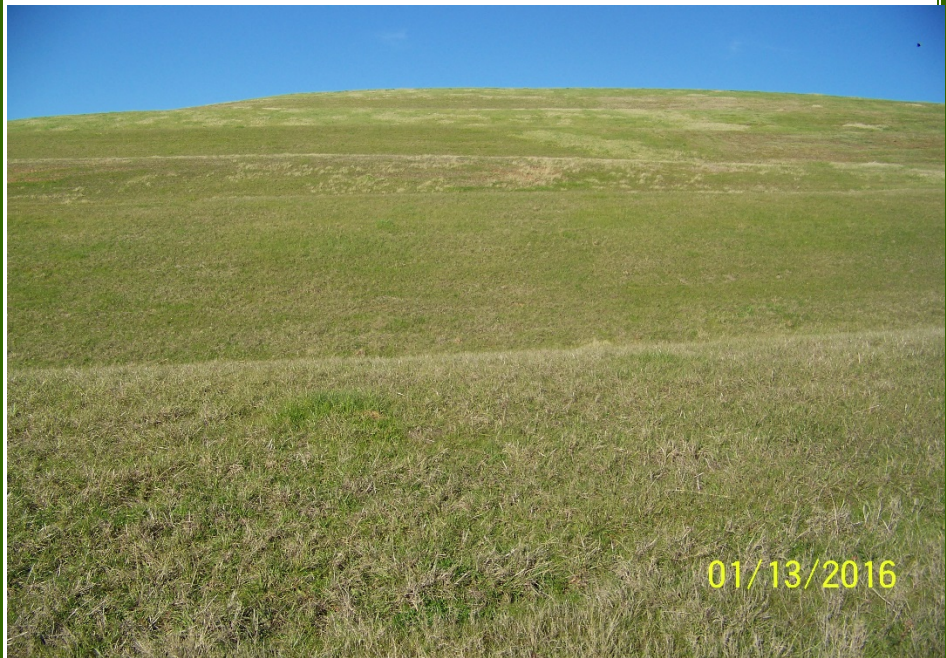
External southern slope showing terraces.

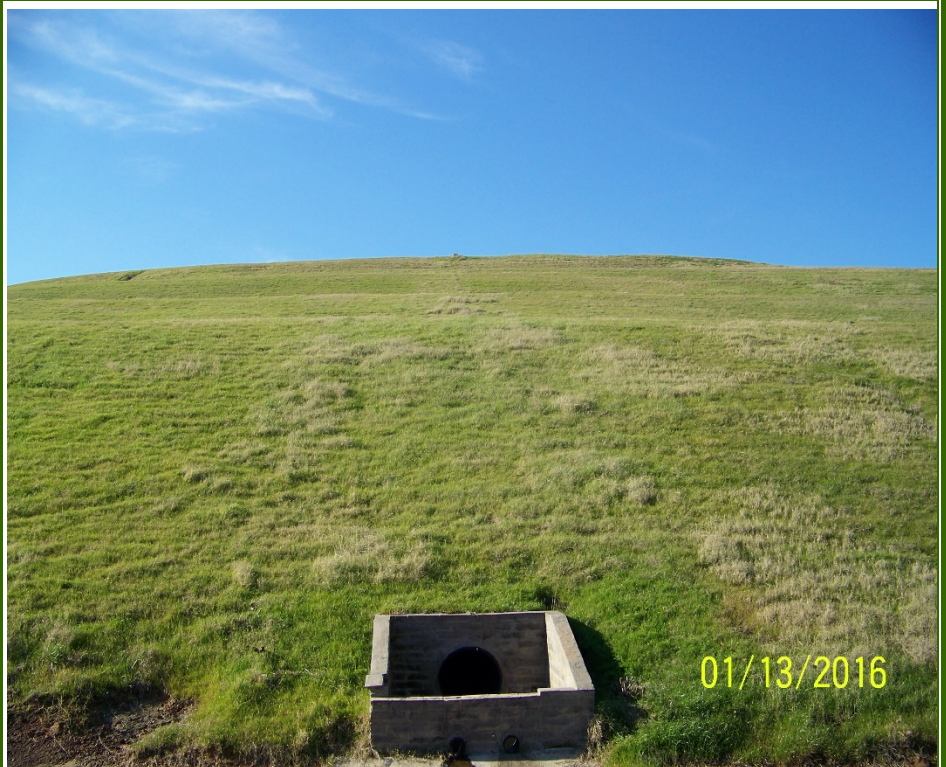
Eastern exterior slope showing discharge opening for upper elevation inlet piping.

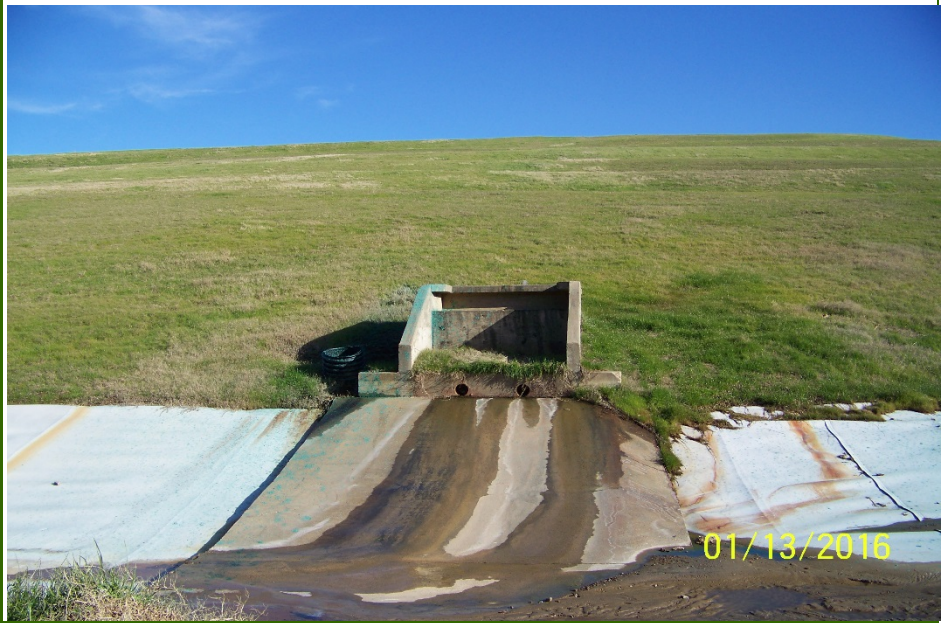
Western exterior slope showing discharge opening for upper elevation inlet piping.

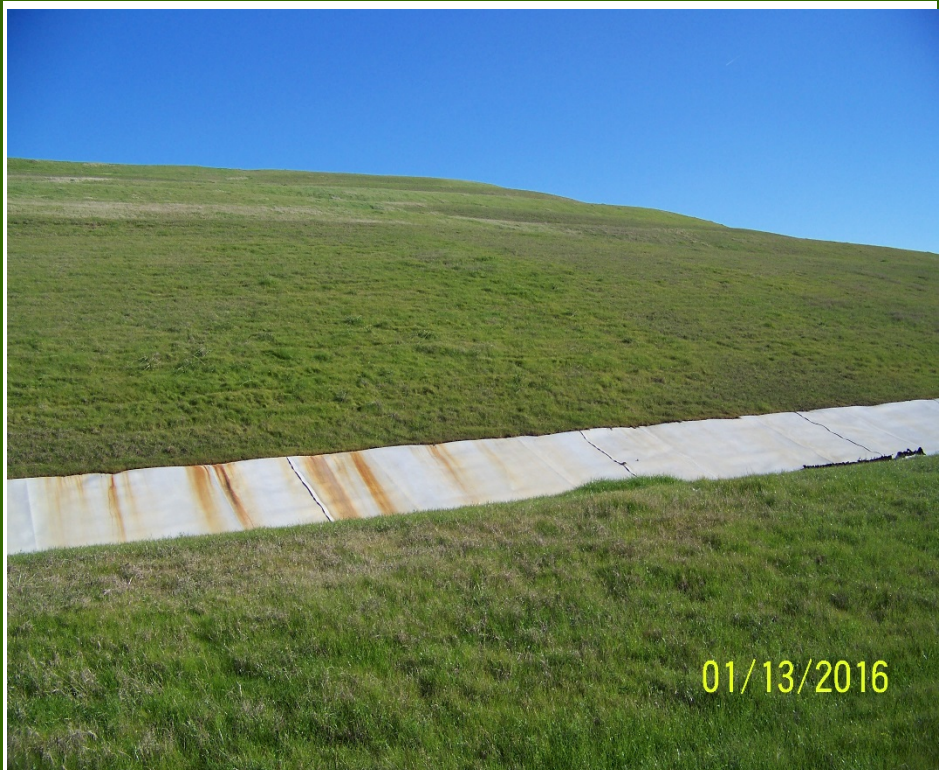
Western exterior slope showing terraces and storm water drainage ditch.

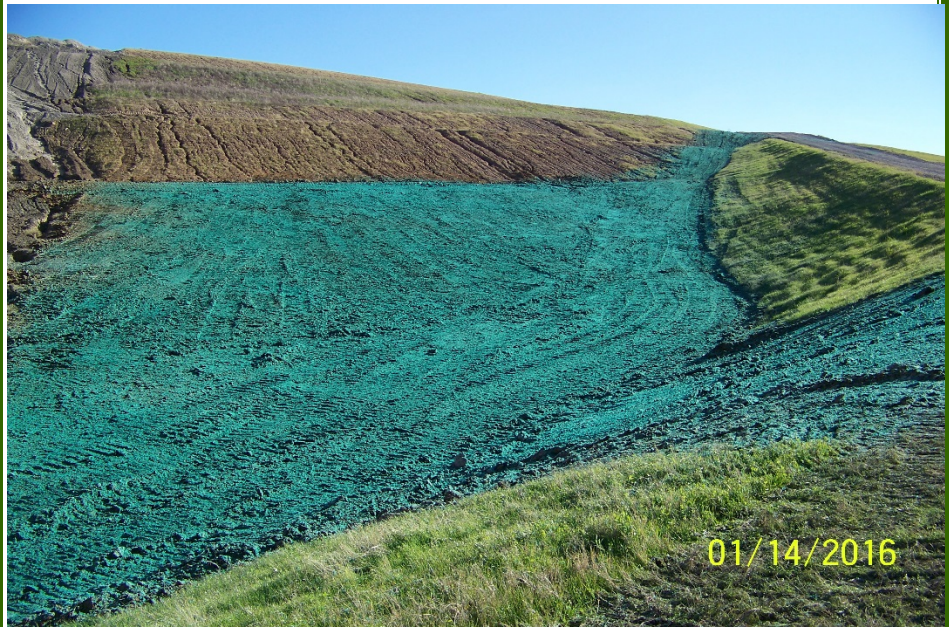
Rills on the western slope of most recent cap installation in the process of being corrected.

If yes, describe (size, location, etc.)	
Is the stormwater being properly diverted by the existing infrastructure?	<input checked="" type="checkbox"/> Yes <input type="checkbox"/> No
If yes, describe (size, location, etc.)	
Is the stormwater infrastructure in good condition?	<input checked="" type="checkbox"/> Yes <input type="checkbox"/> No
Findings:	The exterior slopes were inspected and appeared to be in fair condition. The rills on the recently closed cap on the east and west side slopes must be smoothed and reseeded.
Other observations on the exterior slopes:	None

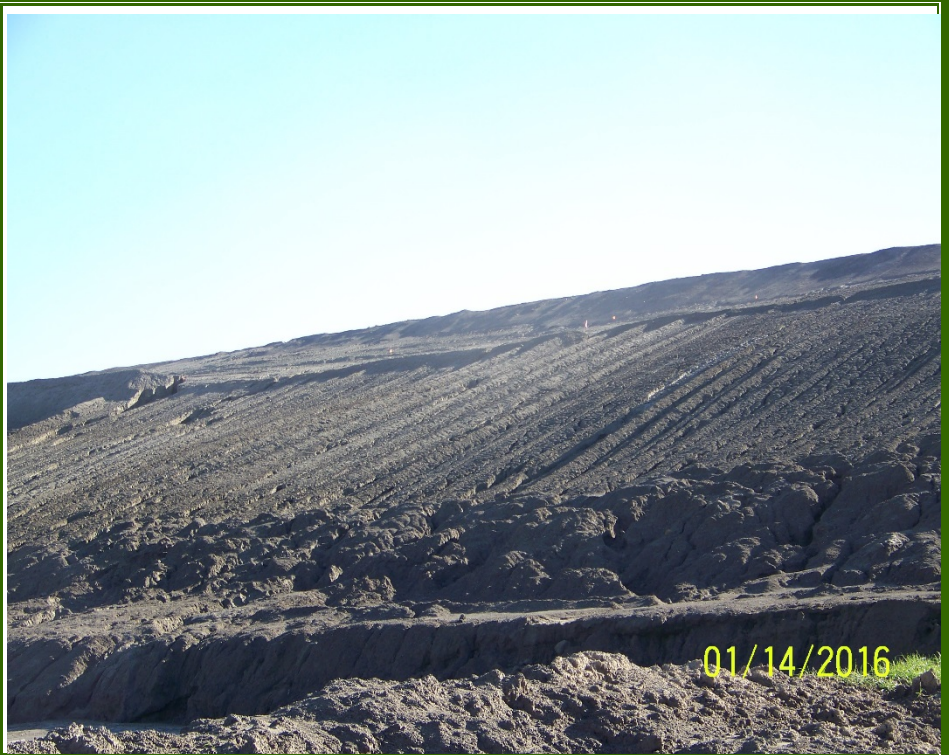
Working face of the landfill.

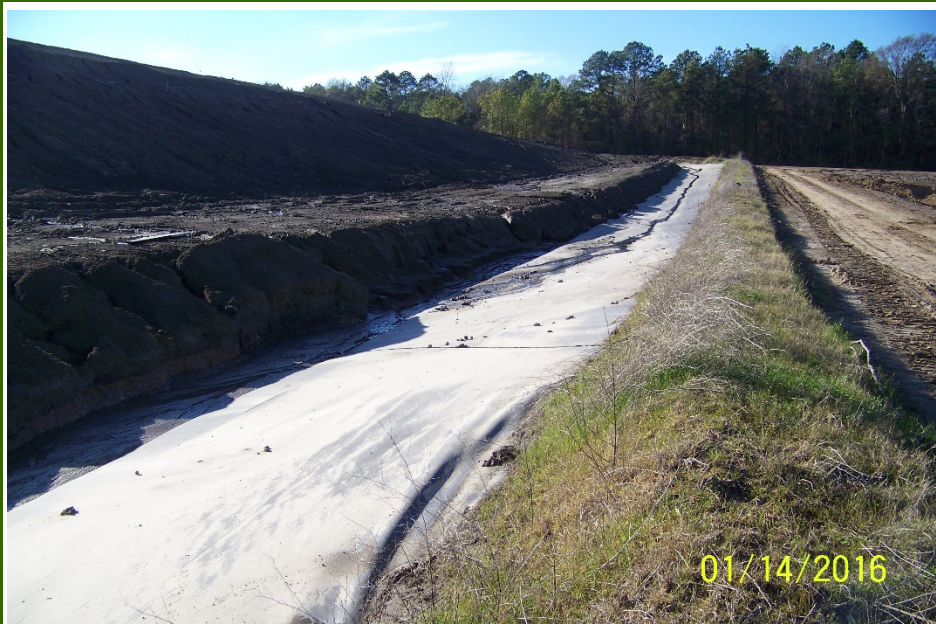
Storm water drainage ditch on edge of working face of landfill that drains to the landfill runoff pond.

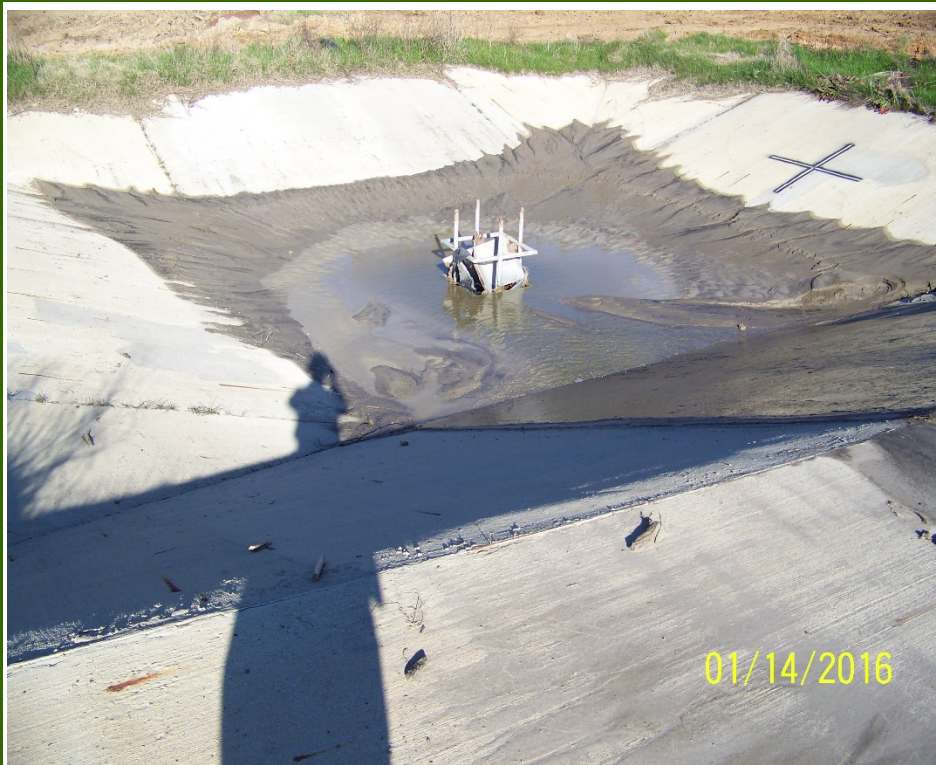
Storm water overflow inlet that drains to the landfill runoff pond.

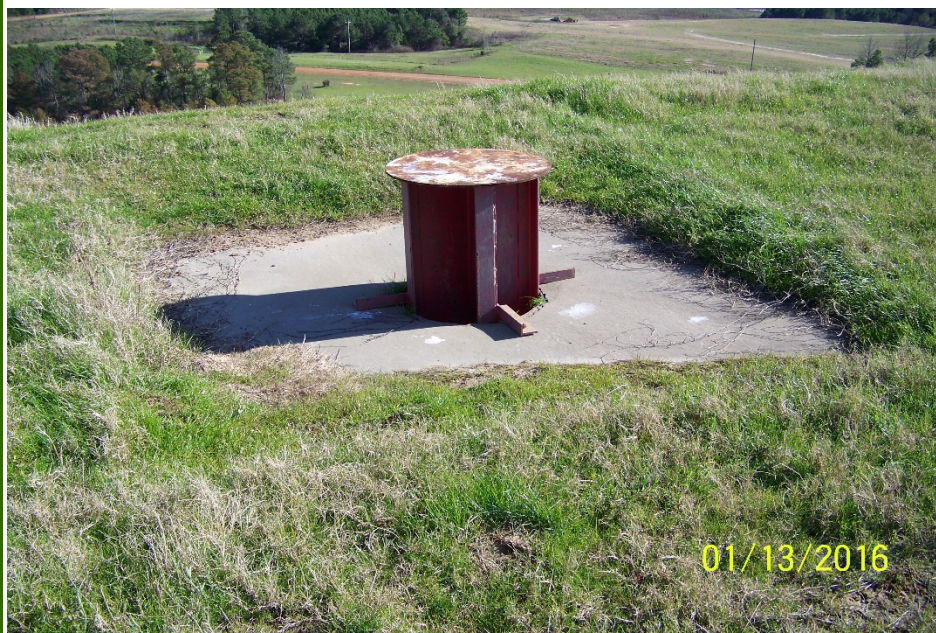
Drop inlet structure on crown of landfill cap.

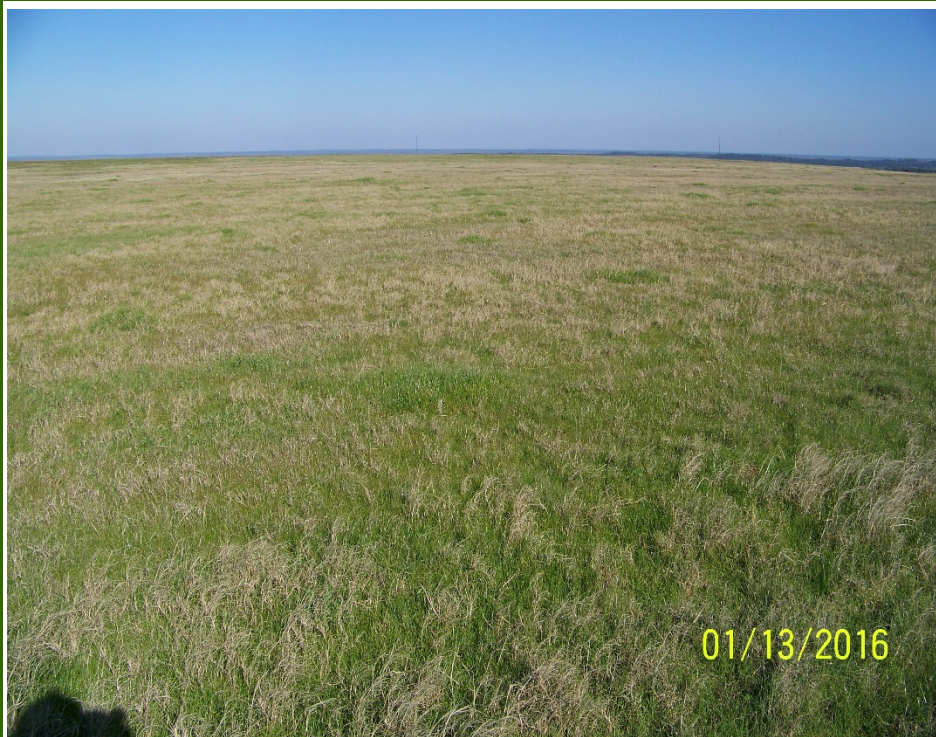
Findings:	The upper elevation flat cap area was inspected and appeared to be in satisfactory condition.
Other observations on the upper elevation flat cap area:	None

Upper elevation flat crown area.
