ANNUAL CCR SURFACE IMPOUNDMENT INSPECTION:			
Facility Name:		Cleco Dolet Hills Power Station	
Address:		963 Power Plant Rd. Mansfield, LA	
Surface Impoundment Name :	Ash Basin No. 2	Owner:	Cleco Power LLC
Surface Impoundment ID:	P-0037	Operator:	Cleco Power LLC
Nearest City:	Mansfield	Parish:	DeSoto
Inspector:		James C. Van Hoof, P.E.	
Company:		Providence Engineering & Environmental Group LLC	
Date of Inspection:		12/11/2019	
Weather at Time of Inspection:		Sunny, cool	
DESCRIPTION OF THE OPERATION OF THE SURFACE IMPOUNDMENTS:			
<p>The bottom ash and economizer ash are mixed with water and sluiced in a slurry form to either of the two Ash Basins. Ash slurry pipelines within each basin enable the discharge of the slurry at multiple points within each basin. The discharge into each respective basin begins at the end of the pipeline network at the point furthest from the weir box, and proceeds toward the front of the pond. As a basin fills with ash, sections of the discharge pipe are removed as needed so that ash can be uniformly deposited and the storage capacity of each basin fully utilized. The ash-laden water is retained in the Ash Basins for a period of time sufficient to sett

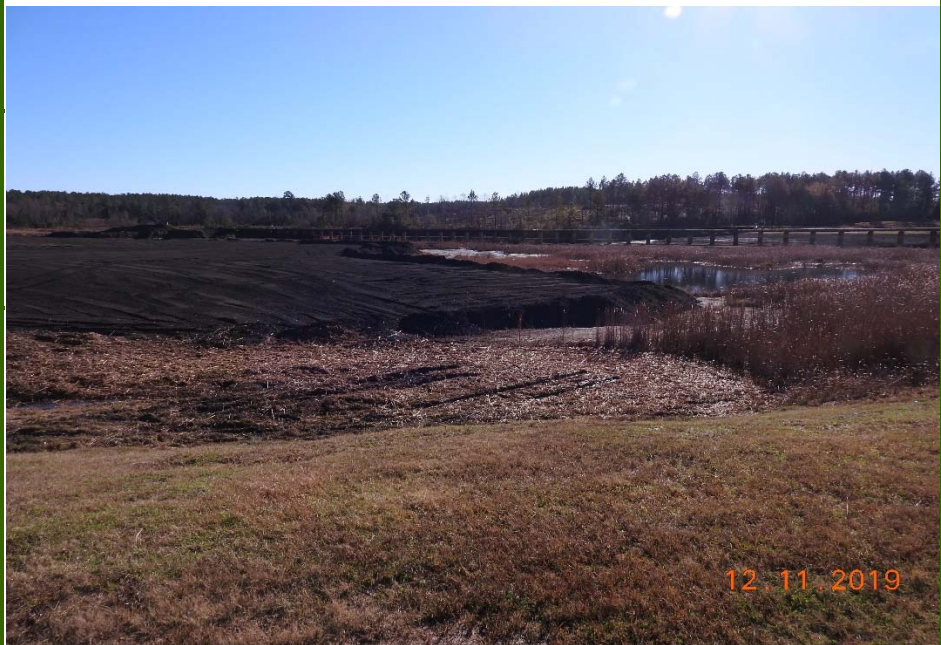
Ash Basin looking at sluice structure.

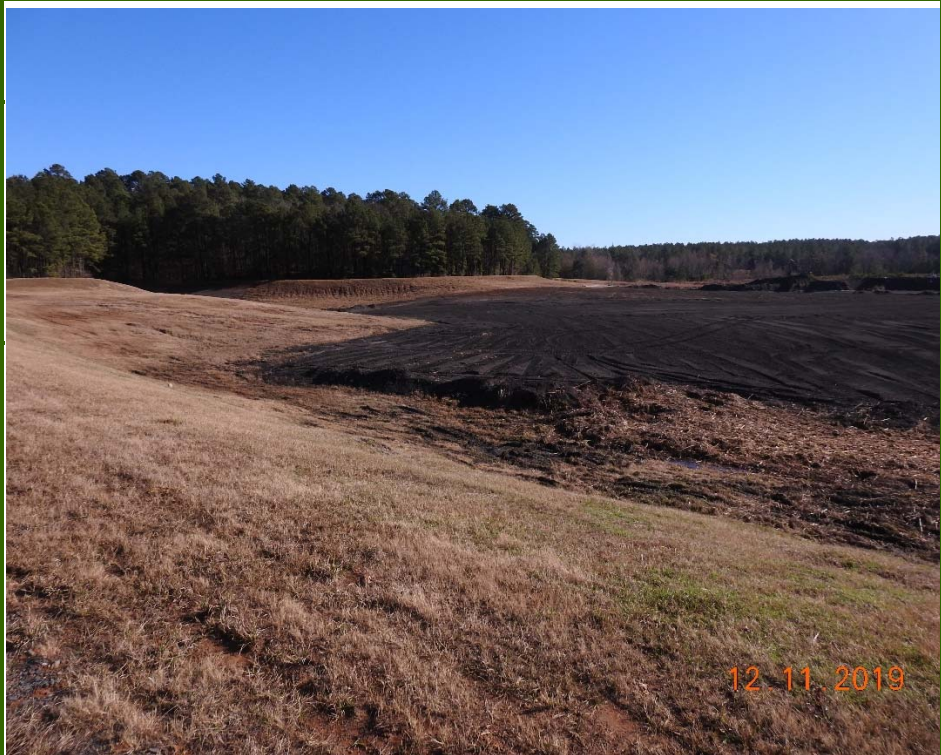
Northern side of Ash Basin.

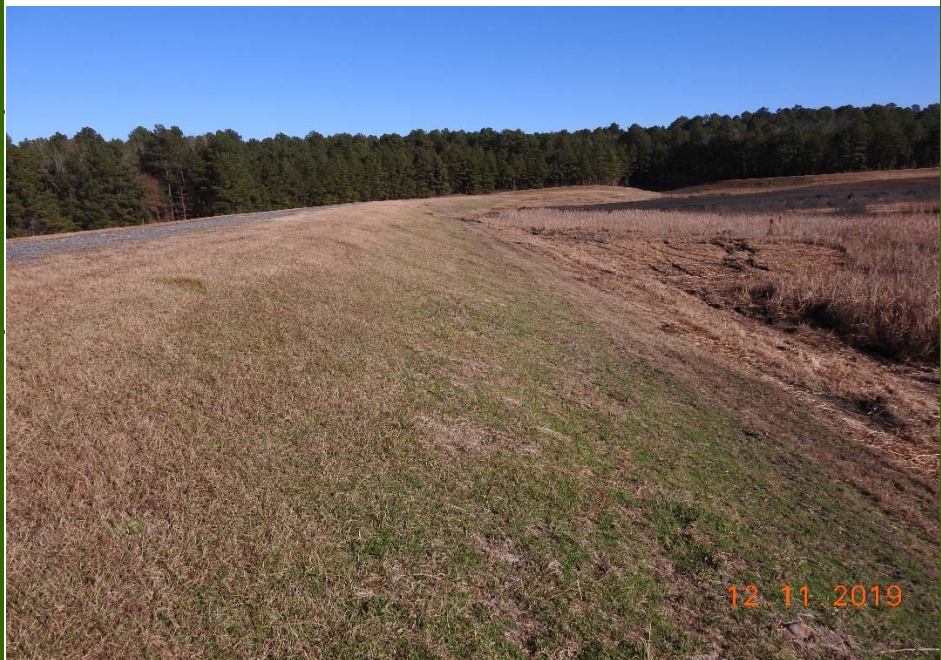
If yes, describe (size of area, location, severity, etc.)	
Findings:	The interior slope was inspected and appeared to be in satisfactory condition. No corrective actions are required at this time.
Other observations on the interior slopes:	None

Internal slope of western levee.

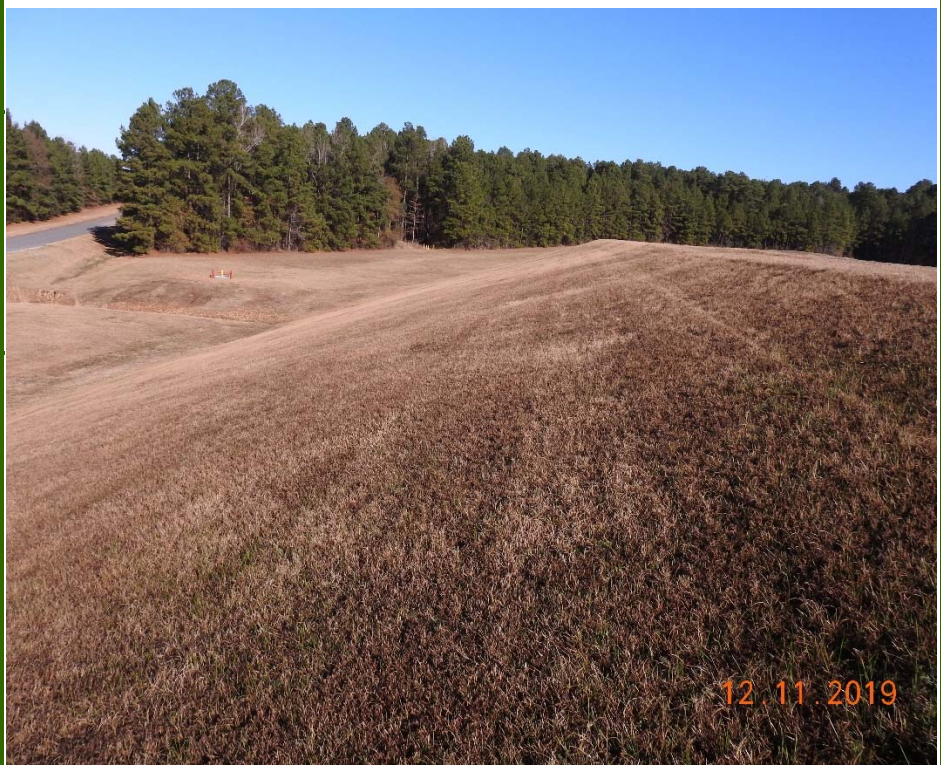
Are there any trees on the slopes?	<input type="checkbox"/> Yes <input checked="" type="checkbox"/> No
If yes, describe (type of vegetation, size, location, etc.)	
Findings:	The exterior slope was inspected and appeared to be in satisfactory condition. No corrective actions are required at this time.
Other observations on the exterior slopes:	None

External slope of western levee.

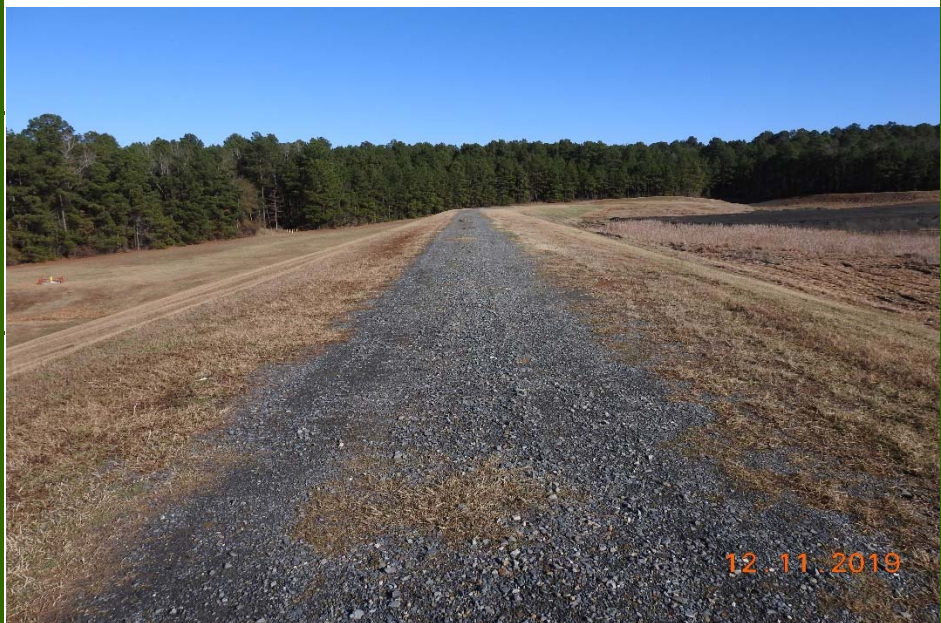
If yes, describe (size, location, etc.)	
Are there any sinkholes?	<input type="checkbox"/> Yes <input checked="" type="checkbox"/> No
If yes, describe (size, location, etc.)	
Findings:	The crest was inspected and appeared to be in satisfactory condition. No corrective actions are required at this time.
Other observations on the crest:	None

Access road on western levee.

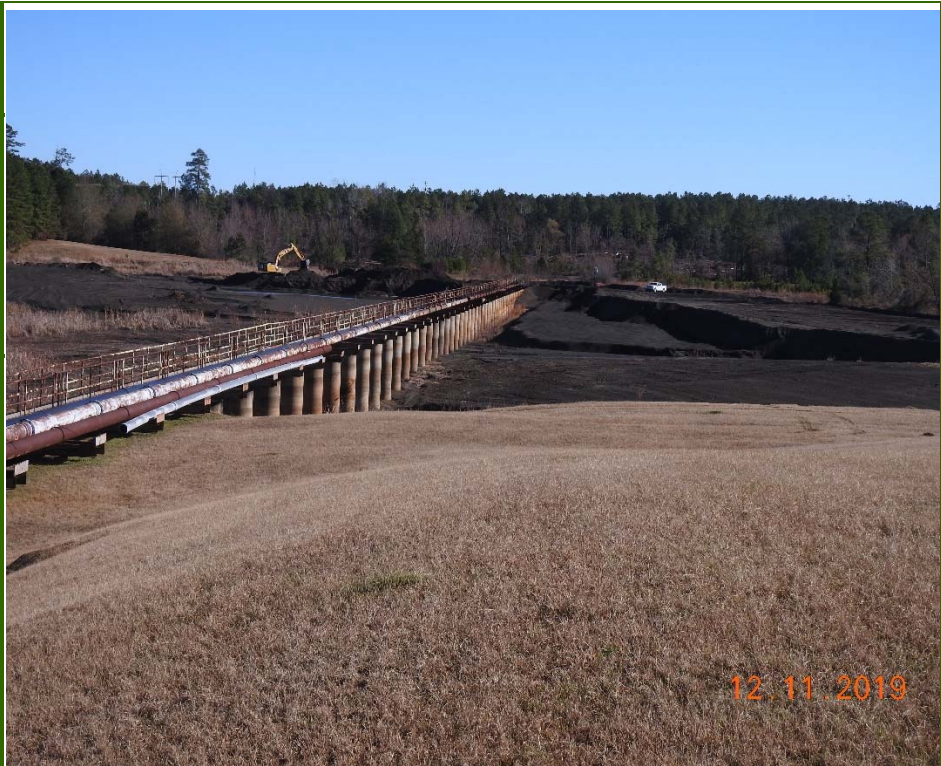
Findings:	The intake works were inspected and appeared to be in satisfactory condition. No corrective actions are required at this time.
Other observations on the intake works:	None

Bottom ash sluice structure.

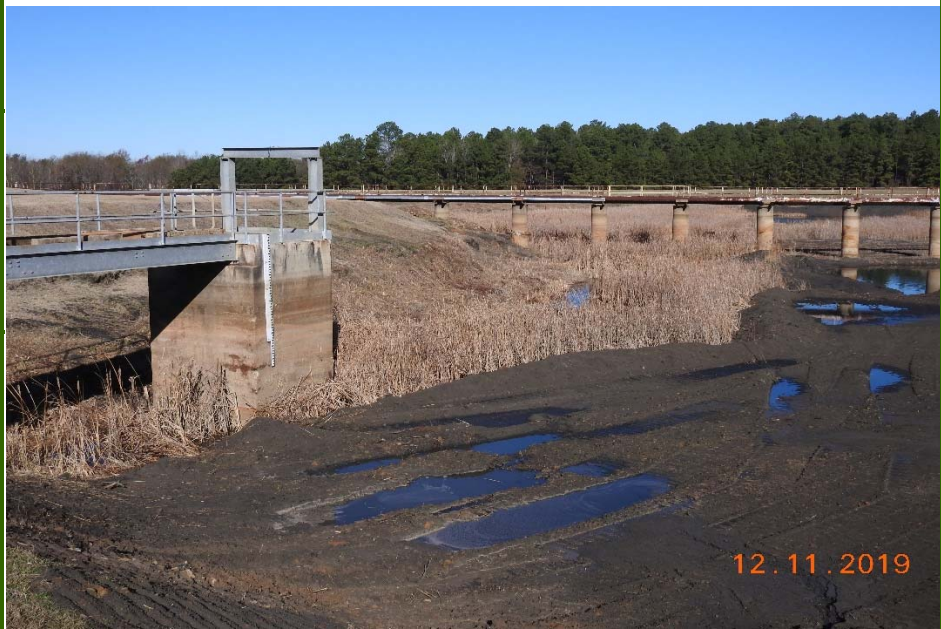
PHYSICAL DAM FEATURES – SPILLWAY/OVERFLOW STRUCTURE:	
Type (1):	Internal Concrete Structure with Adjustable Overflow Weir
Slope Protection:	Encased in concrete
Approach:	Concrete structure surrounded by ash
Erosion:	None observed
Vegetation:	Concrete structure surrounded by ash.
Findings:	The overflow structure was inspected and appeared to be in satisfactory condition. No corrective actions are required at this time.
Other observations on overflow structure:	None
Type (2):	Auxiliary Spillway
Slope Protection:	6" rip rap up to elevation 246.0 NAVD 88.
Approach:	6" rip rap up to elevation 246.0 NAVD 88.
Erosion:	None observed
Vegetation:	Grass vegetation on top of the rip rap as it enters the Secondary Pond.
Findings:	The spillway was inspected and appeared to be in satisfactory condition. No corrective actions are required at this time.
Other observations on the spillway:	None

Overflow weir structure with level gauge.

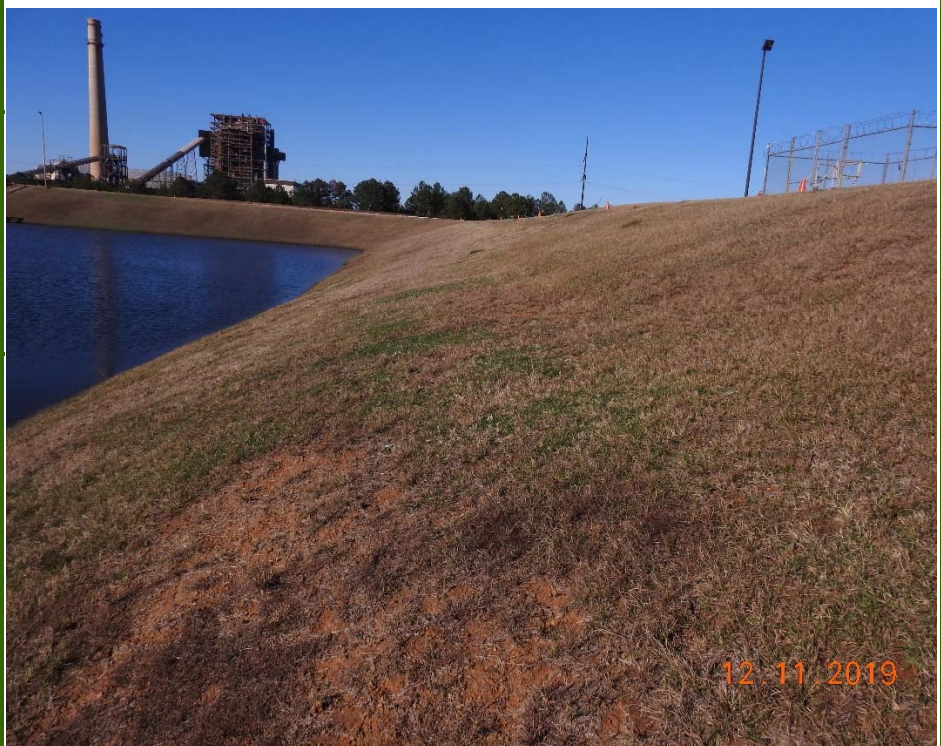
Exterior slope of southern levee.
