ANNUAL CCR SURFACE IMPOUNDMENT INSPECTION			
Facility Name:		Cleco Brame Energy Center	
Address:		275 Rodemacher Rd. Lena, LA	
Surface Impoundment Name :	Fly Ash Pond	Owner:	Cleco Power LLC
Surface Impoundment ID:	P-0005R1	Operator:	Cleco Power LLC
Nearest City:	Boyce	Parish:	Rapides
Inspector:		James C. Van Hoof, P.E.	
Company:		Providence Engineering & Environmental Group LLC	
Date of Inspection:		12/17/2020	
Weather at Time of Inspection:		Sunny, Cool	
DESCRIPTION OF THE OPERATION OF THE SURFACE IMPOUNDMENTS:			
<p>The Brame Energy Center's Bottom Ash and Fly Ash surface impoundments are designed to accept the coal combustion residual (CCR) byproducts derived from burning of the Unit 2 coal for the generation of electricity. The ponds are classified by the Louisiana Department of Environmental Quality (LDEQ) as Type I Surface Impoundments. Water from the Fly Ash surface impoundment is pumped into the Bottom Ash impoundment which discharges by means of three pumps that discharge the wastewater through the outlet pipe on the western end of the pond. This water discharges into Lake Rodemacher via LPDES outfall 401, thence to Bayou Jean de Jean via LPDES outfall 001, then to the Red

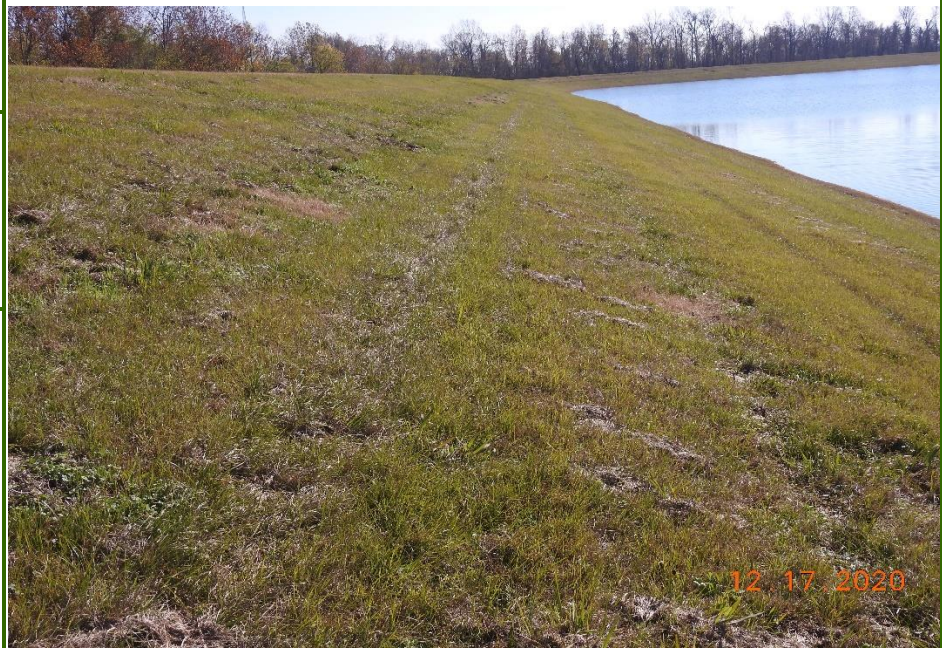
Fly Ash Pond

Interior slope of northern levee.

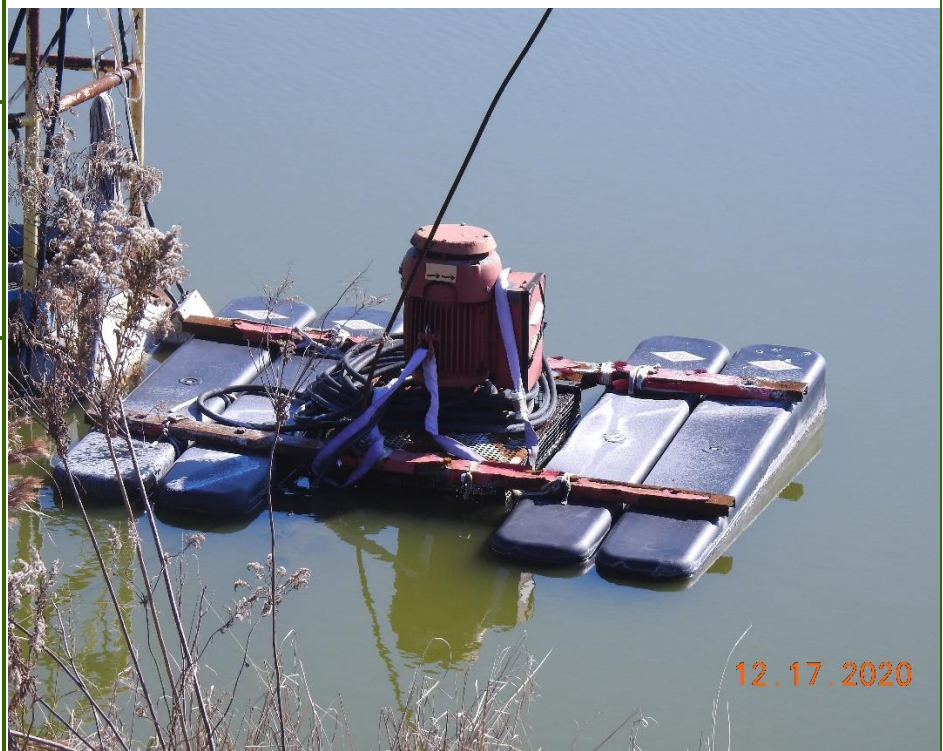
Pump system in Fly Ash Pond that pumps discharge water into the Bottom Ash Pond.

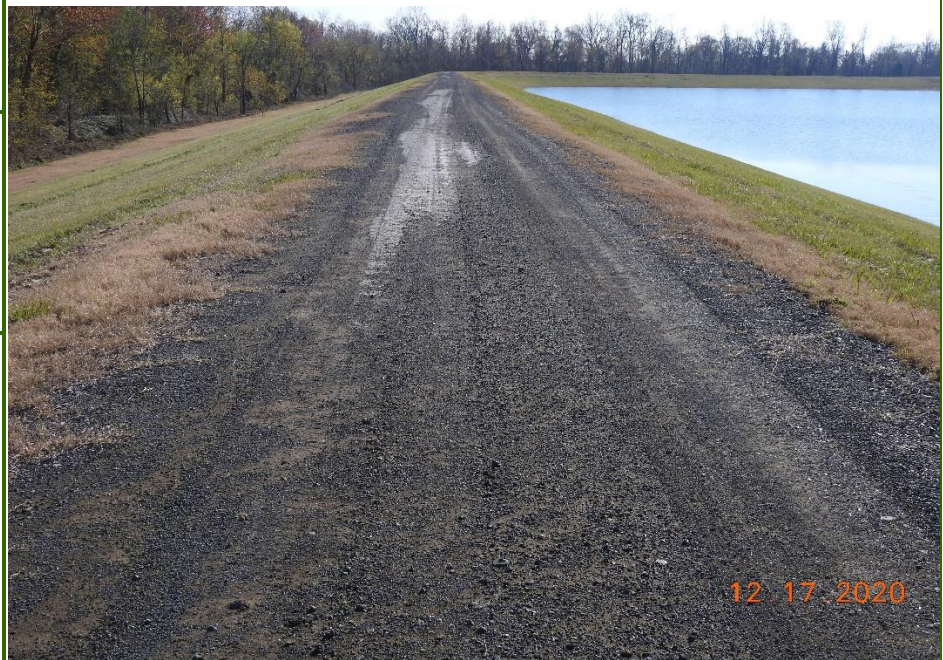
Fly Ash Pond

Crest along the northern levee.

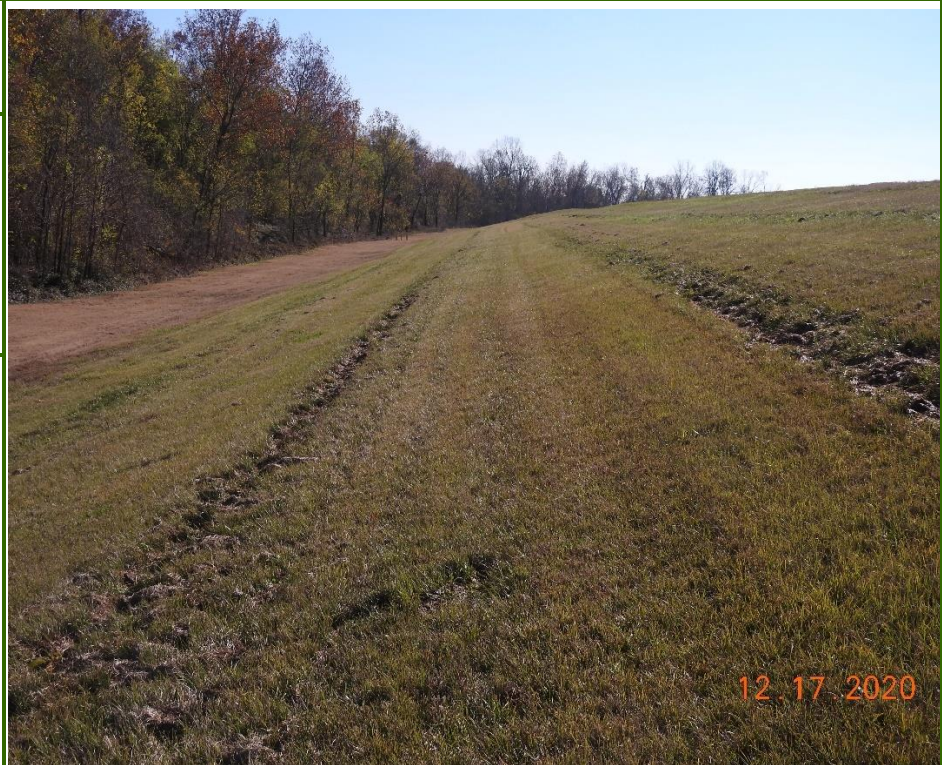
Fly Ash Pond

Northern exterior levee slope.

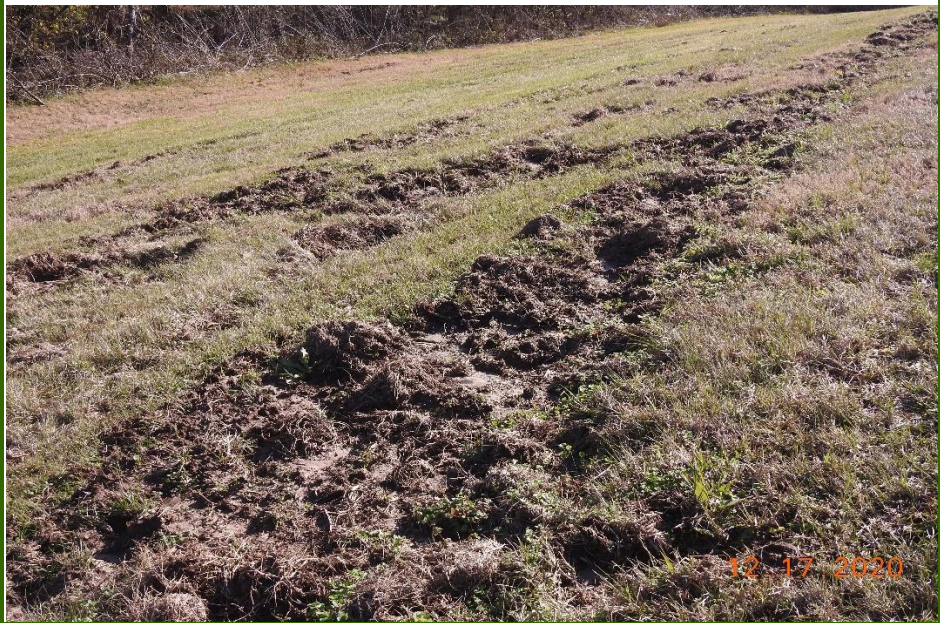
Are there any trees on the slopes?	<input type="checkbox"/> Yes <input checked="" type="checkbox"/> No
If yes, describe (type of vegetation, size, location, etc.)	
Findings:	The exterior slope was inspected and appeared to be in satisfactory condition. Only minor corrective actions are required at this time based on other observations below.
Other observations on the exterior slopes:	Feral hogs have rooted an approximate 1,800 square foot topsoil area on the exterior slope of the Fly Ash Pond along the northeast corner. The area needs to be smoothed, then seeded and fertilized to prevent erosion.

Area along the exterior levee showing where the feral hogs have recently rooted the topsoil.

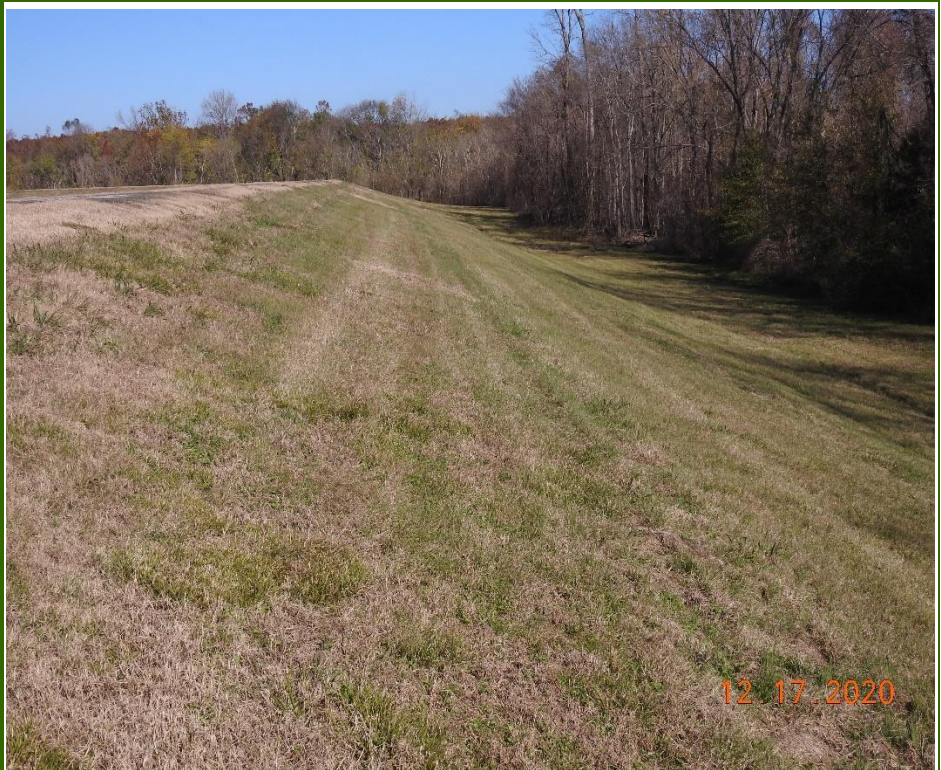
Fly Ash Pond

Eastern exterior slope of levee.

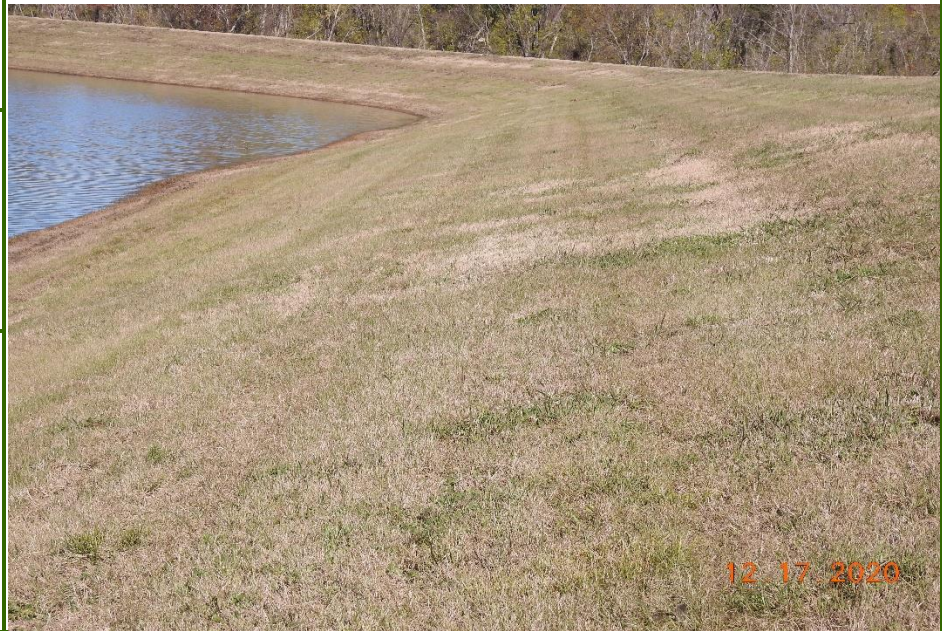
Fly Ash Pond

Eastern interior slope of levee.

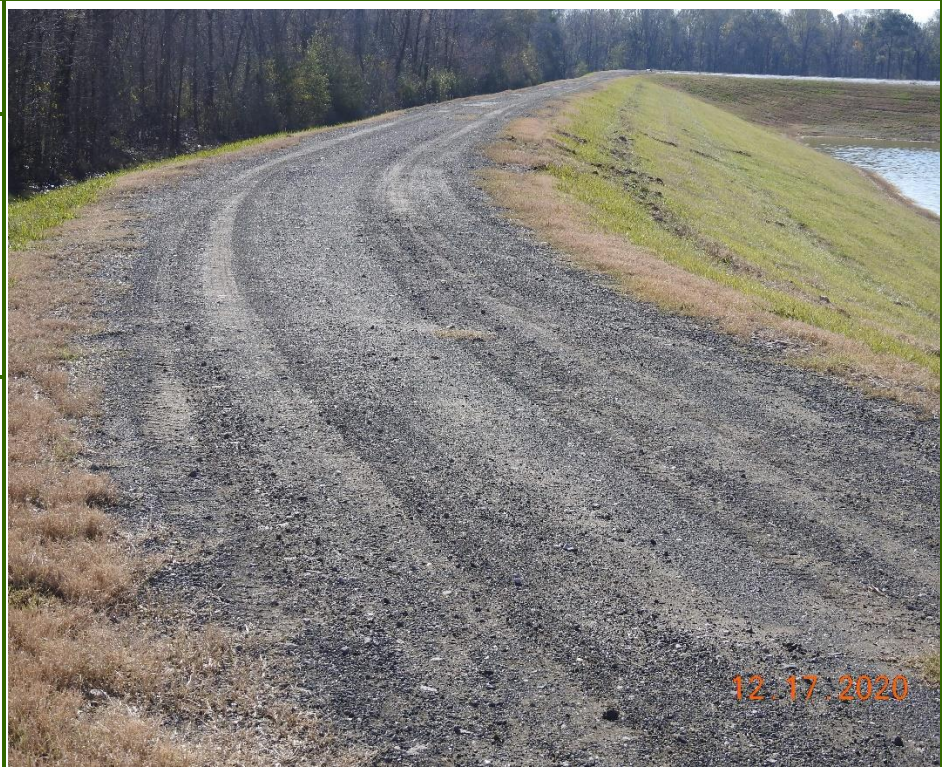
Fly Ash Pond

Crest along eastern levee.

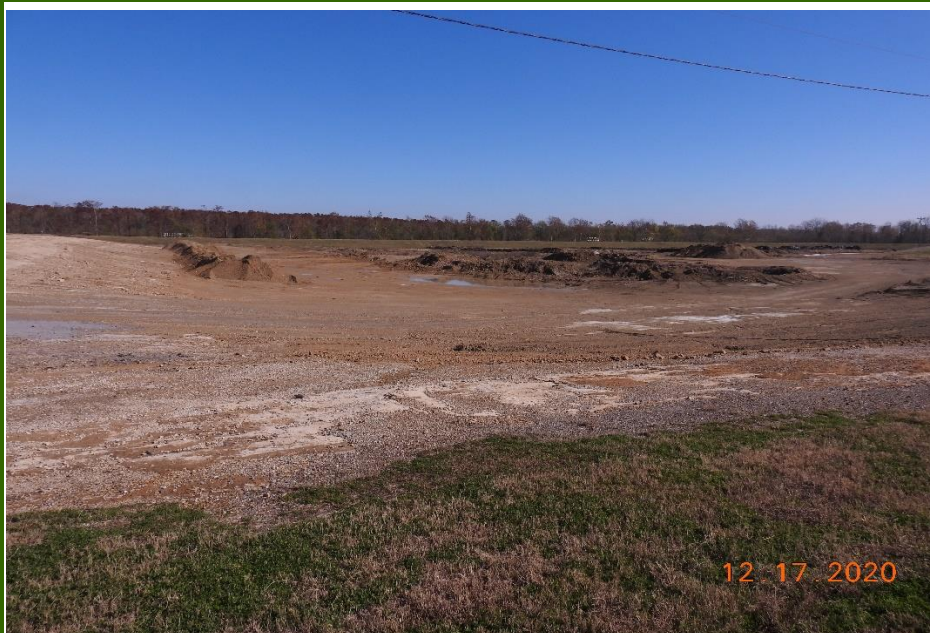
Fly Ash Pond

Fly ash in the Fly Ash Pond.

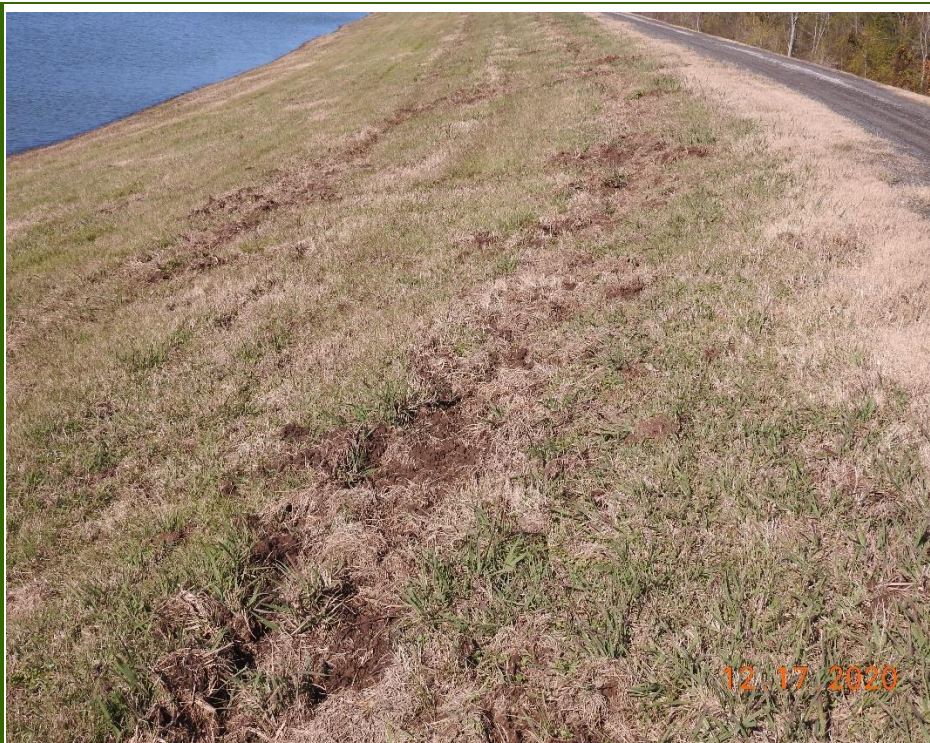
If yes, describe (size of area, location, severity, etc.)	
Findings:	The interior slope was inspected and appeared to be in satisfactory condition. Only minor corrective actions are required at this time based on other observations below.
Other observations on the interior slopes:	Feral hogs have rooted an approximate 1,000 square foot topsoil area on the interior slope of the Fly Ash Pond along the northeast corner. The area needs to be smoothed, then seeded and fertilized to prevent erosion.

Area along the interior levee showing where the feral hogs have recently rooted the topsoil.
