CLECO POWER LLC

BRAME ENERGY CENTER

5-YEAR PERIODIC REVIEW

HAZARD POTENTIAL CLASSIFICATION

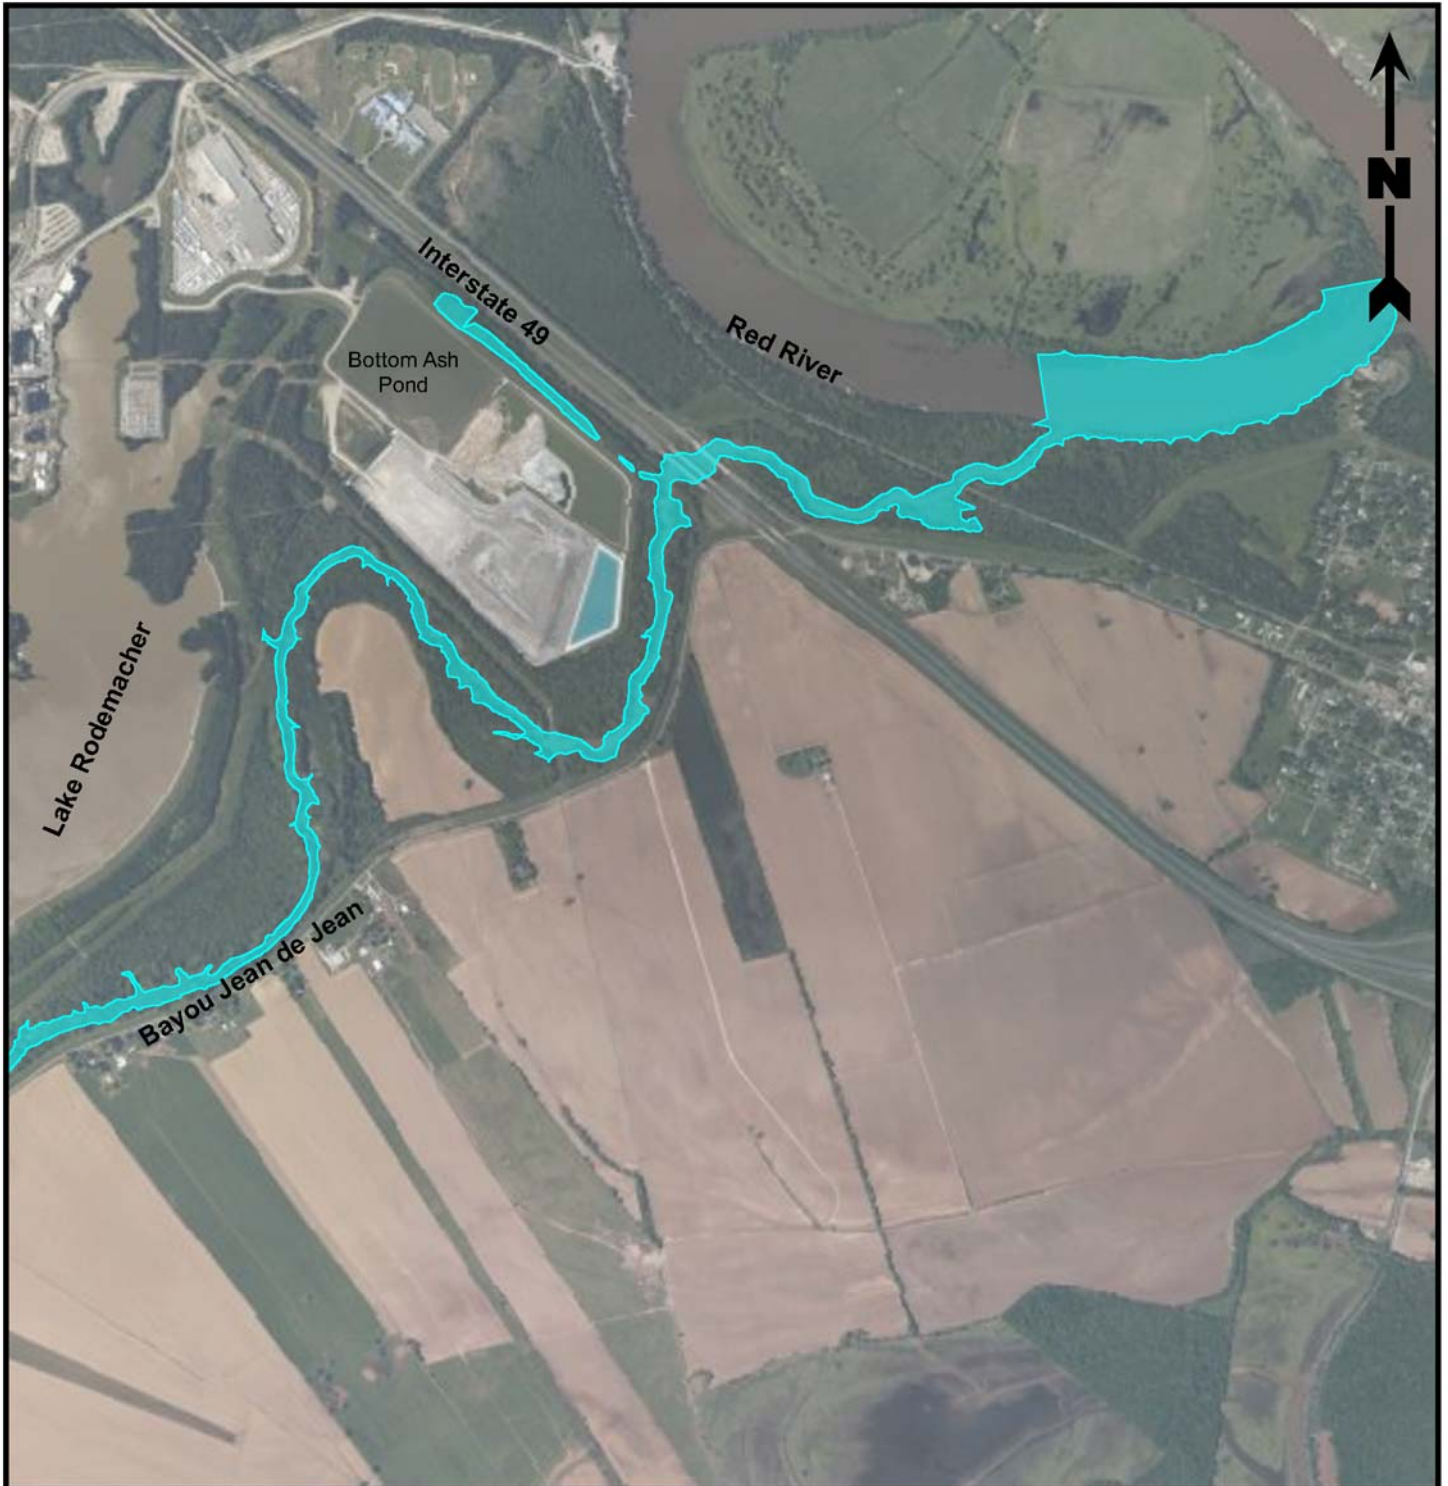
FIGURE 2
BOTTOM ASH POND MOST PROBABLE LOSS

For the Bottom Ash Pond, the Most Probable Loss condition results in no more than a 3' increase which is localized to the channel adjacent to the pond and has no effects to surrounding properties or Interstate 49. The Maximum condition results in no more than a 7' increase which is localized to the channel adjacent to the pond and has no effects to surrounding properties or Interstate 49. The Bottom Ash Pond results are presented in **Figure 2 and Figure 3**.

Most Probable Loss (Avg. El. 75.98')

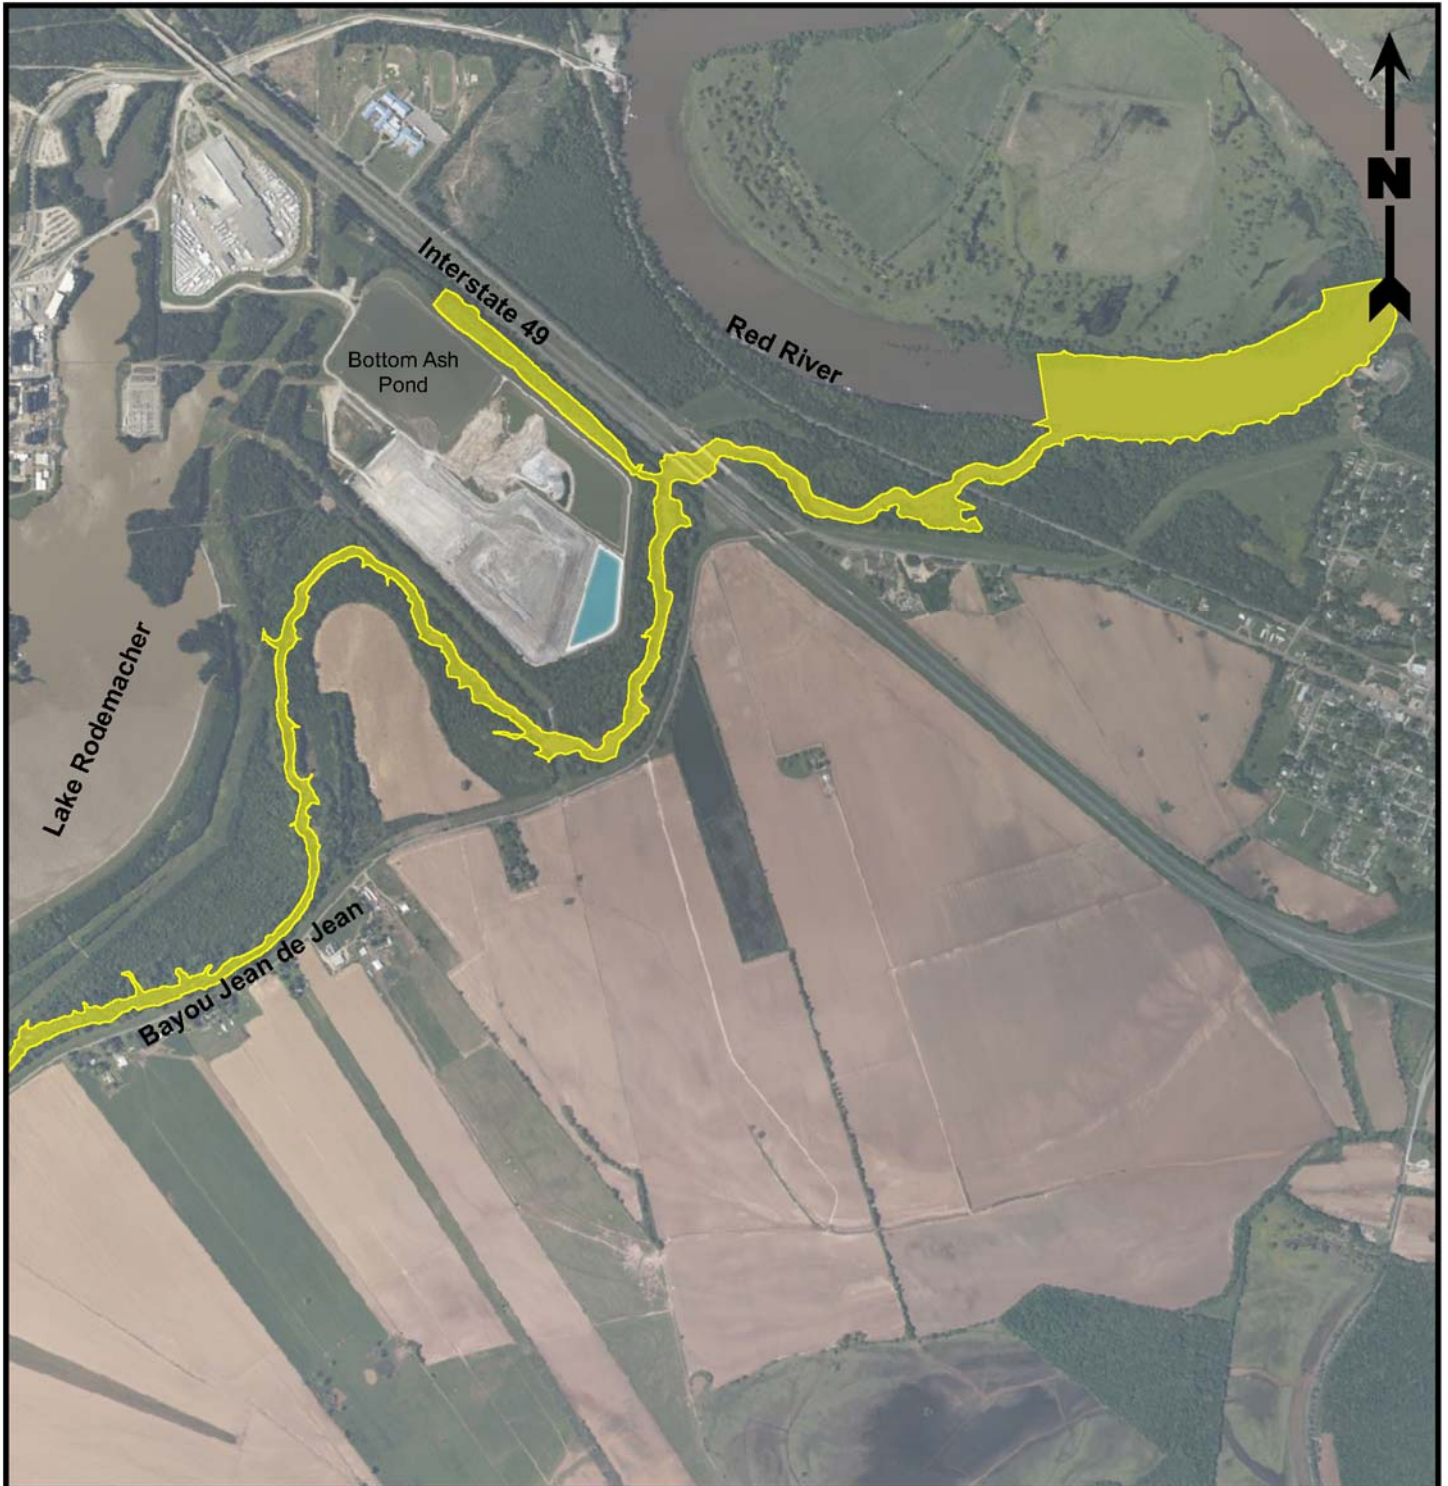
FIGURE 3
BOTTOM ASH POND MAXIMUM LOSS

Maximum Loss (Avg. El. 76.38')
