OCTOBER 2016

# CLECO POWER LLC BRAME ENERGY CENTER

## SAFETY FACTOR ASSESSMENT:

## BOTTOM ASH POND

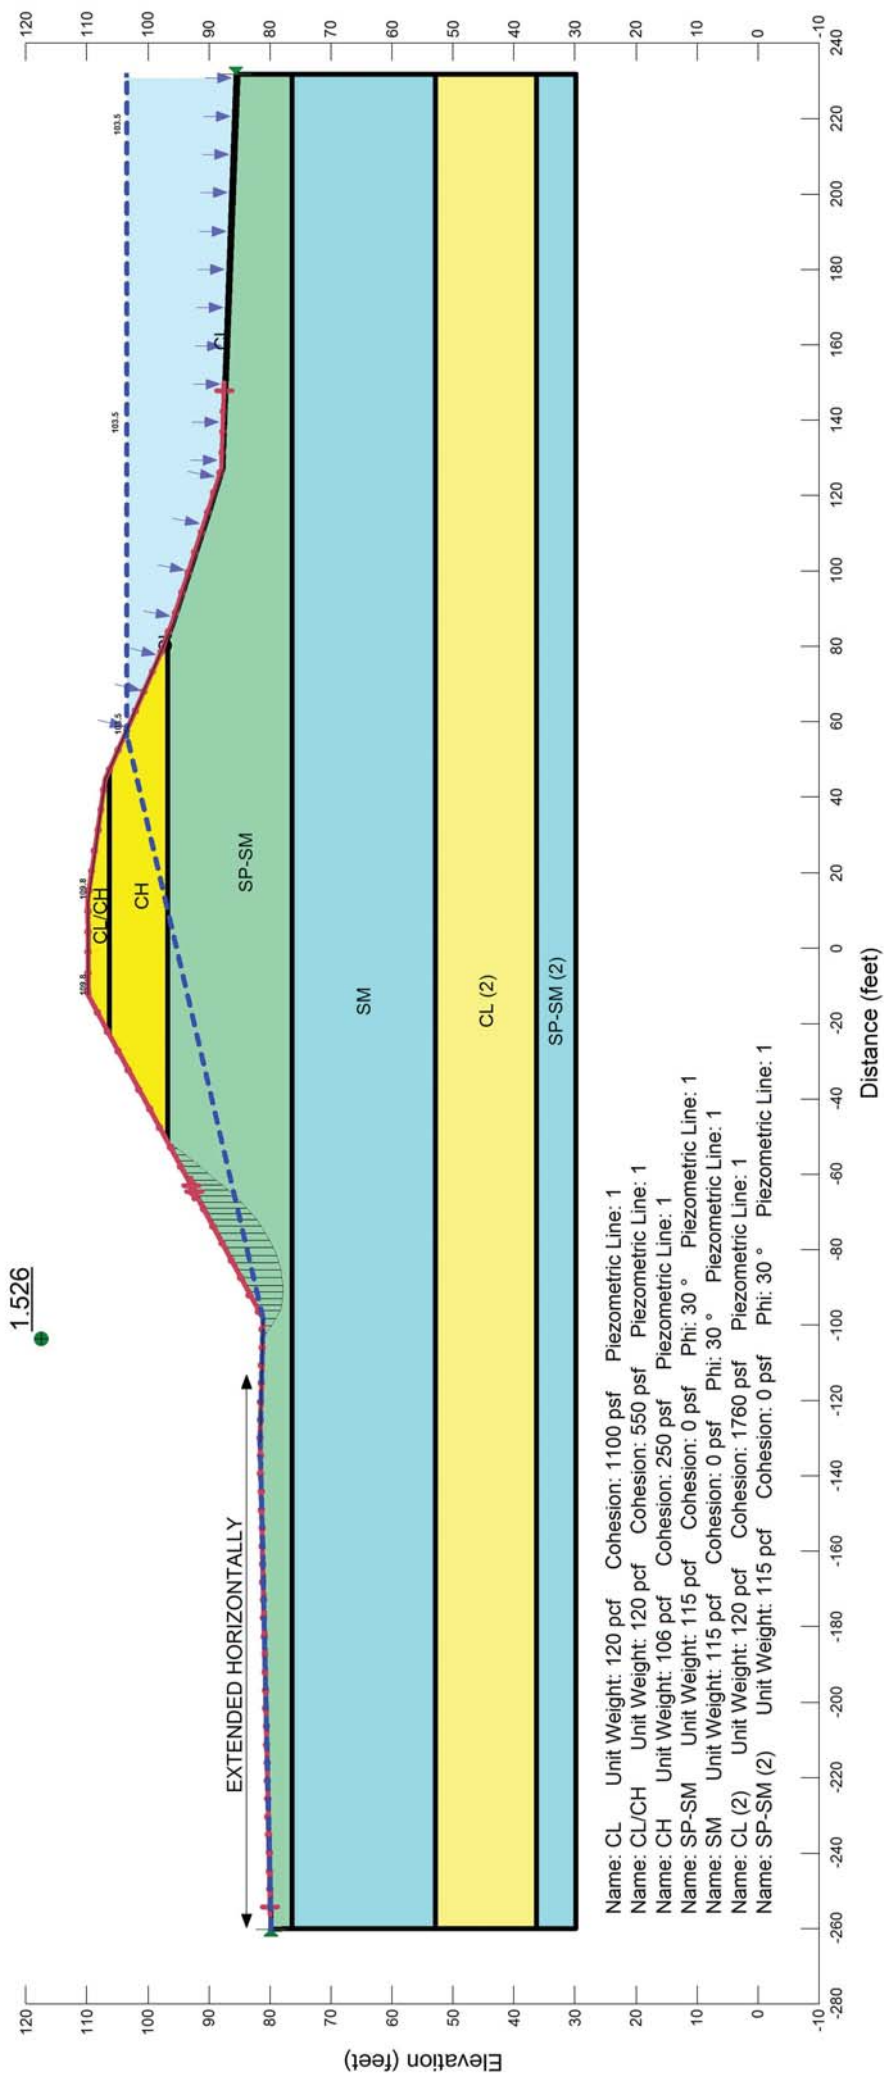
**CLECO BRAME ENERGY CENTER  
 BOTTOM ASH POND - SECTION 1  
 SHORT TERM SLOPE STABILITY ANALYSIS  
 SOIL BORING B-13 (FROM GTL REPORT NO.: 04-16-061)**

Pond	Section #	Condition	Flood Side Water Elevation (feet, NAVD88)	Factor of Safety Obtained	Notes
Bottom Ash Pond	1	Short Term	103.5	1.53	--
	1	Long Term	103.5	1.68	--
	2	Short Term	103.5	2.27	--
	2	Long Term	103.5	2.32	--
	3	Short Term	103.5	1.58	--
	3	Long Term	103.5	1.60	--

Based on the results presented in the above table, all three sections of the Bottom Ash Pond meet minimum required factor of safety with the projected maximum water elevation as shown in above table for both short term and long term conditions. This is based on the soil boring data provided by the client.

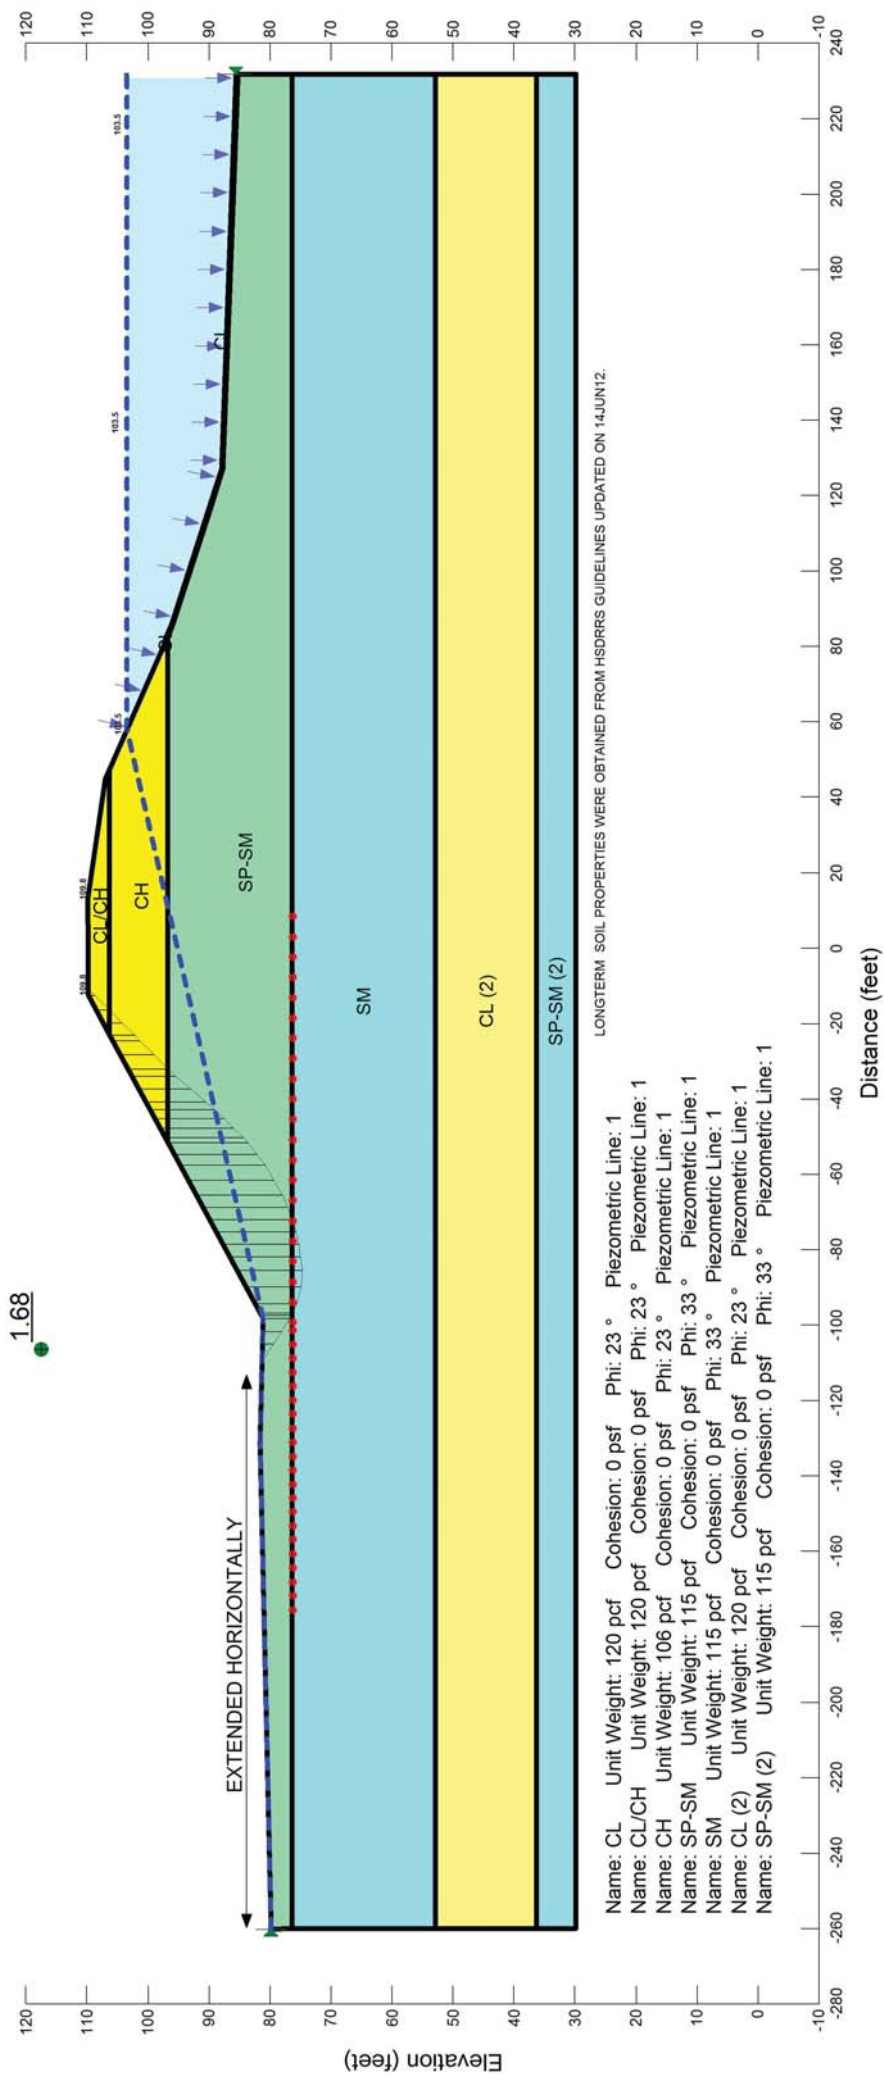
**CLECO BRAME ENERGY CENTER  
 BOTTOM ASH POND - SECTION 1  
 LONG TERM SLOPE STABILITY ANALYSIS (S-CASE)  
 SOIL BORING B-13 (FROM GTL REPORT NO.: 04-16-061)**

Surface Impoundment	Section Number	Soil Boring No.	Maximum Water Elevation (feet NAVD 88)	Analysis	Factor of Safety
Bottom Ash	Section 1	B-13	103.5	Spencer Method Deep Failure	1.68
Bottom Ash	Section 2	B-12	103.5	Spencer Method Deep Failure	2.32
Bottom Ash	Section 3	B-3	103.5	Spencer Method Deep Failure	1.60

The calculated long-term static factor of safety under maximum storage pool loading conditions is greater than 1.50, therefore these safety factors are adequate.

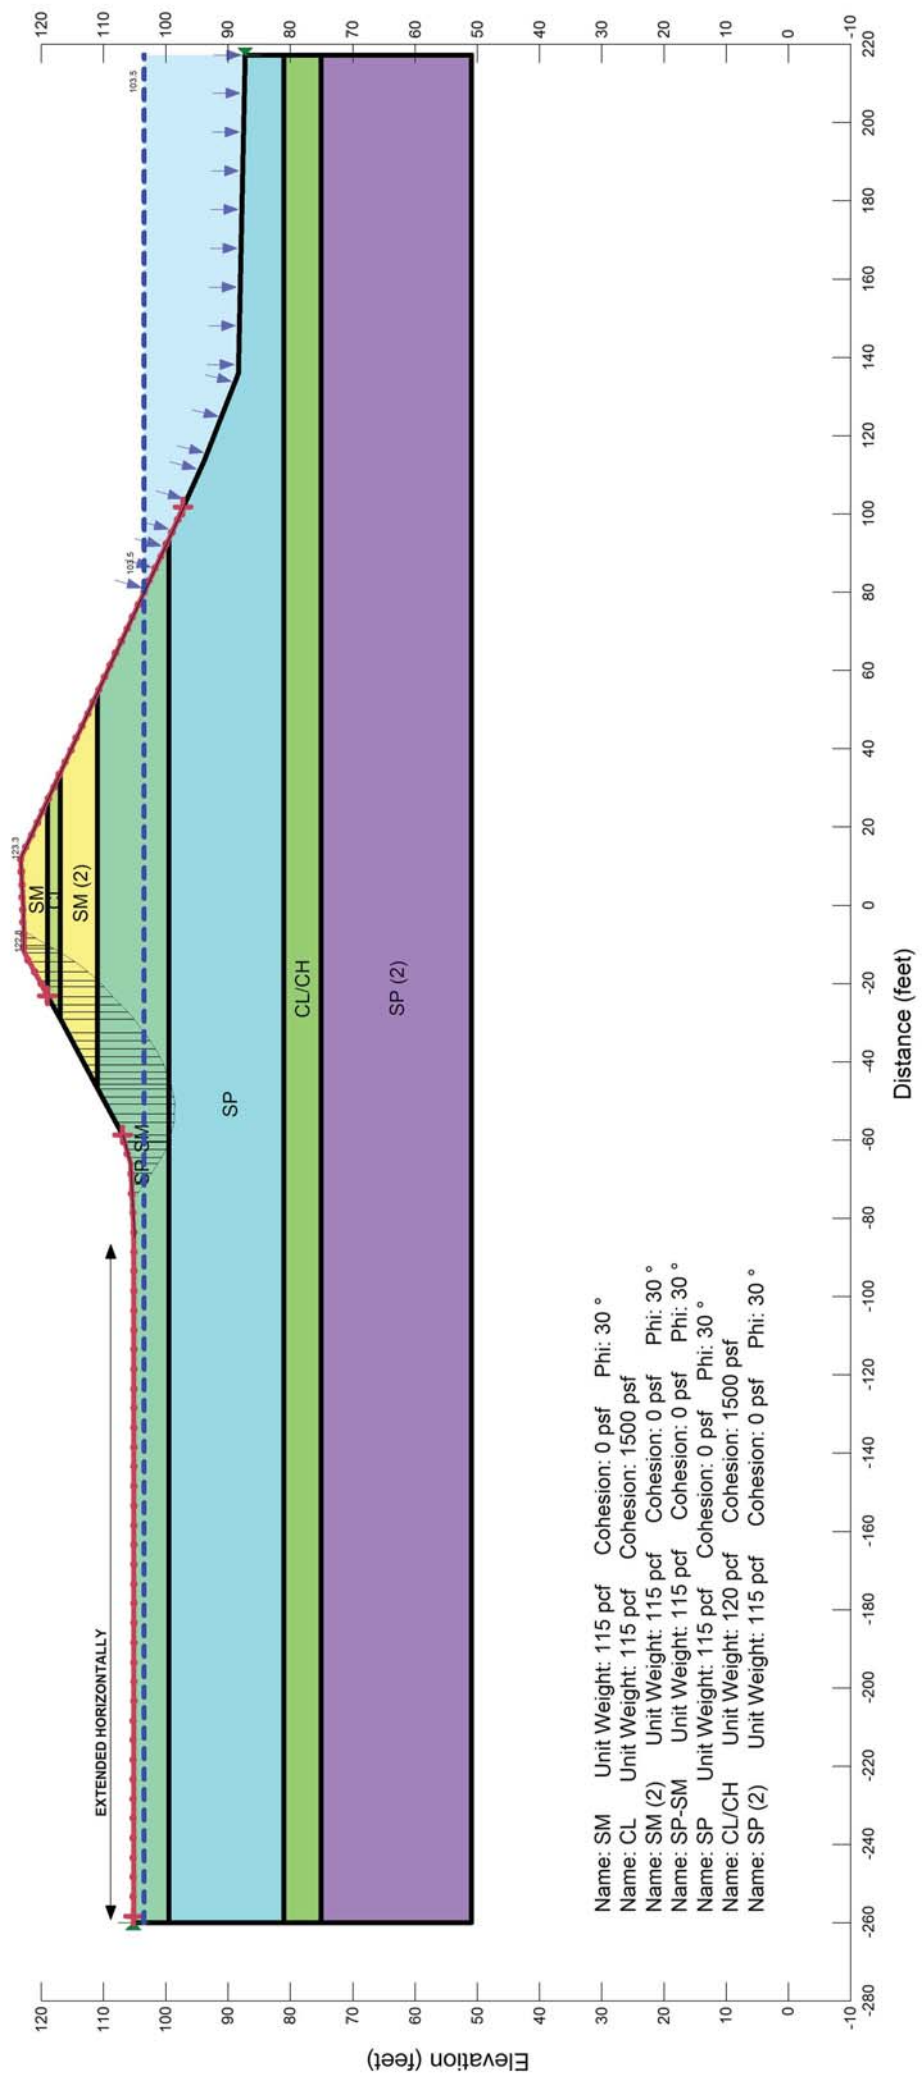
**CLECO BRAME ENERGY CENTER  
 BOTTOM ASH POND - SECTION 2  
 SHORT TERM SLOPE STABILITY ANALYSIS  
 SOIL BORING B-12 (FROM GTL REPORT NO.: 04-16-061)**

2.270

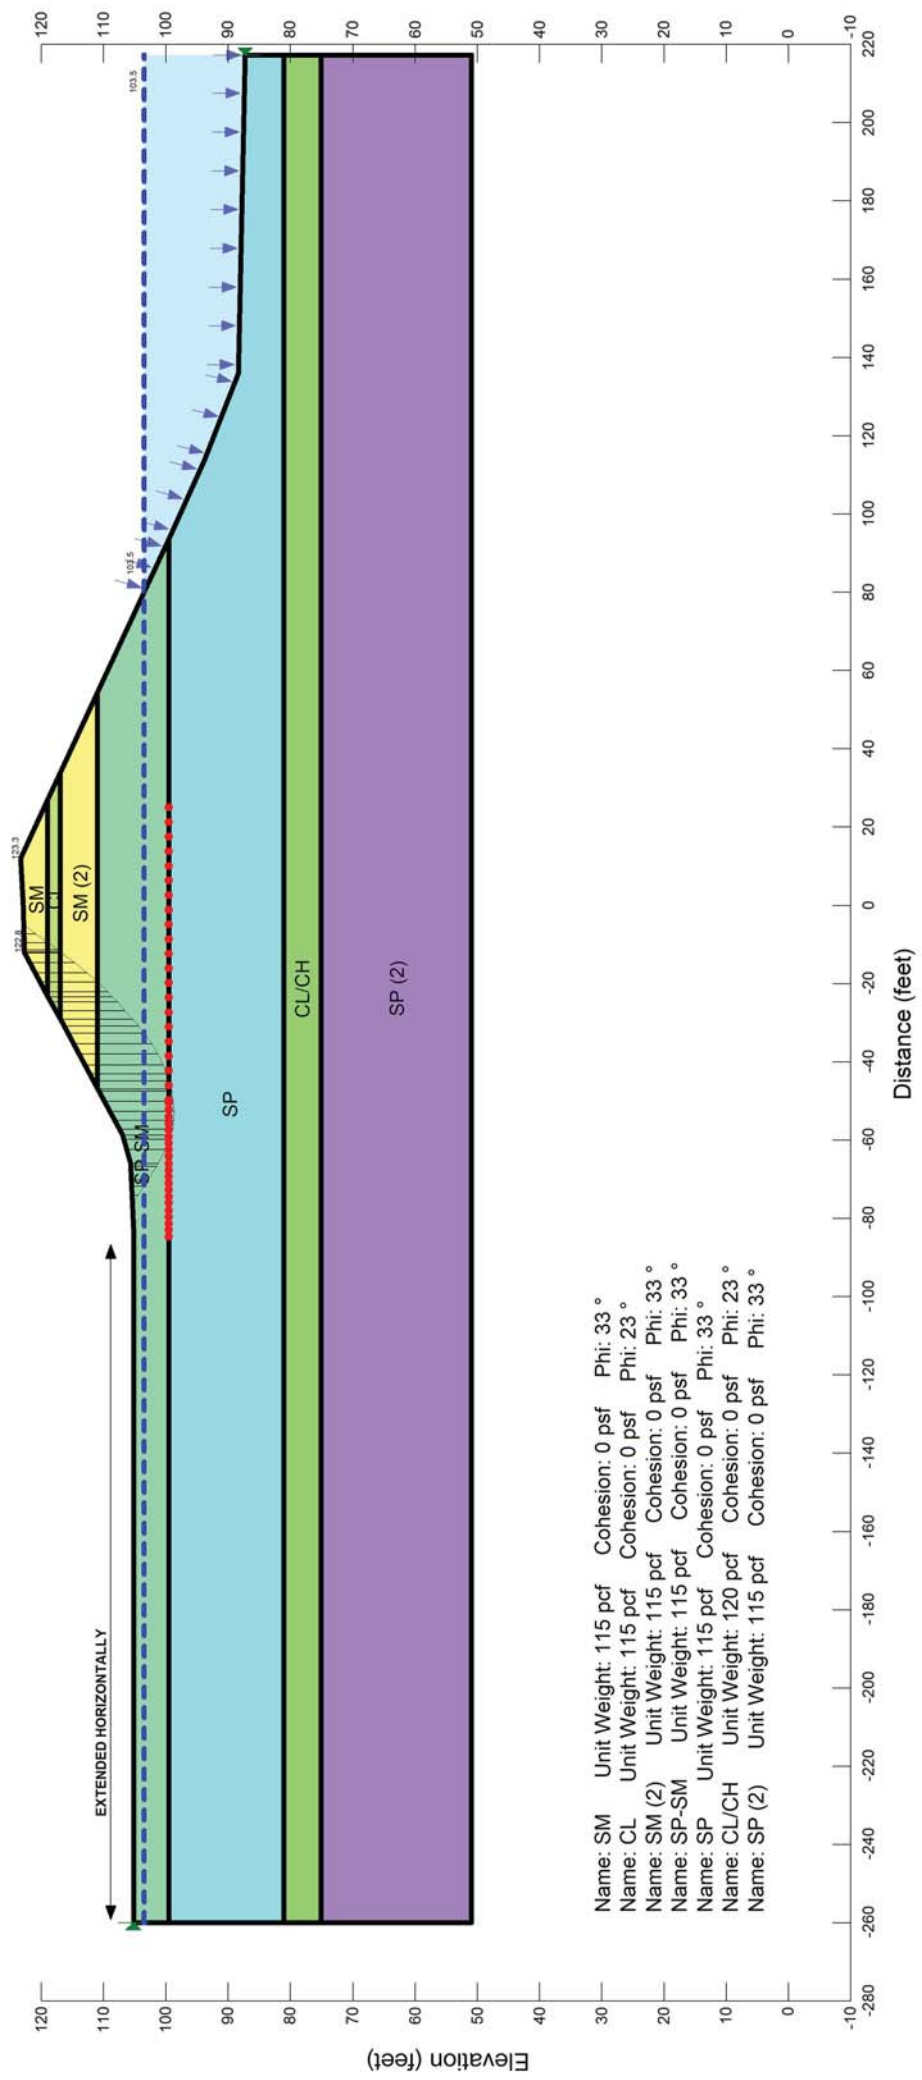
**CLECO BRAME ENERGY CENTER  
 BOTTOM ASH POND - SECTION 2  
 LONG TERM SLOPE STABILITY ANALYSIS (S-CASE)  
 SOIL BORING B-12 (FROM GTL REPORT NO.: 04-16-061)**

2.32

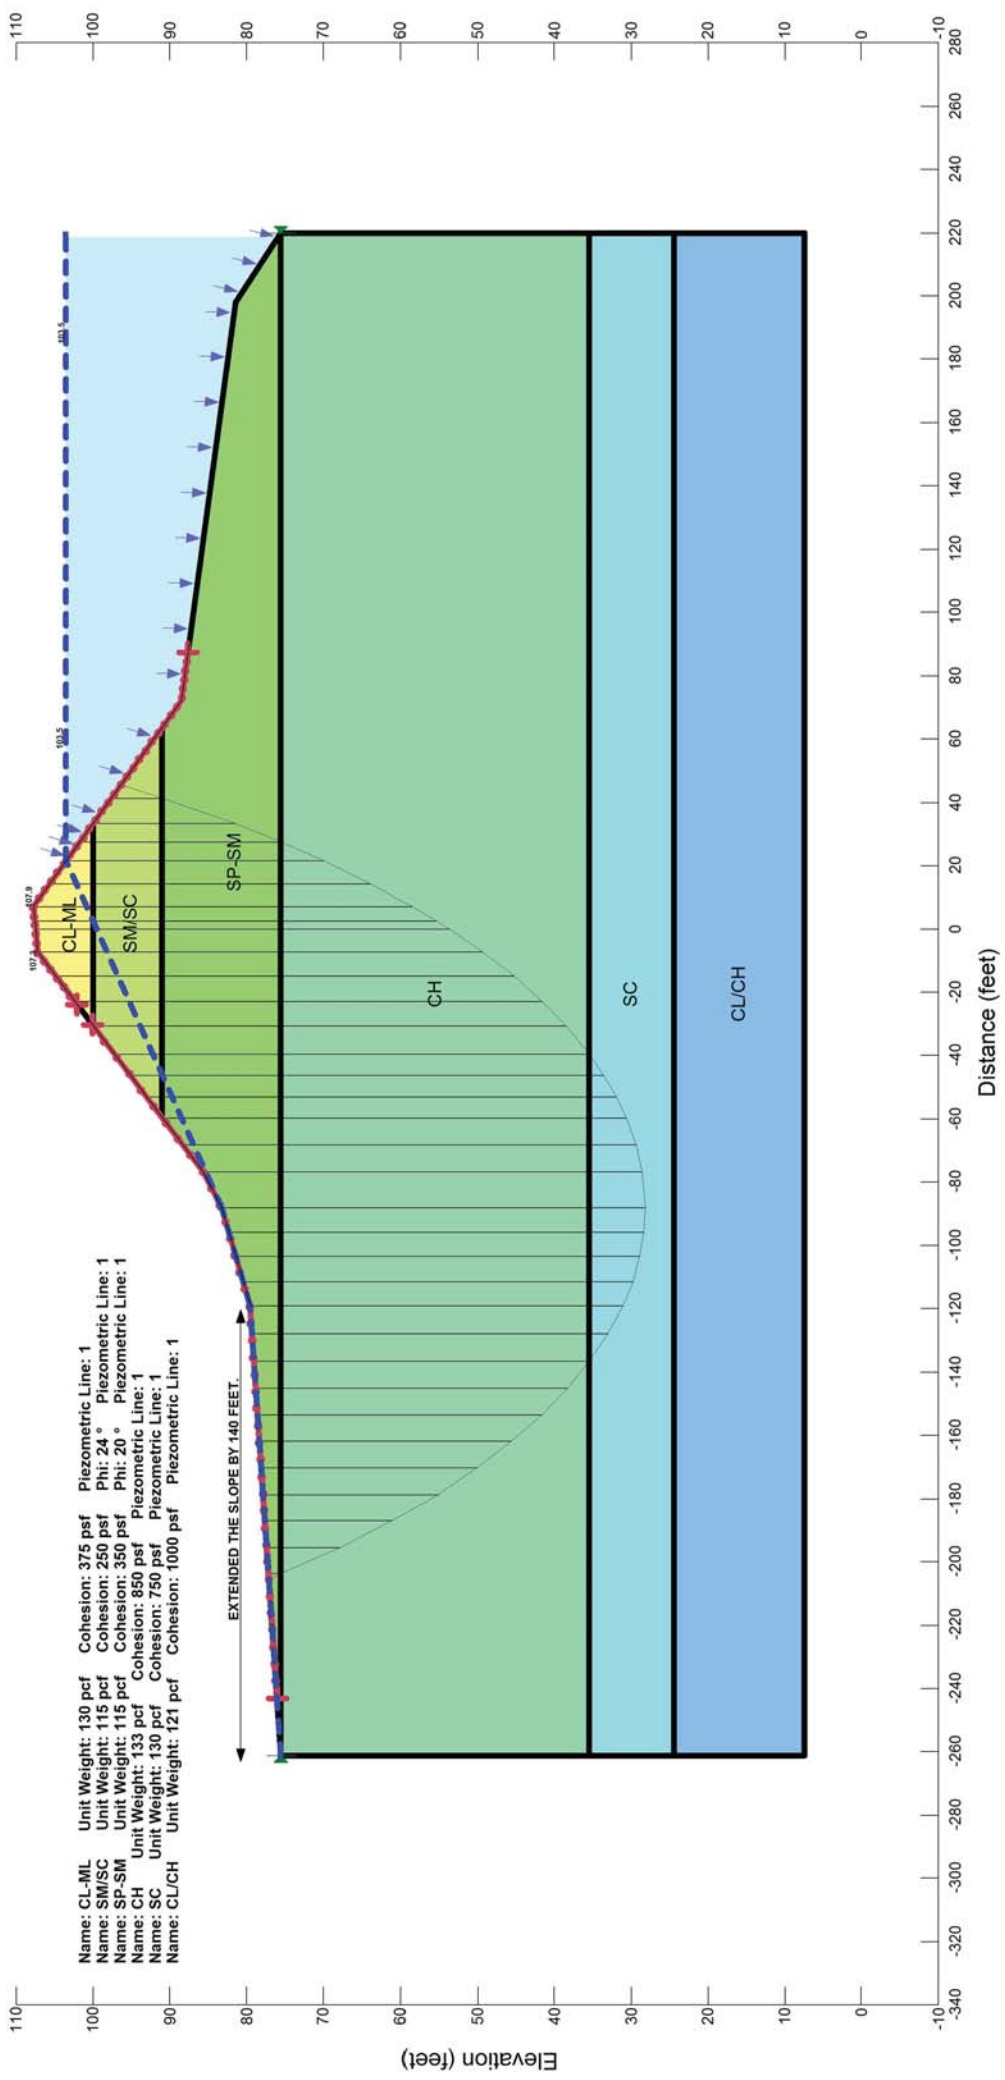
**CLECO BRAME ENERGY CENTER  
 BOTTOM ASH POND - SECTION 3  
 SHORT TERM SLOPE STABILITY ANALYSIS  
 SOIL BORING B-3 (FROM GTL REPORT NO.: 06-11-090)**

1.578

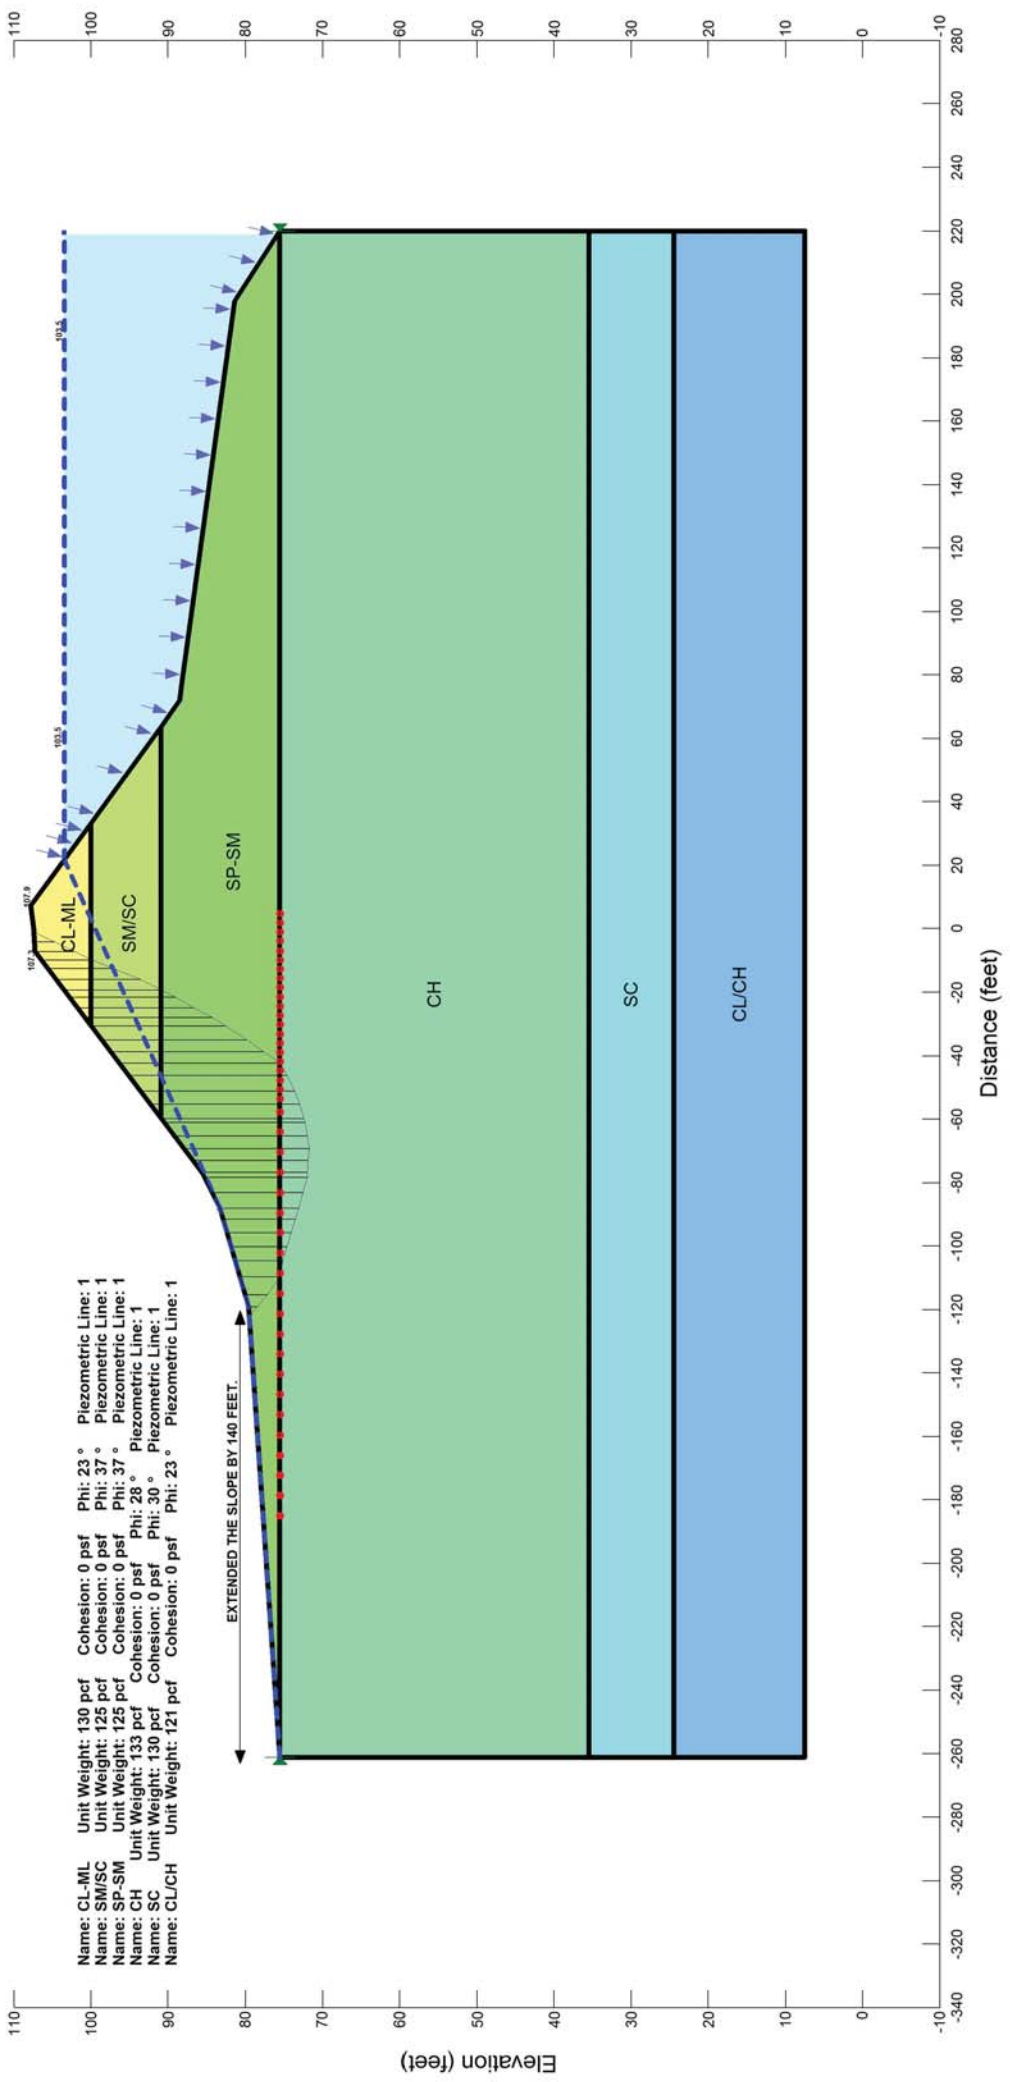
# CLECO BRAME ENERGY CENTER BOTTOM ASH POND - SECTION 3 LONG TERM SLOPE STABILITY ANALYSIS (S-CASE) SOIL BORING B-3 (FROM GTL REPORT NO.: 06-11-090)

EXTENDED THE SLOPE BY 140 FEET.

1.6
