ANNUAL CCR SURFACE IMPOUNDMENT INSPECTION			
Facility Name:		Cleco Brame Energy Center	
Address:		275 Rodemacher Rd. Lena, LA	
Surface Impoundment Name :	Bottom Ash Pond	Owner:	Cleco Power LLC
Surface Impoundment ID:	P-0005	Operator:	Cleco Power LLC
Nearest City:	Boyce	Parish:	Rapides
Inspector:		James C. Van Hoof, P.E.	
Company:		Providence Engineering & Environmental Group LLC	
Date of Inspection:		1/11/2016	
Weather at Time of Inspection:		Sunny, Cool	
DESCRIPTION OF THE OPERATION OF THE SURFACE IMPOUNDMENTS:			
<p>The Brame Energy Center's Bottom Ash and Fly Ash surface impoundments are designed to accept the coal combustion residual (CCR) byproducts derived from burning of the Unit 2 coal for the generation of electricity. The ponds are classified by the Louisiana Department of Environmental Quality (LDEQ) as Type I Surface Impoundments. Water from the Fly Ash surface impoundment is pumped into the Bottom Ash impoundment which discharges by means of three pumps that discharge the wastewater through the outlet pipe on the northern end of the pond. This water discharges into Lake Rodemacher via LPDES outfall 401, thence to Bayou Jean de Jean via LPDES outfall 001, then to the Re

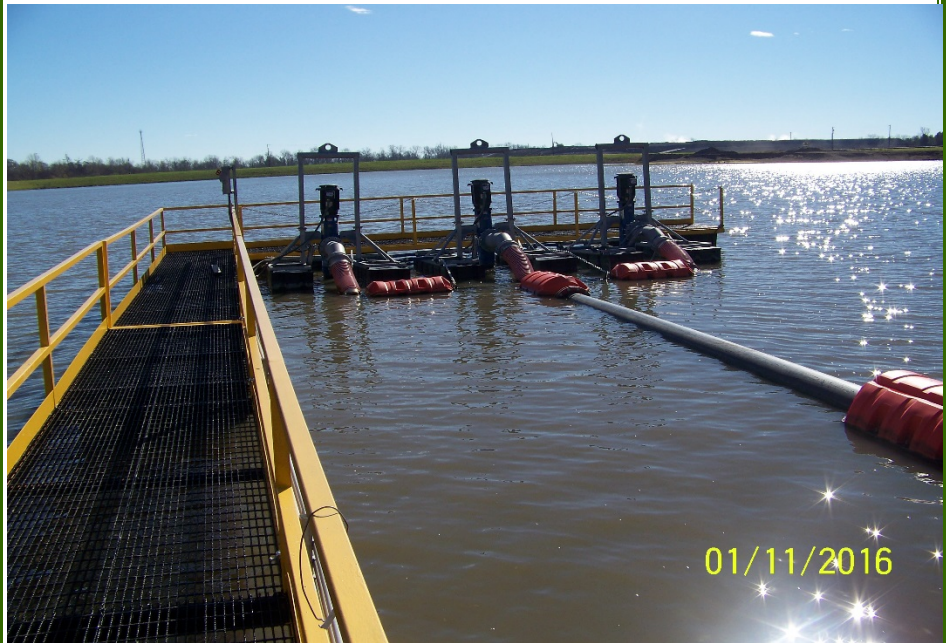
Bottom Ash Pond

Floating pump structure functioning normally.

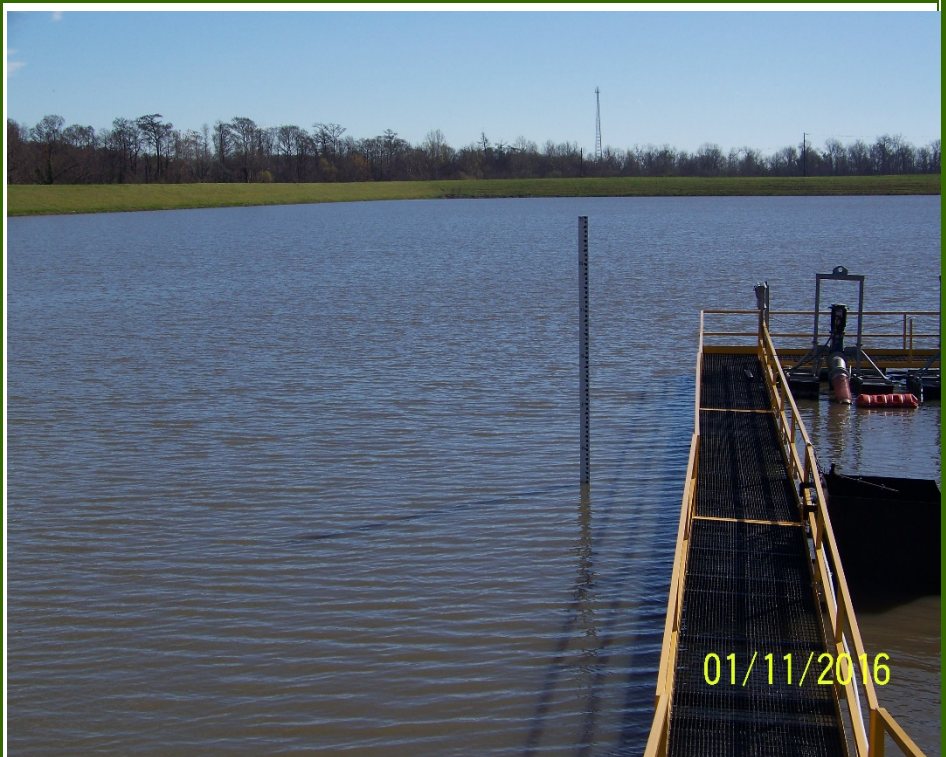
Bottom Ash Pond

Level Gauge near floating pump structure in Bottom Ash Pond.

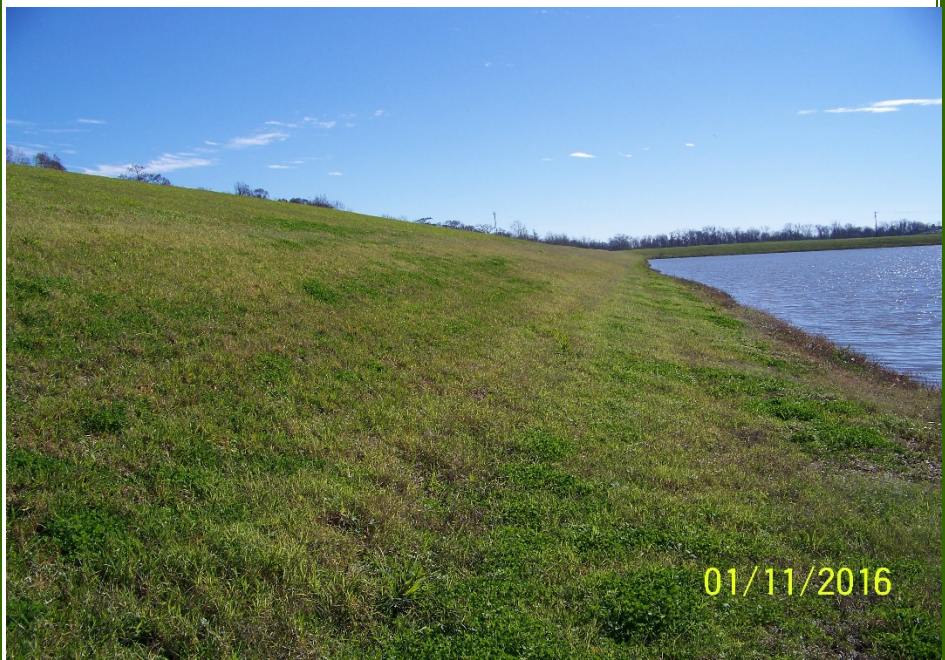
Bottom Ash Pond

Are there any Sinkholes Observed?	<input type="checkbox"/> Yes <input checked="" type="checkbox"/> No
If yes, describe (size of area, location, severity, etc.)	
Findings:	The interior slope was inspected and appeared to be in satisfactory condition. No corrective actions are required at this time.
Other observations on the interior slopes:	None

Northern slope of internal levee.

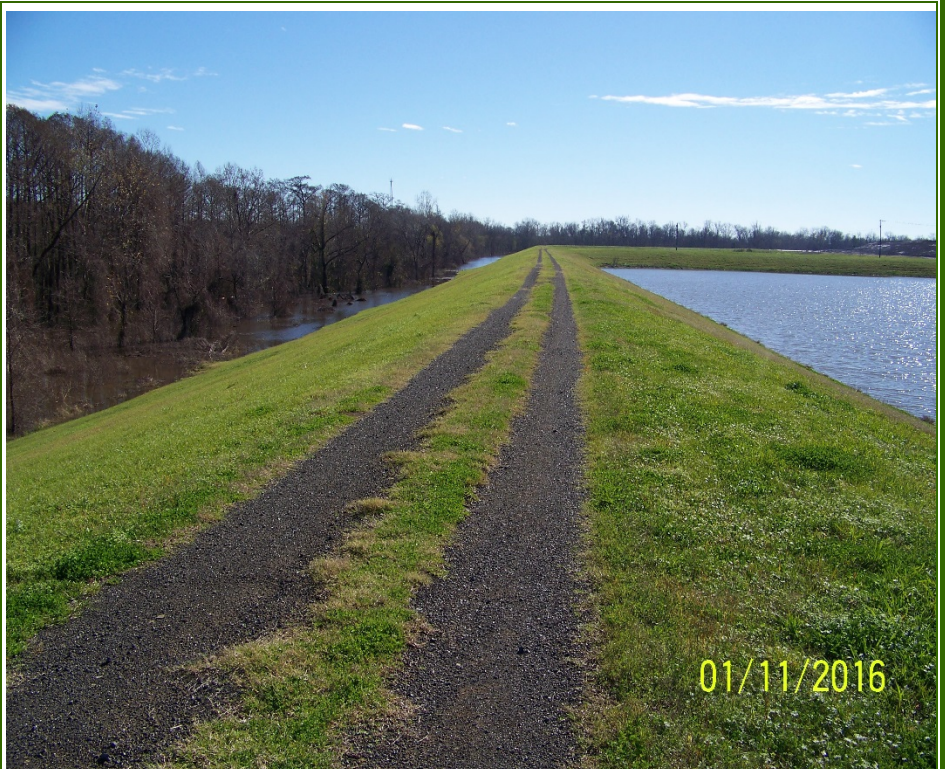
Bottom Ash Pond

If yes, describe (size of area, location, severity, etc.)	
Findings:	The abutment/toe was inspected and appeared to be in satisfactory condition. No corrective actions are required at this time.
Other observations on the abutment/toe: It should be noted that the northern exterior toe was under water due to the rising water levels on the Red River backing up into Bayou Jean de Jean. Therefore inspection of that area was not possible.

Crest of northern levee. High water levels due to the Red River are shown on the toe of the exterior levee.

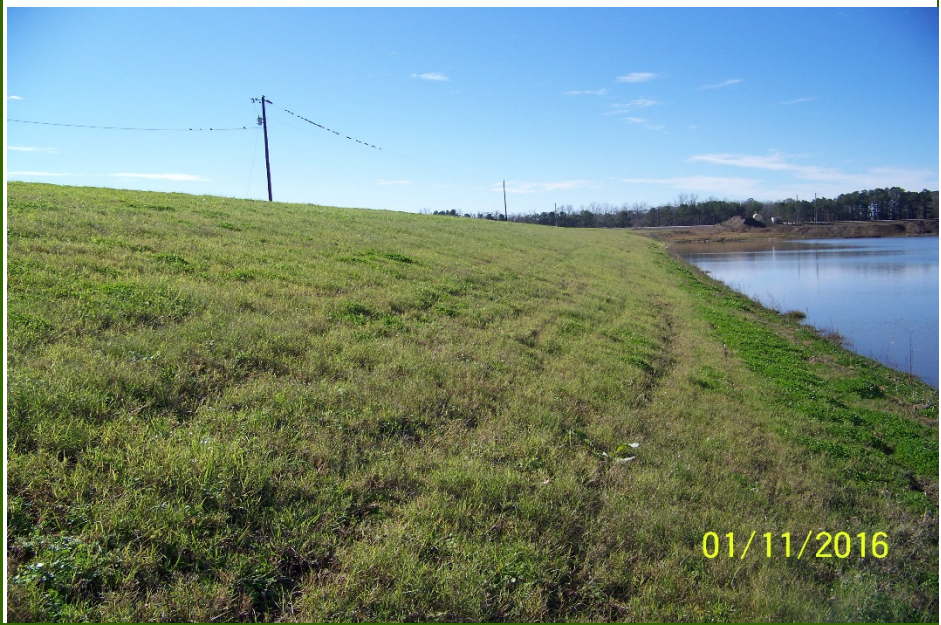
Bottom Ash Pond

Inside slope of eastern levee.

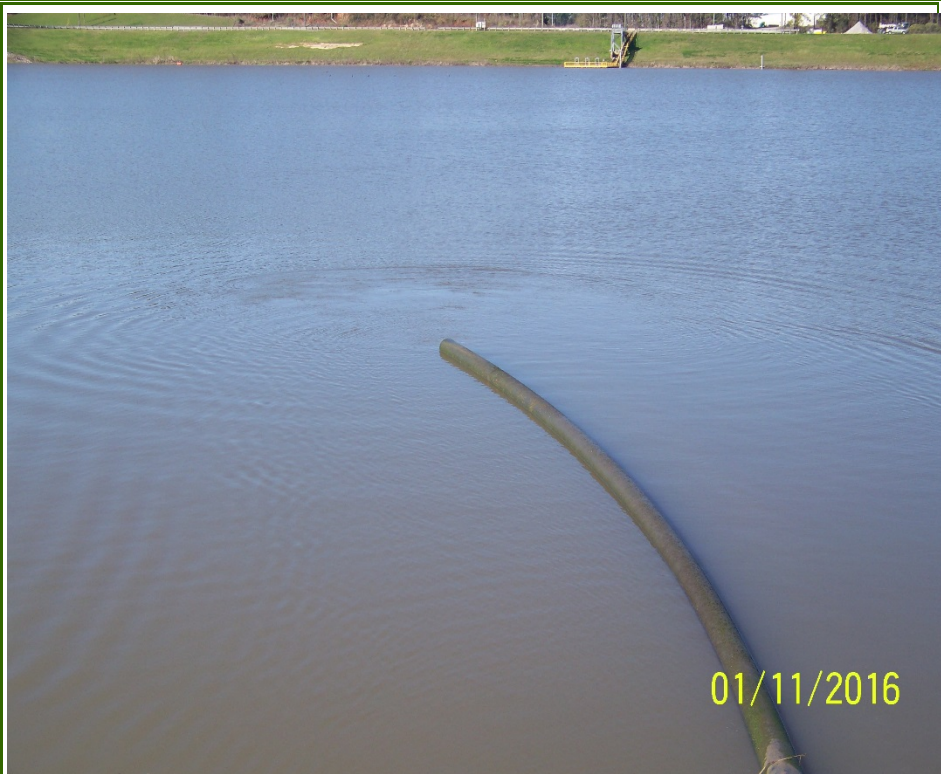
Bottom Ash Pond

Discharge pipe from the Fly Ash Pond into the Bottom Ash Pond.

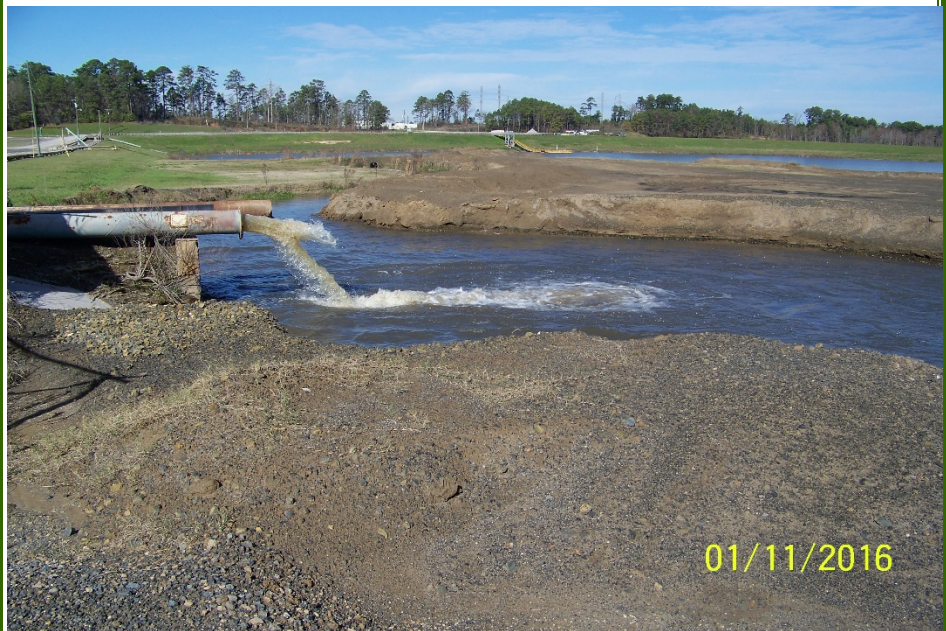
Bottom Ash Pond

Sluice pipe discharging into the Bottom Ash Pond.

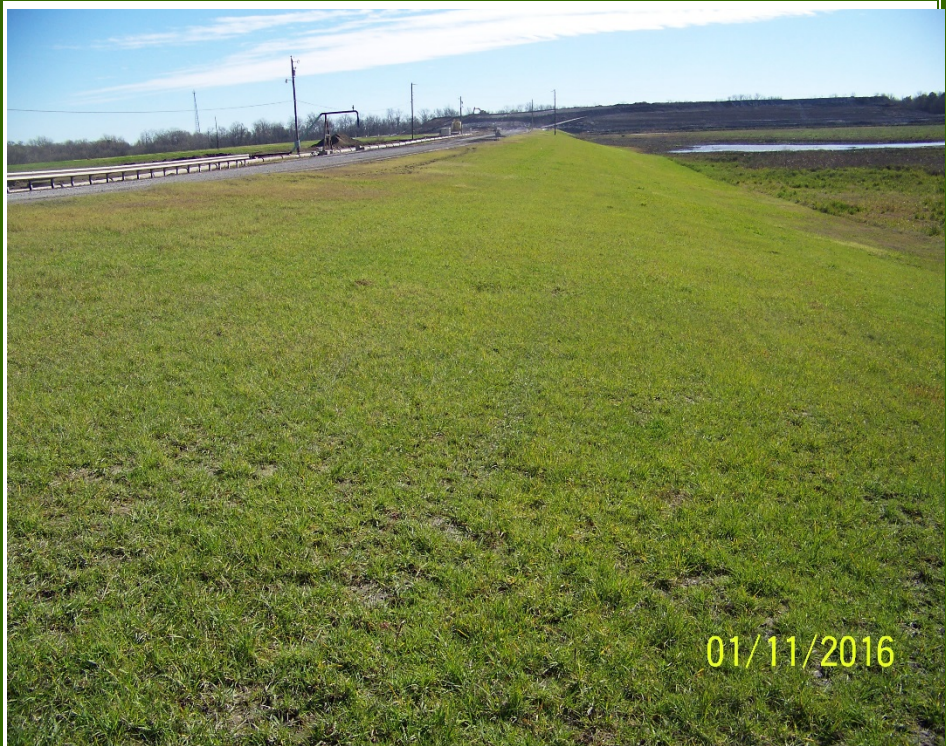
Bottom Ash Pond

If yes, describe (size of area, location, severity, etc.)	
Are there any trees on the slopes?	<input type="checkbox"/> Yes <input checked="" type="checkbox"/> No
If yes, describe (type of vegetation, size, location, etc.)	
Findings:	The exterior slope was inspected and appeared to be in satisfactory condition. No corrective actions are required at this time.
Other observations on the exterior slopes:	None

External slope of southern levee.

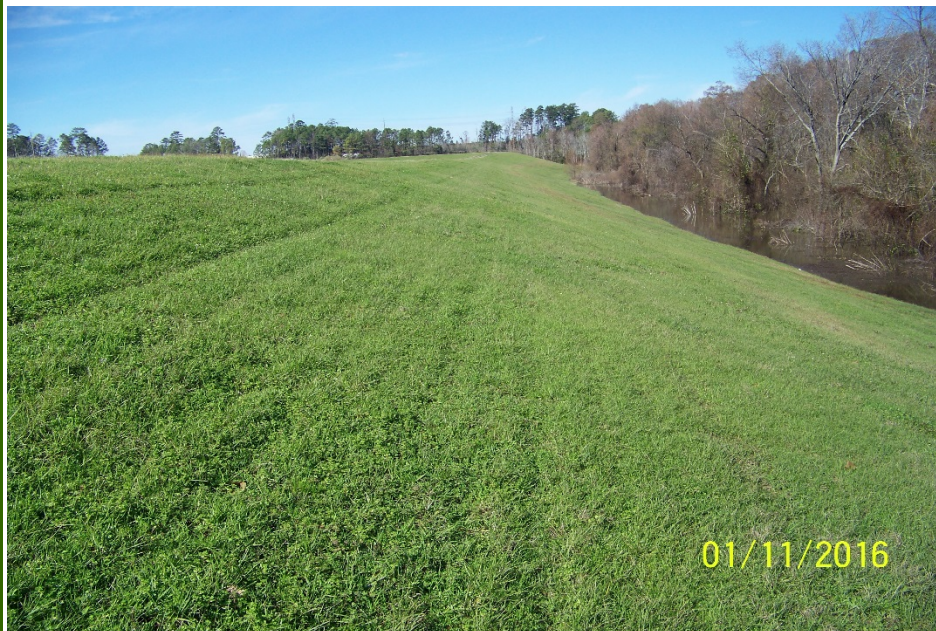
Bottom Ash Pond

Exterior slope of northern levee.

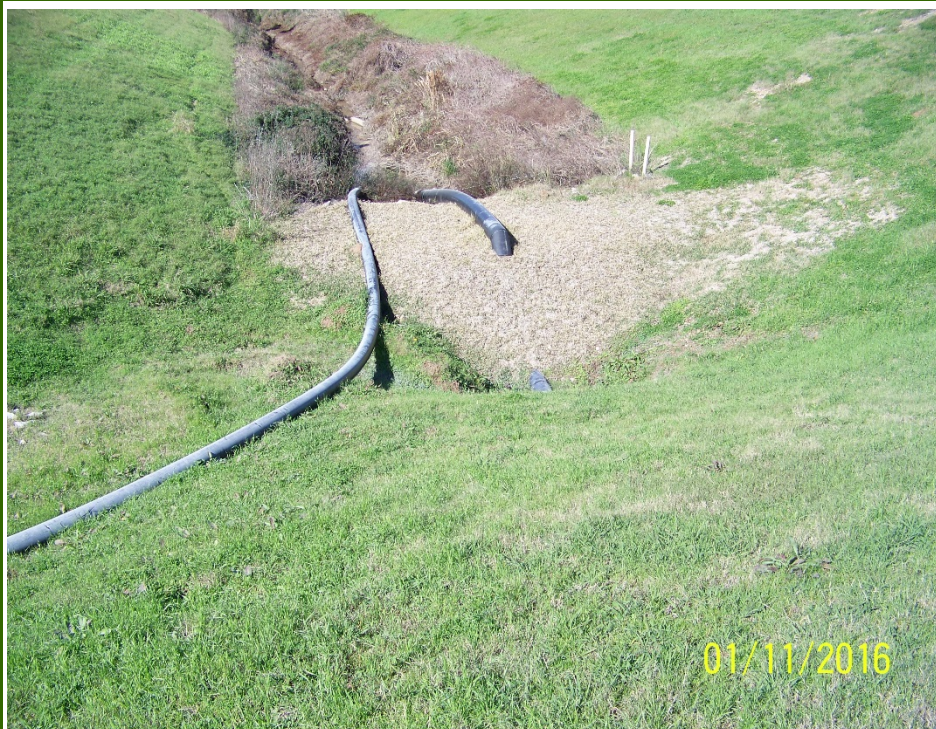
Bottom Ash Pond

If no, describe (type of debris, reason for obstruction, etc.)	
Describe the quality of discharge from the hydraulic structure (turbidity, depth, etc.)	The outflowing water is relatively clear and discharges to Lake Rodemacher via LPDES Outfall 401 which cycles back to the plant.
Findings:	The outlet works were inspected and appeared to be in satisfactory condition. No corrective actions are required at this time.
Other observations on the outlet works:	None

Bottom Ash discharge pipe shown outside the western levee towards Lake Rodemacher.
