ANNUAL CCR SURFACE IMPOUNDMENT INSPECTION			
Facility Name:		Cleco Brame Energy Center	
Address:		275 Rodemacher Rd. Lena, LA	
Surface Impoundment Name :	Bottom Ash Pond	Owner:	Cleco Power LLC
Surface Impoundment ID:	P-0005	Operator:	Cleco Power LLC
Nearest City:	Boyce	Parish:	Rapides
Inspector:		James C. Van Hoof, P.E.	
Company:		Providence Engineering & Environmental Group LLC	
Date of Inspection:		12/10/2019	
Weather at Time of Inspection:		Cloudy, Cool	
DESCRIPTION OF THE OPERATION OF THE SURFACE IMPOUNDMENTS:			
<p>The Brame Energy Center's Bottom Ash and Fly Ash surface impoundments are designed to accept the coal combustion residual (CCR) byproducts derived from burning of the Unit 2 coal for the generation of electricity. The ponds are classified by the Louisiana Department of Environmental Quality (LDEQ) as Type I Surface Impoundments. Water from the Fly Ash surface impoundment is pumped into the Bottom Ash impoundment which discharges by means of three pumps that discharge the wastewater through the outlet pipe on the western end of the pond. This water discharges into Lake Rodemacher via LPDES outfall 401, thence to Bayou Jean de Jean via LPDES outfall 001, then to the R

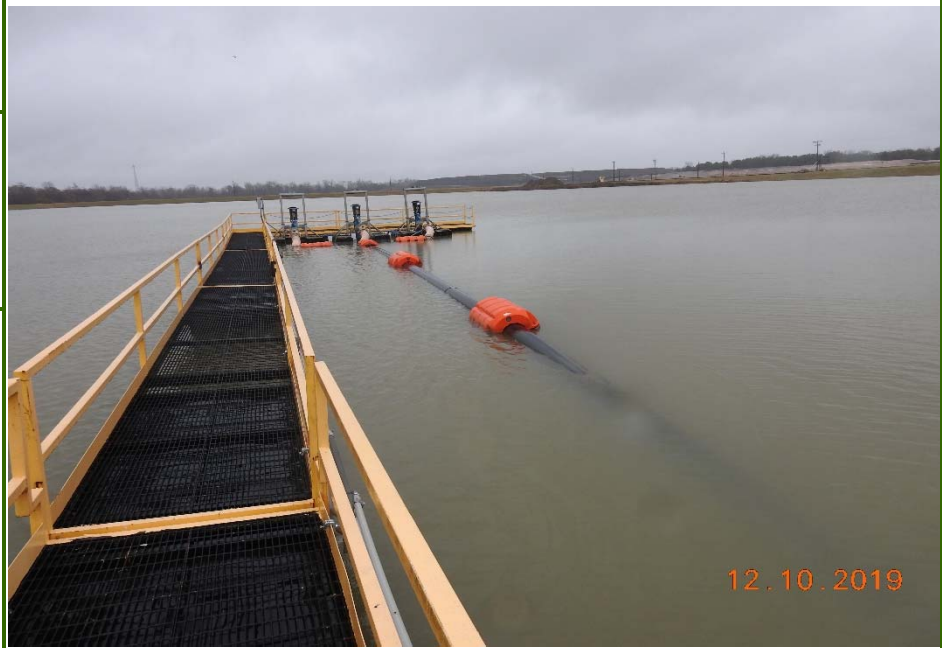
Bottom Ash Pond

Floating pump structure in Bottom Ash Pond.

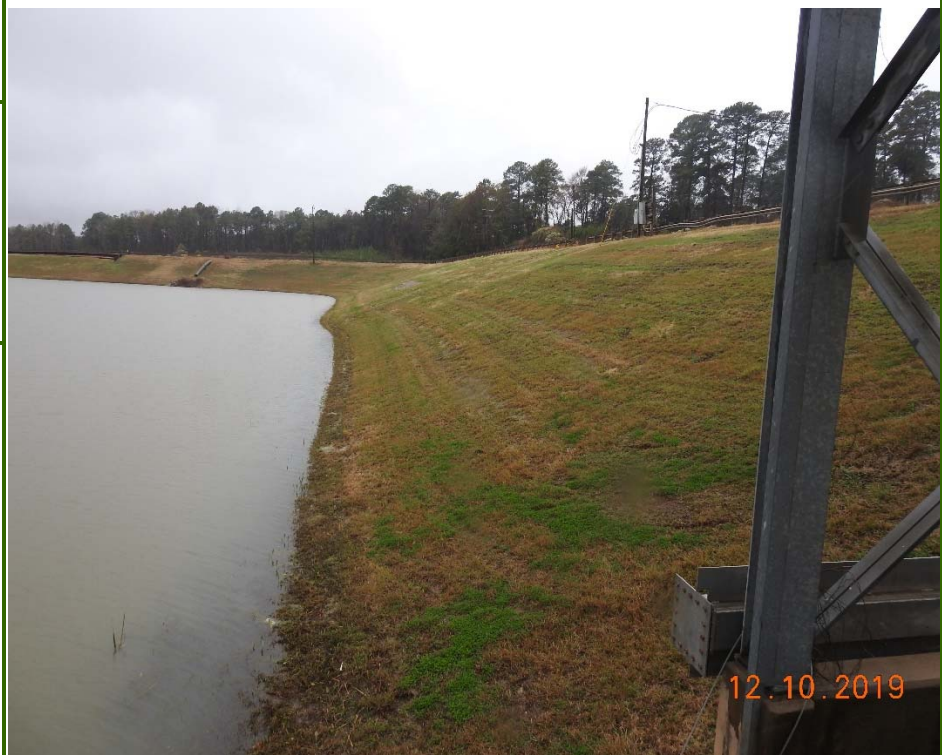
Bottom Ash Pond

Western slope of interior levee.

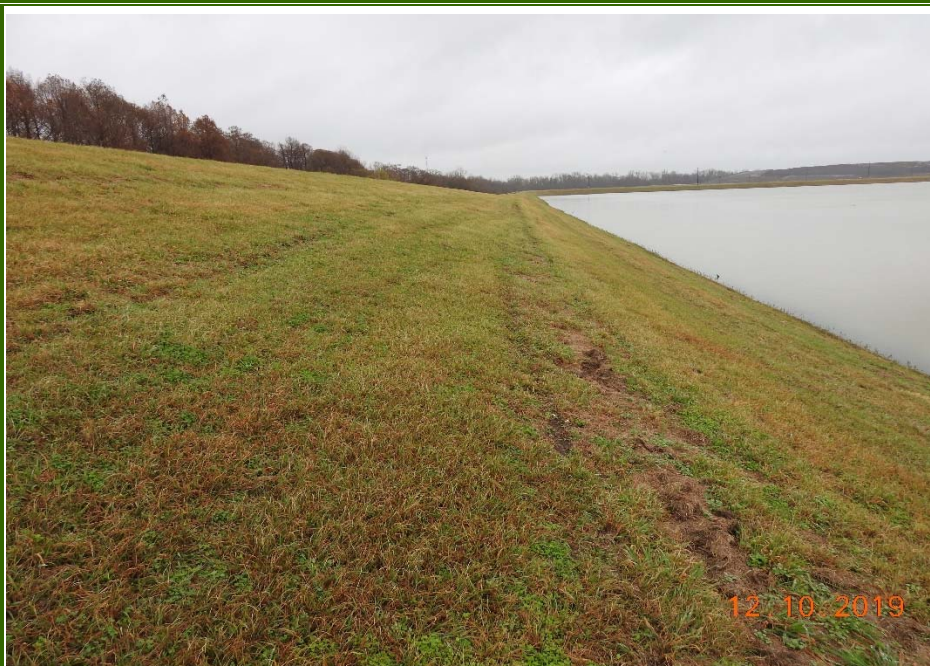
Bottom Ash Pond

Northern slope of internal levee.

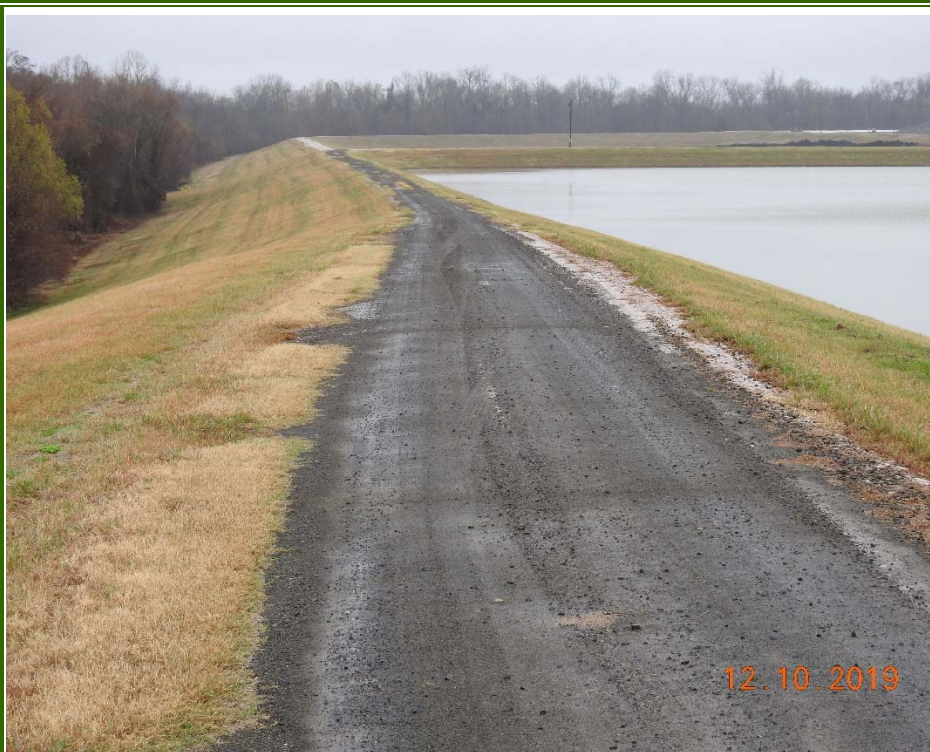
Bottom Ash Pond

Crest of northern levee.

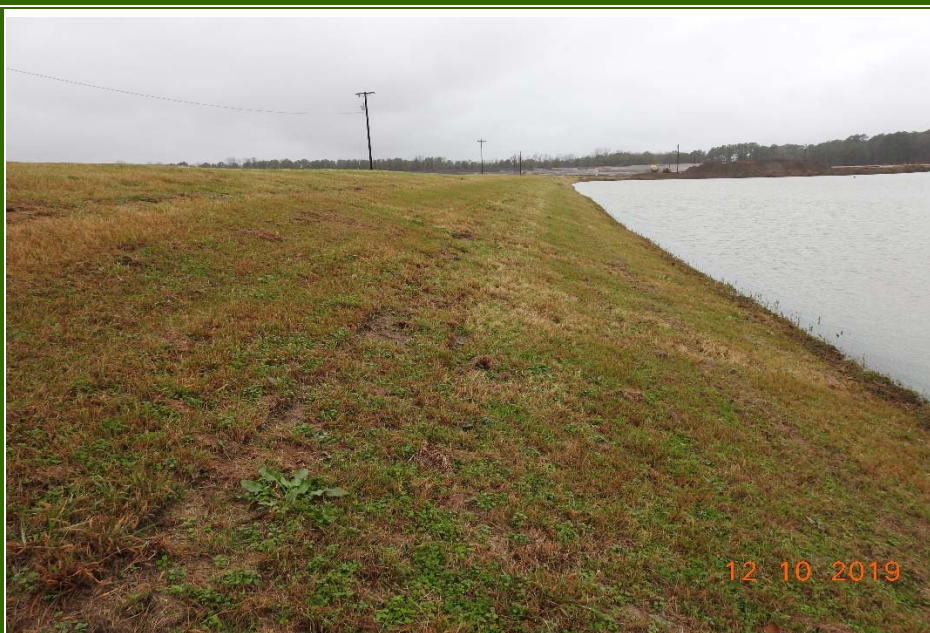
Bottom Ash Pond

Inside slope of eastern levee.

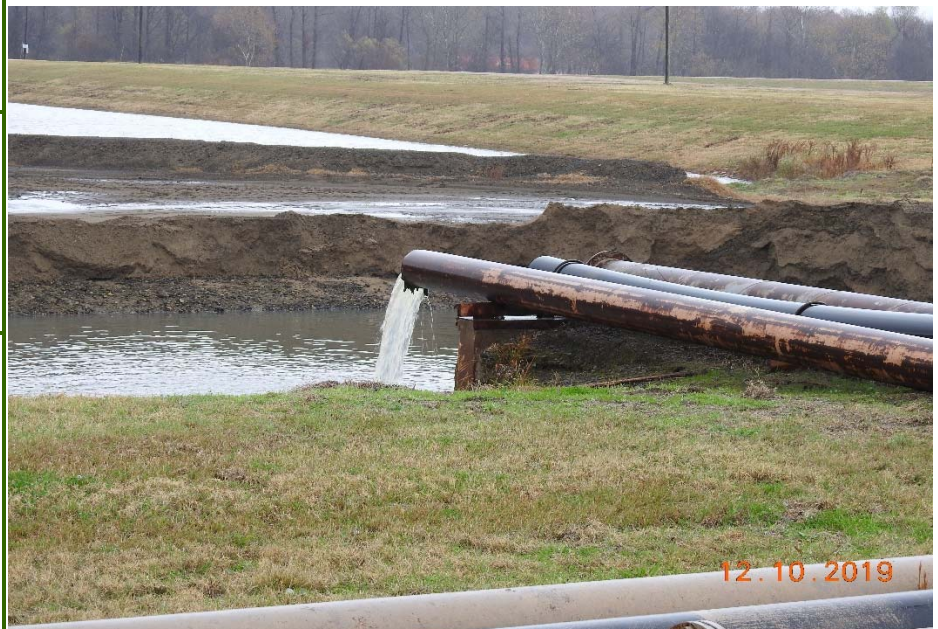
Bottom Ash Pond

Sluice pipe discharging into the Bottom Ash Pond.

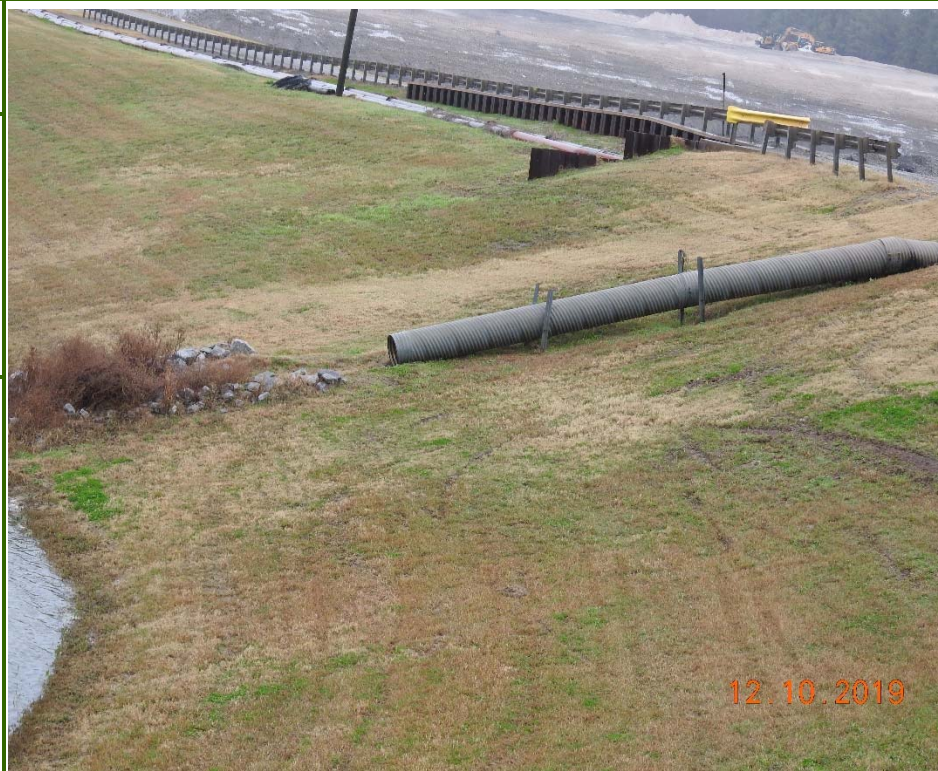
Bottom Ash Pond

Storm water discharge pipe from sluice pipe trench.

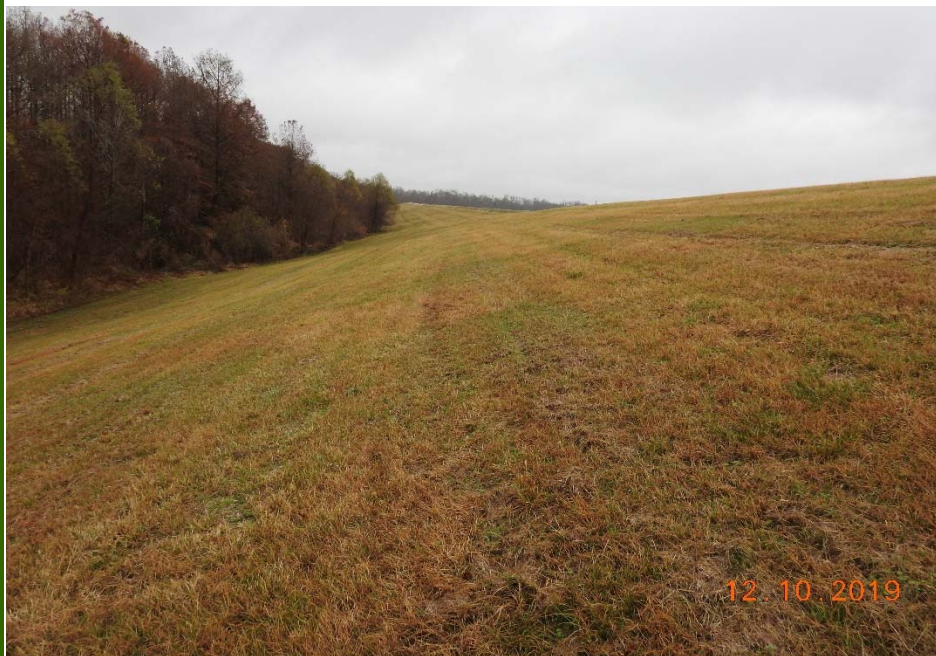
Bottom Ash Pond

Exterior slope of northern levee.

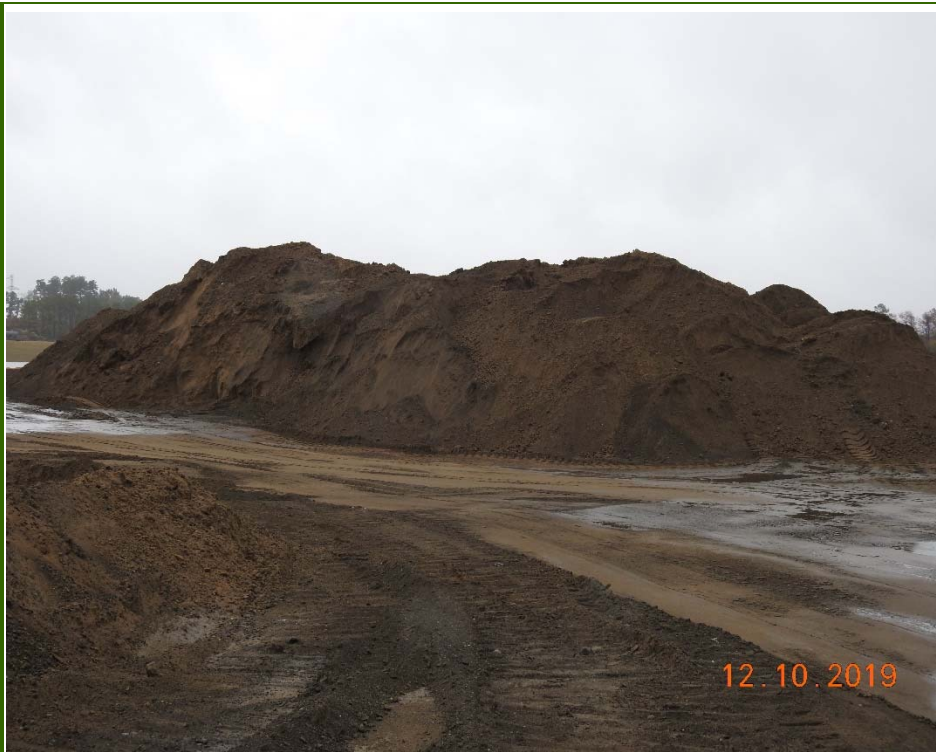
Bottom Ash Pond

Bottom ash shown in southeast corner of Bottom Ash Pond.

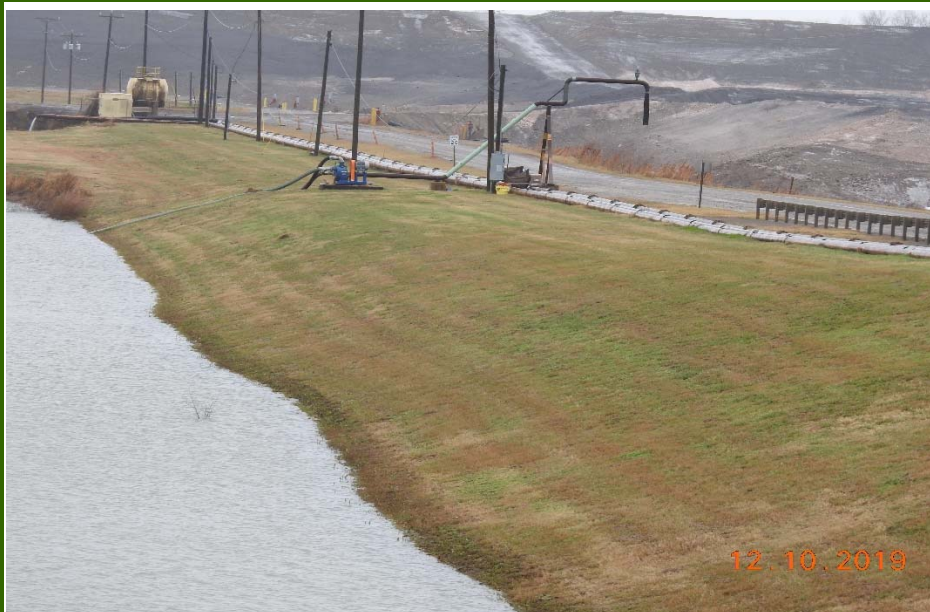
Bottom Ash Pond

Interior slope of southern levee.

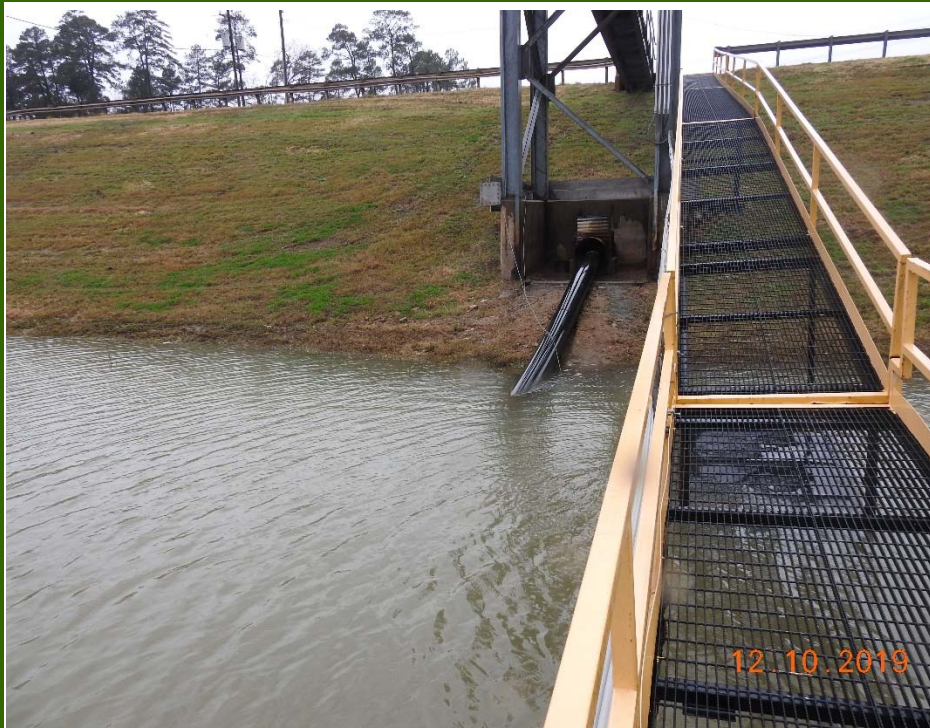
Bottom Ash Pond

Bottom Ash discharge pipe shown on interior of the western levee.
