ANNUAL CCR SURFACE IMPOUNDMENT INSPECTION			
Facility Name:		Cleco Brame Energy Center	
Address:		275 Rodemacher Rd. Lena, LA	
Surface Impoundment Name :	Fly Ash Pond	Owner:	Cleco Power LLC
Surface Impoundment ID:	P-0005	Operator:	Cleco Power LLC
Nearest City:	Boyce	Parish:	Rapides
Inspector:		James C. Van Hoof, P.E.	
Company:		Providence Engineering & Environmental Group LLC	
Date of Inspection:		1/11/2016	
Weather at Time of Inspection:		Sunny, Cool	
DESCRIPTION OF THE OPERATION OF THE SURFACE IMPOUNDMENTS:			
<p>The Brame Energy Center's Bottom Ash and Fly Ash surface impoundments are designed to accept the coal combustion residual (CCR) byproducts derived from burning of the Unit 2 coal for the generation of electricity. The ponds are classified by the Louisiana Department of Environmental Quality (LDEQ) as Type I Surface Impoundments. Water from the Fly Ash surface impoundment is pumped into the Bottom Ash impoundment which discharges by means of three pumps that discharge the wastewater through the outlet pipe on the northern end of the pond. This water discharges into Lake Rodemacher via LPDES outfall 401, thence to Bayou Jean de Jean via LPDES outfall 001, then to the Red R

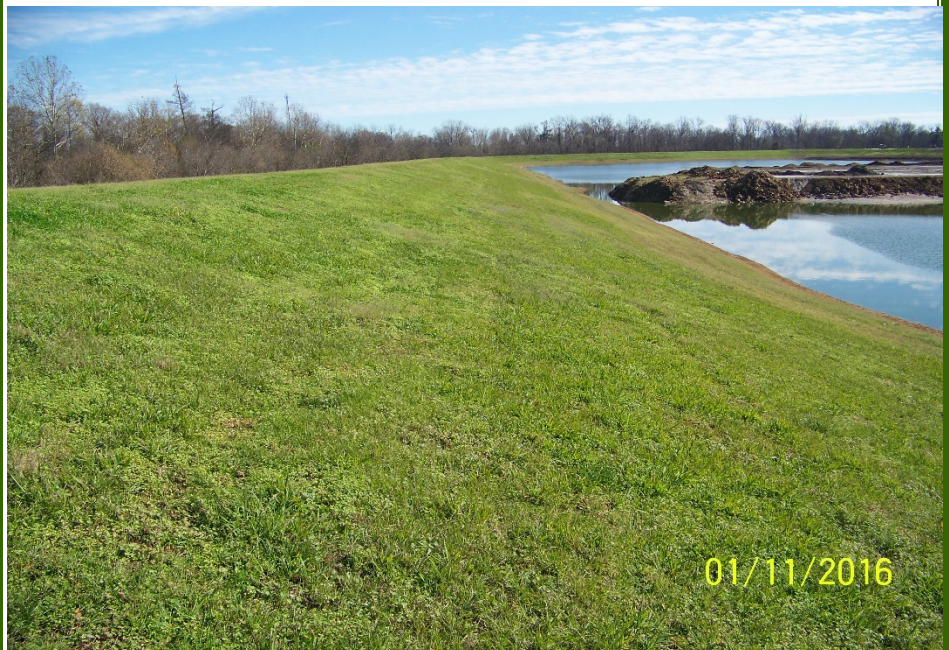
Internal slope of northern levee.

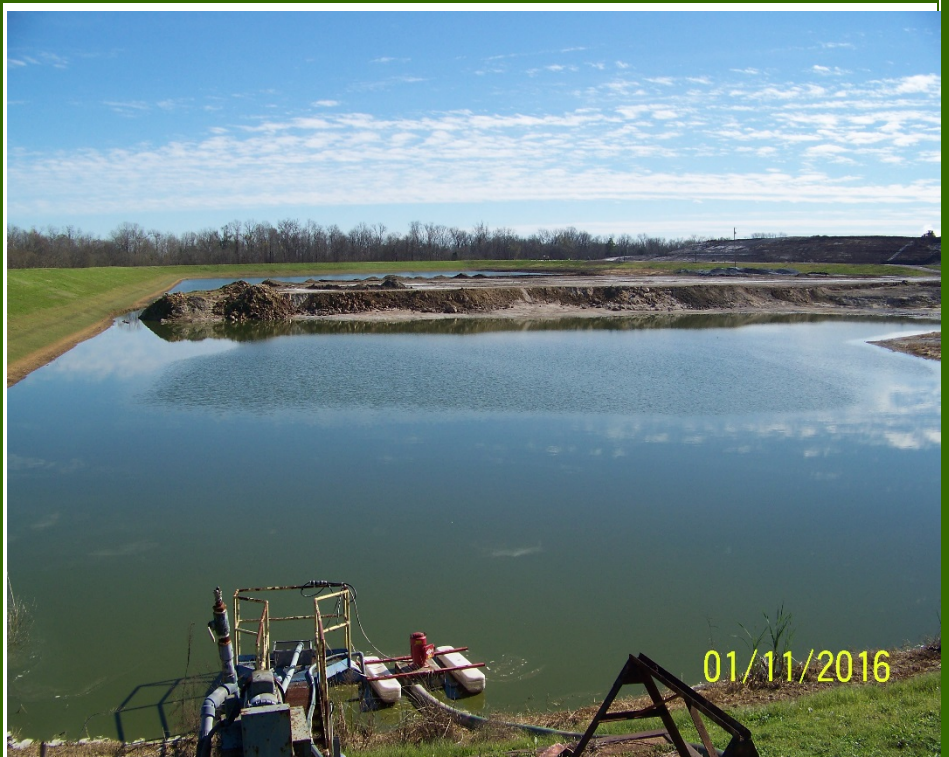
Pump system in Fly Ash Pond that pumps discharge into the Bottom Ash Pond.

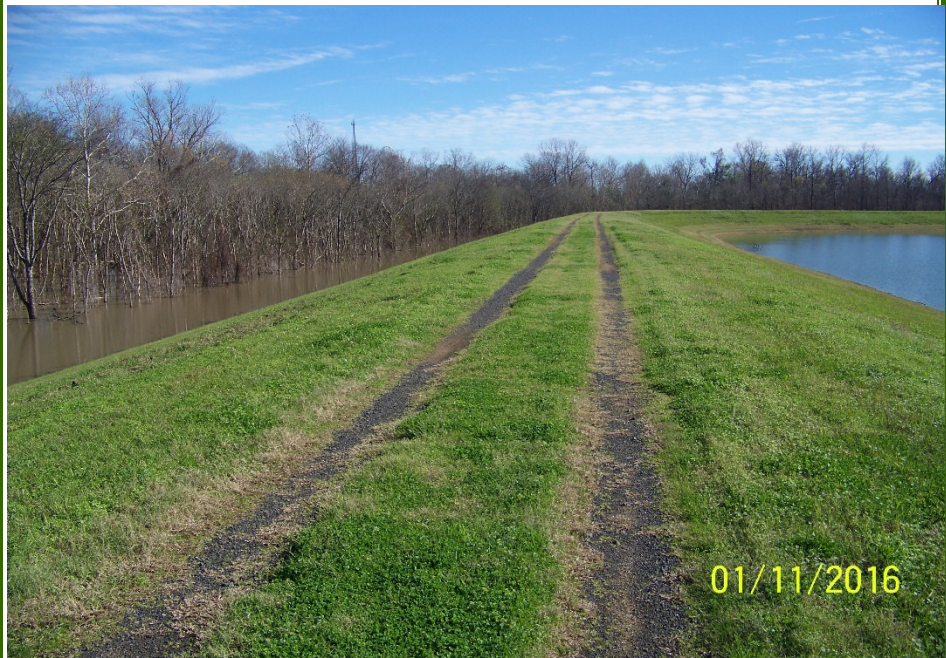
If yes, describe (size of area, location, severity, etc.)	
Findings:	The abutment/toe was inspected and appeared to be in satisfactory condition. No corrective actions are required at this time.
Other observations on the abutment/toe: It should be noted that the northern exterior toe was under water due to the rising water levels on the Red River backing up into Bayou Jean de Jean. Therefore inspection of that area was not possible.

Crest along the northern levee. High water levels from the Red River are shown along the exterior toe.

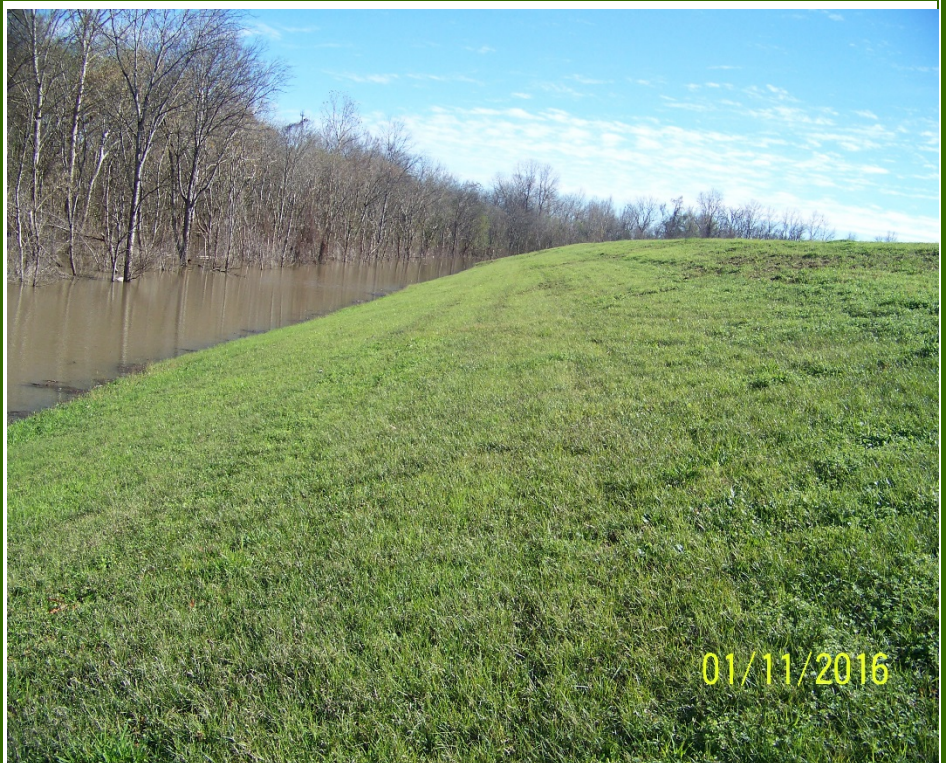
Northern exterior levee slope showing high water levels from the Red River along the exterior toe.

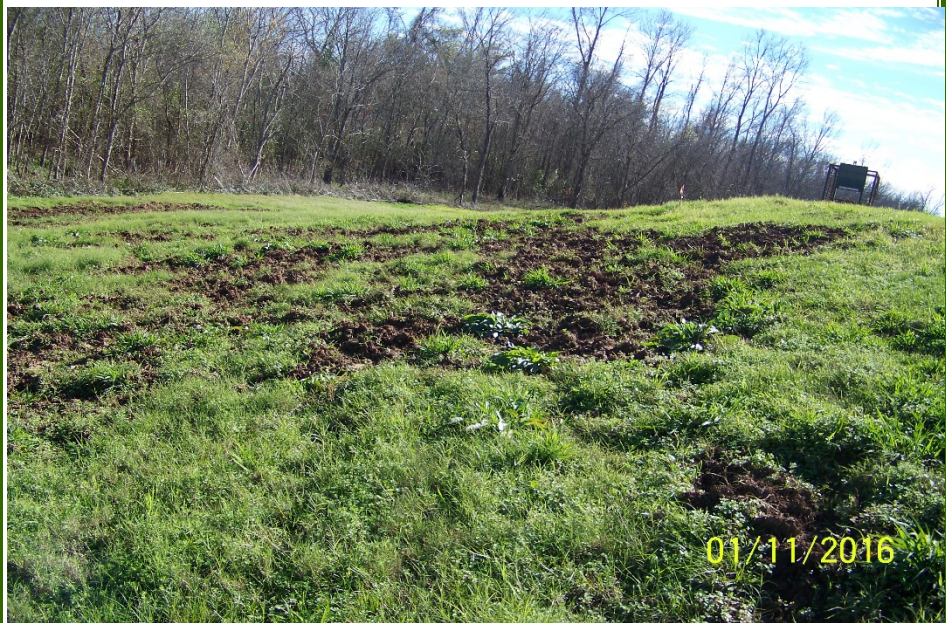
If yes, describe (size of area, location, severity, etc.)	
Are there any trees on the slopes?	<input type="checkbox"/> Yes <input checked="" type="checkbox"/> No
If yes, describe (type of vegetation, size, location, etc.)	
Findings:	The exterior slope was inspected and appeared to be in satisfactory condition. Only minor corrective actions are required at this time based on other observations below.
Other observations on the exterior slopes: Feral hogs have rooted an approximate 9,000 square foot area on the exterior slope of the Fly Ash Pond along the north and northeast levee. Traps have been set at this location to remove the hogs. Cleco is working with the local LA Department of Wildlife & Fisheries on this issue. Once the hogs have been removed from this area Cleco will smooth the area, then seed and fertilize.

DOCUMENTATION REVIEW:	
Weekly Inspections Reviewed:	<input checked="" type="checkbox"/> Yes <input type="checkbox"/> No
Findings: Feral hogs rooting on Fly Ash Pond levee was noted.	
Monthly Instrument Inspections Reviewed:	<input checked="" type="checkbox"/> Yes <input type="checkbox"/> No
Findings: No issues noted	
Groundwater Monitoring:	Monitoring wells are in-place.
Drawings Reviewed:	<input checked="" type="checkbox"/> Yes <input type="checkbox"/> No
Are there any changes in the geometry of the surface impoundment structure since the previous inspection?	<input type="checkbox"/> Yes <input type="checkbox"/> No <input checked="" type="checkbox"/> NA
If yes, describe (size, location, etc.)	
Other observations:	None

Area along the exterior levee showing where the feral hogs have rooted the area.

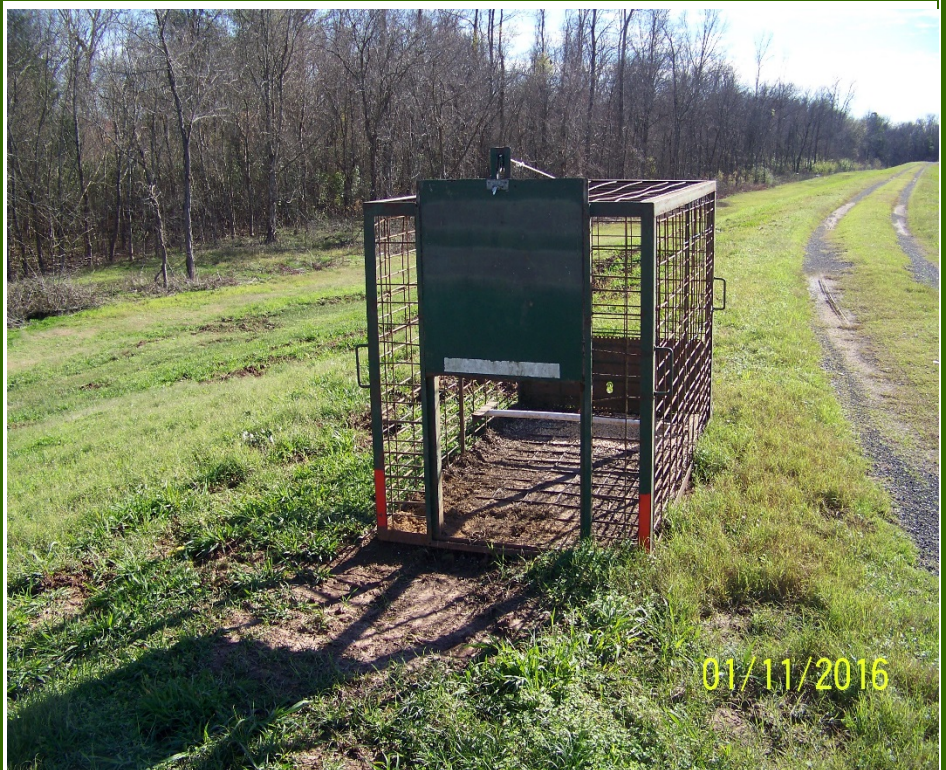
Hog trap set along the eastern levee.

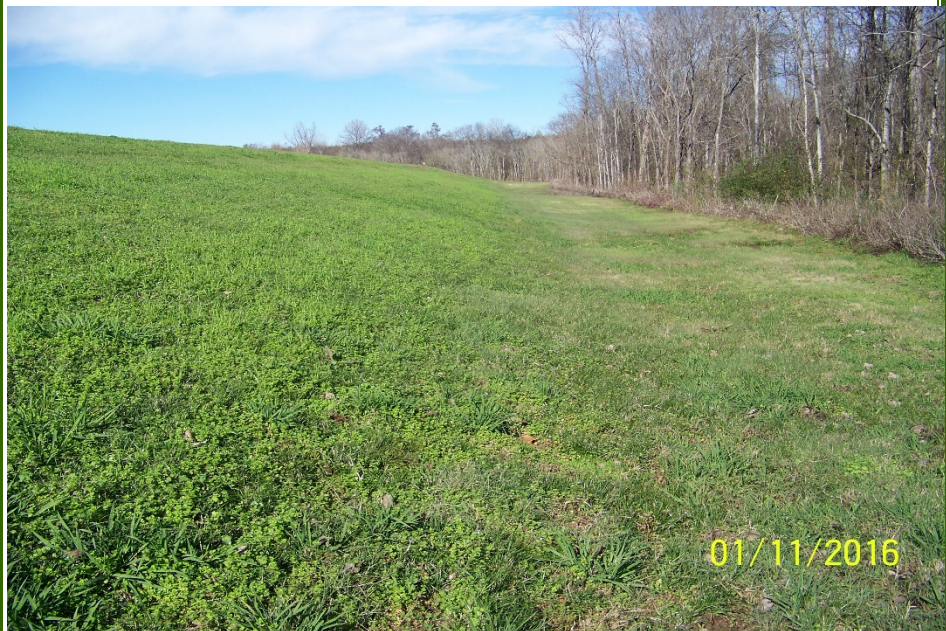
Eastern exterior slope of levee.

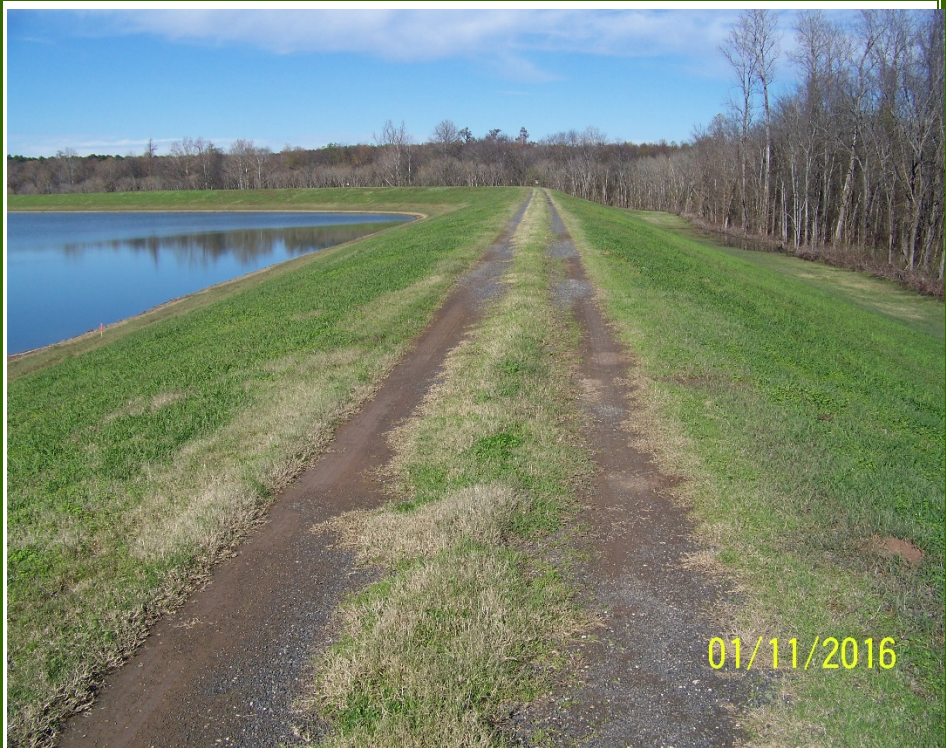
Crest along eastern levee.

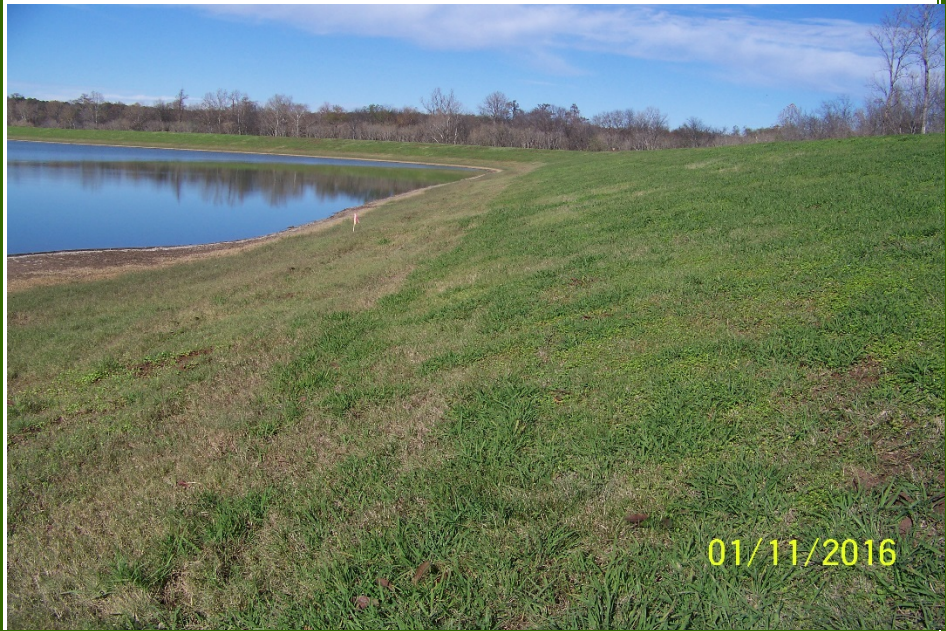
Eastern internal slope of levee.

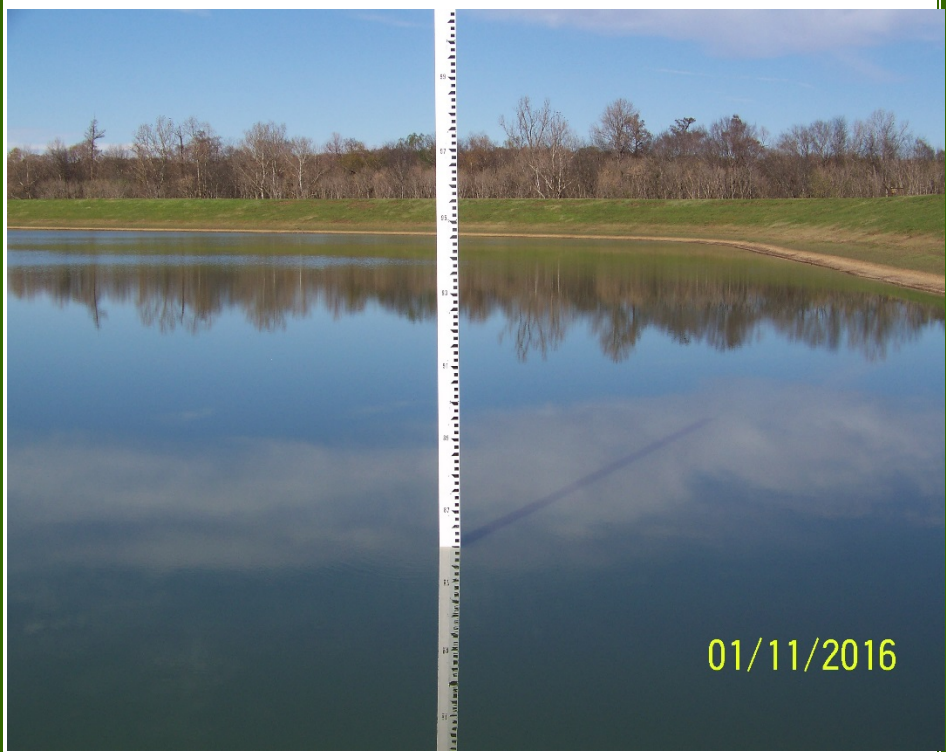
Level Gauge on Fly Ash Pond.

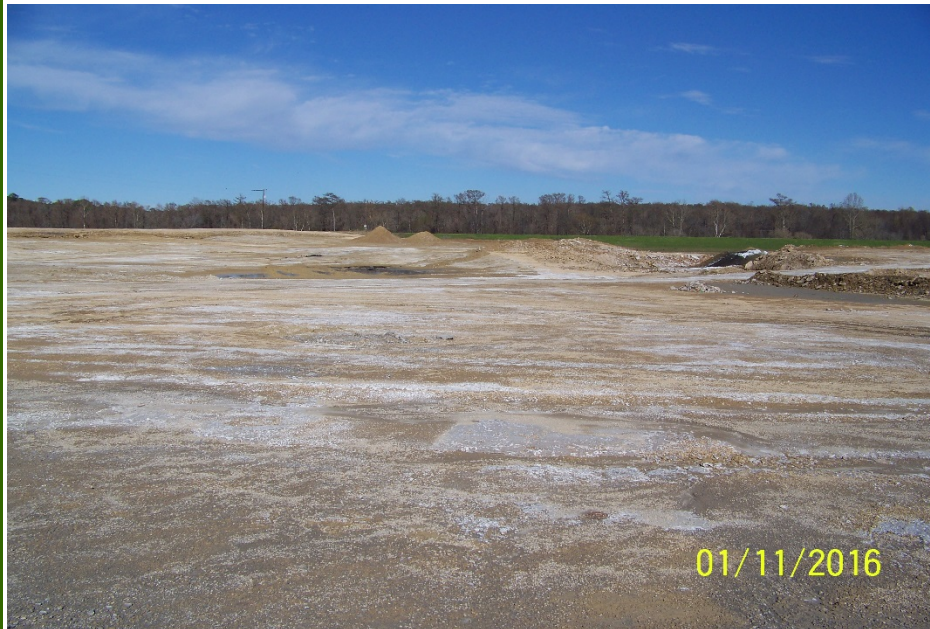
Fly ash in the Fly Ash Pond.

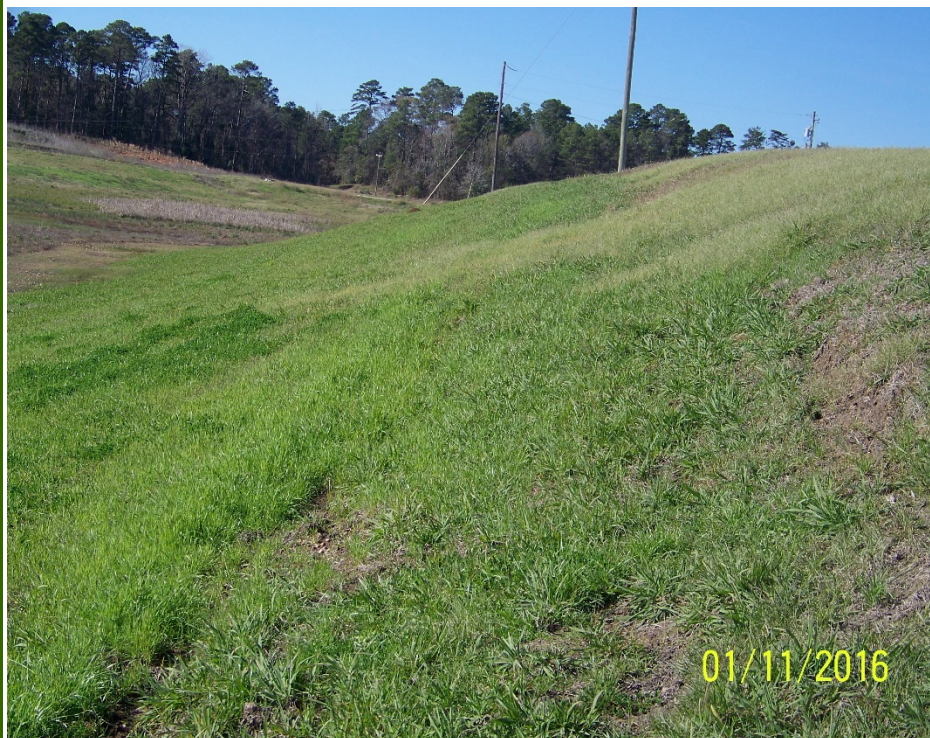
Southern exterior slope of levee.
