ANNUAL CCR SURFACE IMPOUNDMENT INSPECTION			
Facility Name:		Cleco Brame Energy Center	
Address:		275 Rodemacher Rd. Lena, LA	
Surface Impoundment Name :	Fly Ash Pond	Owner:	Cleco Power LLC
Surface Impoundment ID:	P-0005	Operator:	Cleco Power LLC
Nearest City:	Boyce	Parish:	Rapides
Inspector:		James C. Van Hoof, P.E.	
Company:		Providence Engineering & Environmental Group LLC	
Date of Inspection:		12/10/2018	
Weather at Time of Inspection:		Sunny, Cool	
DESCRIPTION OF THE OPERATION OF THE SURFACE IMPOUNDMENTS:			
<p>The Brame Energy Center's Bottom Ash and Fly Ash surface impoundments are designed to accept the coal combustion residual (CCR) byproducts derived from burning of the Unit 2 coal for the generation of electricity. The ponds are classified by the Louisiana Department of Environmental Quality (LDEQ) as Type I Surface Impoundments. Water from the Fly Ash surface impoundment is pumped into the Bottom Ash impoundment which discharges by means of three pumps that discharge the wastewater through the outlet pipe on the western end of the pond. This water discharges into Lake Rodemacher via LPDES outfall 401, thence to Bayou Jean de Jean via LPDES outfall 001, then to the Red R

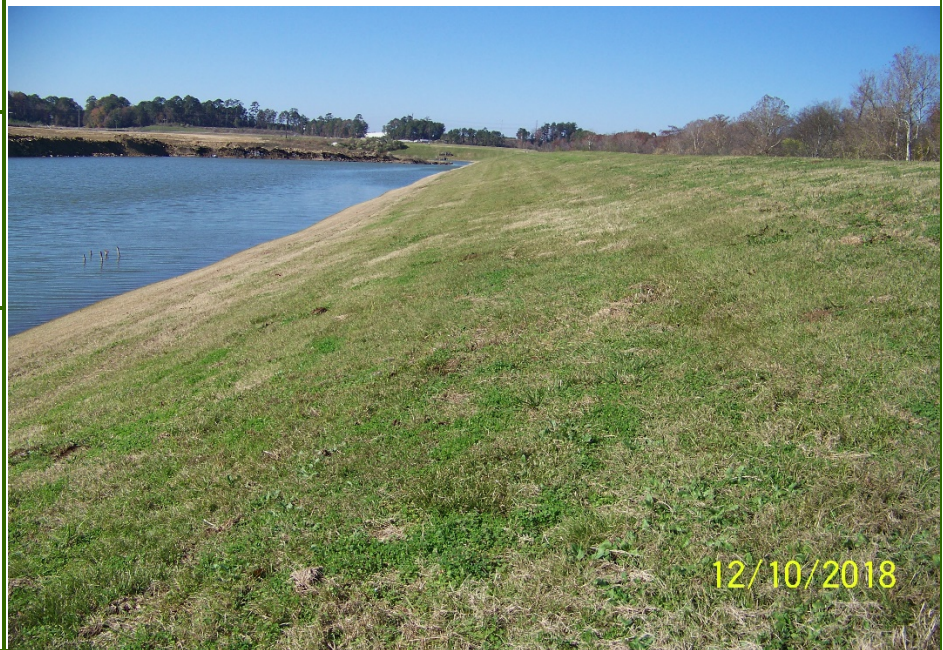
Interior slope of northern levee.

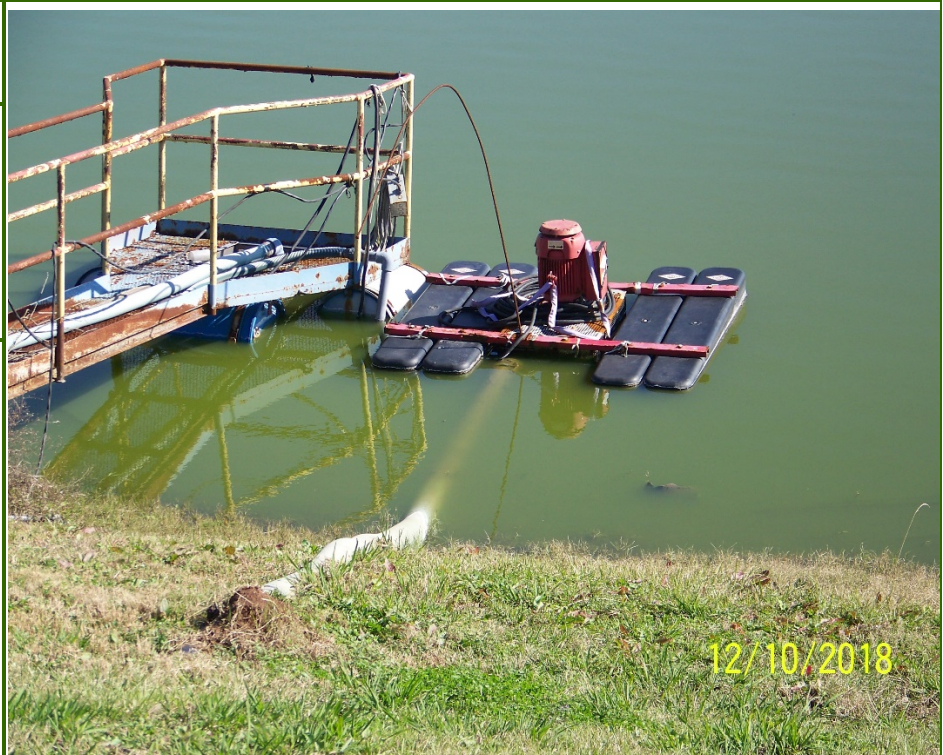
Pump system in Fly Ash Pond that pumps discharge water into the Bottom Ash Pond.

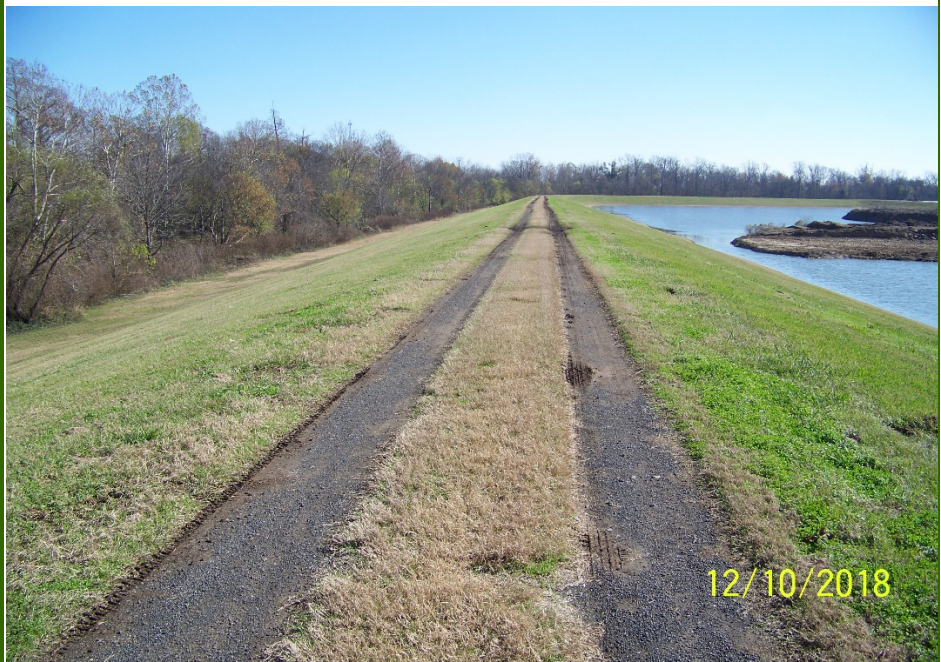
Crest along the northern levee.

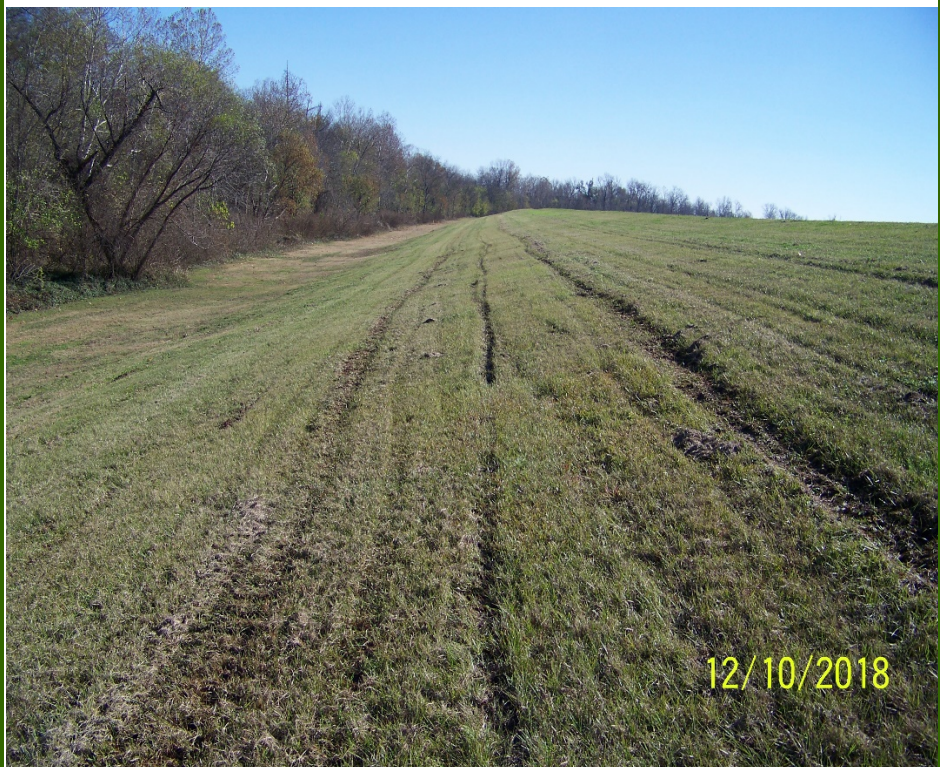
Northern exterior levee slope.

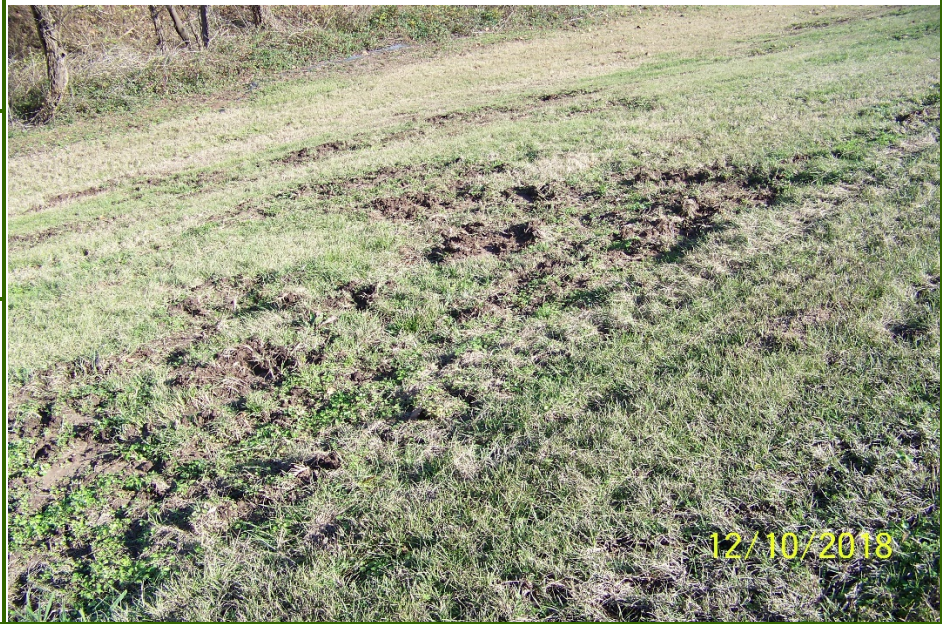
DOCUMENTATION REVIEW:	
Weekly Inspections Reviewed:	<input checked="" type="checkbox"/> Yes <input type="checkbox"/> No
Findings: Feral hogs rutted topsoil on exterior levee.	
Monthly Instrument Inspections Reviewed:	<input checked="" type="checkbox"/> Yes <input type="checkbox"/> No
Findings: No Issues.	
Groundwater Monitoring:	Monitoring wells are in-place.
Drawings Reviewed:	<input checked="" type="checkbox"/> Yes <input type="checkbox"/> No
Are there any changes in the geometry of the surface impoundment structure since the previous inspection?	<input type="checkbox"/> Yes <input checked="" type="checkbox"/> No <input type="checkbox"/> NA
If yes, describe (size, location, etc.)	
Other observations:	None

Area along the exterior levee showing where the feral hogs have recently rooted the topsoil.

Are there any trees on the slopes?	<input type="checkbox"/> Yes <input checked="" type="checkbox"/> No
If yes, describe (type of vegetation, size, location, etc.)	
Findings:	The exterior slope was inspected and appeared to be in satisfactory condition. Only minor corrective actions are required at this time based on other observations below.
Other observations on the exterior slopes:	Feral hogs have rooted an approximate 1,000 square foot topsoil area on the exterior slope of the Fly Ash Pond along the northeast corner. The area needs to be smoothed, then seeded and fertilized to prevent erosion.

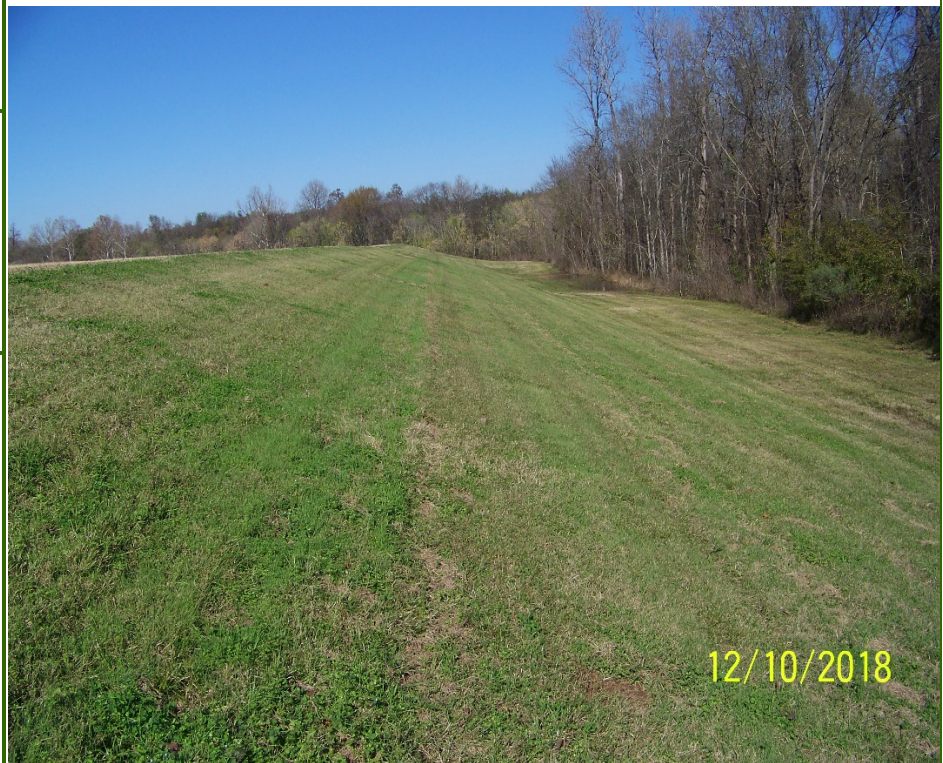
Eastern exterior slope of levee.

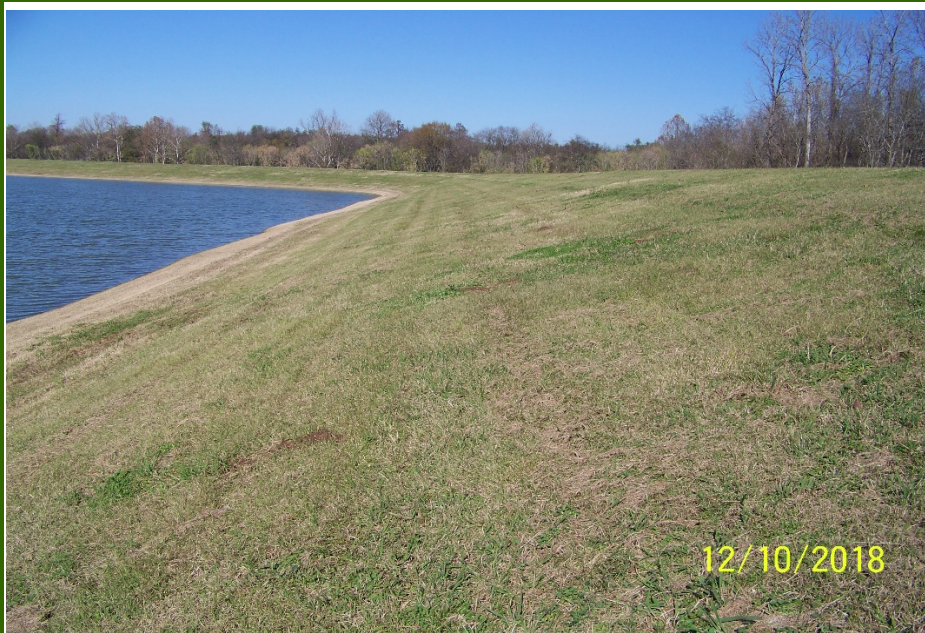
Eastern interior slope of levee.

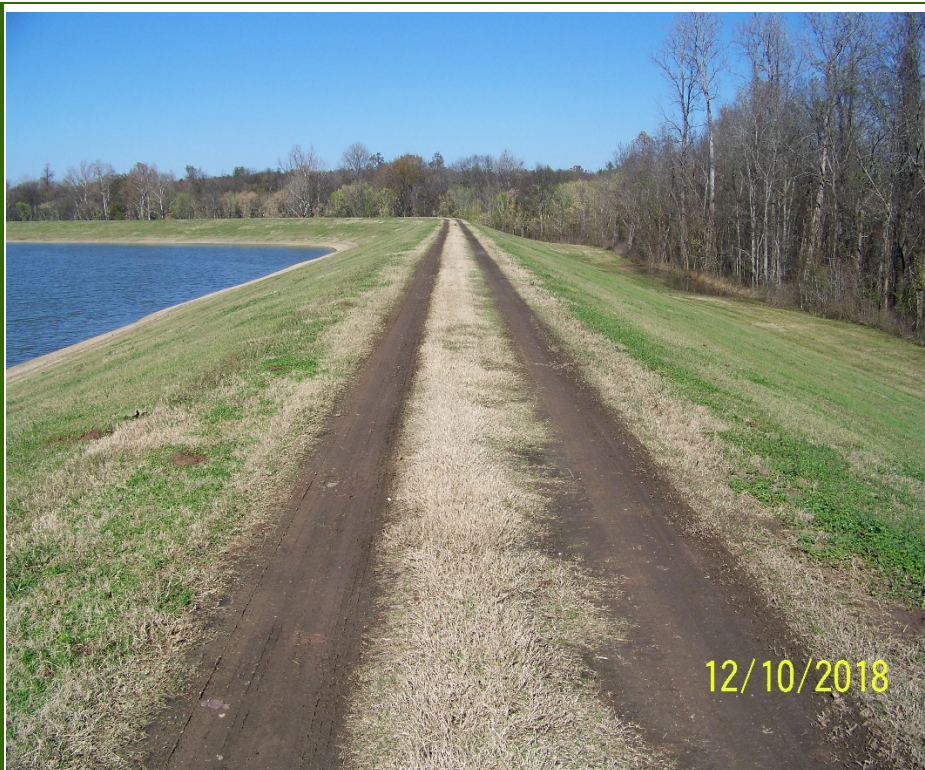
Crest along eastern levee.

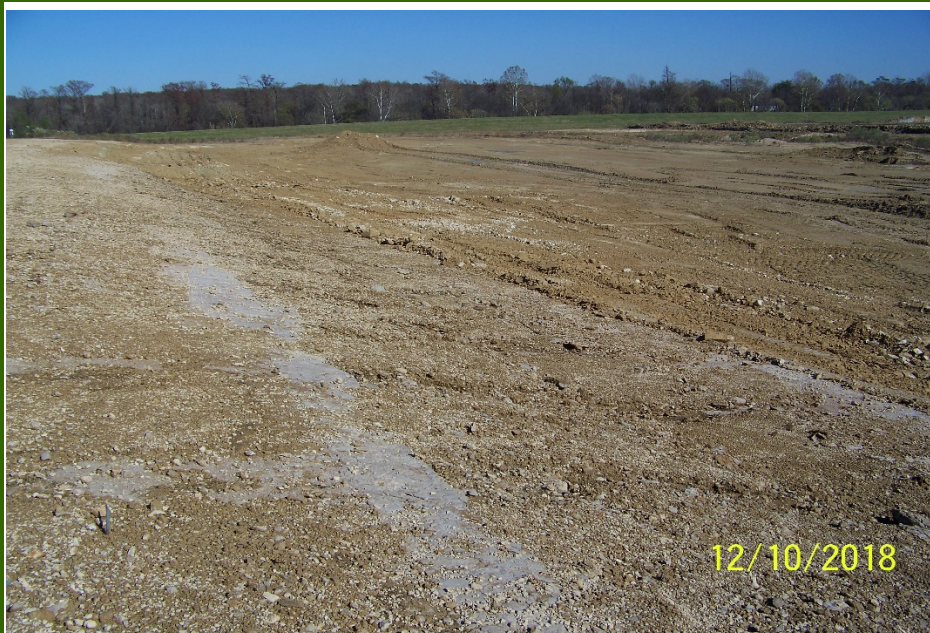
Fly ash in the Fly Ash Pond.

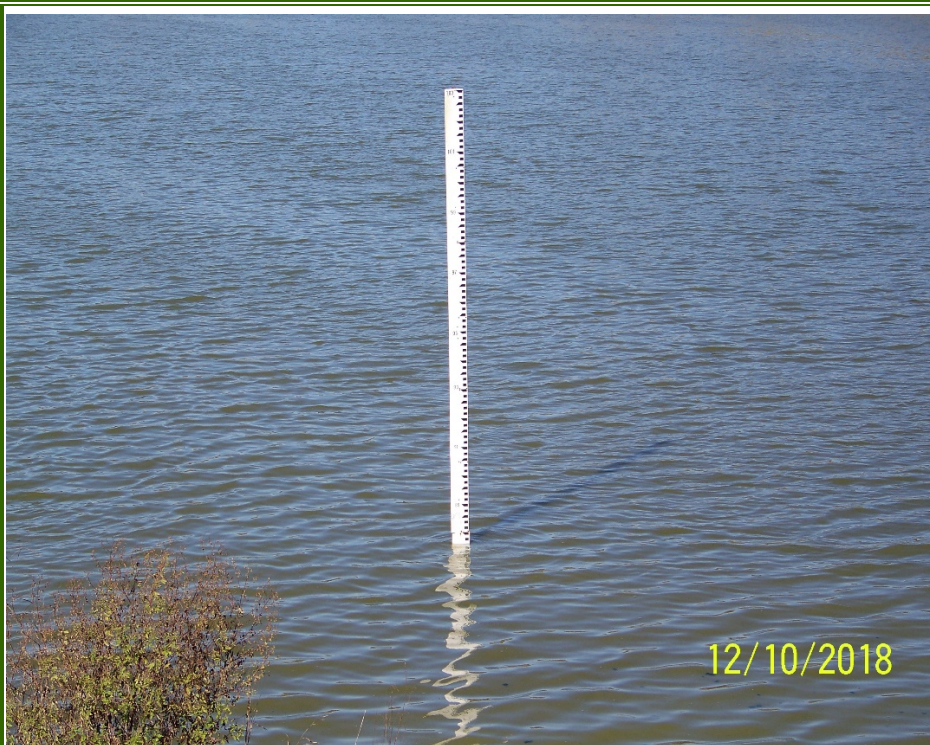
Level Gauge in Fly Ash Pond.
